September 28, 2022

RE: TREE CONSERVATION REPORT FOR 210 CLEARVIEW AVENUE, OTTAWA

DRAWING: Tree Information Plan

PROJECT: 210 CLEARVIEW AVENUE
CITY OF OTTAWA

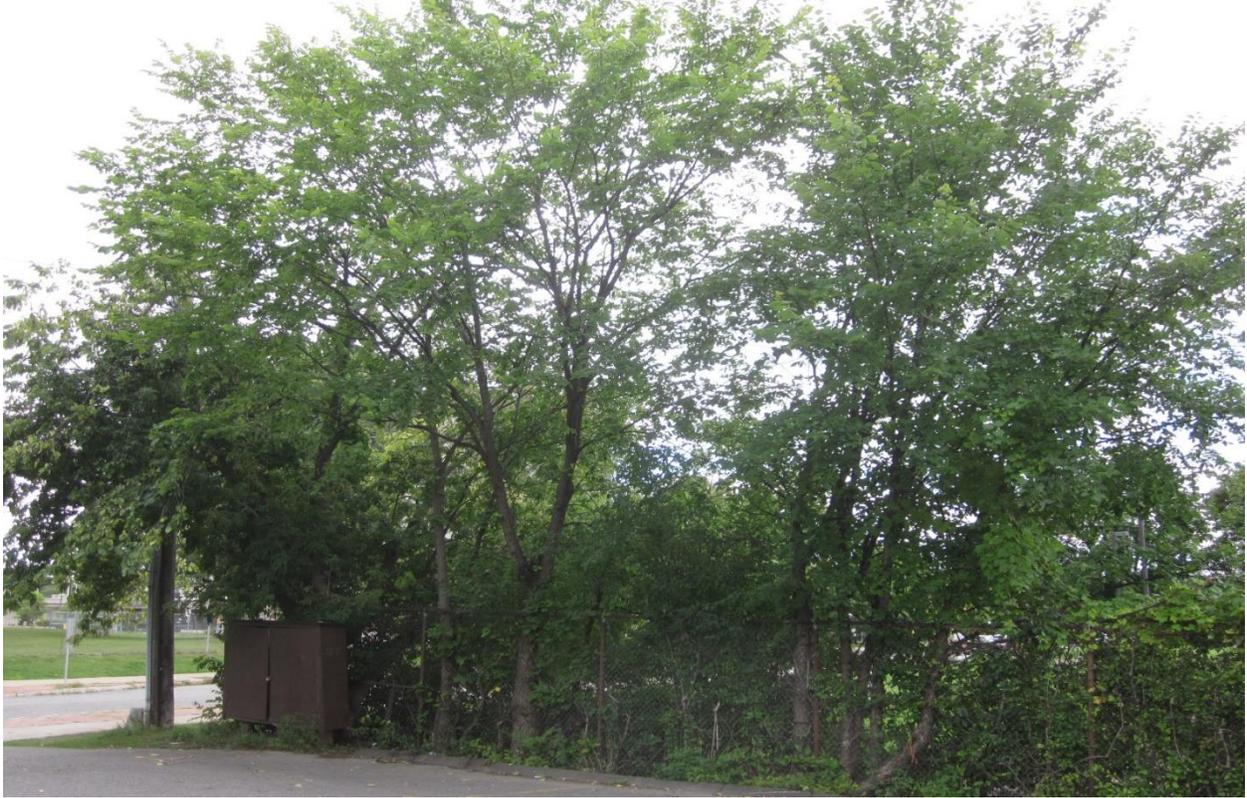
5	White elm (<i>Ulmus americana</i>)	12	Shared	Fair; maturing; divergent form towards northwest; leader offset due to past clearance pruning from over property line; no outward signs of Dutch elm disease (<i>Ophiostoma novo-ulmi</i>); native species
6	White elm (<i>Ulmus americana</i>)	16	Shared	Good; maturing; generally upright form with co-dominant leaders at 4m; no outward signs of Dutch elm disease (<i>Ophiostoma novo-ulmi</i>); native species
7	White elm (<i>Ulmus americana</i>)	16	Shared	Good; maturing; generally upright form with suppressed lateral at 3m on northwest and co-dominant leaders at 4m; no outward signs of Dutch elm disease (<i>Ophiostoma novo-ulmi</i>); native species
8	White elm (<i>Ulmus americana</i>)	14 avg.	Shared	Fair; maturing; double stemmed at grade; divergent and asymmetric towards southeast; no outward signs of Dutch elm disease (<i>Ophiostoma novo-ulmi</i>); native species

9	White elm (<i>Ulmus americana</i>)	12 avg.	Shared	Fair; maturing; double stemmed at grade; divergent and asymmetric towards northwest; growing through chain link fence; no outward signs of Dutch elm disease (<i>Ophiostoma novo-ulmi</i>); native species

Picture 1. Trees #5 to 11 at 210 Clearview Avenue

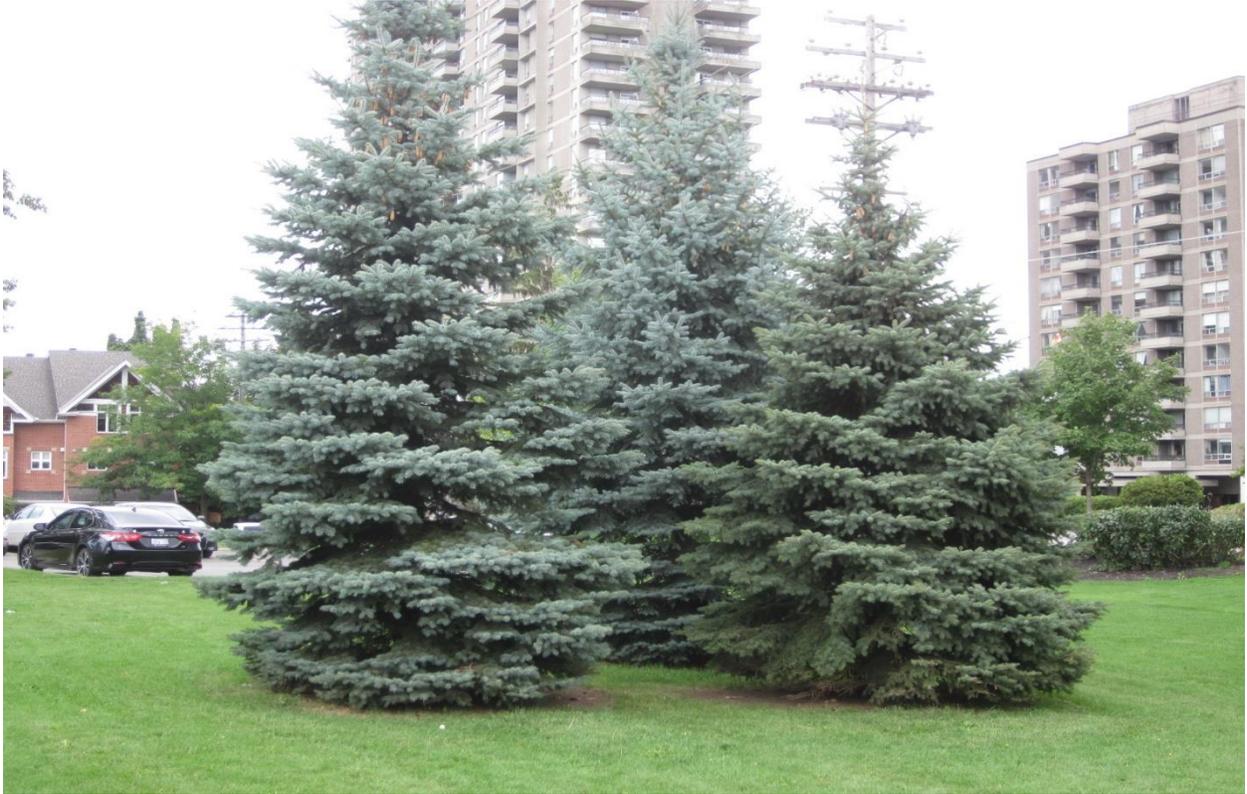
17	Colorado spruce (<i>Picea pungens</i>)	18	Private	Good; maturing; living crown held to ground; good crown density, growth increment and needle colour; introduced species
18	Buckthorn (<i>Rhamnus spp.</i>)	10 avg.	Private	Fair; mature; multi-stemmed from grade; introduced invasive species

Picture 2. Trees #15-17 at 210 Clearview Avenue

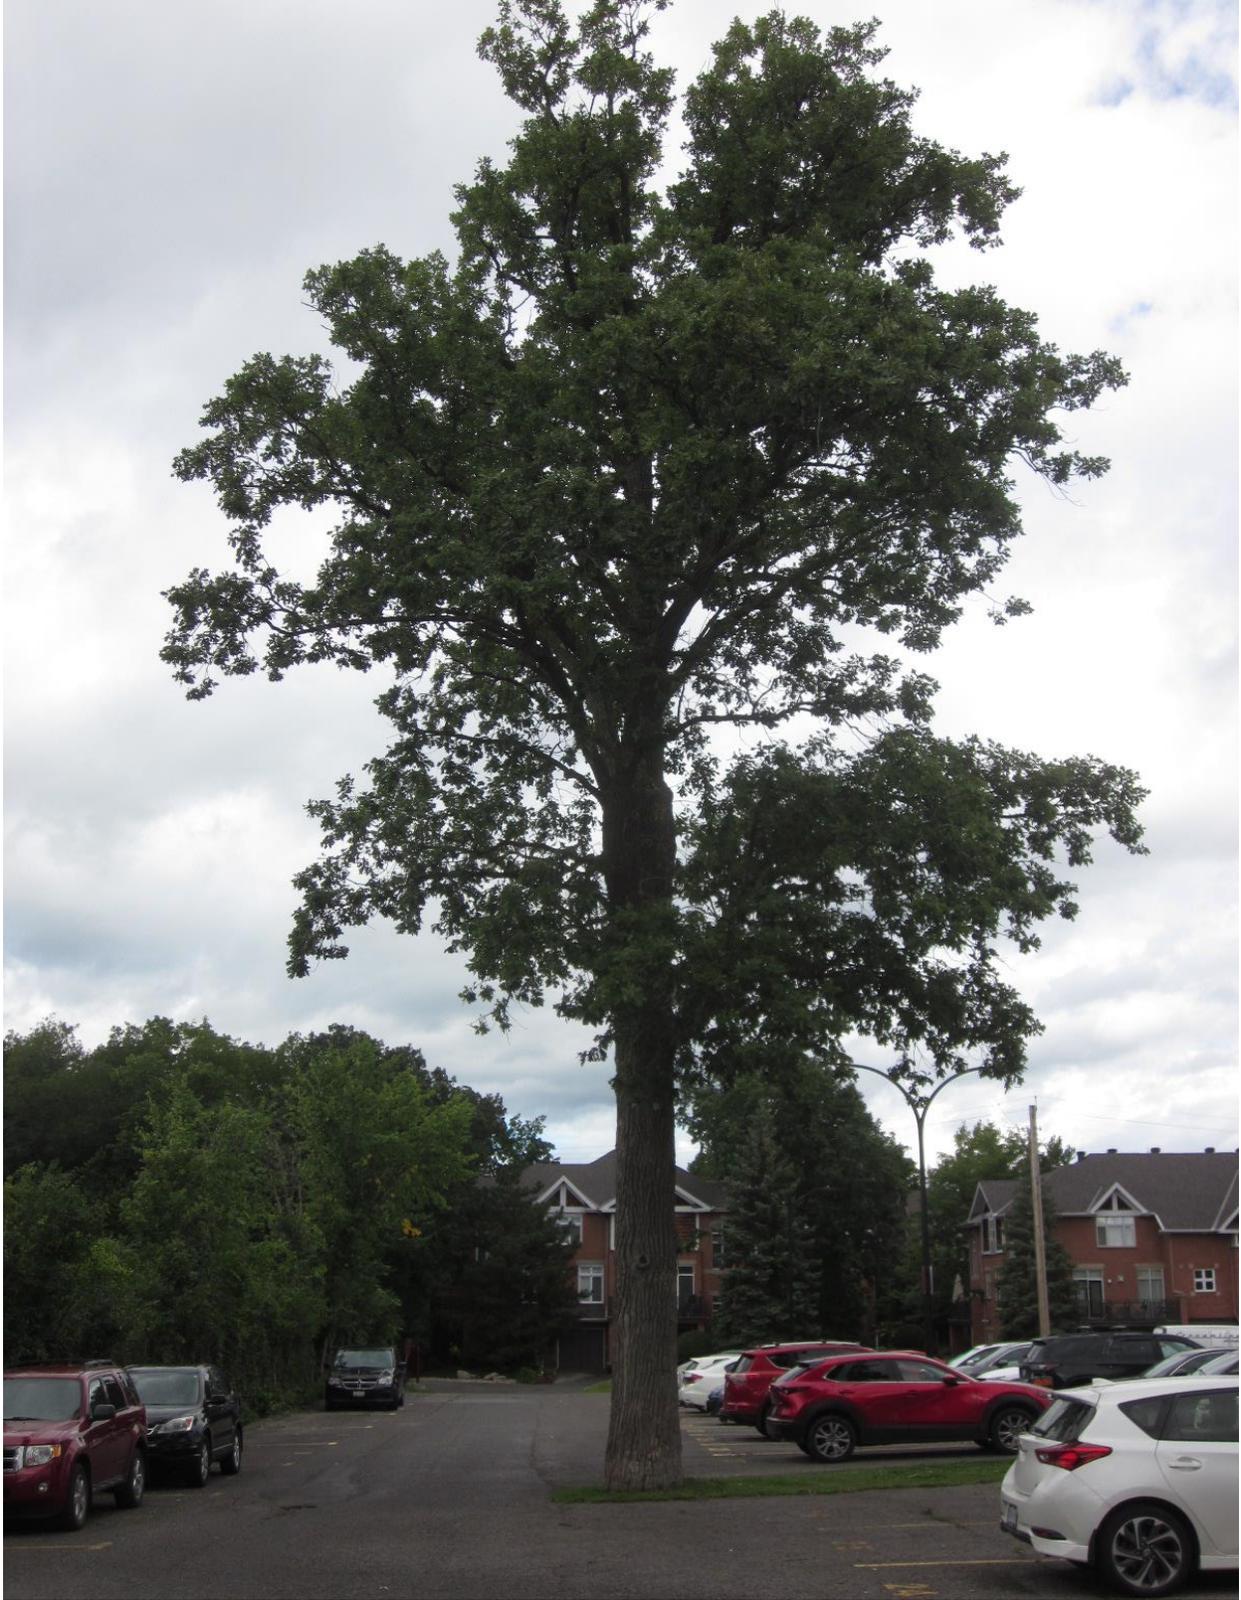
Tree No.	Tree species	DBH ¹ (cm)	Owner -ship ²	Condition, age class, tree condition notes & species origin
1	White elm (<i>Ulmus americana</i>)	16	Shared	Good; maturing; single stemmed with three competing leaders at 3.5m; no outward signs of Dutch elm disease (<i>Ophiostoma novo-ulmi</i>); native species
2	White elm (<i>Ulmus americana</i>)	17	Shared	Fair; maturing; divergent form and crown asymmetric towards southeast; no outward signs of Dutch elm disease (<i>Ophiostoma novo-ulmi</i>); native species
3	White elm (<i>Ulmus americana</i>)	14	Shared	Good; maturing; generally upright in form; co-dominant leaders at 4m; intertwined with tree #2; no outward signs of Dutch elm disease (<i>Ophiostoma novo-ulmi</i>); native species
4	Bur oak (<i>Quercus macrocarpa</i>)	88	Private	Fair; very mature; upright form; co-dominant stems at 8.5m with cavity in between; extremely restricted rooting area; good crown density and leaf colour; dieback pruned in past; native species

Picture 3. Tree #4 at 210 Clearview Avenue

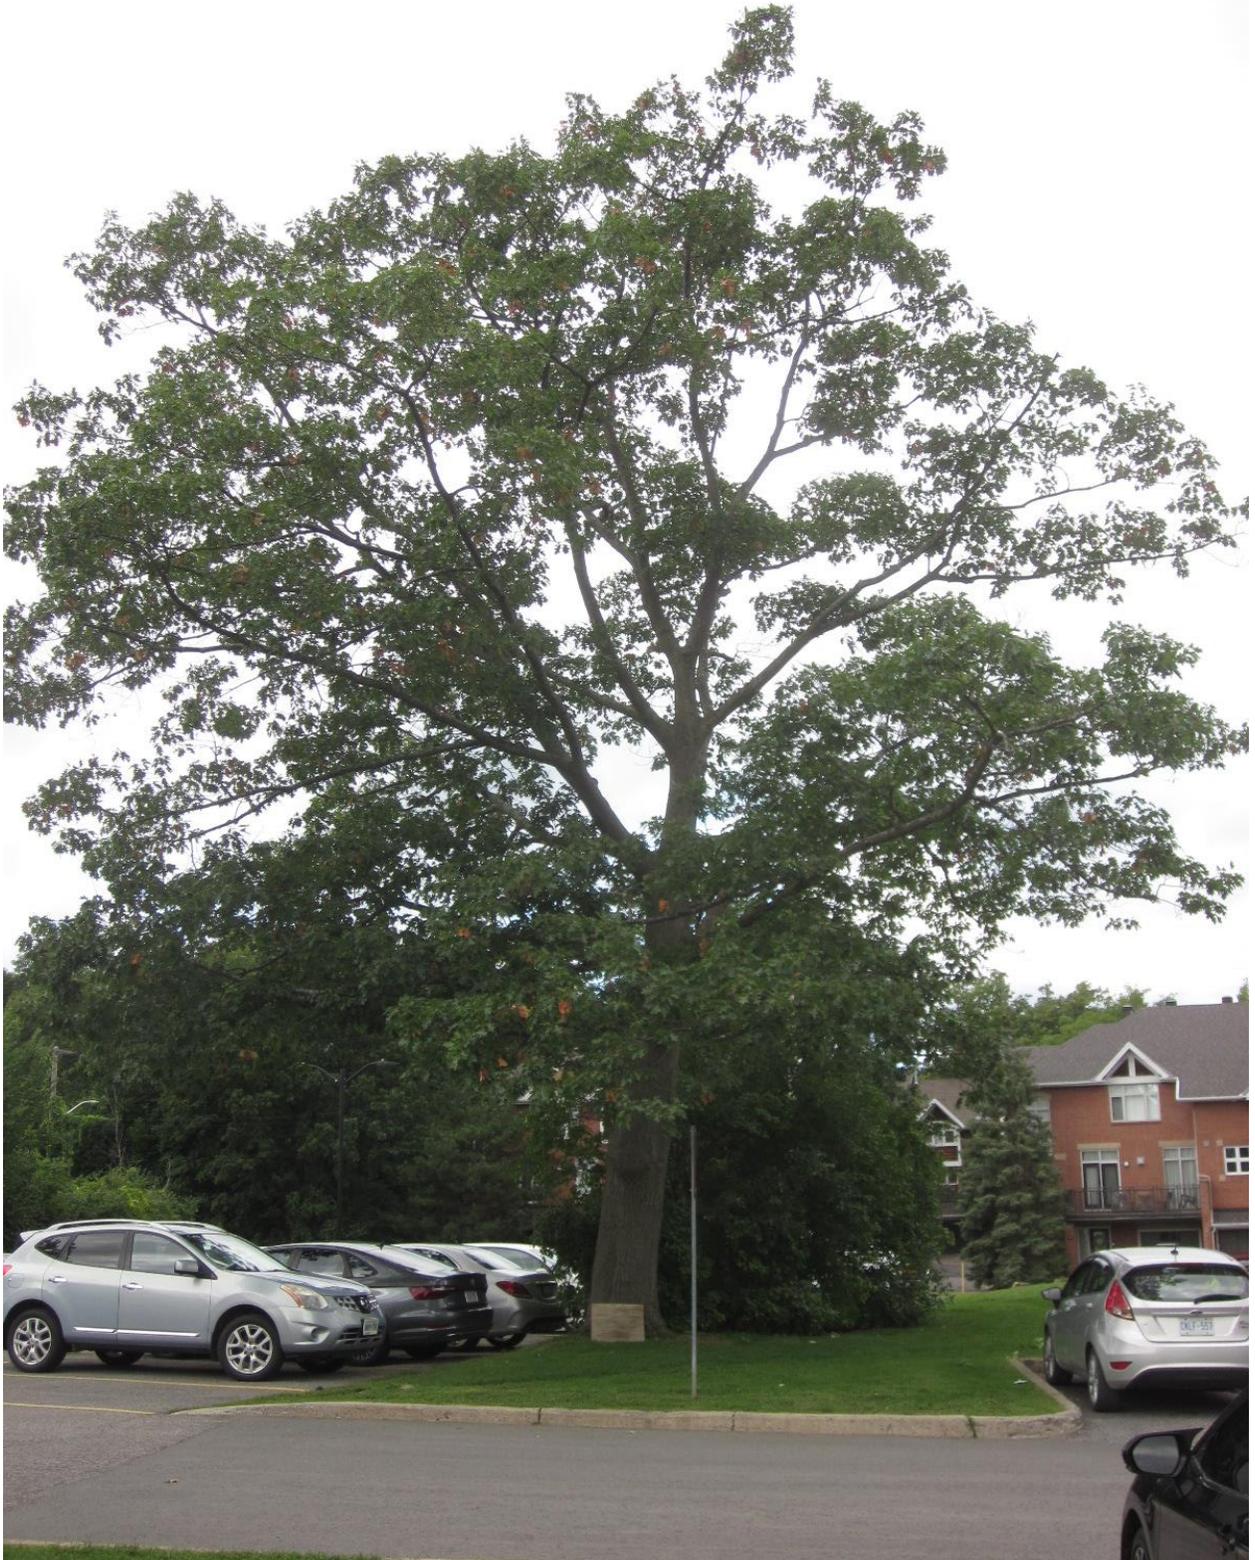
Tree No.	Tree species	DBH ¹ (cm)	Owner -ship ²	Condition, age class, tree condition notes & species origin
19	Red oak (<i>Quercus rubra</i>)	85	Private	Fair; very mature; main stem mildly divergent towards east with co-dominant leaders at 7m; suppressed laterals starting at 3m; broad crown with good density and leaf colour; moderately restricted rooting area – roots deflecting away from edge of edge of asphalt parking lot; native species
20	Red maple (<i>Acer rubrum</i>)	36	Private	Good; mature; generally upright form – central dominant stem with parallel competing laterals at 1.5-1.75m; native species
21	Red maple (<i>Acer rubrum</i>)	31	Private	Good; mature; co-dominant stems at 3m; primary union weak; crown asymmetric towards northwest due to influence of tree #20; several binding roots; native species
22	Norway spruce (<i>Picea abies</i>)	36	Private	Fair; mature; planted on slight rise in elevation – droughty location; fair crown density, growth increment and needle colour; introduced species

Picture 4. Tree #19 at 210 Clearview Avenue

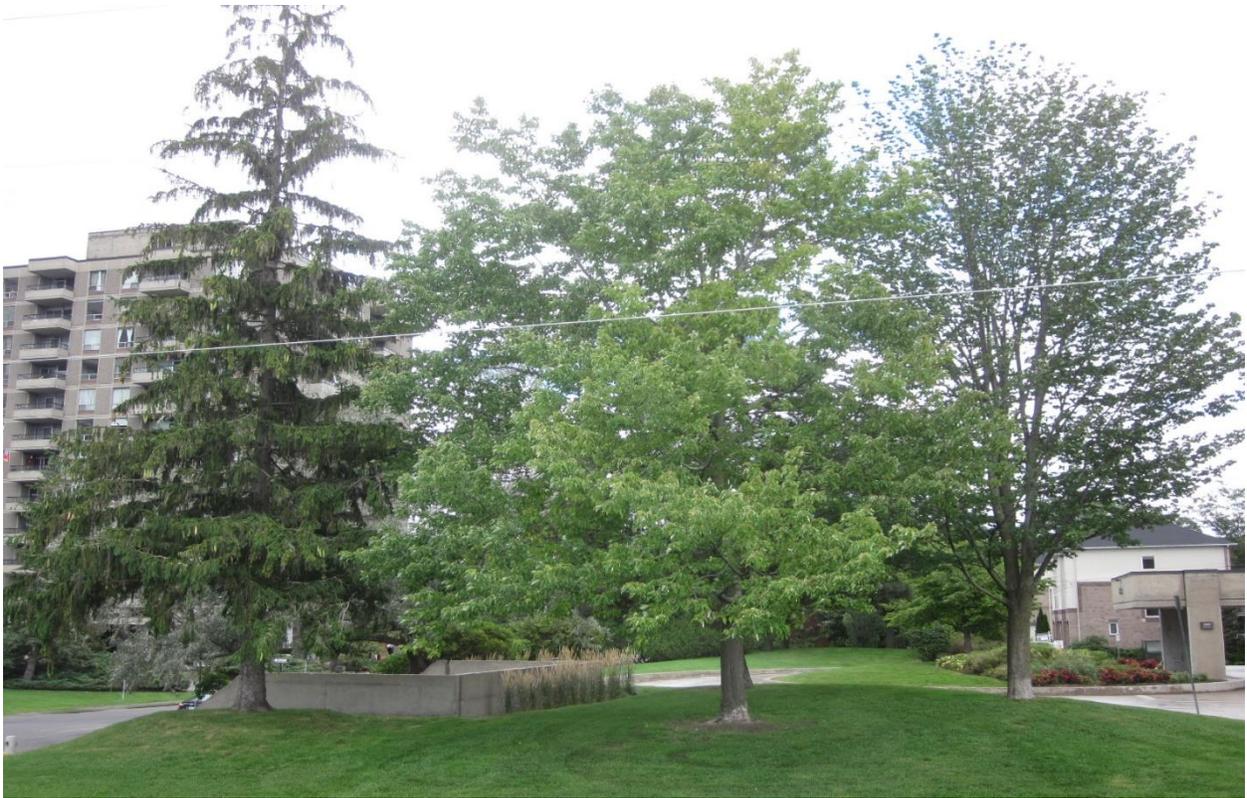
23	Austrian pine (<i>Pinus nigra</i>)	32	Private	Good; mature; upright form; crown mildly asymmetric towards east/northeast due to influence of trees #20 and 21; good crown density, growth increment and needle colour; mild diplodia tip blight (<i>Sphaeropsis sapinea</i>); introduced species
24	Russian-olive (<i>Elaeagnus angustifolia</i>)	33 avg.	Private	Fair; mature; four stemmed from grade; stems mildly to heavily divergent towards west; crown asymmetric due to ongoing need to clearance prune from garage ramp; introduced invasive species
25	Crab apple (<i>Malus spp.</i>)	21	Private	Good; maturing; bole divergent towards northeast; central stem straightens at 2.25m; laterals start at 1.5m; dense crown; cultivar
26	Little-leaf linden (<i>Tilia cordata</i>)	41	Private	Good; mature; upright form; co-dominant stems at 4m – parallel; crown dense, asymmetric towards west; multiple binding roots; introduced species

Picture 5. Trees #20, 21 and 22 (right to left) at 210 Clearview Avenue

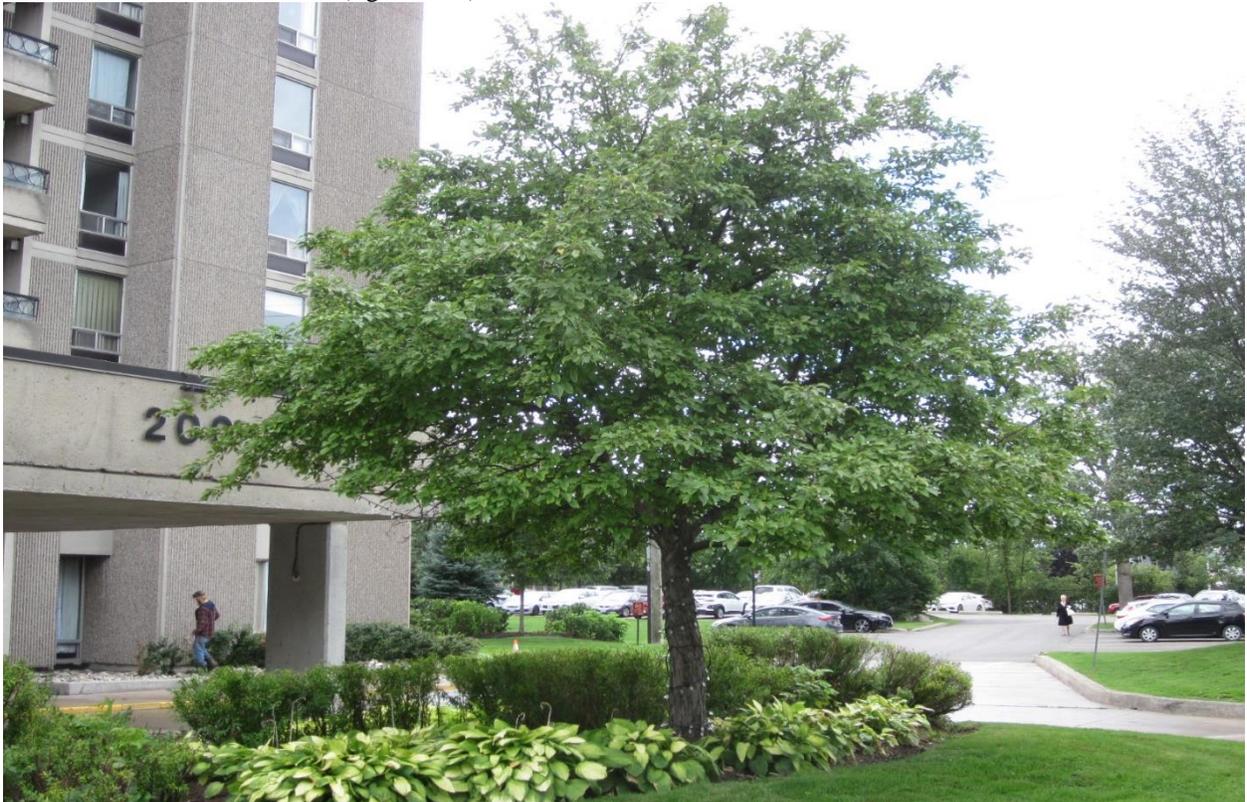
Picture 6. Tree #25 at 210 Clearview Avenue

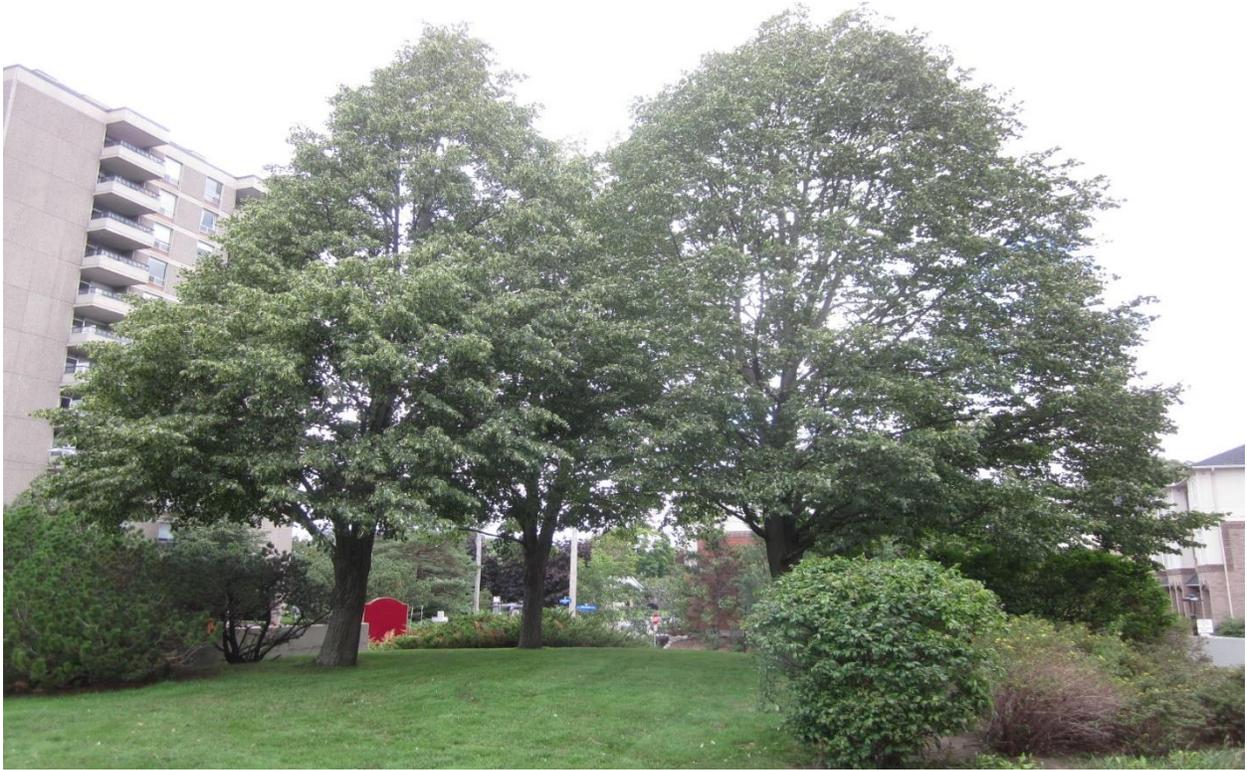
27	Little-leaf linden (<i>Tilia cordata</i>)	42	Private	Good; mature; central stem with competing lateral at 1.5m on west; mildly divergent and moderately asymmetric towards south due to influence of trees #26 and 28; several girdling roots; broad, moderately dense crown; introduced species

Tree No.	Tree species	DBH ¹ (cm)	Owner -ship ²	Condition, age class, tree condition notes & species origin
28	Little-leaf linden (<i>Tilia cordata</i>)	34	Private	Good; mature; co-dominant stems at 2m; mildly divergent and moderately asymmetric towards east/northeast; crown moderately dense; root collar obscured; introduced species
29	Mugho pine (<i>Pinus mugo</i>)	14 avg.	Private	Fair; very mature; three stems at grade – all heavily divergent towards east; fair crown density, growth increment and needle colour; introduced species
30	Norway maple (<i>Acer platanoides</i>)	26	City	Good; mature; ‘Crimson King’ variety; central stem with co-dominant leaders at 5.5m; upper stem divergent towards north due to influence of tree #31; exposed root collar – planted high; seam on north side of bole to 1.5m; introduced invasive species
31	Little-leaf linden (<i>Tilia cordata</i>)	57	Private	Good; very mature; co-dominant stems at 4m; mildly divergent towards north/northeast; crown mildly asymmetric due to ongoing clearance pruning from building; multiple binding roots; several exposed, damaged surface roots; introduced species

Picture 7. Trees #26 and 27 (foreground) and #28 (background) at 210 Clearview Avenue

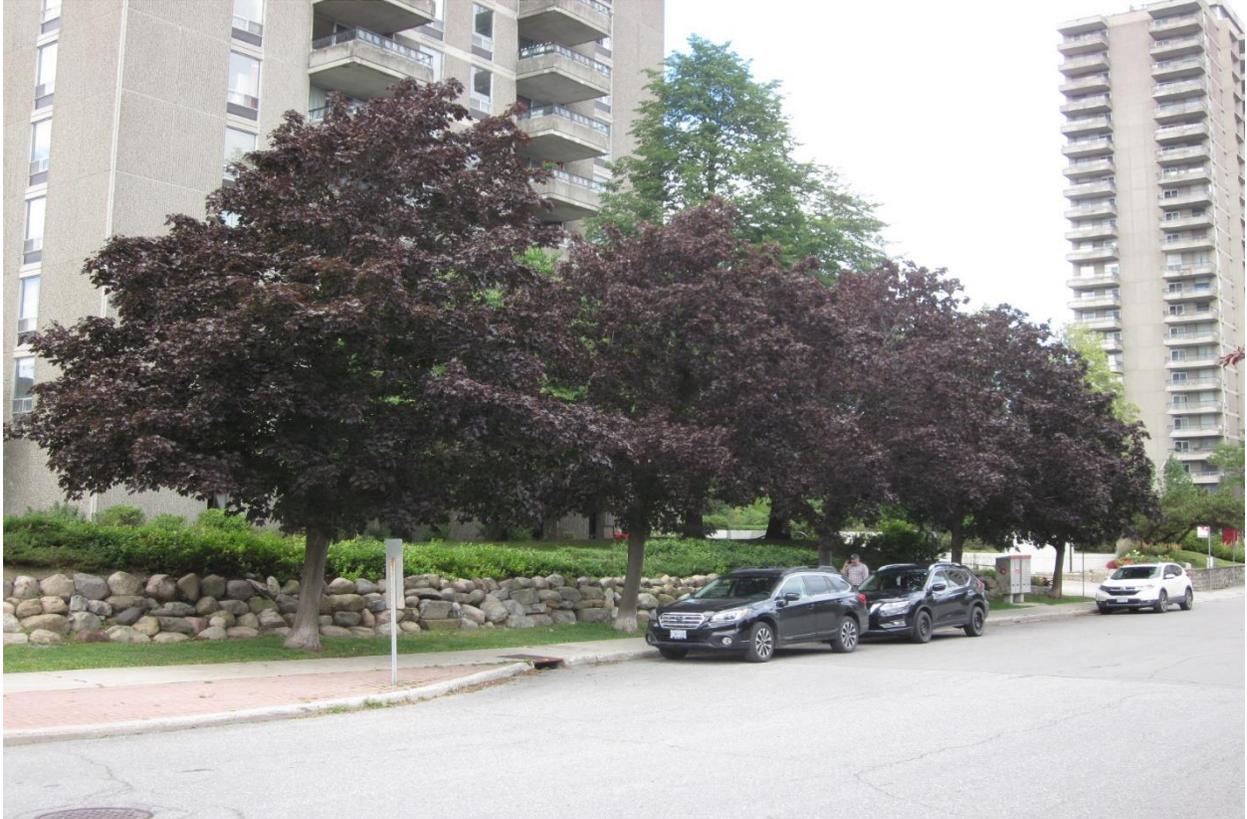
32	Norway maple (<i>Acer platanoides</i>)	30	City	Good; mature; ‘Crimson King’ variety; central upright stem; co-dominant divergent leaders at 5.5m; divergent form and crown asymmetric due to influence of tree #33; exposed root collar – planted high; introduced invasive species
33	Little-leaf linden (<i>Tilia cordata</i>)	44	Private	Good; mature; central dominant stem for most of height; mildly divergent form towards north; living crown held at 4m due to influence of surrounding trees; major girdling roots on west and east; exposed, damaged surface root; introduced species
34	Japanese tree lilac (<i>Syringa reticulata</i>)	20 avg.	Private	Fair; mature; four stemmed from grade - two upright dominant stems and two heavily suppressed and divergent stems towards southeast; entire crown asymmetric towards south/southwest due to influence of tree #33; cultivar

Tree No.	Tree species	DBH ¹ (cm)	Owner -ship ²	Condition, age class, tree condition notes & species origin
35	Norway maple (<i>Acer platanoides</i>)	29	City	Good; mature; 'Crimson King' variety; central upright stem; co-dominant divergent leaders at 5.5m; divergent form and crown asymmetric due to influence of trees #33 and 34; exposed root collar – planted high; girdling root on west; introduced invasive species
36	Norway maple (<i>Acer platanoides</i>)	27	City	Good; mature; 'Crimson King' variety; central stem with co-dominant leaders at 3.5m – both divergent towards east; exposed root collar – planted high; introduced invasive species
37	Norway maple (<i>Acer platanoides</i>)	28	City	Good; mature; 'Crimson King' variety; central stem with co-dominant leaders at 5.5m; dense crown; exposed root collar – planted high; introduced invasive species
38	Russian-olive (<i>Elaeagnus angustifolia</i>)	32	Private	Very poor; one remaining stem of four; divergent towards southeast; in advanced decline; introduced invasive species

Picture 8. Trees #30, 32 and 35-37 (right to left) at 210 Clearview Avenue

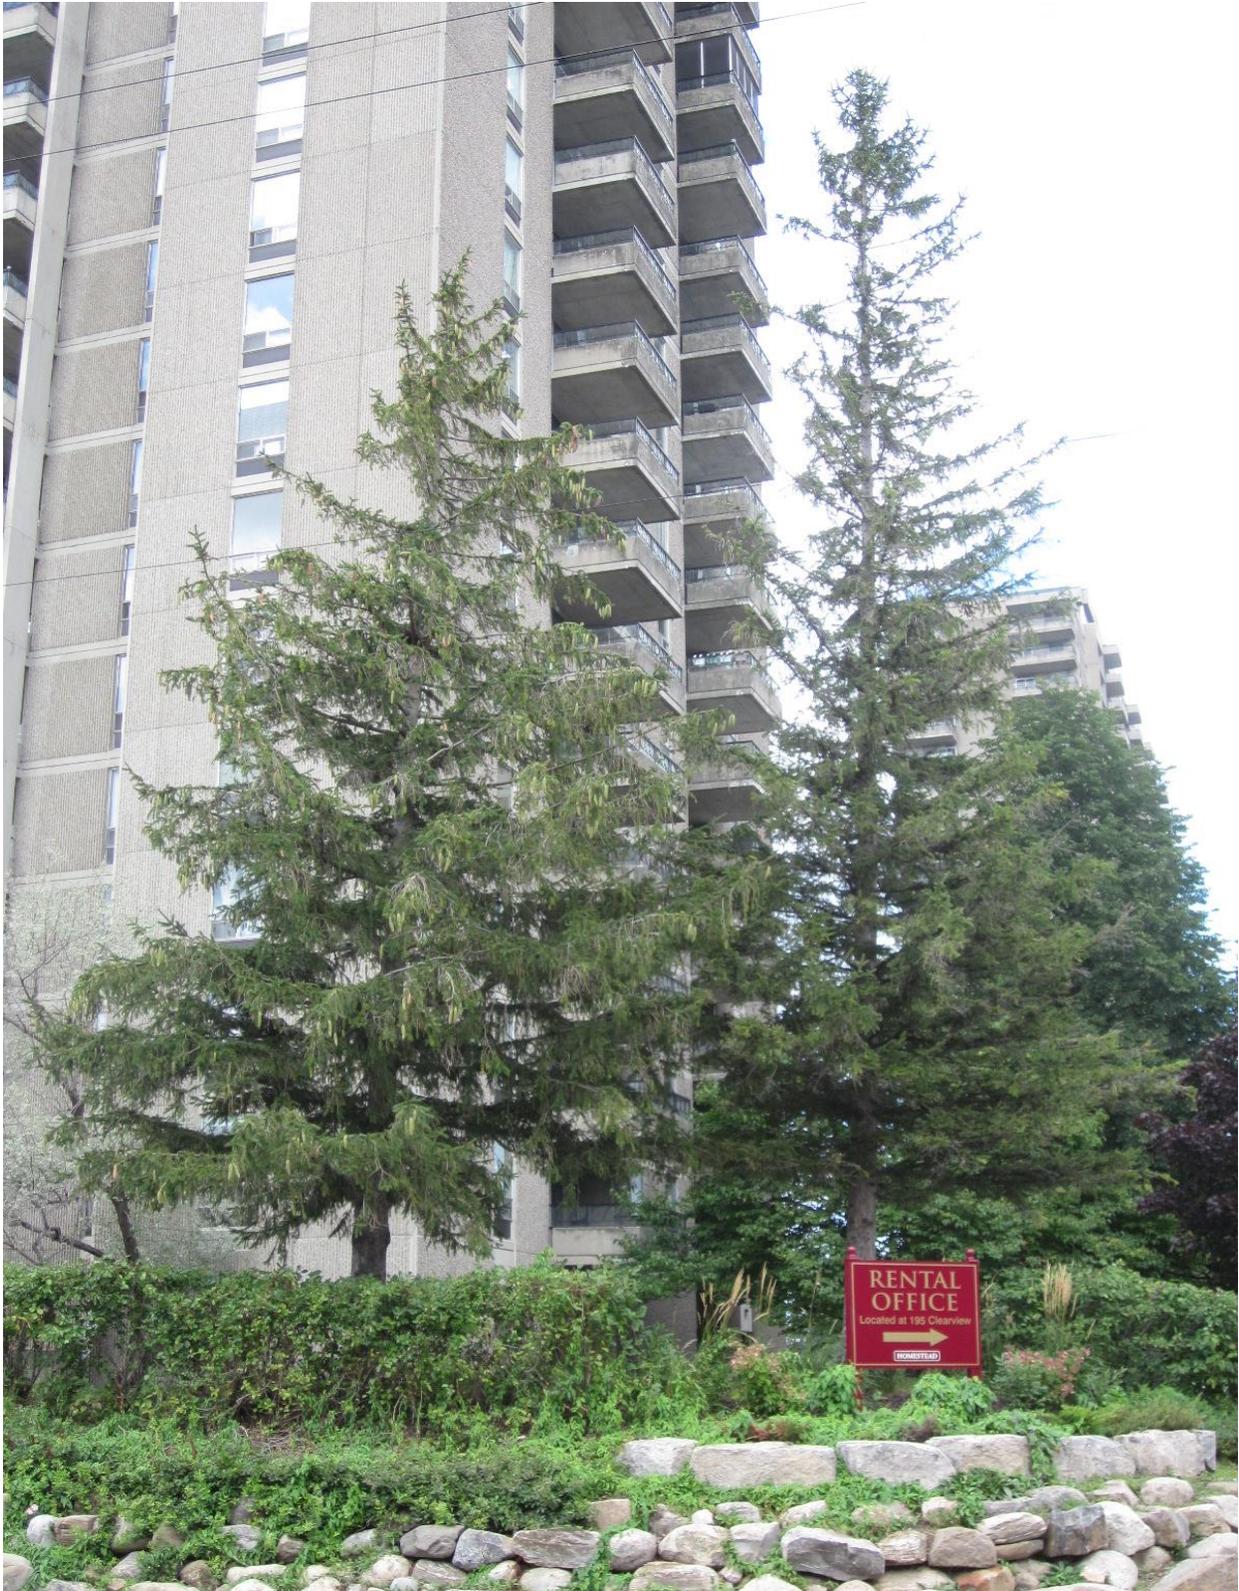
39	White spruce (<i>Picea glauca</i>)	29	Private	Fair; mature; scattered dieback; planted on slight rise in elevation – droughty location; fair crown density, growth increment and needle colour; native species
40	Norway spruce (<i>Picea abies</i>)	33	Private	Fair; mature; planted on slight rise in elevation – droughty location; poor crown density, fair growth increment and needle colour; introduced species

Picture 9. Trees #39 and 40 (right to left) at 210 Clearview Avenue
