Cardinal Creek Village – South Side

Headwater Drainage Feature Assessment

March 2021

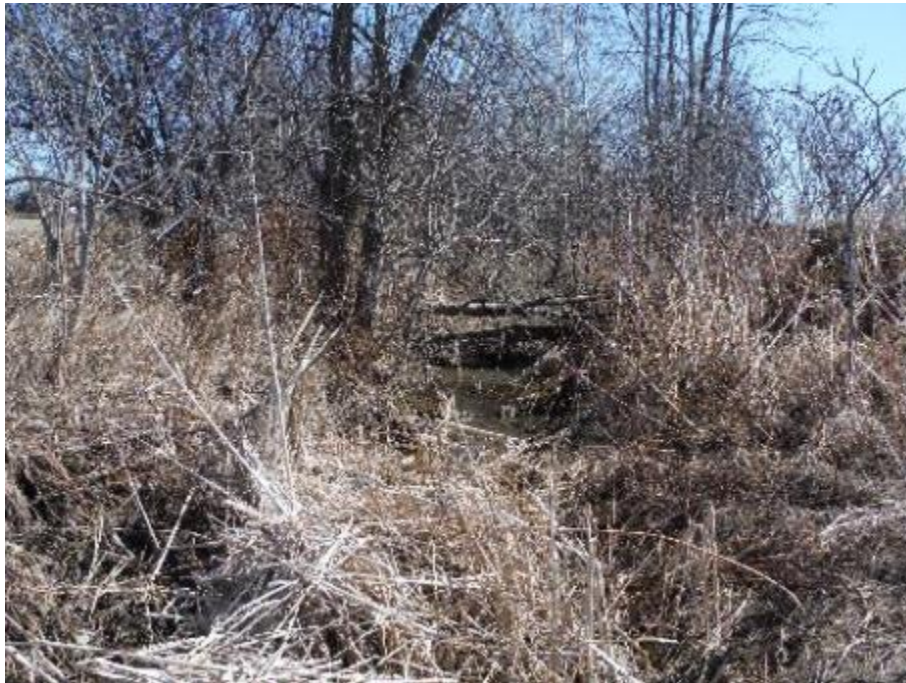
Photo 1: North Channel through the windrow, looking upstream (April 6, 2020).

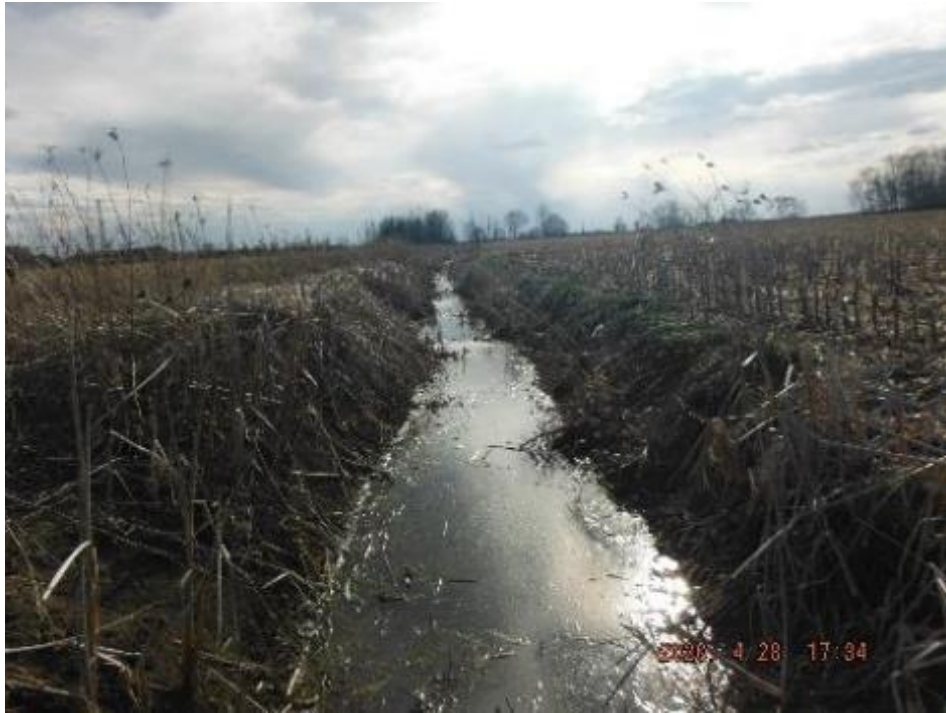
Photo 2: North Channel in the agricultural field (April 28, 2020)

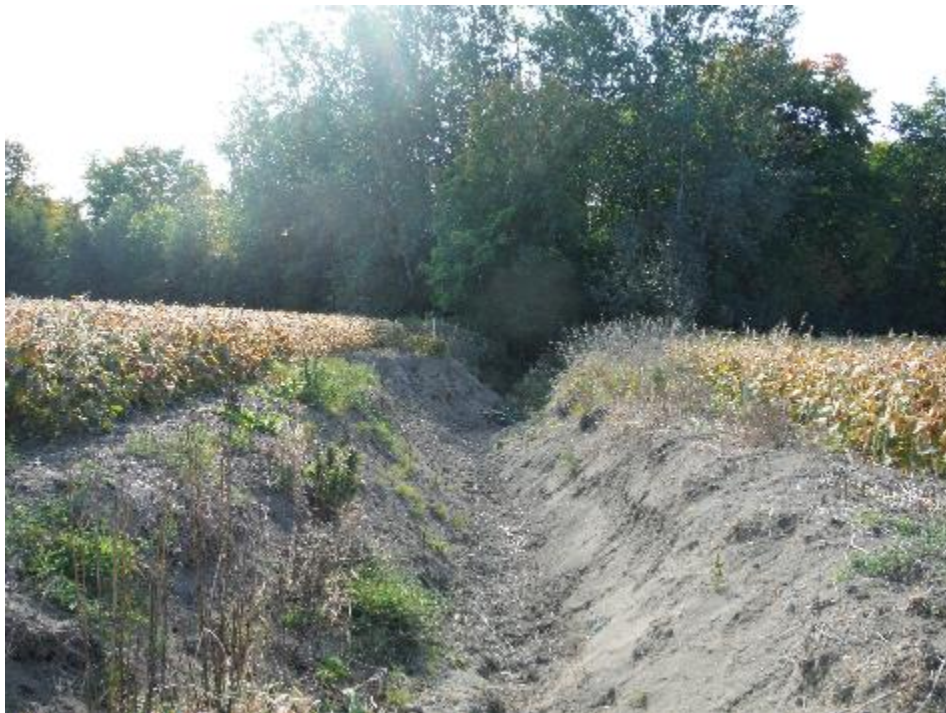
Photo 3: North Channel, downstream of the reach break B (September 21, 2020)

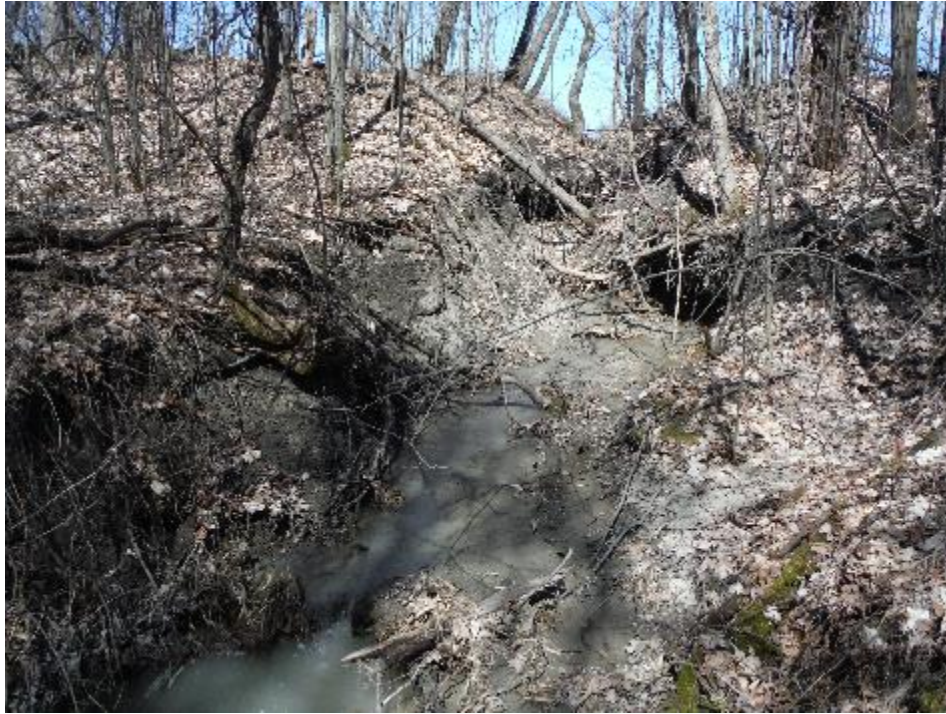
Photo 4: Downstream portion of the North Channel showing the physical barrier (April 6, 2020)

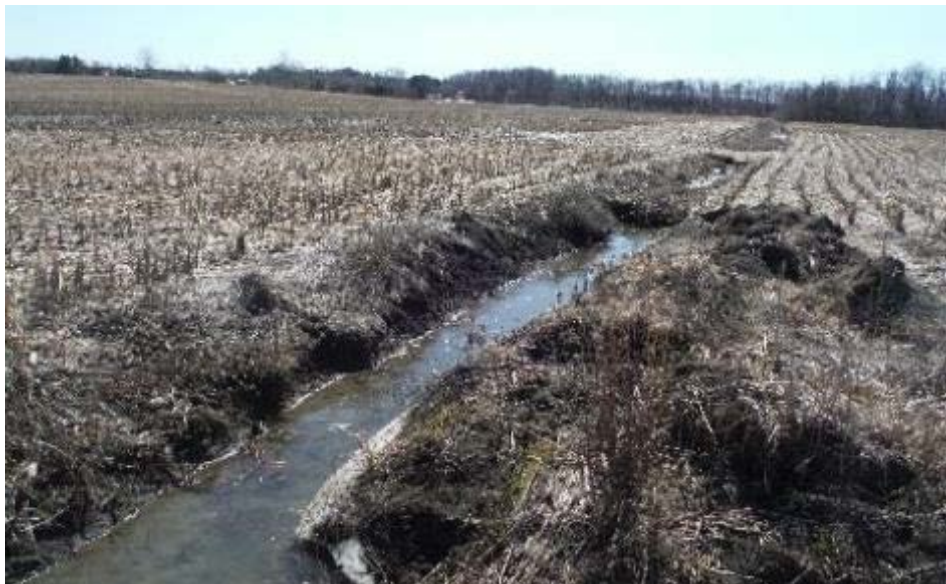
Feature 1 is found on the east side of the site. It is a short feature (35 m) that is connected to the North Channel. This channel is inclined to the north and there was a gradient barrier between it and the Feature 2. This is compounded by a blocked culvert.

Photo 5: Feature 1 (April 6, 2020)

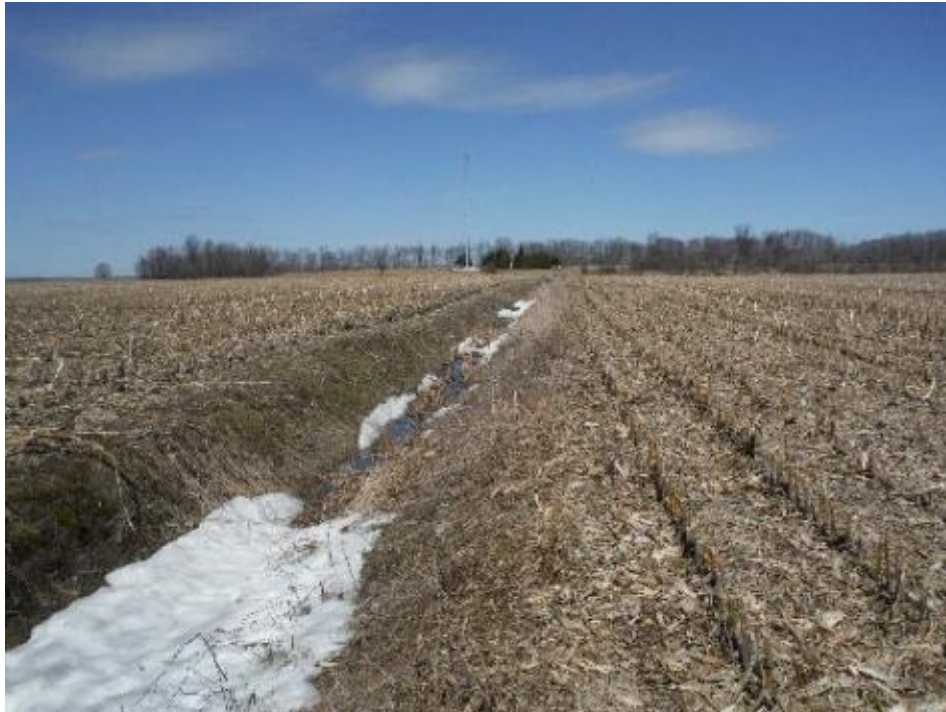
Photo 6: Feature 2, looking upstream from the center of the feature (April 6, 2020)

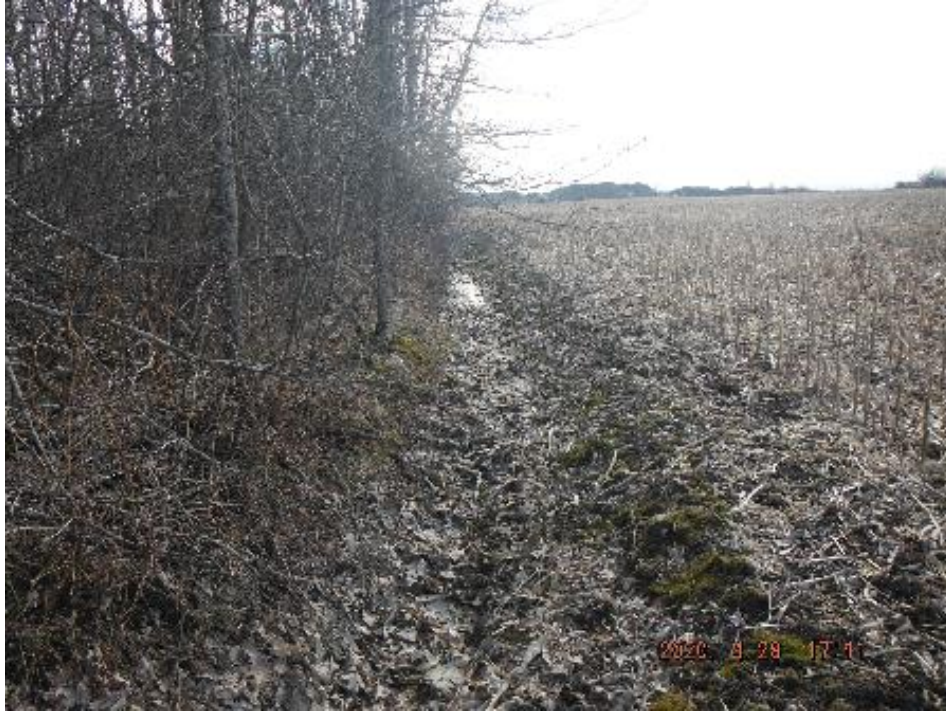
Photo 7: Feature 3a, looking upstream (April 28, 2020)

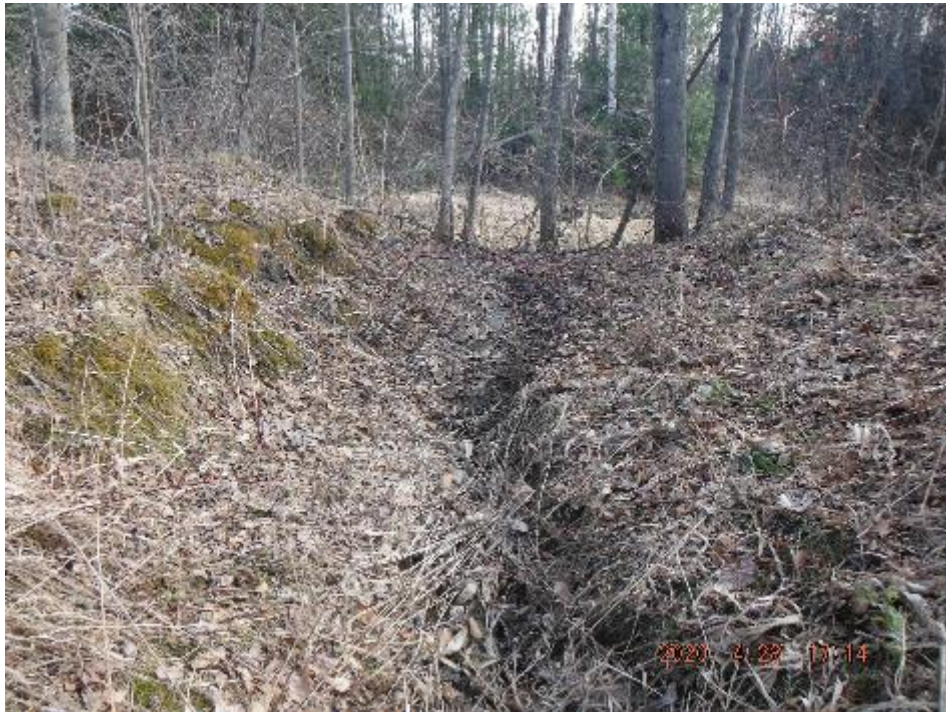
Photo 8: Feature 3b that is inclined and flows to South Tributary (April 28, 2020)

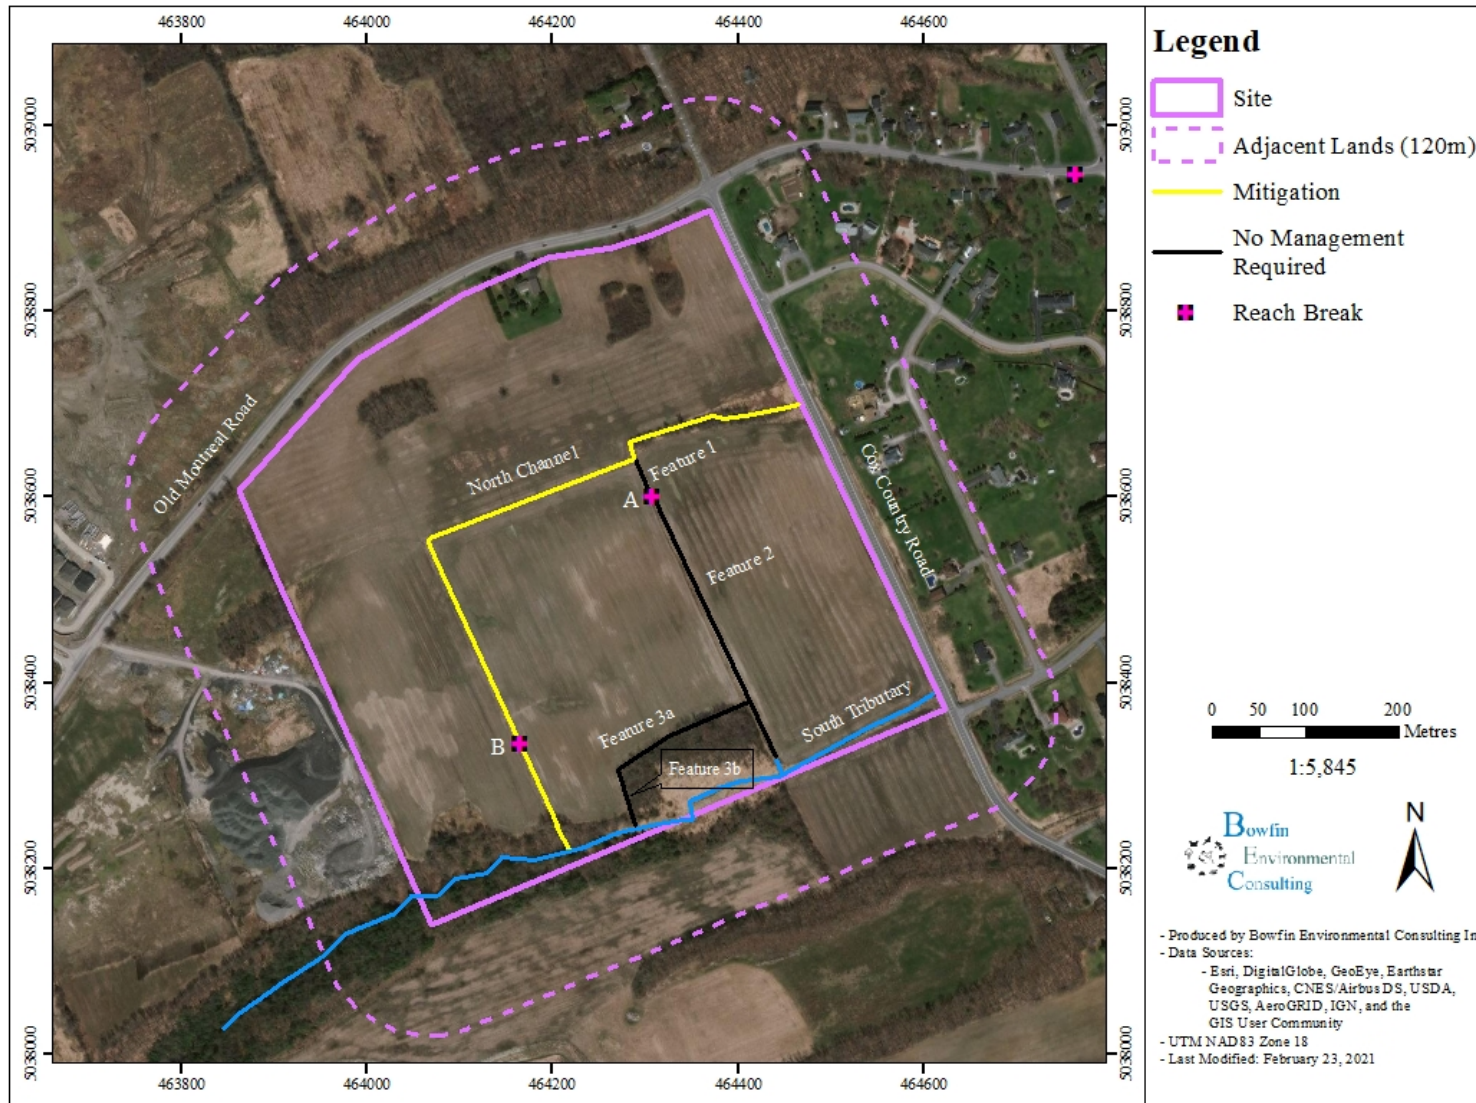
Figure 5: Management Recommendations

The North Channel comes out as Mitigation on its downstream side, where it experiences flowing water. This is restricted to the area that has eroded creating a narrower channel with an incline. Further upstream, the majority of the feature would come out as No Management Required because of the standing water.

The field investigations found that this channel was not providing ecological functions (apart from a couple of tree frogs, not within wetland habitat and not sufficient to be significant). The flow was causing erosion and impacting the valley of South Tributary. It is recommended that this is considered during design and measures to prevent this erosion from continuing be implemented.

While the flow was classed as significant, this is a very low threshold to meet. It is recommended that the stormwater management of the site be designed to ensure that the water reaching the South Tributary is not negatively impacted in terms of quantity or quality.

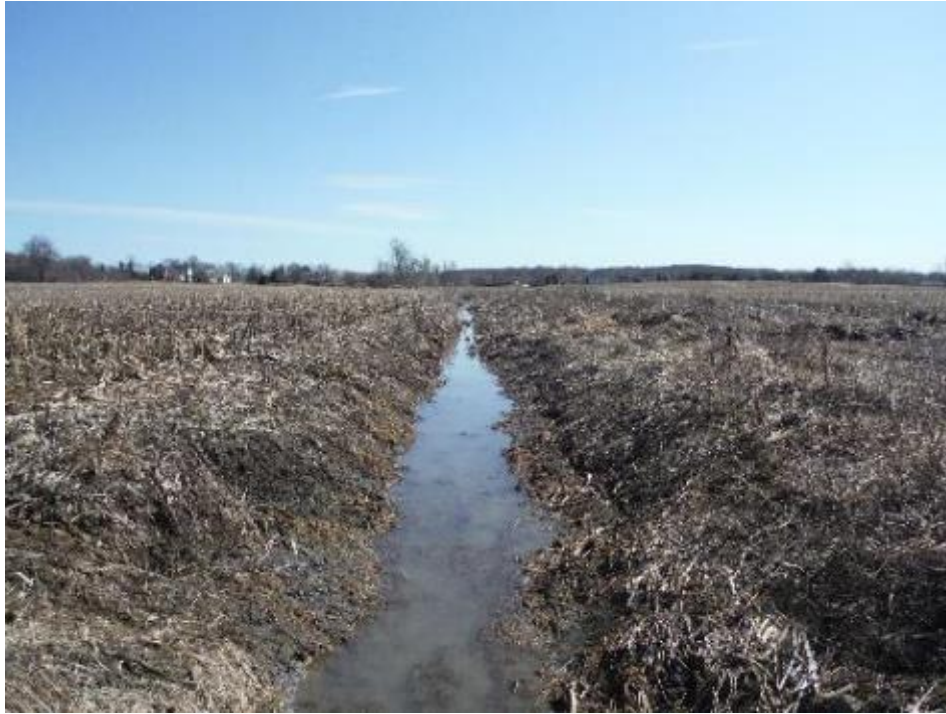
Photo 9: Station 1 looking upstream from downstream (April 6, 2020)

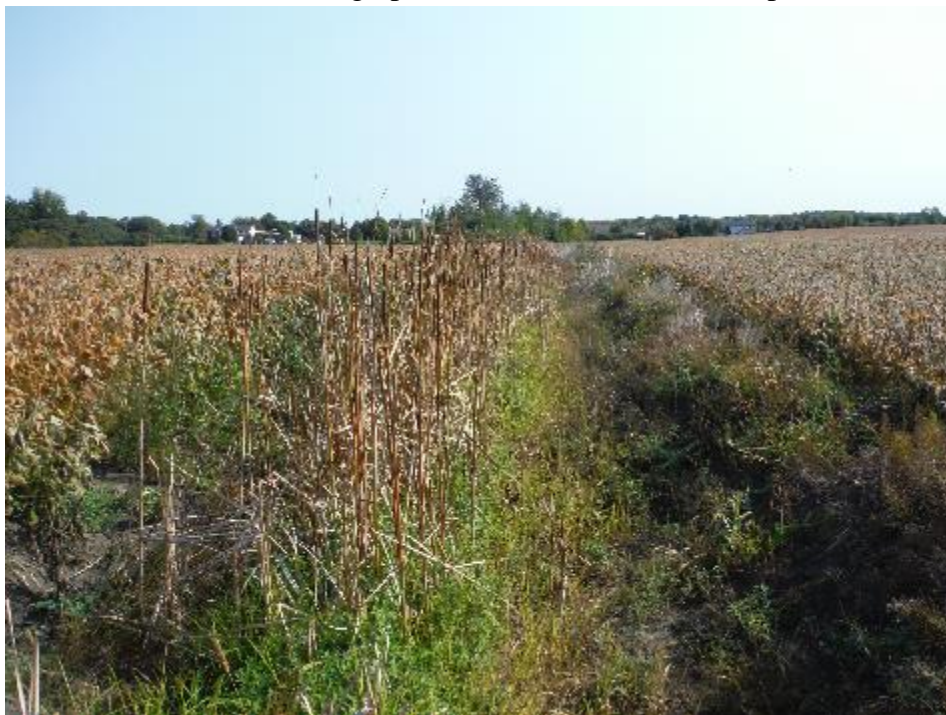
Photo 10: Station 1 looking upstream from downstream (September 21, 2020)

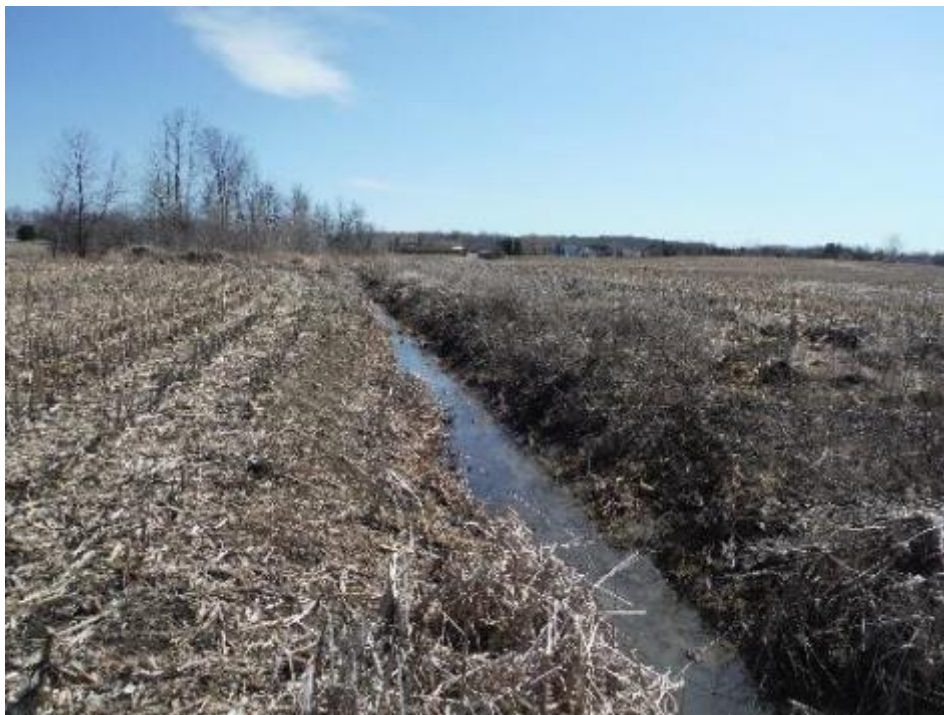
Photo 11: Station 2 looking upstream from downstream (April 6, 2020)

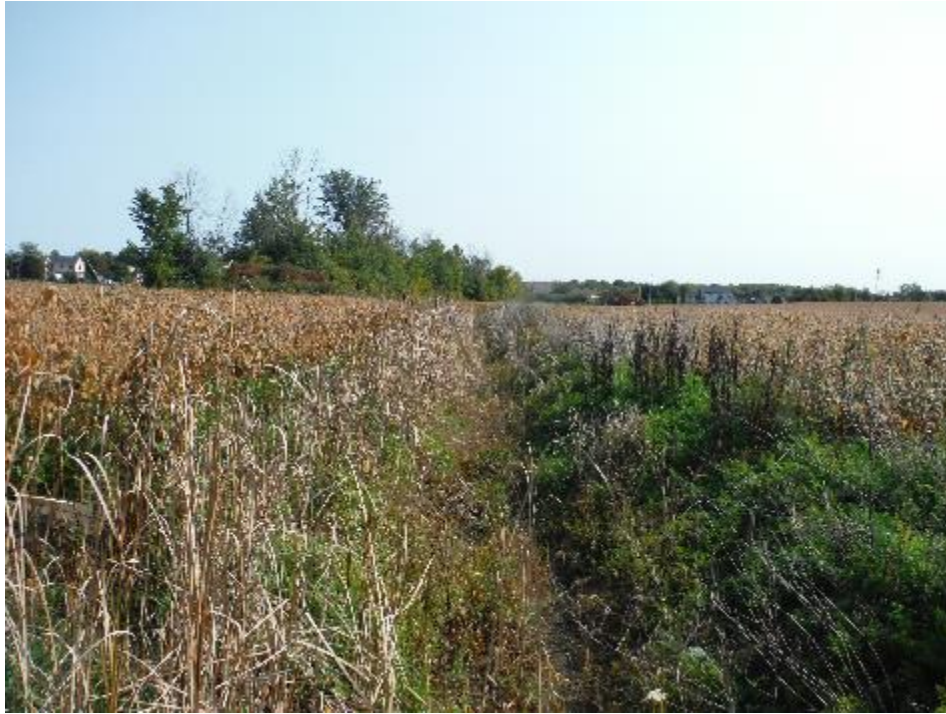
Photo 12: Station 2 looking upstream from downstream (September 21, 2020)

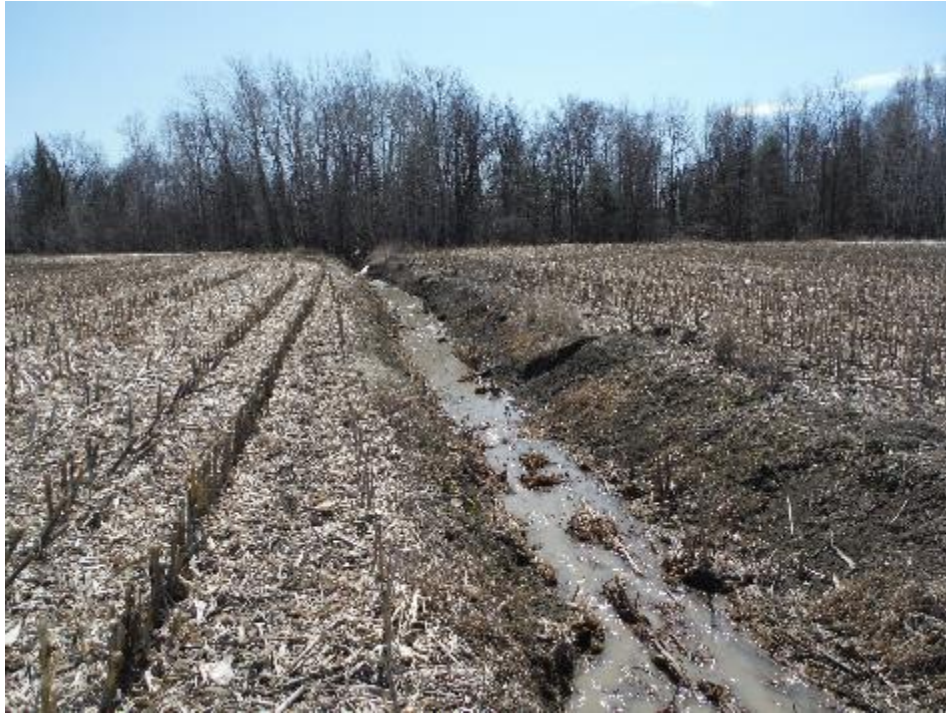
Photo 13: Station 3 looking downstream from upstream (April 6, 2020)

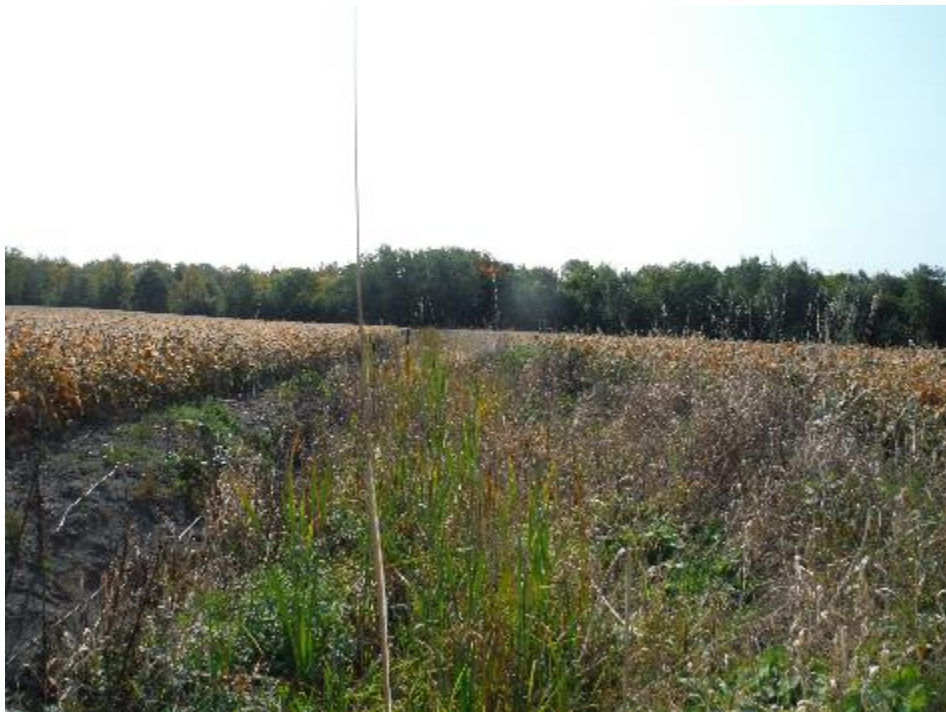
Photo 14: Station 3 looking downstream from upstream (September 21, 2020)

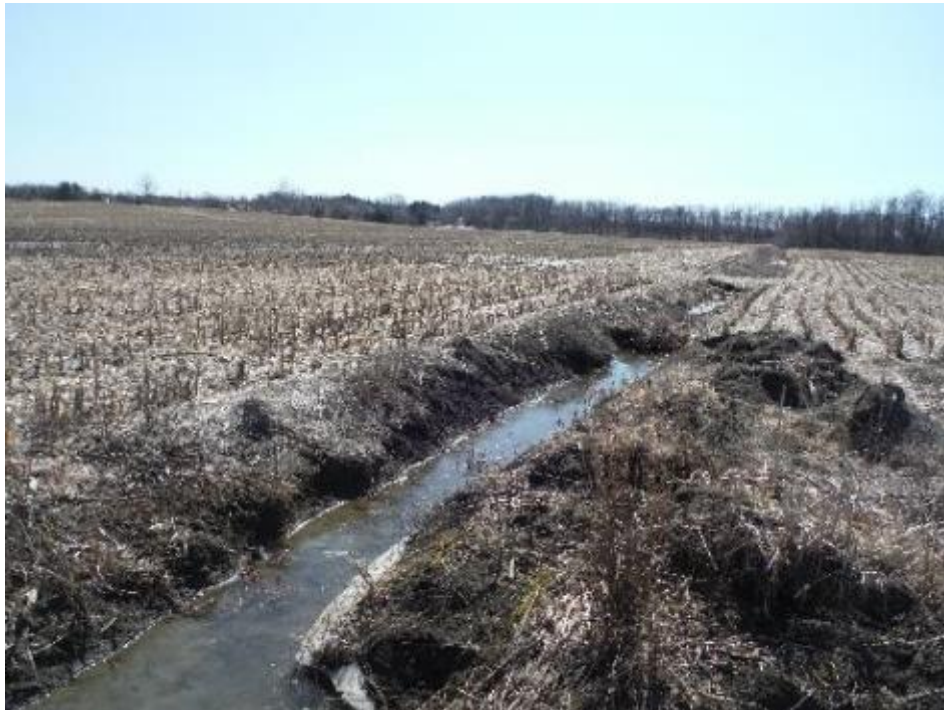
Photo 15: Feature 1 looking upstream from downstream (April 6, 2020)

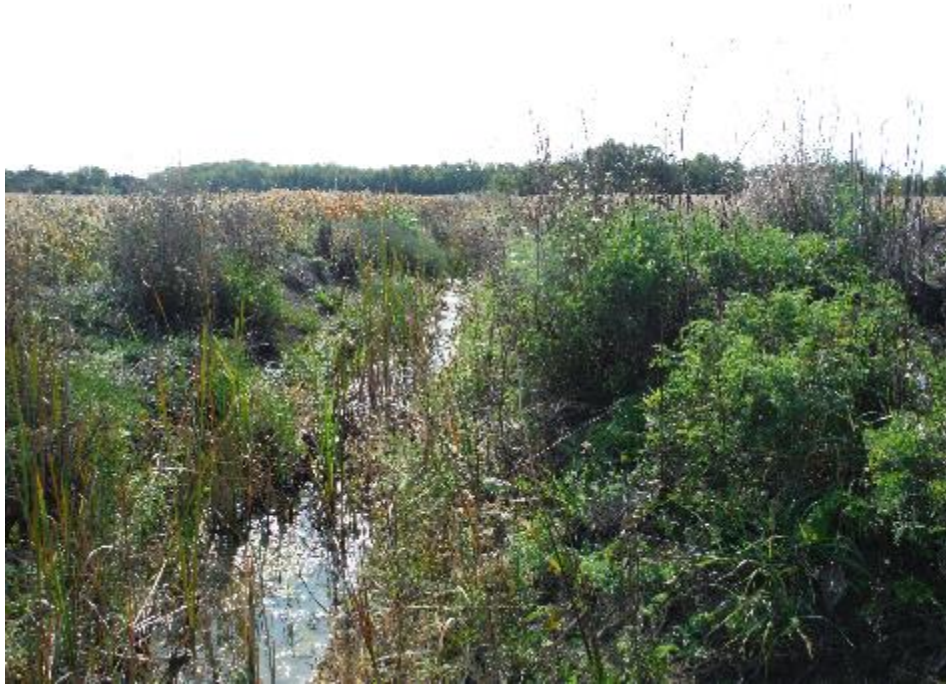
Photo 16: Feature 1 looking upstream from downstream (September 21, 2020)

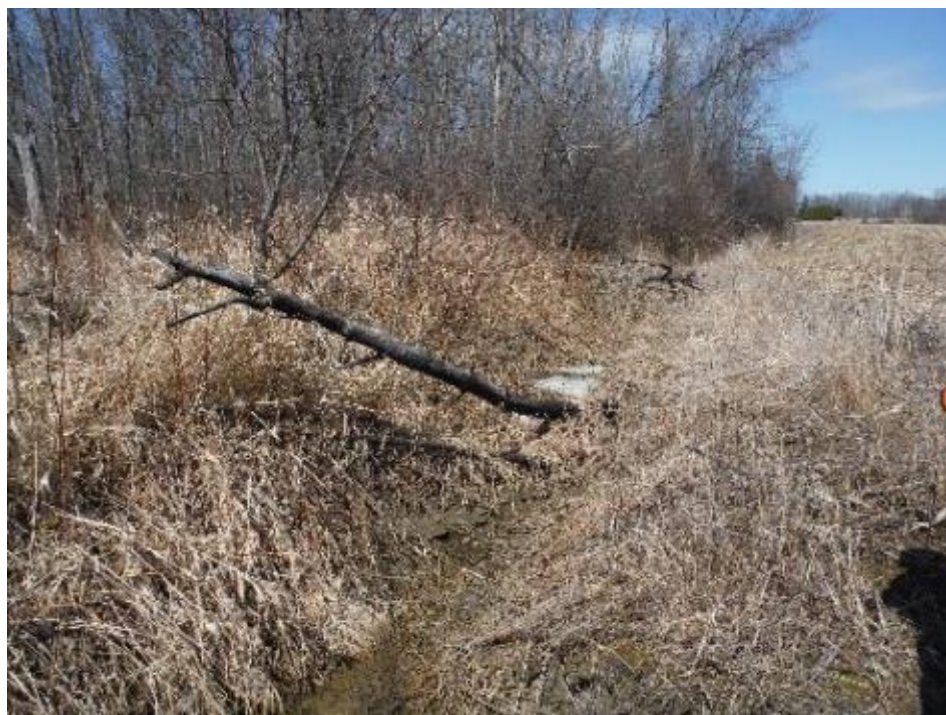
The station was not fished as there was a fish barrier on the downstream end, in the form of vegetation and gradient issues, and is too densely vegetated to sample. No fish habitat was

Photo 17: View of the fish barrier from downstream (April 6, 2020)

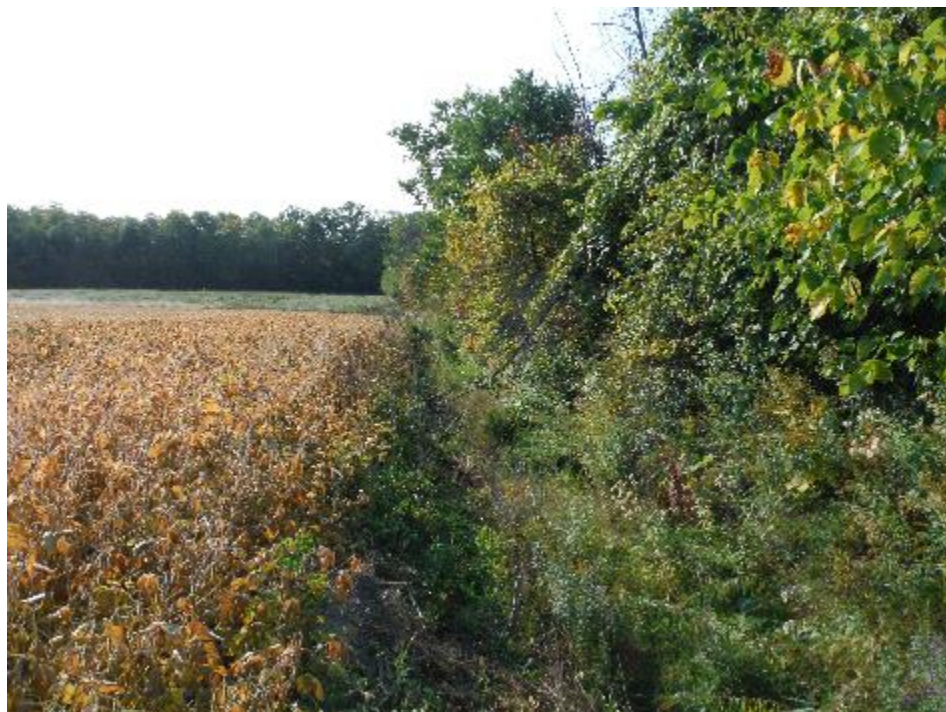
Photo 18: Station 4. looking downstream from the center of the feature (September 21, 2020)

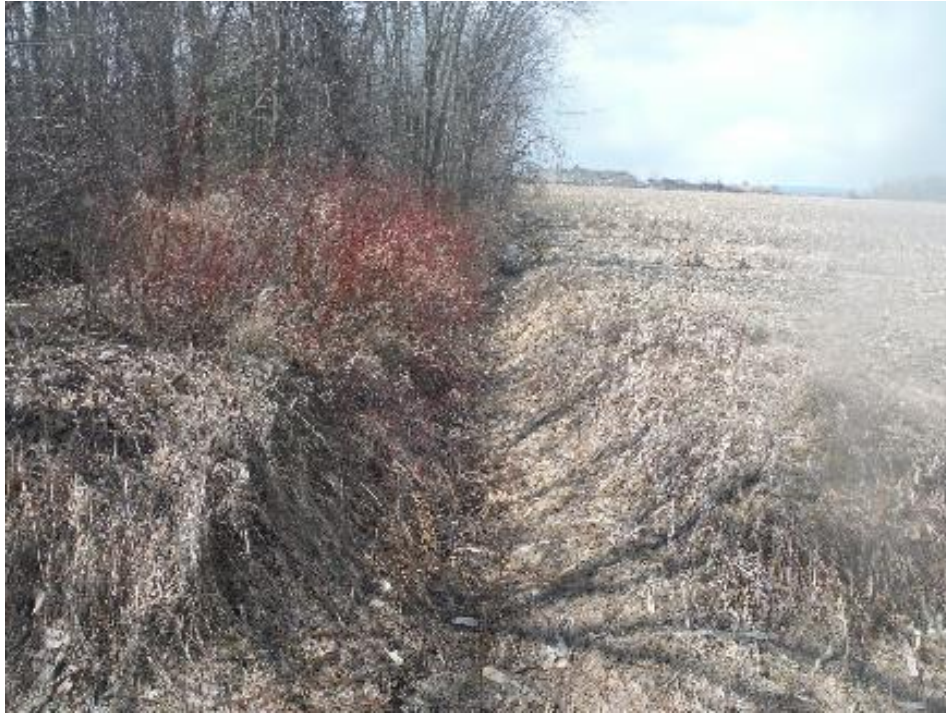
Photo 19: Station 5 looking upstream from the downstream end (April 16, 2020)

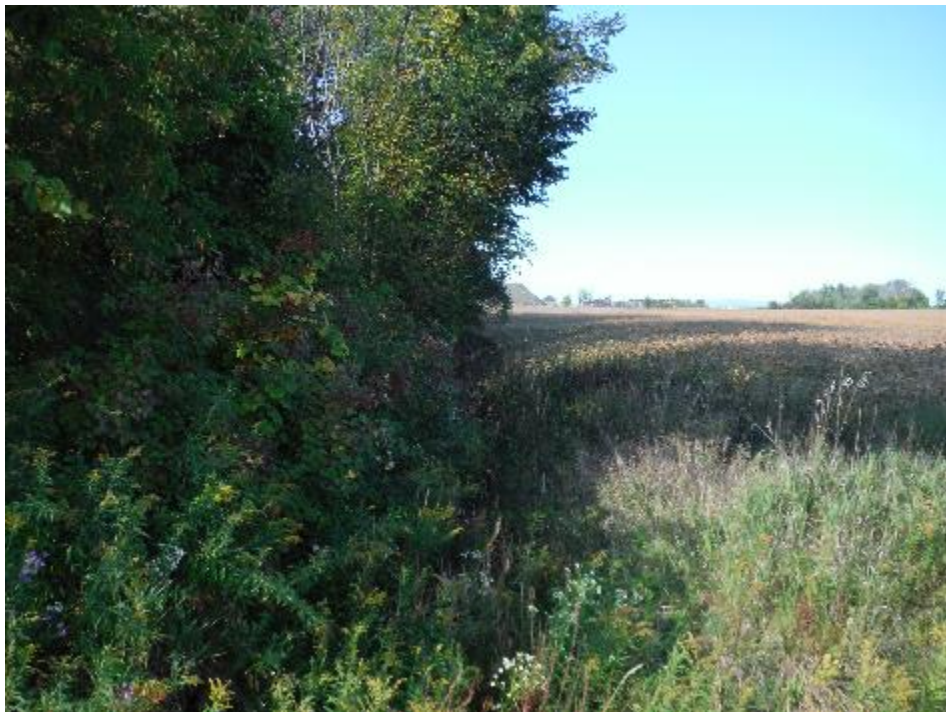
Photo 20: Station 5 looking upstream from the downstream end (September 21, 2020)

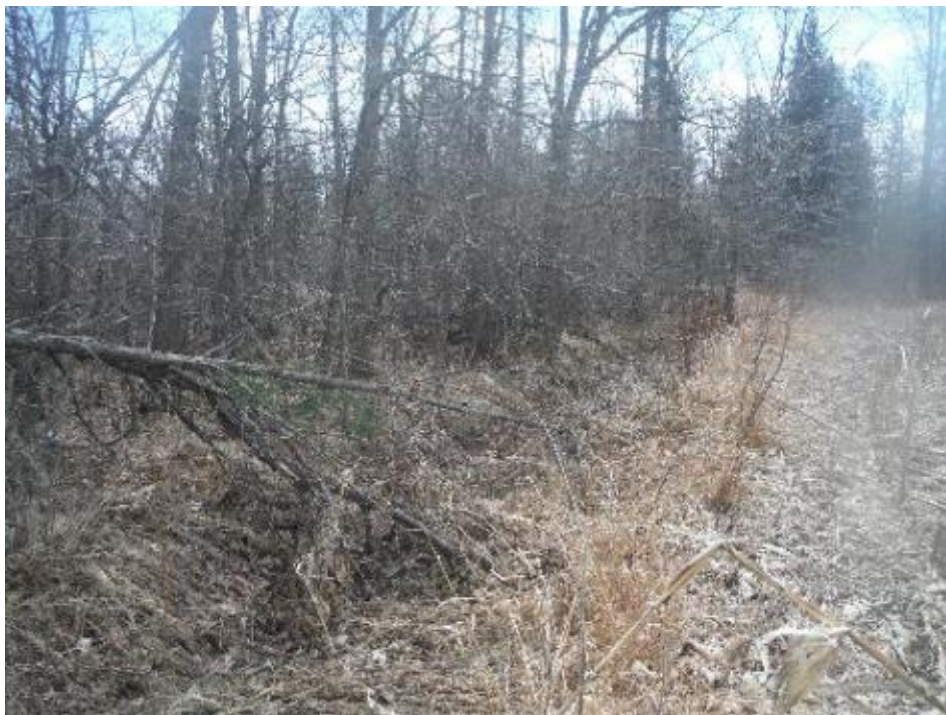
Photo 21: Station 6 looking downstream from the upstream end (April 16, 2020)

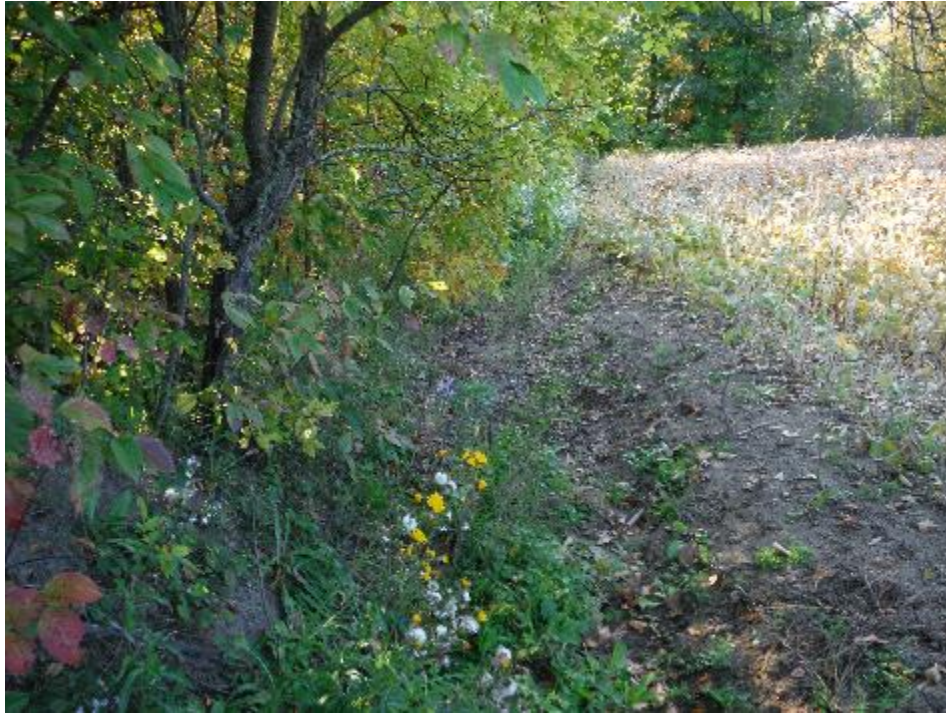
Photo 22: Station 6 looking downstream from the upstream end (September 21, 2020)
