RE: TREE CONSERVATION REPORT FOR 1209 ST. LAURENT BOULEVARD, OTTAWA

Project
MULTI UNIT RESIDENTIAL BUILDING
 1209 ST. LAURENT BOULEVARD

Sheet Number
L1
 D07-12-22-0089

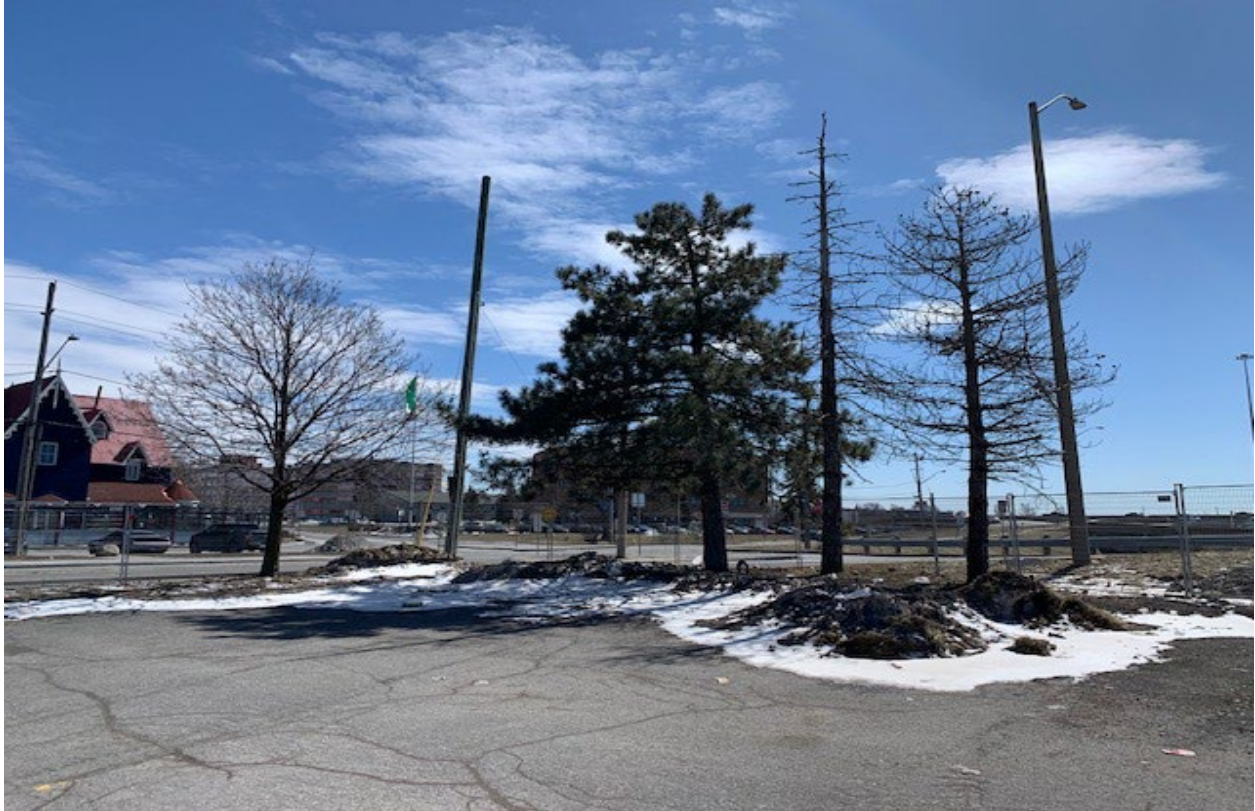
6	Norway maple (<i>Acer platanoides</i>)/ Moderate-Good	25	2.5	Good; mature; central dominant stem with competing leaders at 4m from grade; suppressed laterals starting at 1.5m; dense, compact crown; introduced invasive species; to be removed (conflicts with site access)
7	Austrian pine (<i>Pinus nigra</i>)/ Moderate-Good	41	-	Good; mature; dominant central stem; crown asymmetric due to influence of nearby trees; good crown density, growth increment and needle colour; introduced species; to be removed (will not survive root loss)
8	Austrian pine (<i>Pinus nigra</i>)/ Moderate-Good	26	-	Fair; mature; dominant central stem; crown asymmetric due to influence of nearby trees; good crown density, growth increment and needle colour; introduced species; to be removed (will not survive root loss)
9	Austrian pine (<i>Pinus nigra</i>)/ Moderate-Good	31	-	Fair; mature; dominant central stem; crown asymmetric due to influence of nearby trees; good crown density, growth increment and needle colour; introduced species; to be removed (will not survive root loss)

Picture 2. Trees #3-6 (right to left) at 1209 St. Laurent Boulevard

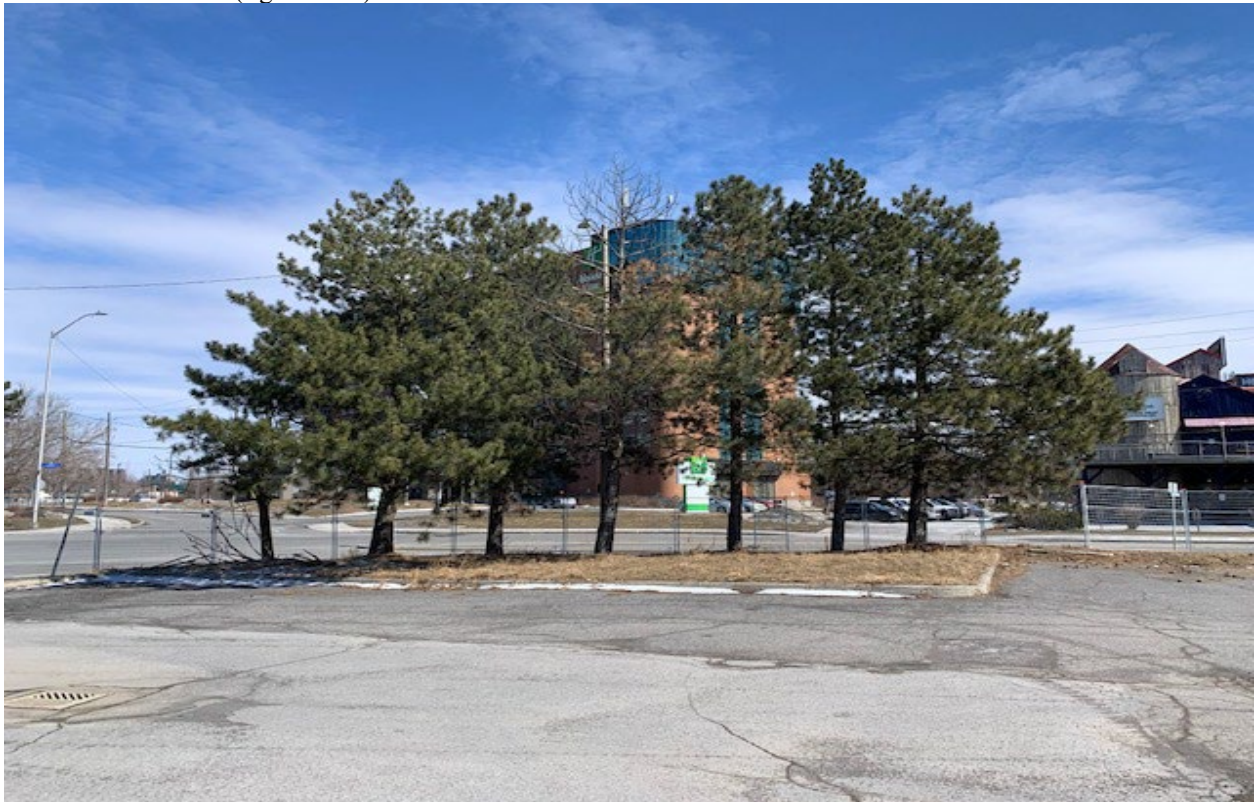
Tree No.	Tree species /Tolerance to Construction ¹	DBH ² (cm)	CRZ ³	Condition, age class, tree condition notes & preservation status (to be removed or preserved and protected)
10	Austrian pine (<i>Pinus nigra</i>)/ Moderate-Good	31	-	Very poor; mature; top half of crown dead, bottom with poor crown density, growth increment and needle colour; introduced species; to be removed (very poor condition and will not survive root loss)
11	Austrian pine (<i>Pinus nigra</i>)/ Moderate-Good	33	-	Fair; mature; crown moderately asymmetric due to influence of nearby trees; good crown density, growth increment and needle colour; introduced species; to be removed (will not survive root loss)
12	Austrian pine (<i>Pinus nigra</i>)/ Moderate-Good	43	-	Fair; mature; lower crown dead due to influence of nearby pine and maple trees; good crown density, growth increment and needle colour; introduced species; to be removed (will not survive root loss)

13	Norway maple (<i>Acer platanoides</i>)	22	-	Dead; mature; broken in two; to be removed (dead)
14	Austrian pine (<i>Pinus nigra</i>)	33	-	Dead; mature; seeded Siberian elm (<i>Ulmus pumila</i>) growing at base; to be removed (dead)
15	Austrian pine (<i>Pinus nigra</i>)/ Moderate-Good	26	-	Poor; mature; stunted growth form; poor crown density, growth increment and needle colour; introduced species; to be removed (poor condition)
16	Austrian pine (<i>Pinus nigra</i>)/ Moderate-Good	29	-	Poor; mature; stunted growth form; heavy vine (<i>Vitis</i> spp.) growth into crown; very poor crown density, growth increment and needle colour; introduced species; to be removed (poor condition)
17	Austrian pine (<i>Pinus nigra</i>)/ Moderate-Good	34	3.4	Fair; mature; crown asymmetric due to influence of nearby trees; vine (<i>Vitis</i> spp.) growth into crown; fair crown density and needle colour, good growth increment; hydro line runs through crown apex; introduced species; to be removed (conflicts with site access)

Picture 3. Trees #7-13 (right to left) at 1209 St. Laurent Boulevard

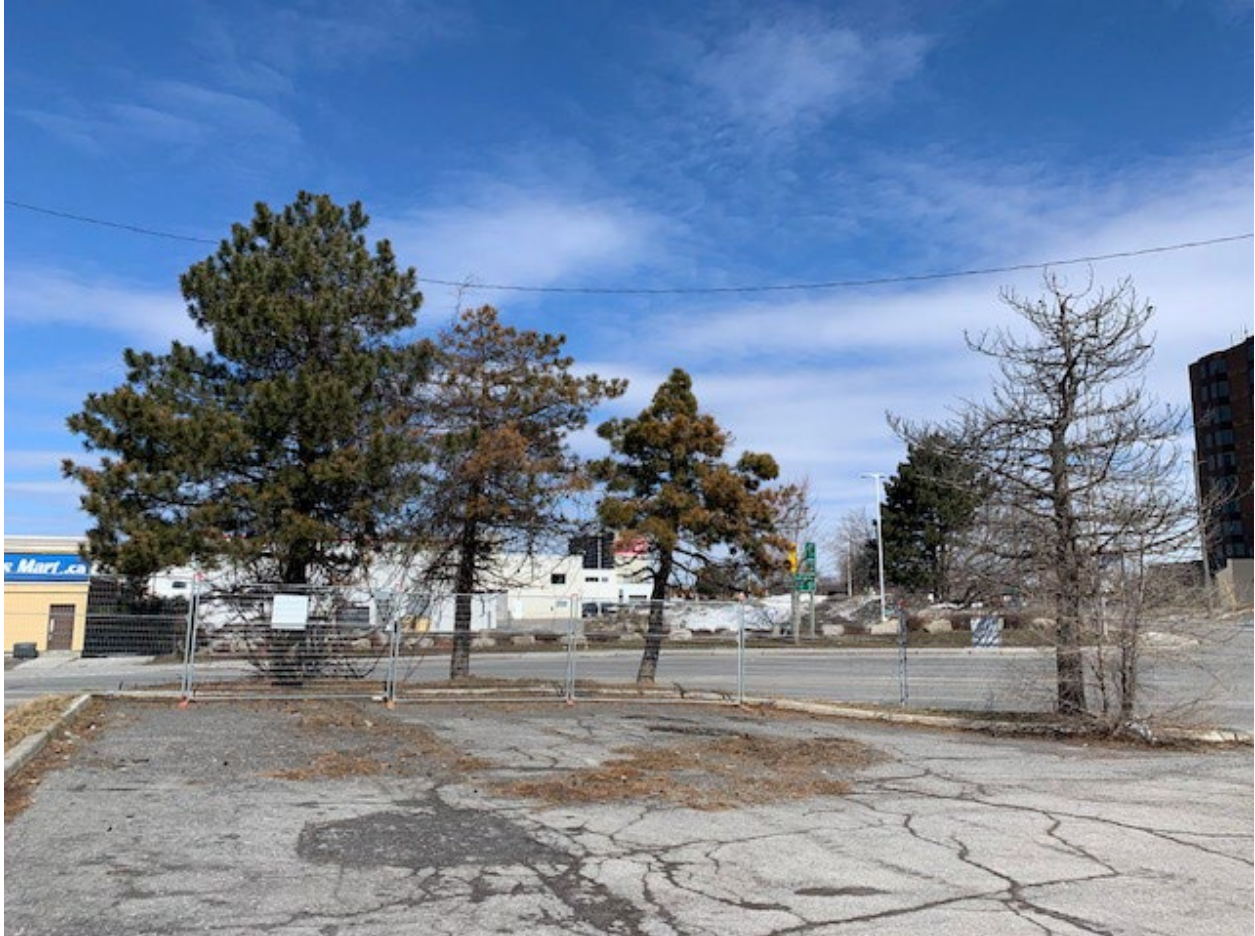
Picture 4. Trees #14-17 (right to left) at 1209 St. Laurent Boulevard
