110394936 CANADA INC.

TREE CONSERVATION REPORT

1299 Richmond Road

CIMA+ file number: A001359
May 29, 2023 – Review 000

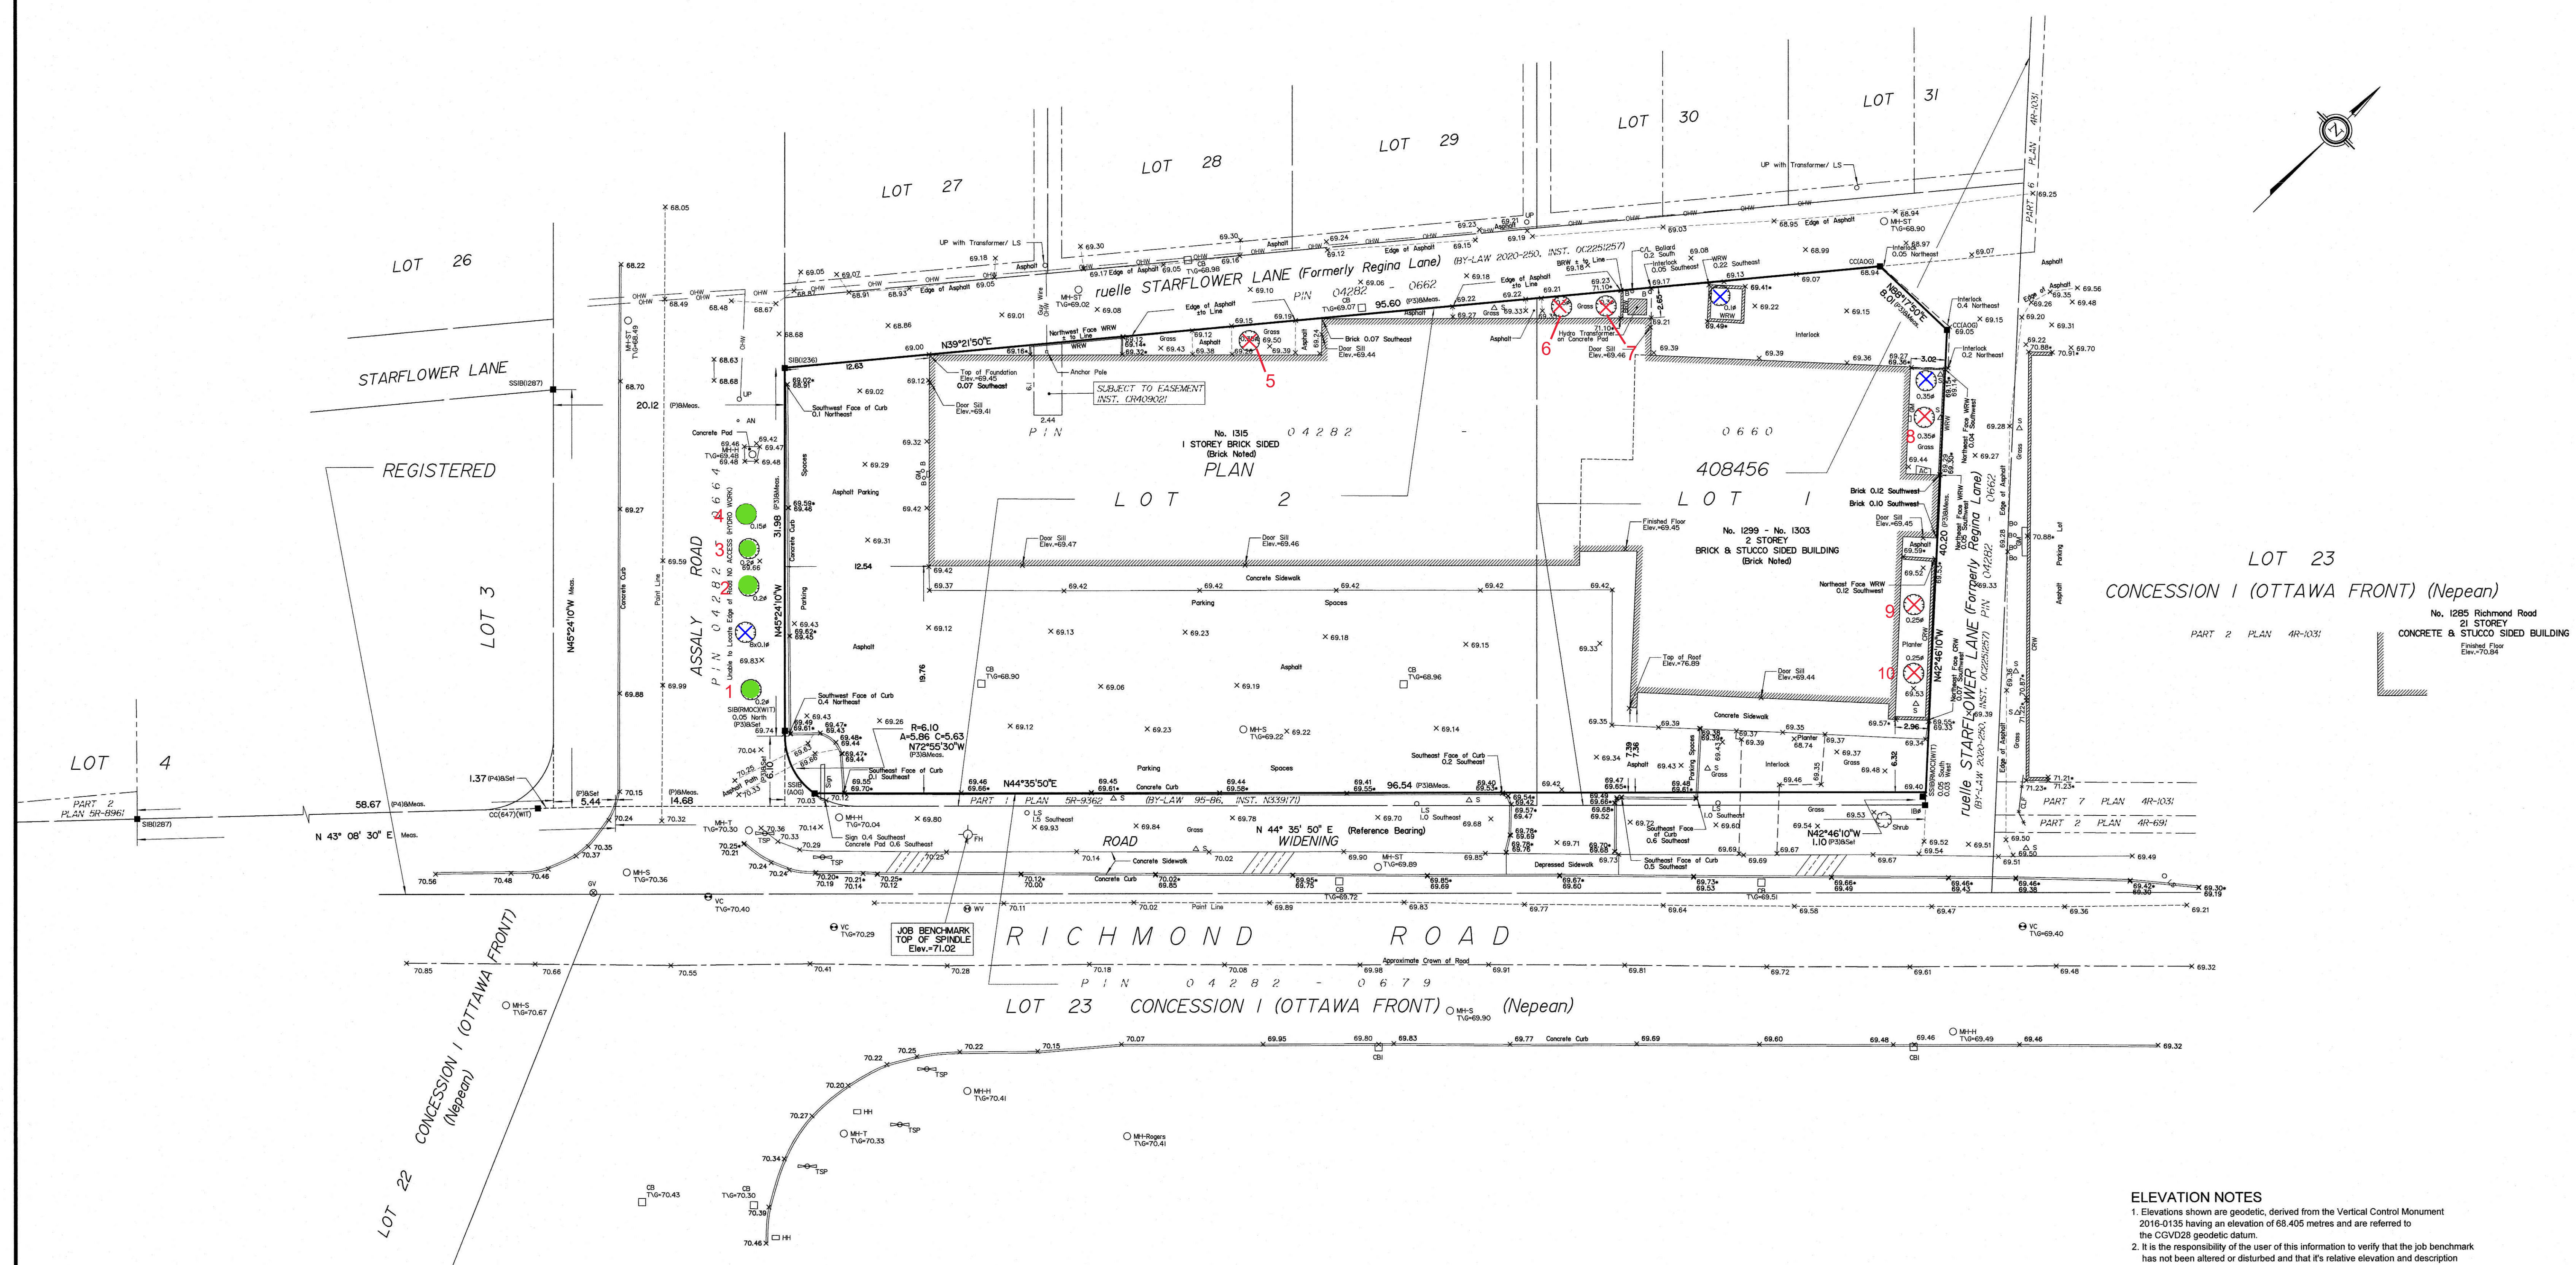
Appendix A Tree Inventory and Assessment Table and Figure

Based on the species and conditions of the trees located within the site and the extent of the grading limits of the proposed project design it has been decided to retain 4 trees and remove 6 trees on site.

Trees to be Removed	Trees to be Injured	Trees to be Retained
6	0	4

- + Delineation of the disturbance limits within work areas will be clearly defined on drawings and on the site prior to construction;
- + Install Tree Protection Fencing prior to commencement of construction activities, and retain fencing until construction activities have been completed, as per City of Ottawa’s Tree Protection (By-law No. 2020-340), Part VI:
