# TREE CONSERVATION REPORT

121 Brae Crescent, Ottawa

Tree Conservation Report submitted as Partial  
Requirements for a Site Plan Control Application,  
April 24, 2023

# Tree Conservation Report v2.0

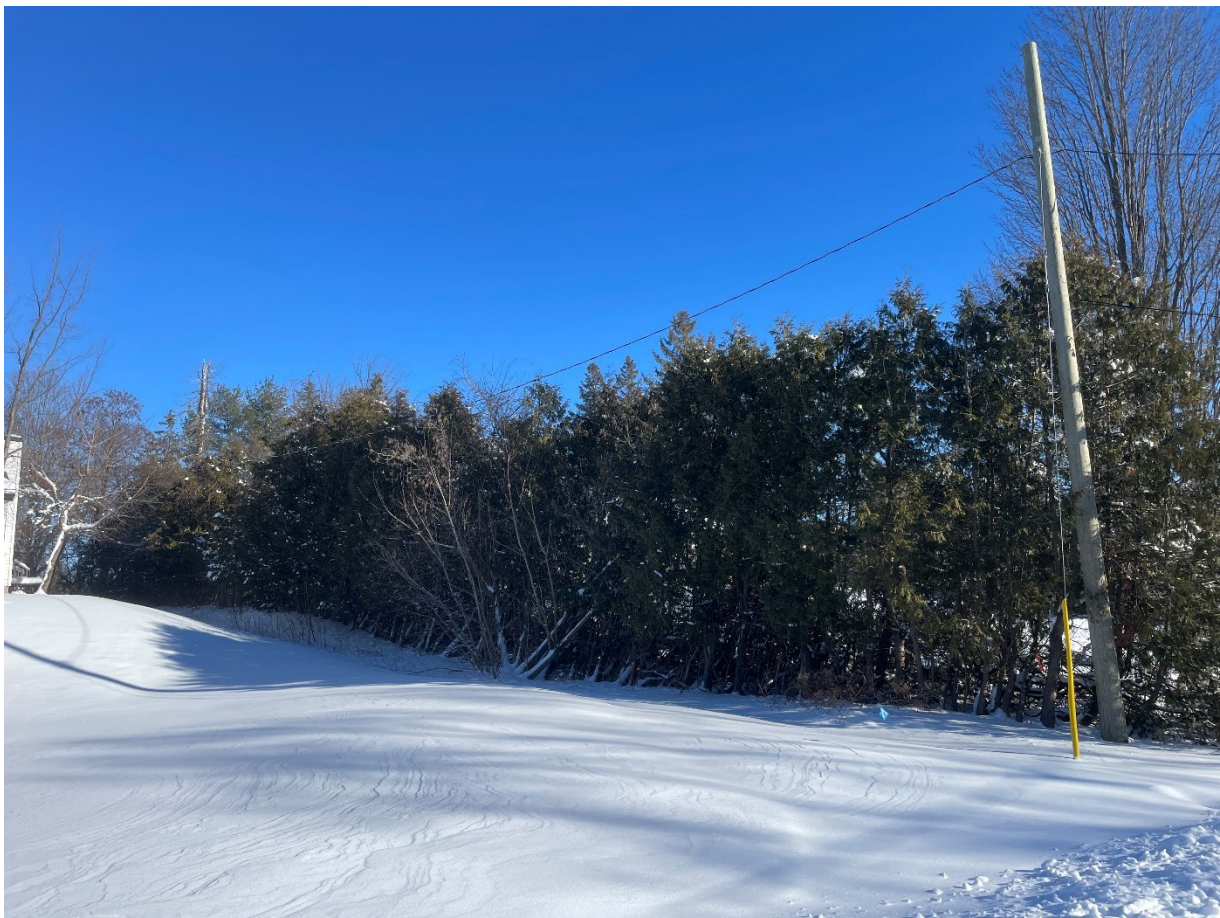
Figure 1: Cedar hedge along the southern property line with Manitoba maple visible in the middle

Some root damage may occur to the cedar hedge along the southern property line when installing the pavement for the new parking area. To mitigate damage to the root system, digging the soil and cutting the roots manually is recommended. Any exposed roots should be covered with organic material immediately and be kept moist. There may be some roots within the excavation area for the new building of root 3. Root damage could be reduced by severing roots manually and/or applying a deep root fertilizer one year post construction if there tree is showing any signs of stress.

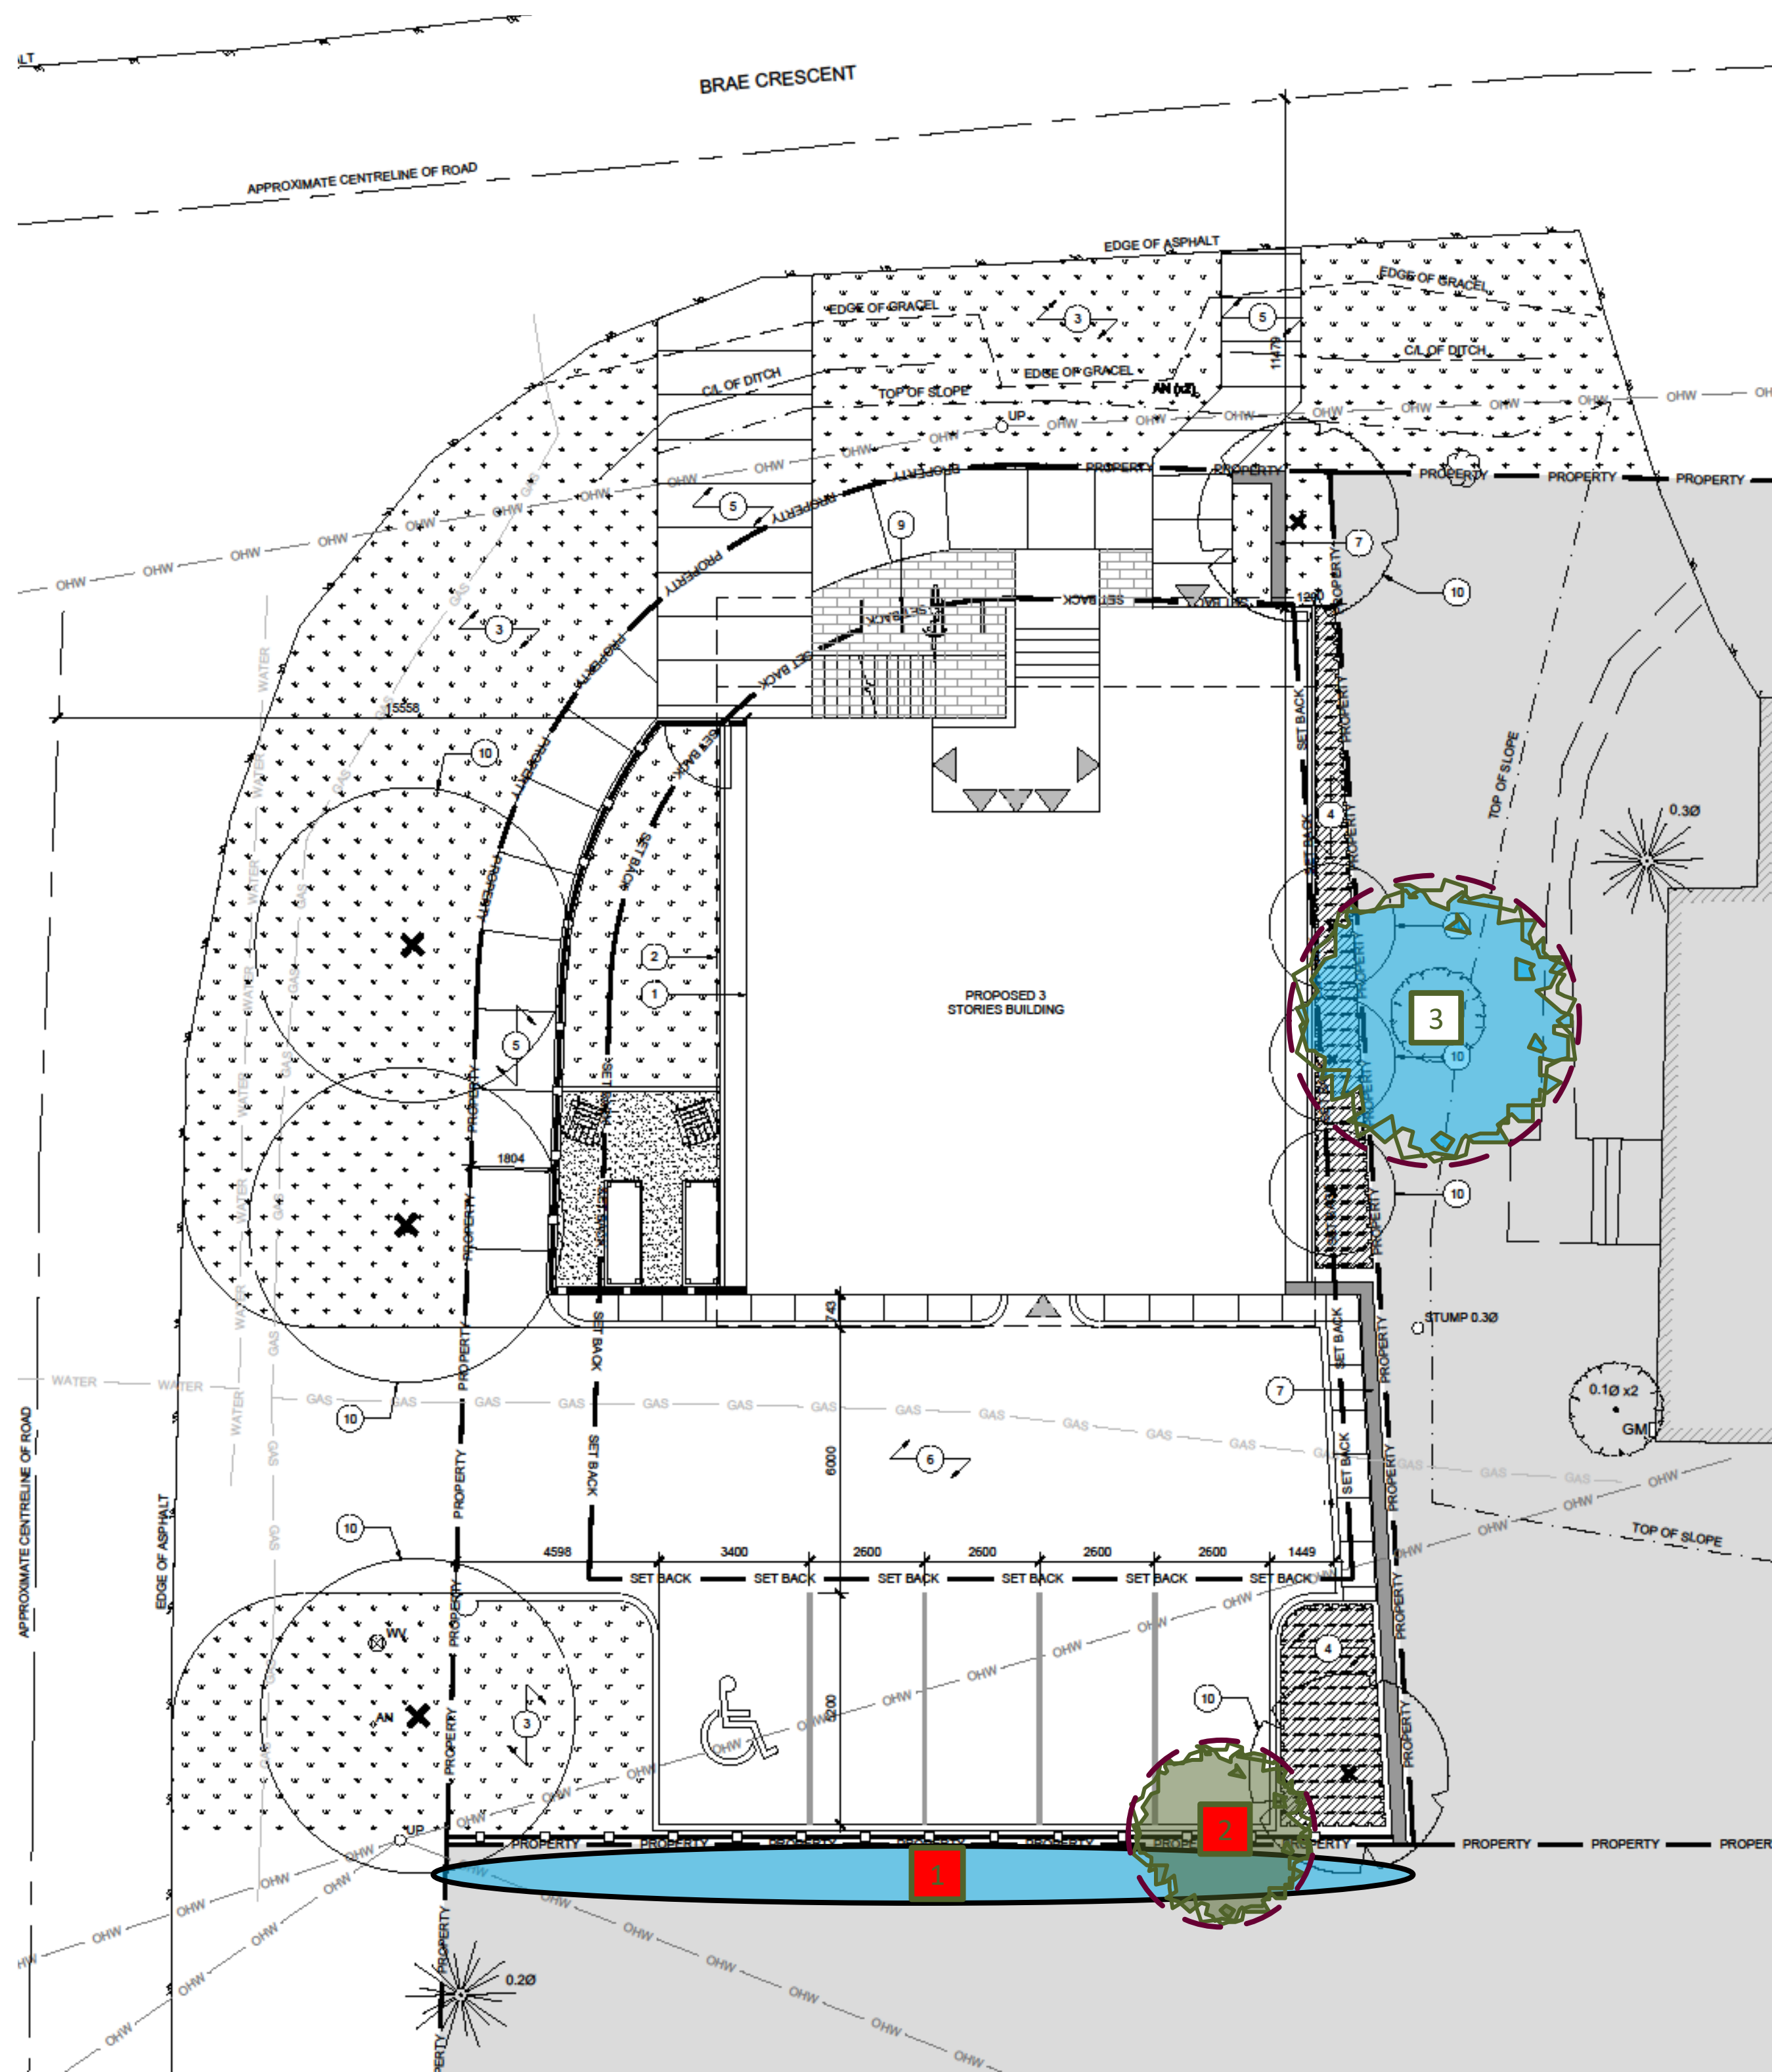
Tree Conservation Report – 121 Brae  
 Proposed Development and Conserved Vegetation  
 Tree layer prepared by Dendron Forestry Services  
 Version 2.0, April 24, 2023  
 For more information, please contact info@dendronforestry.ca

Tree <sup>1</sup>	Species	Diameter at breast height (dbh)	Ownership <sup>2,3</sup>	Condition	Action
1	Eastern white cedar ( <i>Thuja occidentalis</i> )	5-15 cm	Jointly owned, mostly on adjacent property at 3 Norway Spruce; approximately 6-8 m in height	Fair; has not been maintained on the subject property side recently	Remove due to design of parking area and installation of retaining wall; permission from adjacent property owner required; <b>Tree Permit required</b>
2 <sup>4</sup>	Manitoba maple ( <i>Acer negundo</i> )	Multi-stemmed, 5-15	Jointly owned with adjacent property at 3 Norway Spruce	Good/fair; good vigour, poor form	Remove; conflict with proposed parking area
3	Crabapple ( <i>Malus spp</i> )	30 cm (estimate)	Adjacent property at 123 Brae	Good	Retain and protect; light pruning of branches may be required for clearance, if significant root damage occurs during excavation for the new building, consider a deep root fertilizer one year after construction
