November 03, 2023

1900 and 2000 CITYPARK DRIVE TREE INVENTORY AND RETENTION REVIEW

1900 & 2000 CITY PARK DRIVE

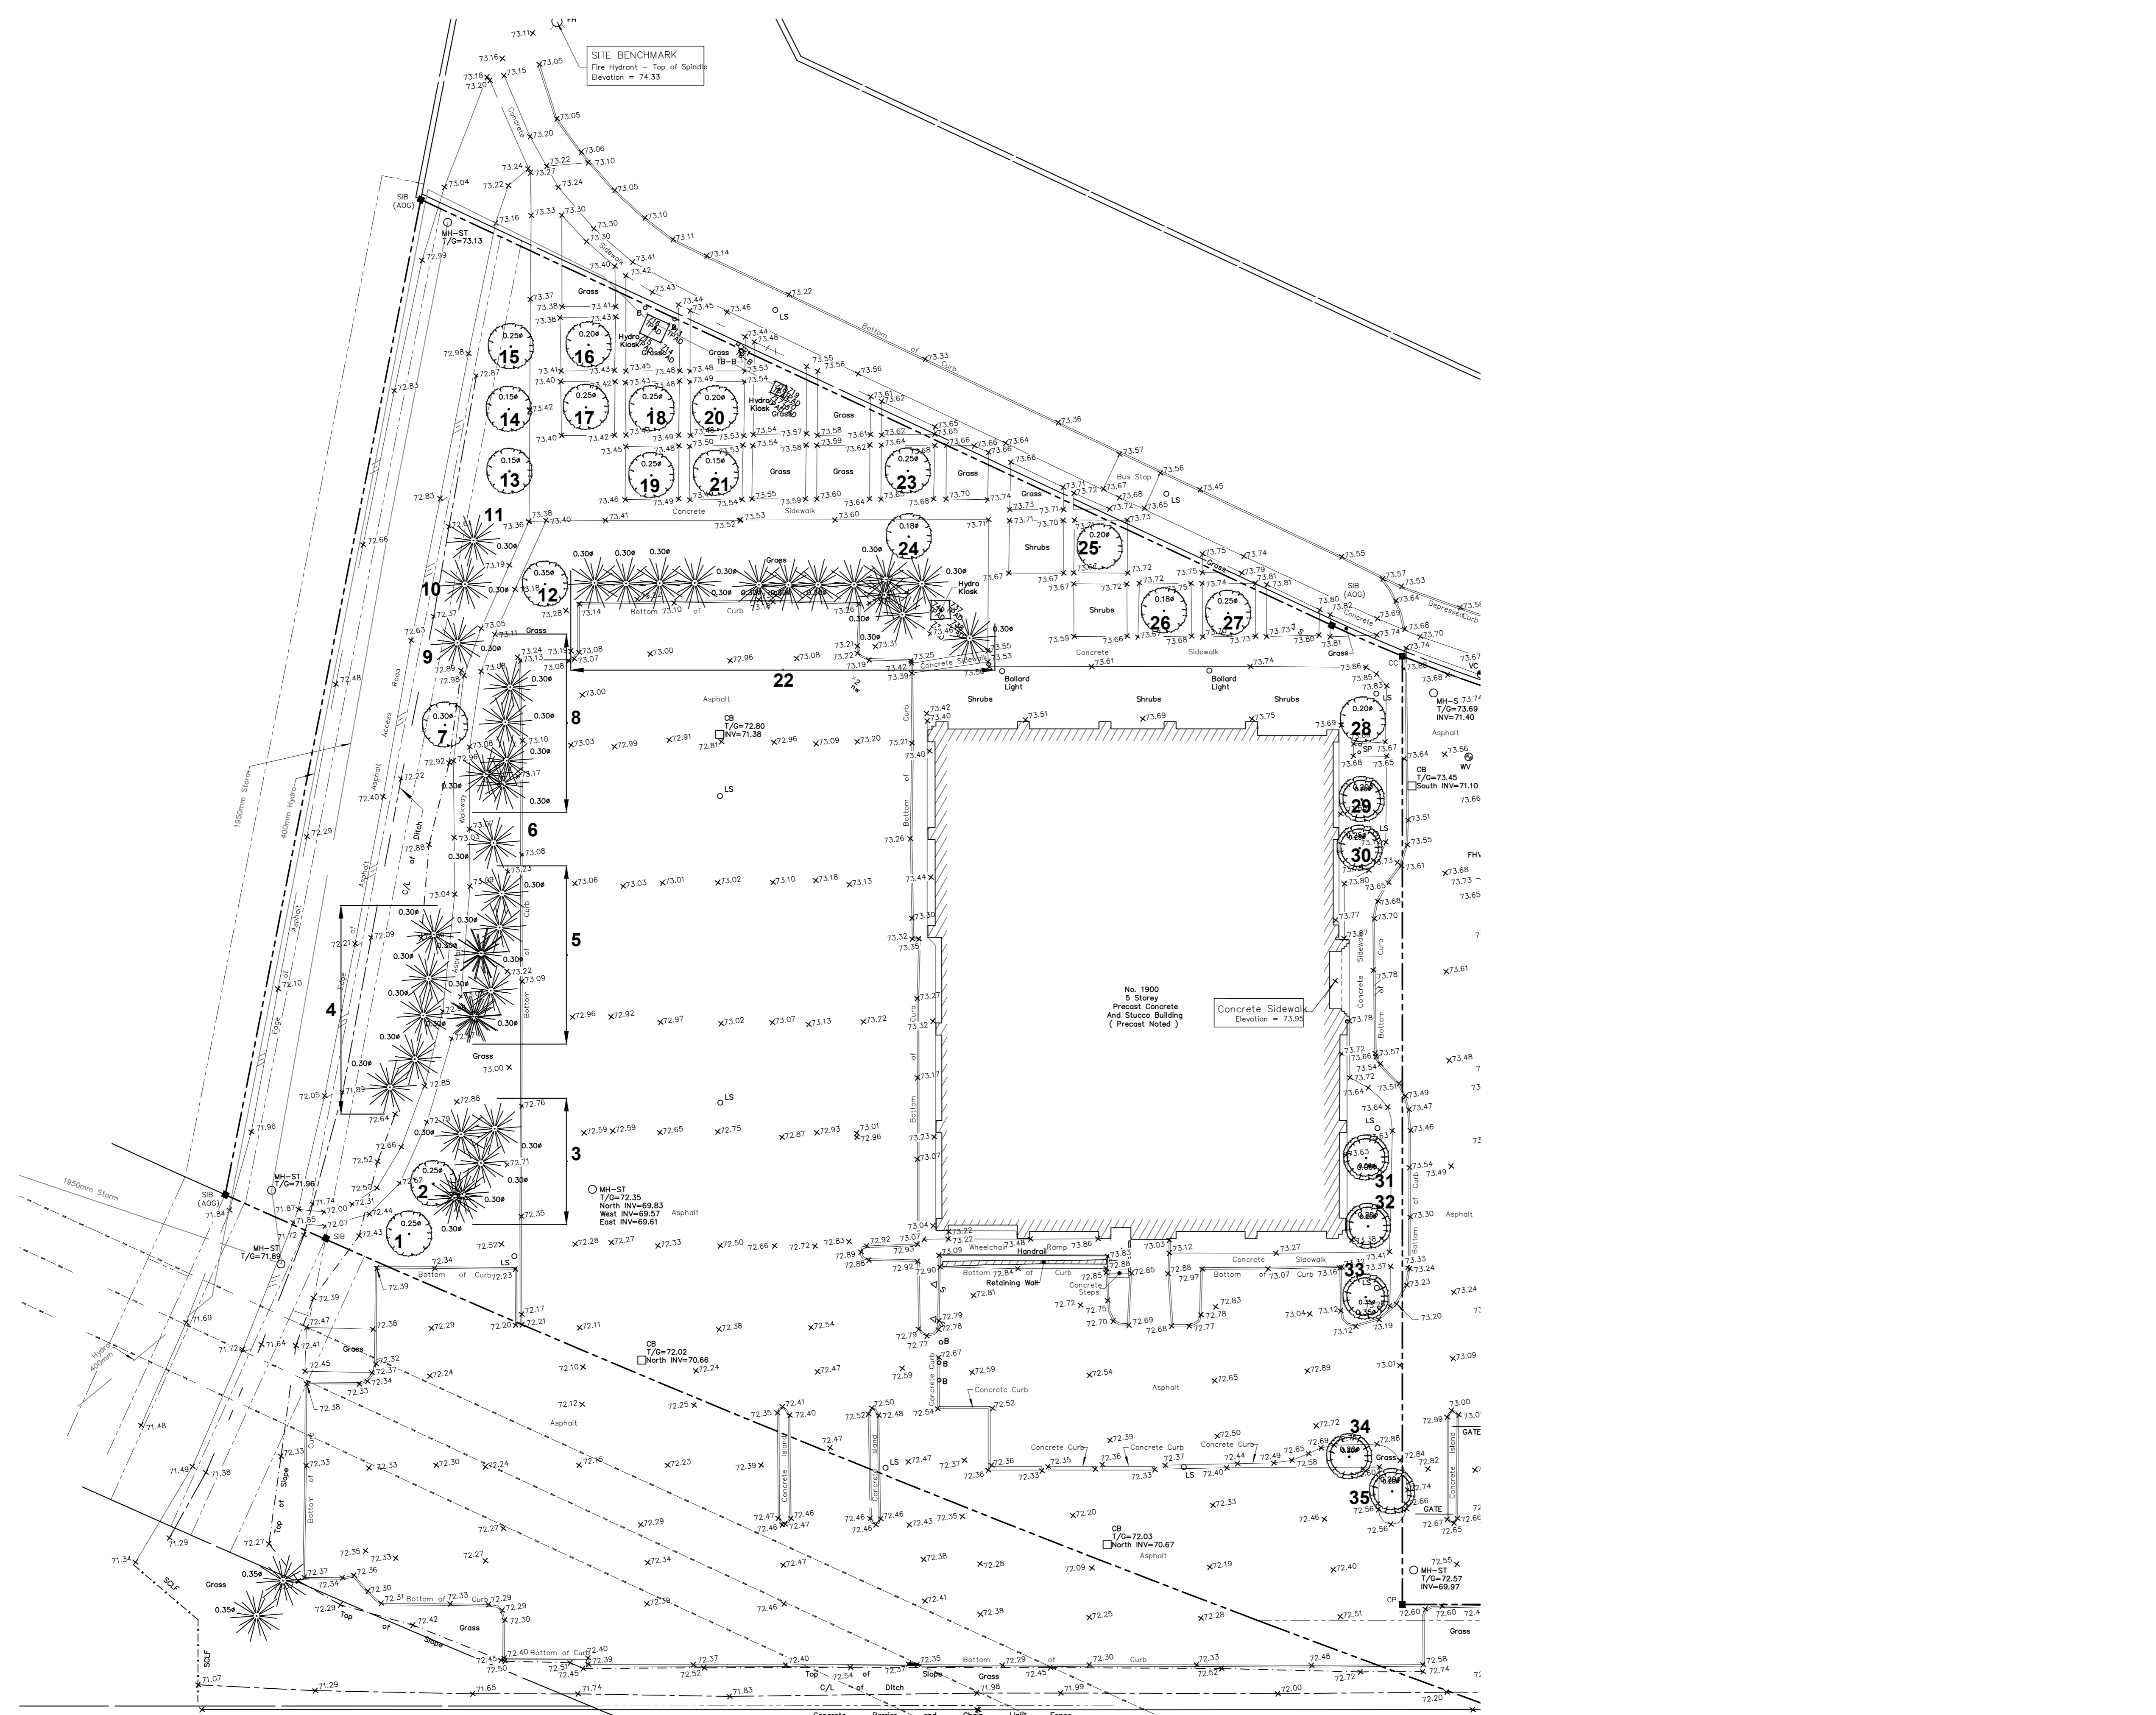
drawing title
1900 CITY PARK DRIVE EXISTING VEGETATION

This block consists of an existing 5 storey building, parking and built landscape with semi mature trees. The majority of the species here are Norway Maple, Colorado Spruce and Japanese Tree Lilac, semi-mature to mature size, from poor to good condition, refer to chart.

Tree Retention: Preservation opportunities exist in the north west corner (parkland dedication) (trees #8-21), depending on the future use. The remainder of the trees would be removed. A final review of retention possibilities will be undertaken during the site plan control process with a final site plan layout. Refer to attached tree retention areas.

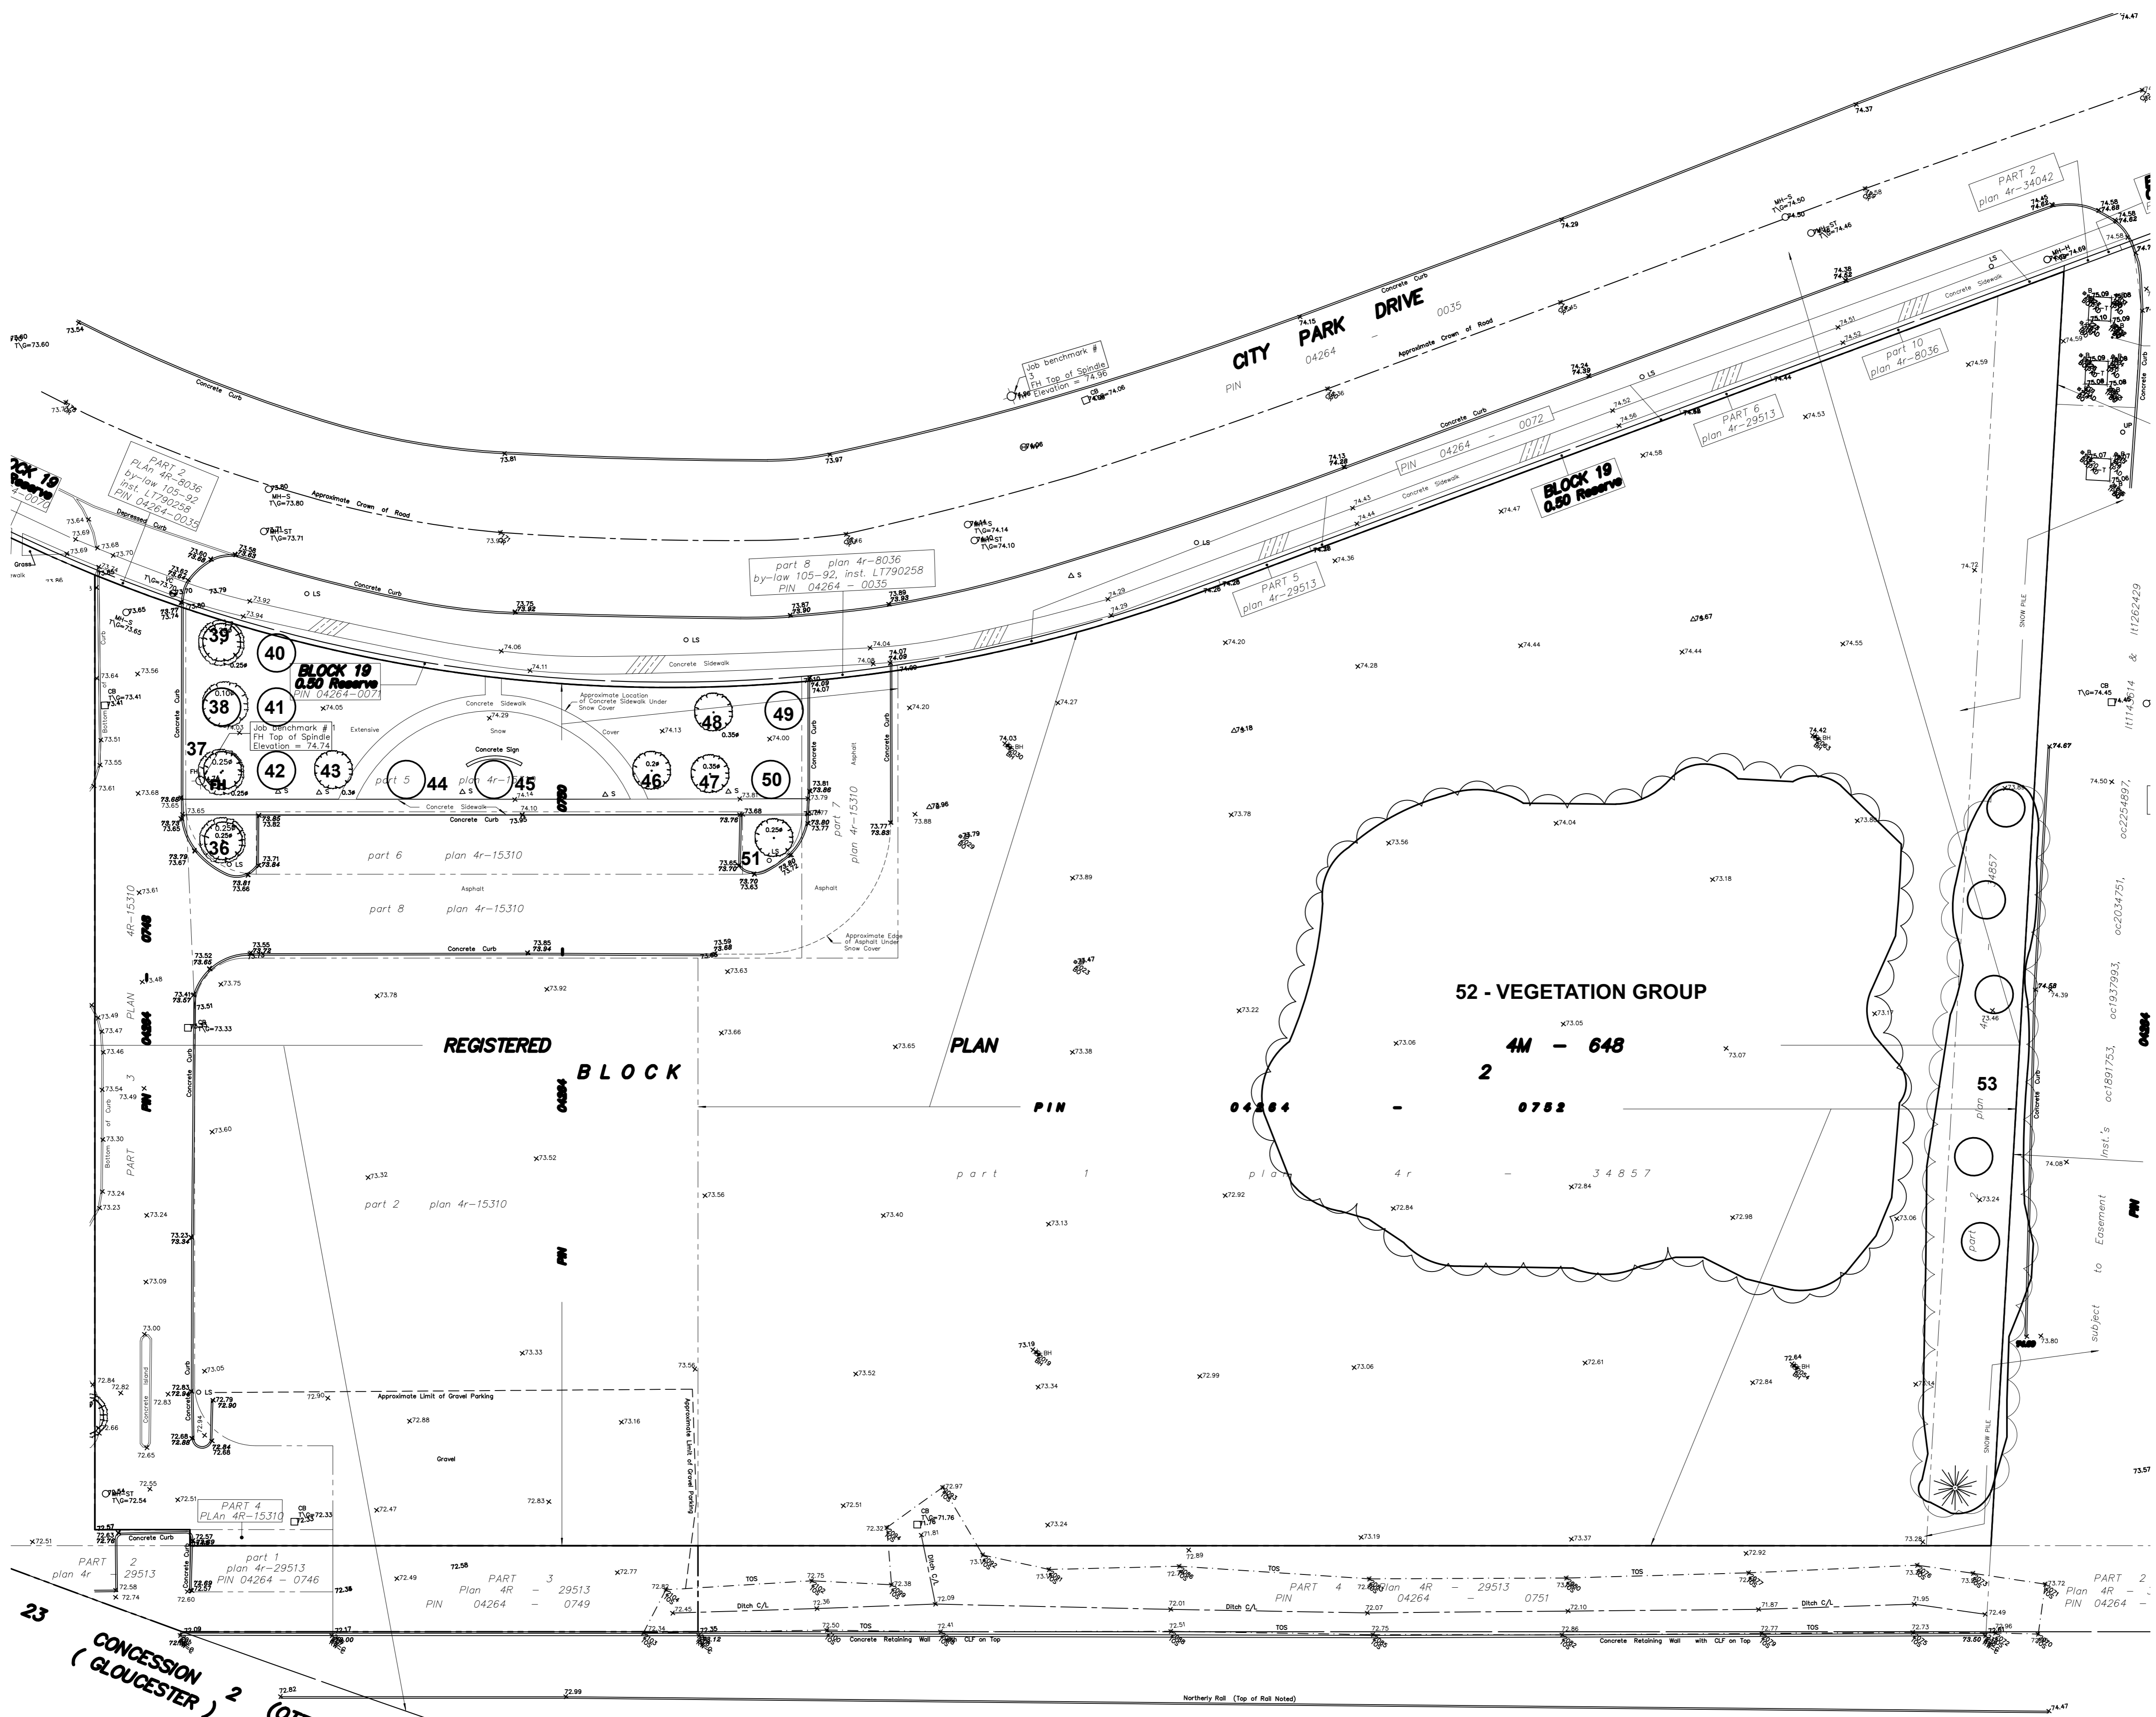
drawing title
2000 CITY PARK DRIVE EXISTING VEGETATION

Majority of this block is vacant field. Existing planted trees are located in the north-western portion (young to maturing Norway Maple and Crab Apple) and along the eastern property line (young Norway Maple, Colorado Spruce and White Elm). A naturalized vegetation area is centrally located consisting mainly of young White Elm and Buckthorn. Condition is very poor to good, refer to chart.

Tree Retention: based on the current schematic site plan, preservation opportunities exist in the north west corner in the r.o.w. adjacent to the proposed entrance drive (trees #36-40, 48 & 49). The remainder of the trees would be removed. A final review of retention possibilities will be undertaken during the site plan control process with a final site plan layout. Refer to attached tree retention areas.
