Geotechnical Investigation

Proposed Residential Development

4386 Rideau Valley Drive
Ottawa, Ontario

Report PG5828-1 Revision 4 dated April 4, 2024

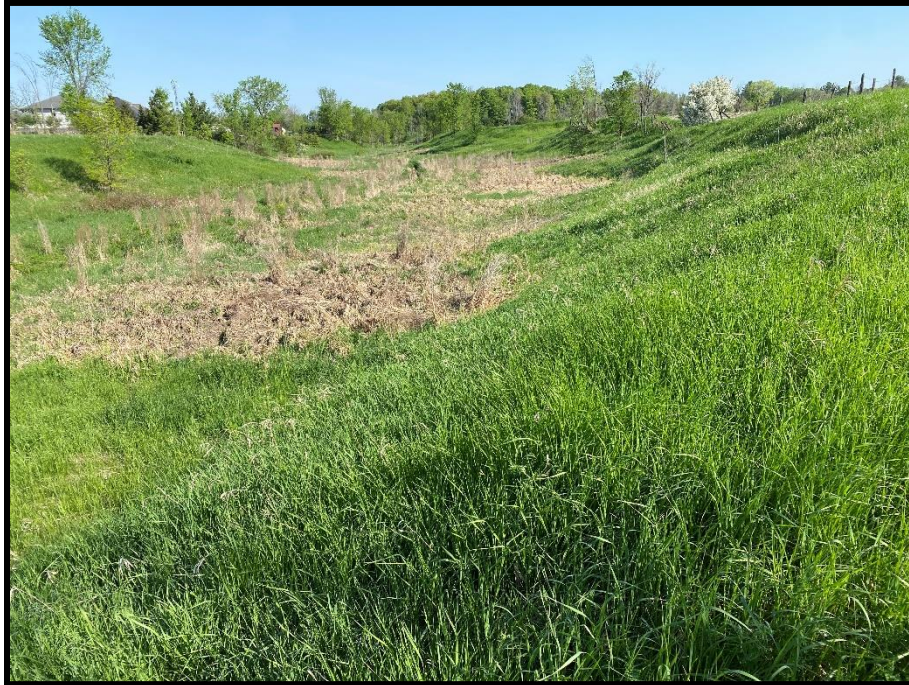
Photo 1: Area located at the bottom of the slope along the south-west portion of the subject site. Area is well vegetated and sloped gradually towards the valley floor.

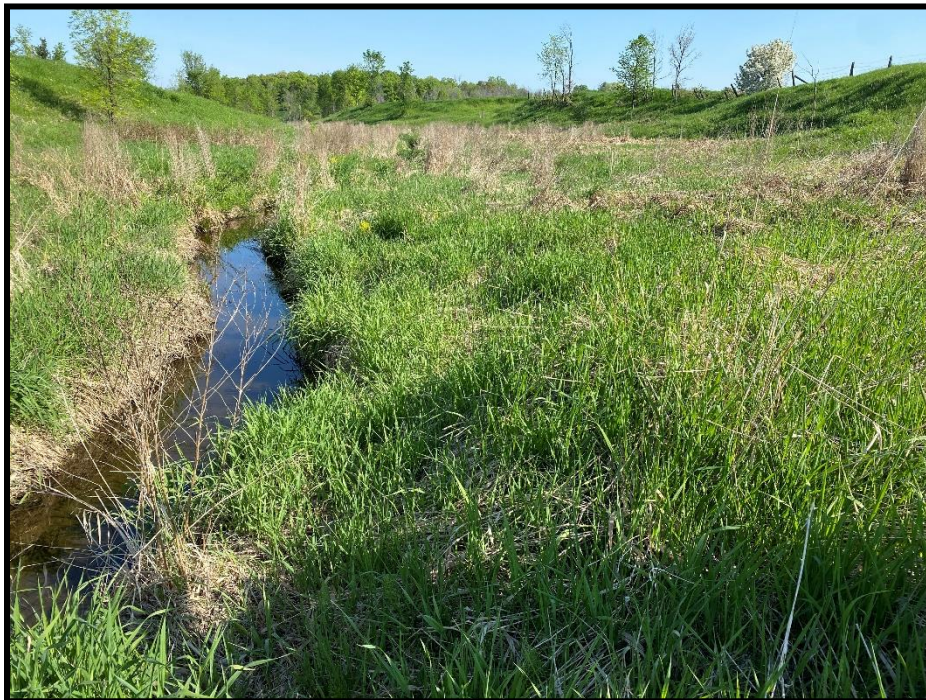
Photo 2: Area along creek tributary and south-west portion of the subject site. Area appeared to be well vegetated and did not appear to be eroded at the time of site visit. Water throughout creek tributary appeared to be flowing very slowly and/or ponding.

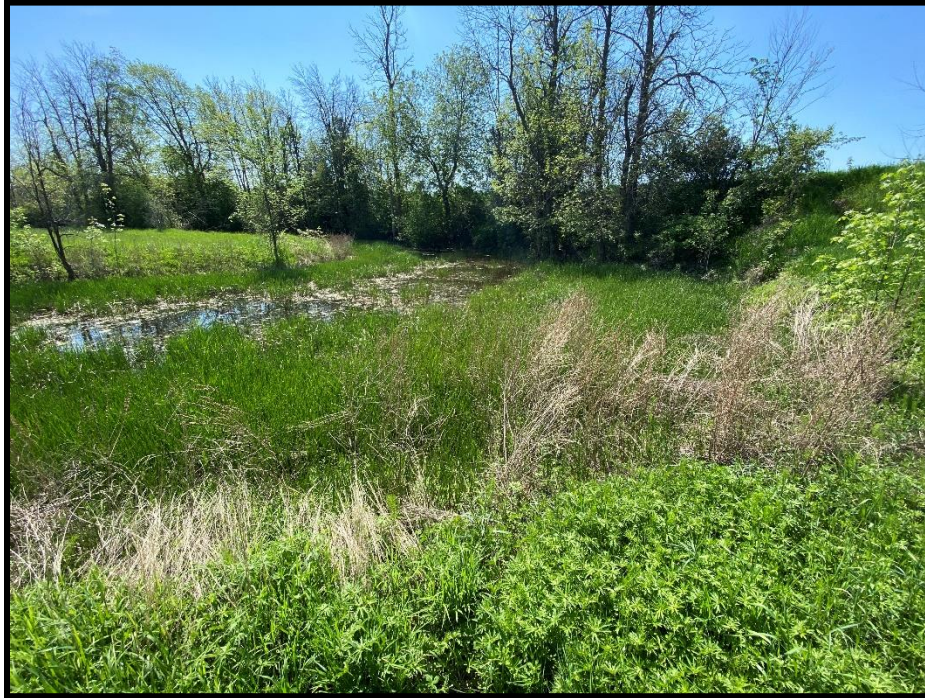
Photo 17: Area of Ruisseau Mud Creek valley floor along north-east portion of subject site. Photographed area appeared to contain well rooted vegetation and mature trees. No erosion observed along toe of slope at time of site visit.

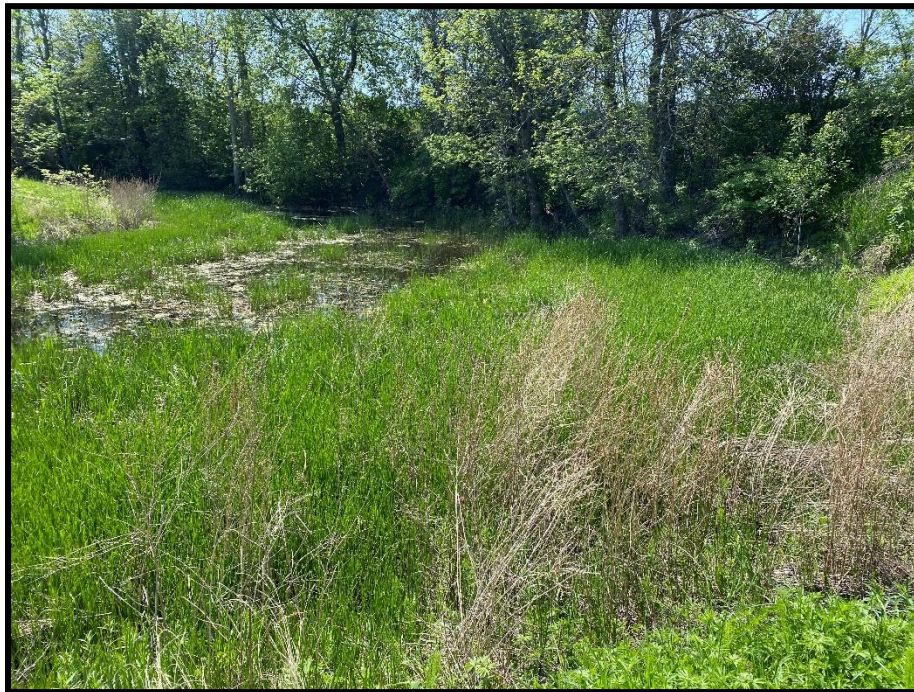
Photo 17b: Close-up of Photo 17 - Area of Ruisseau Mud Creek valley floor along north-east portion of subject site. Photographed area appeared to contain well rooted vegetation and mature trees. No erosion observed along toe of slope at time of site visit.
