McKinnon's Creek Erosion Hazard Assessment

930 Smith Road, Navan, Ontario

December 8, 2023 (Revised March 22 and June 18, 2024)
PN23106

Project Number: PN23106

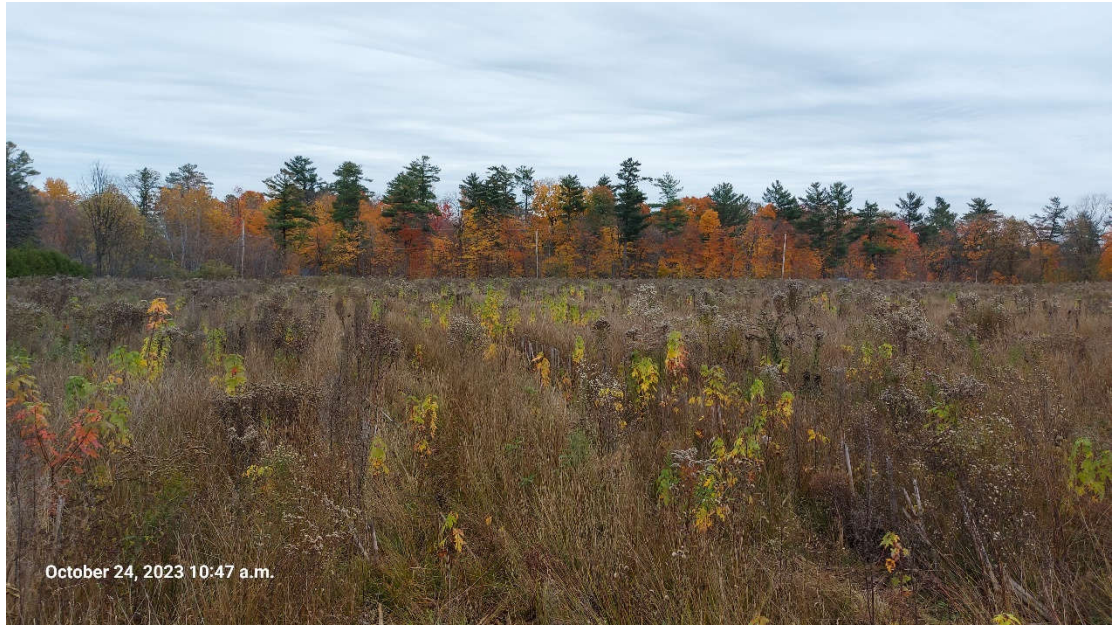
Photo 1
McKinnon's Creek
930 Smith Road, Navan

Photograph taken facing east towards Smith Road from the center of the subject site. No established drainage features were observed within the site.

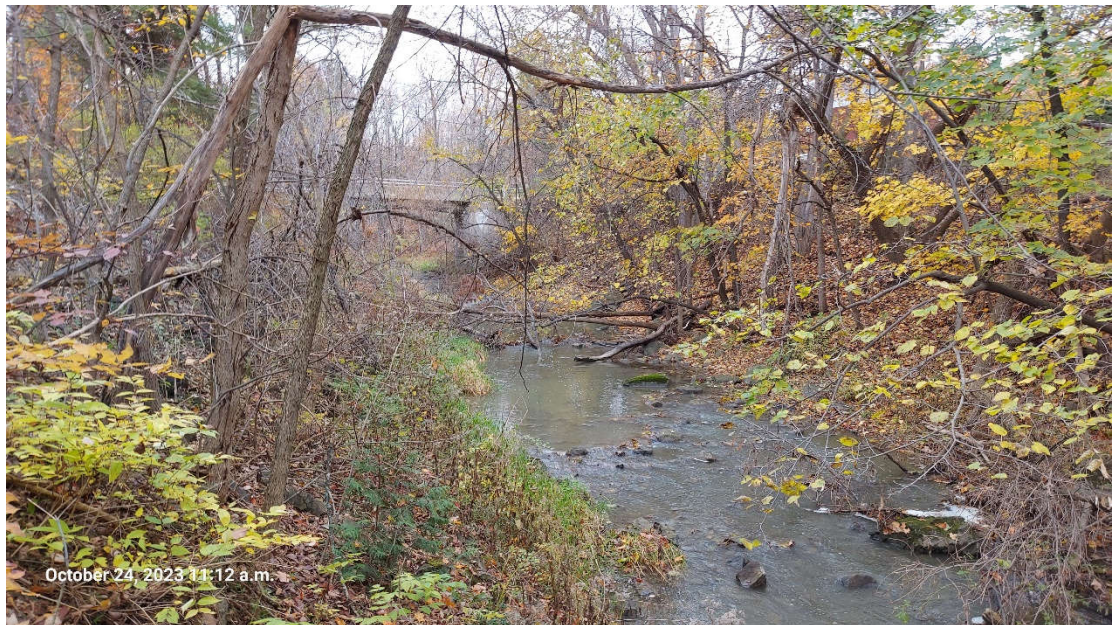
Photo 2
McKinnon's Creek
930 Smith Road, Navan

Photograph taken facing north at the most upstream extent of **MC-2**. For approximately 75 m along the right bank from the crossing, placed angular riprap covered the bank.

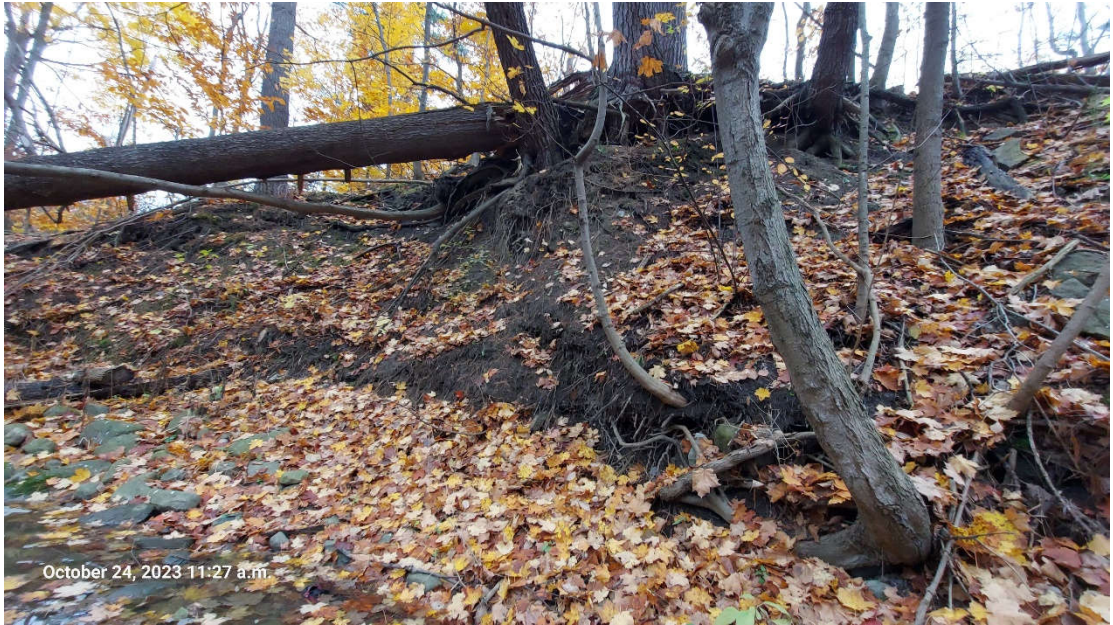
Photo 3
McKinnon's Creek
930 Smith Road, Navan

Photograph taken facing southwest at the right bank. A large cutface in the valley wall (approximately 5-7 m tall, 10-15 m long) was observed. Young J-hooked trees and exposed roots were present.

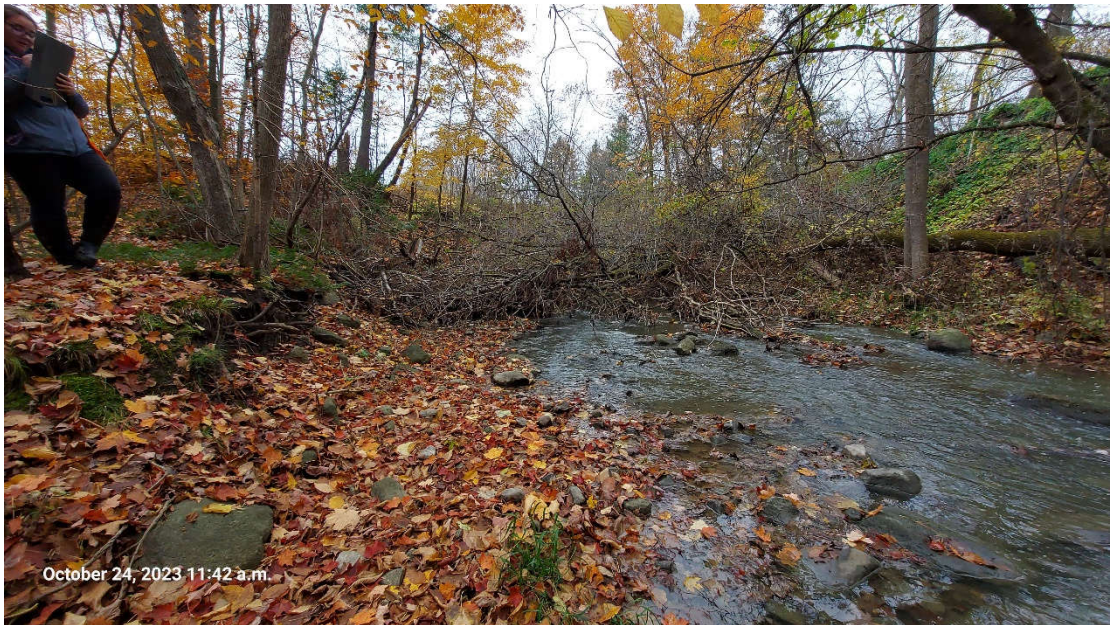
Photo 4
McKinnon's Creek
930 Smith Road, Navan

Photograph taken facing north at the upstream extent of the reach. Large woody debris was frequently observed along the reach (approx. every 50-100m).

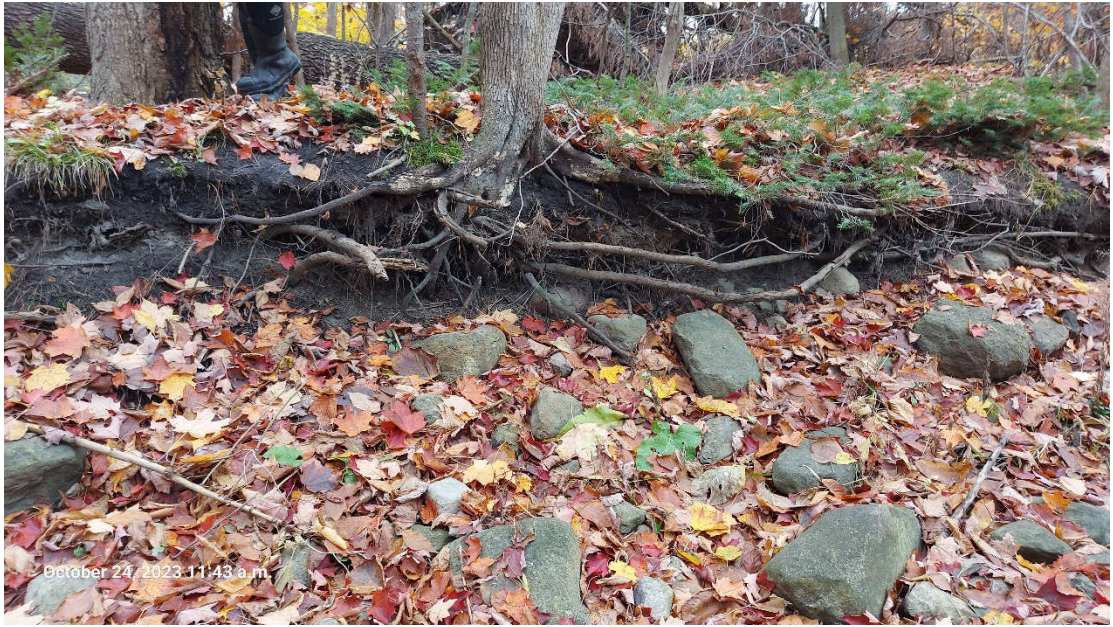
Photo 5
McKinnon's Creek
930 Smith Road, Navan

Photograph taken facing the left bank along the center of the reach. Exposed roots were commonly observed. Large boulders and cobbles were observed along the channel banks.

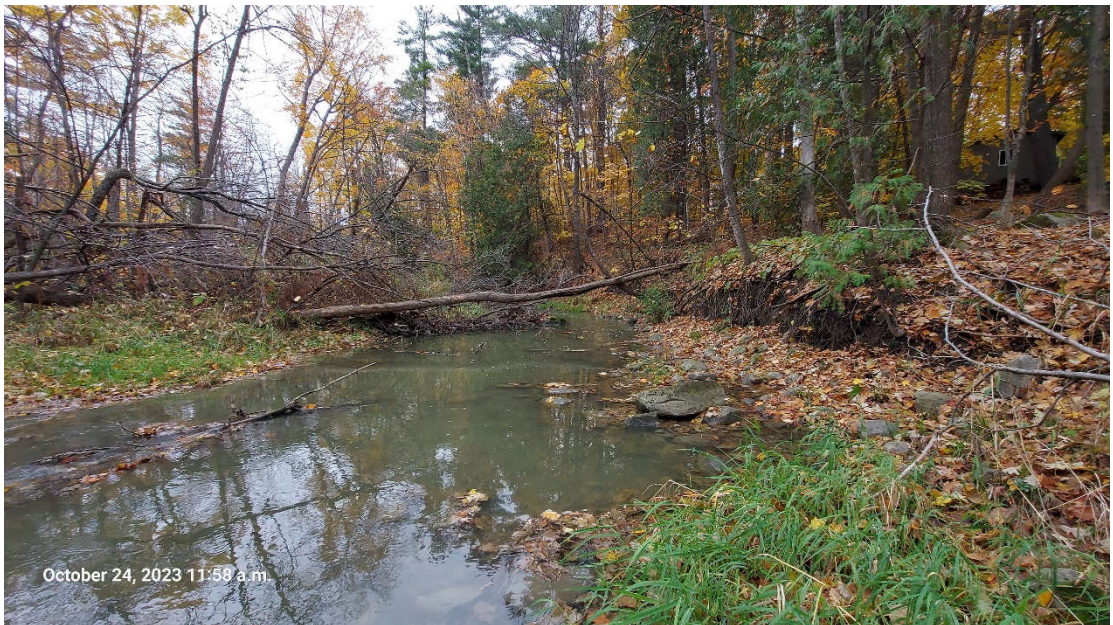
Photo 6
McKinnon's Creek
930 Smith Road, Navan

Photograph taken facing north along the center of the reach. Basal scour, exposed roots and J-hooked trees were observed along the outside bends of the channel.

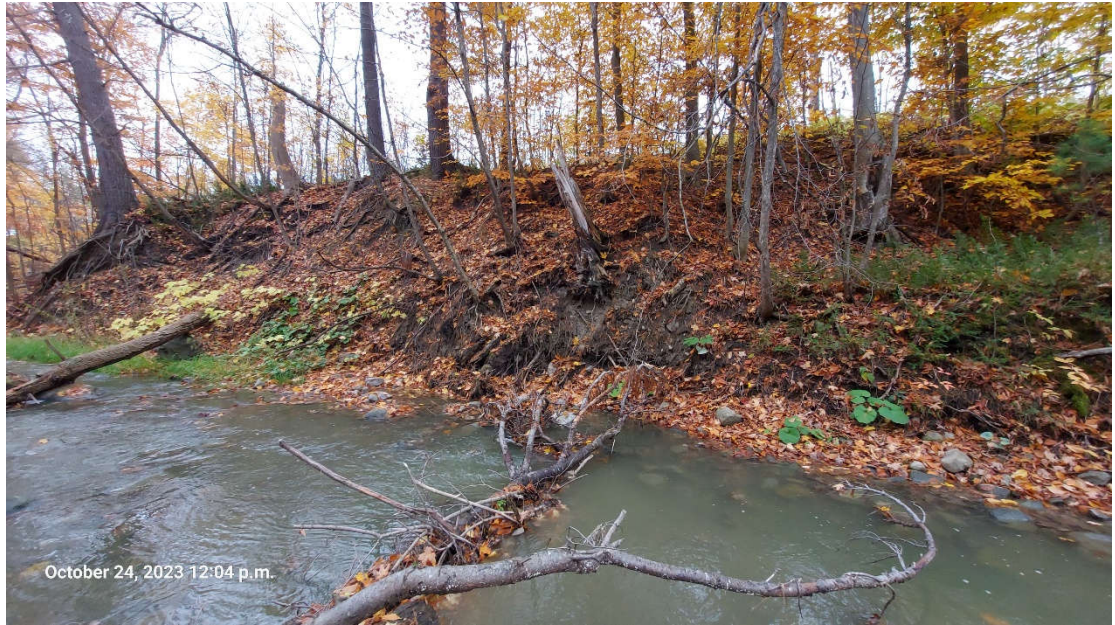
Photo 7
McKinnon's Creek
930 Smith Road, Navan

Evidence of channel adjustment was observed throughout the reach. Three occurrences of valley wall contact were noted, with cut banks ranging from 2 - 7 m in height and 10 - 25 m in length. Basal scouring was observed along the outside bends, resulting in undercutting (concentrated at the downstream extent) ranging from 0.23 - 1.05 m. J-hooked trees and exposed roots were also commonly observed. Large woody debris was extensive throughout the reach, both in the channel and the cutbank, and was present every 50 - 100m. Channel bank angles ranged from 30 - 90°, and erosion was observed along 60 - 100% of the reach.

Photograph taken facing west along the right bank of the reach. Valley wall contact was observed at 3 occurrences throughout the reach, exposing tree roots and soil.

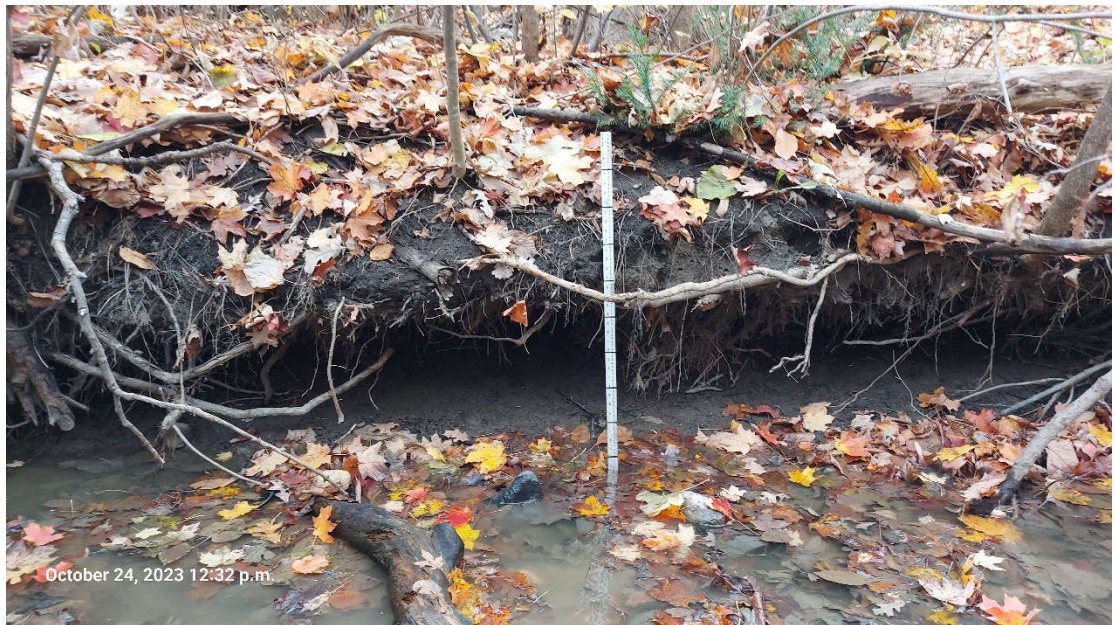
Photo 8
McKinnon's Creek
930 Smith Road, Navan

Photograph taken facing the right bank at the downstream extent of the reach. Undercutting was not commonly observed with exception to the outside bend along the downstream extent of the reach where undercutting was measured up to 1.05 m.

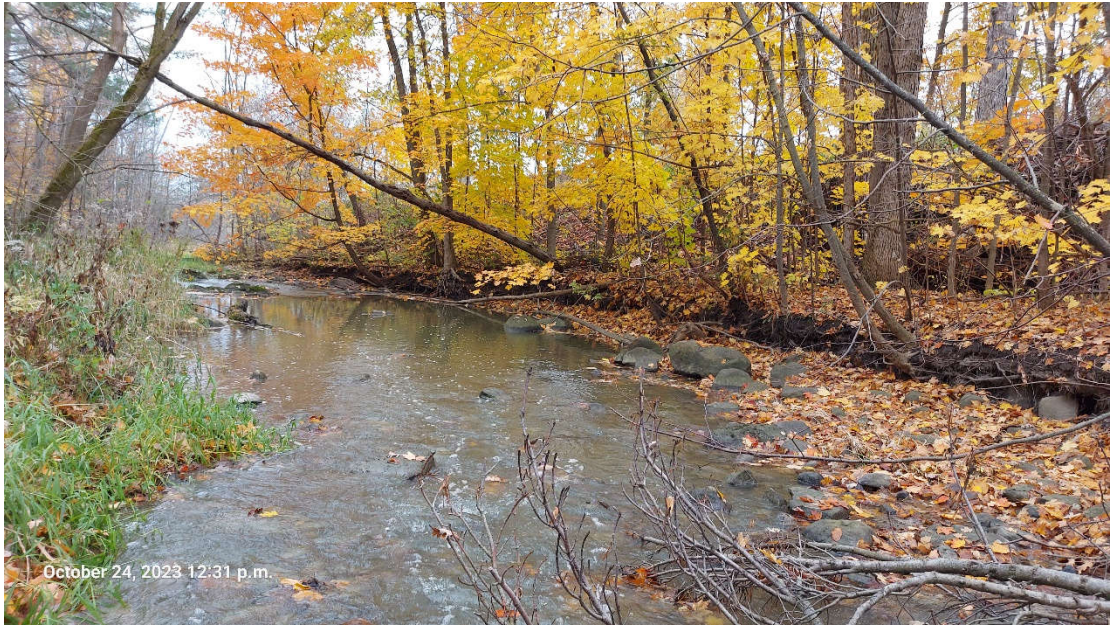
Photo 9
McKinnon's Creek
930 Smith Road, Navan

Photograph taken facing south at the most downstream extent of the reach. Basal scour was observed along the outside bend, and vegetated bars along the inside bend.

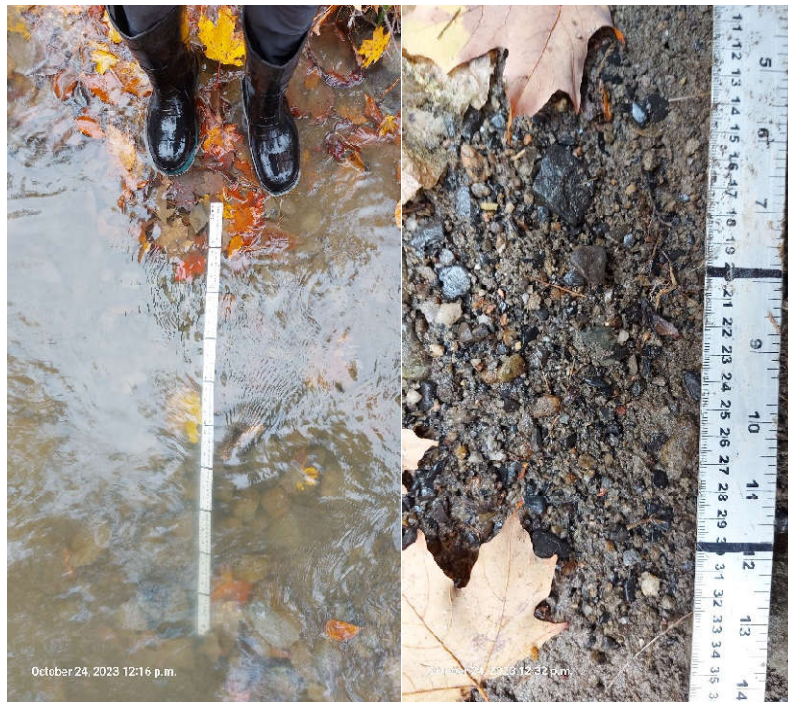
Photo 10
McKinnon's Creek
930 Smith Road, Navan

Photographs of the channel bed and banks. Instream substrate ranged from sand, gravel and cobbles in the pools and runs, and up to boulders in the riffles. Bank materials ranged from fine materials to gravel and cobbles.

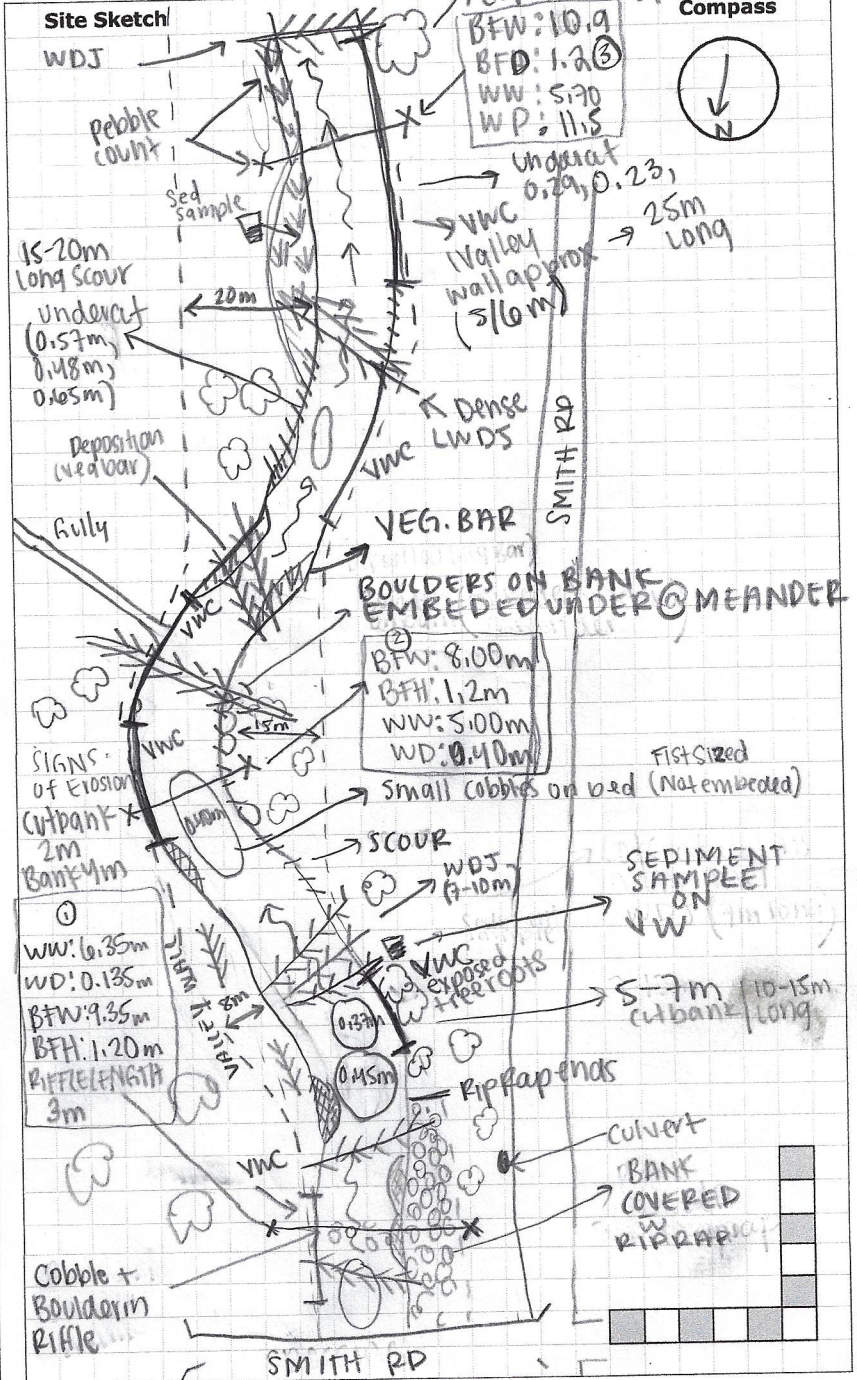
Notes: WH indicators + 2m from current depth. RIFFLE / pool spacing: 10-15m juvenile J hooks observed. meander amplitude: 25m RIFFLE LENGTH: 2-5m
