**TREE CONSERVATION REPORT**

1299 Richmond Road

CIMA+ file number: A001359  
August 27, 2024 – Review 002

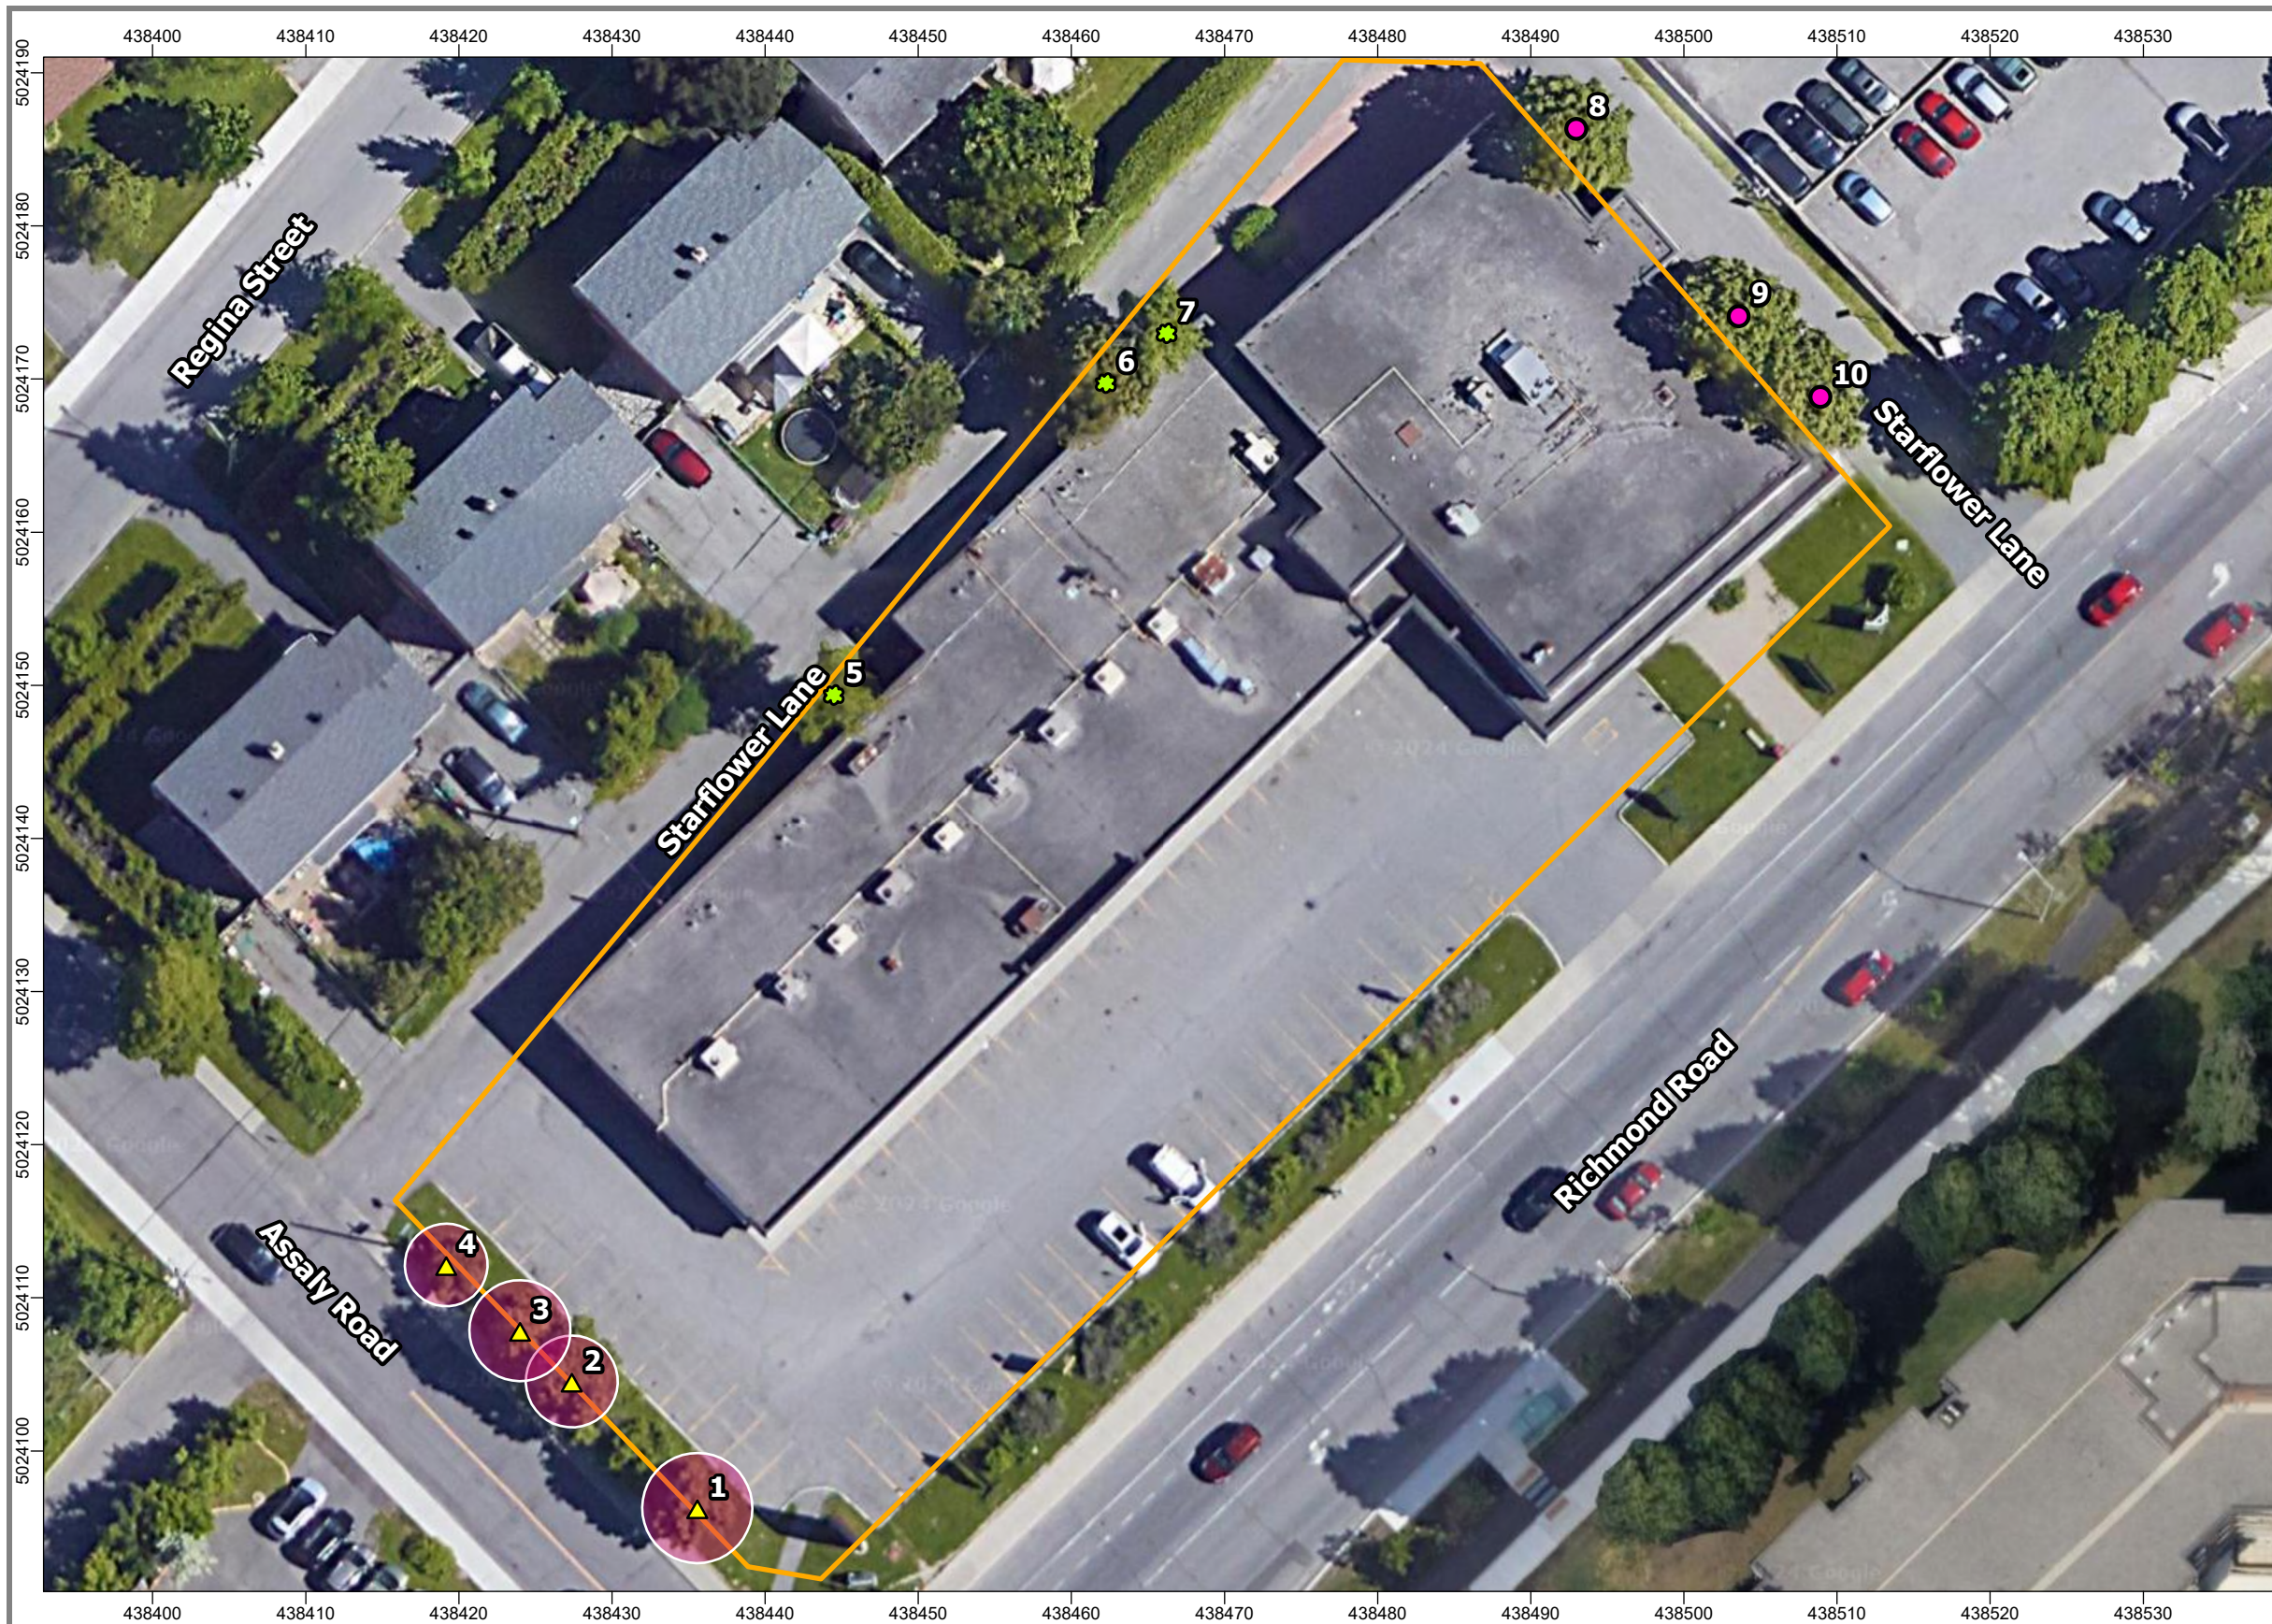
Map 1 - Current Vegetation

A total of 10 trees were assessed as part of this inventory, all of which were alive. The only species observed on site was small-leaved linden, *Tilia cordata*. The condition of the trees on site ranged from Excellent to Poor.

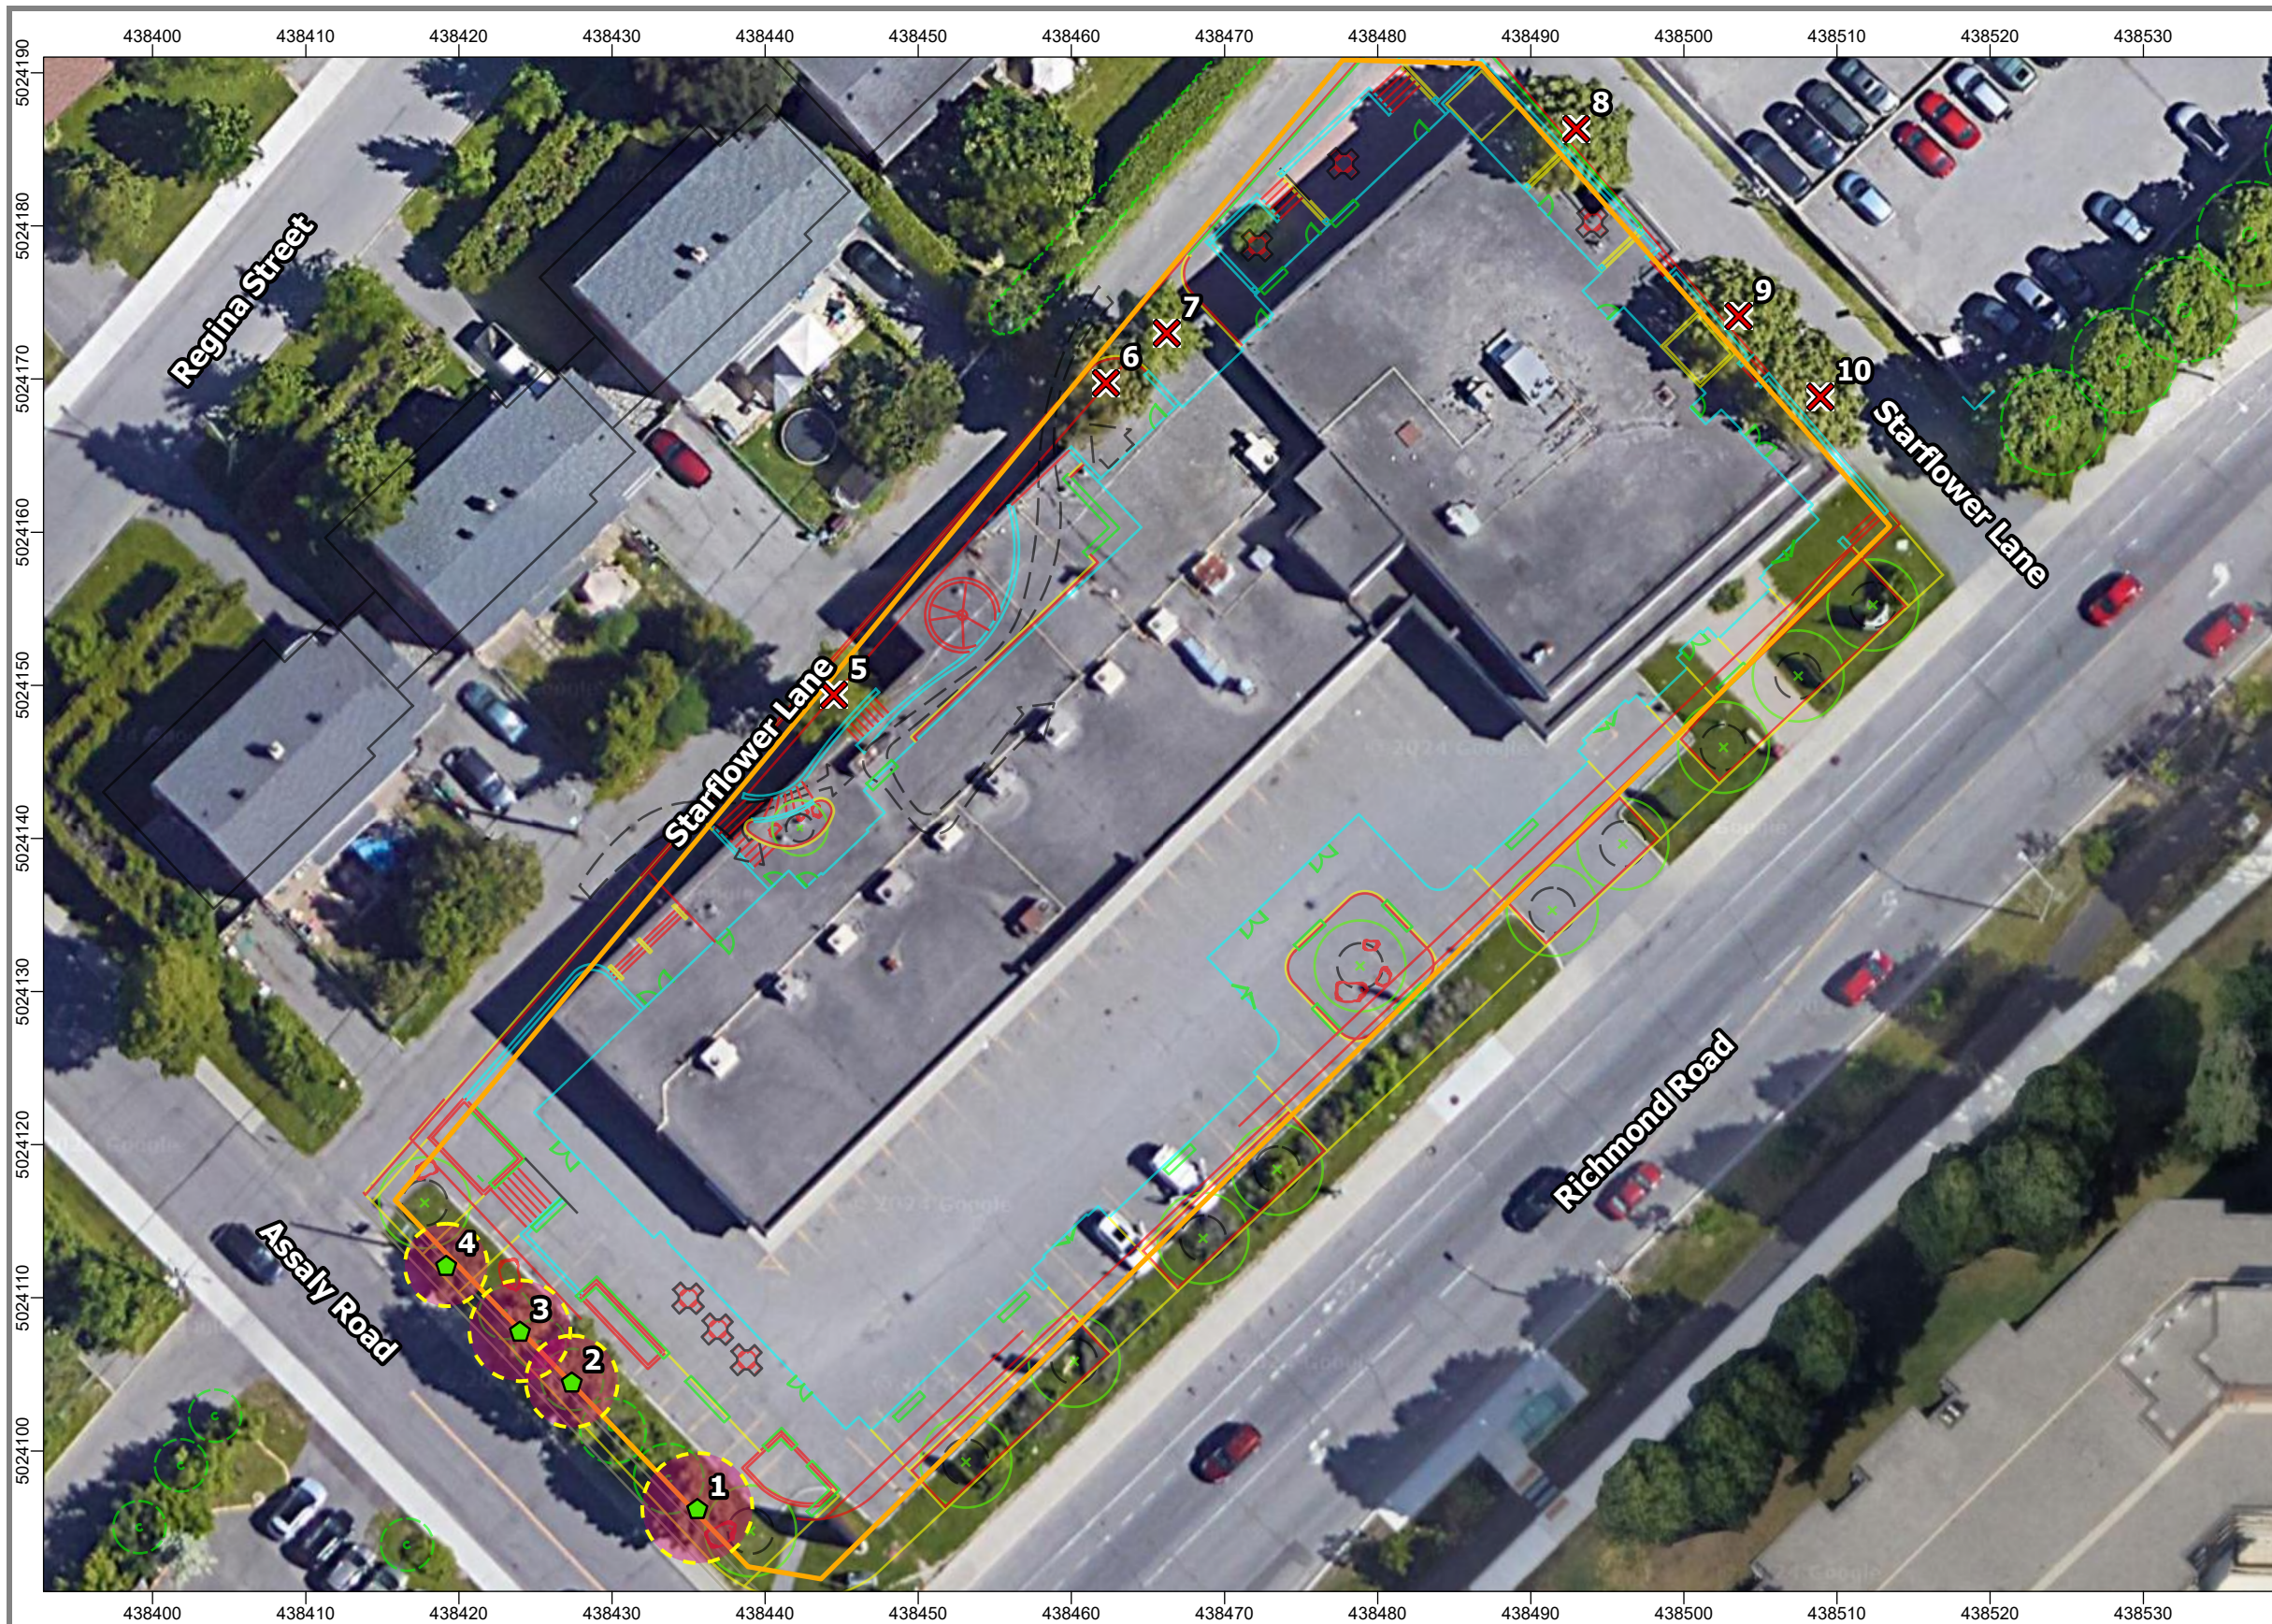
Map 2 - Proposed Development & Conserved Vegetation

Based on the species and conditions of the trees located within the site and the extent of the grading limits of the proposed project design it has been decided to retain 4 trees and remove 6 trees on the Site.

In order to successfully preserve trees that are recommended for on-site retention, the following series of mitigation measures is recommended. These recommended measures largely center on the minimum CRZ of trees (The CRZ is calculated as DBH x 10 cm), as defined by the City’s Tree Conservation Report Guidelines. The following measures are being recommended to protect the CRZ of all trees slated for retention and/or impact:

- + Delineation of the disturbance limits within work areas will be clearly defined on drawings and on the site prior to construction;
- + Install Tree Protection Fencing prior to commencement of construction activities, and retain fencing until construction activities have been completed, as per City of Ottawa’s Tree Protection (By-law No. 2020-340), Part VI:

- Tree protection fencing shall be at least 1.2 metres in height (or as per the approved Tree Conservation or Tree Information Report) and installed in such a way that the fence cannot be altered. It is to be installed no closer than the outer edge of the CRZ. Other such measures as required by the General Manager shall be implemented to protect the tree.
