## TECHNICAL MEMORANDUM

**DATE** December 22, 2022

**Project No.** 21482114

### FLUVIAL GEOMORPHIC ASSESSMENT AT SUBJECT AREA OF THE RIDEAU RIVER TO SUPPORT PROPOSED DEVELOPMENT AT 3930 AND 3960 RIVERSIDE DRIVE

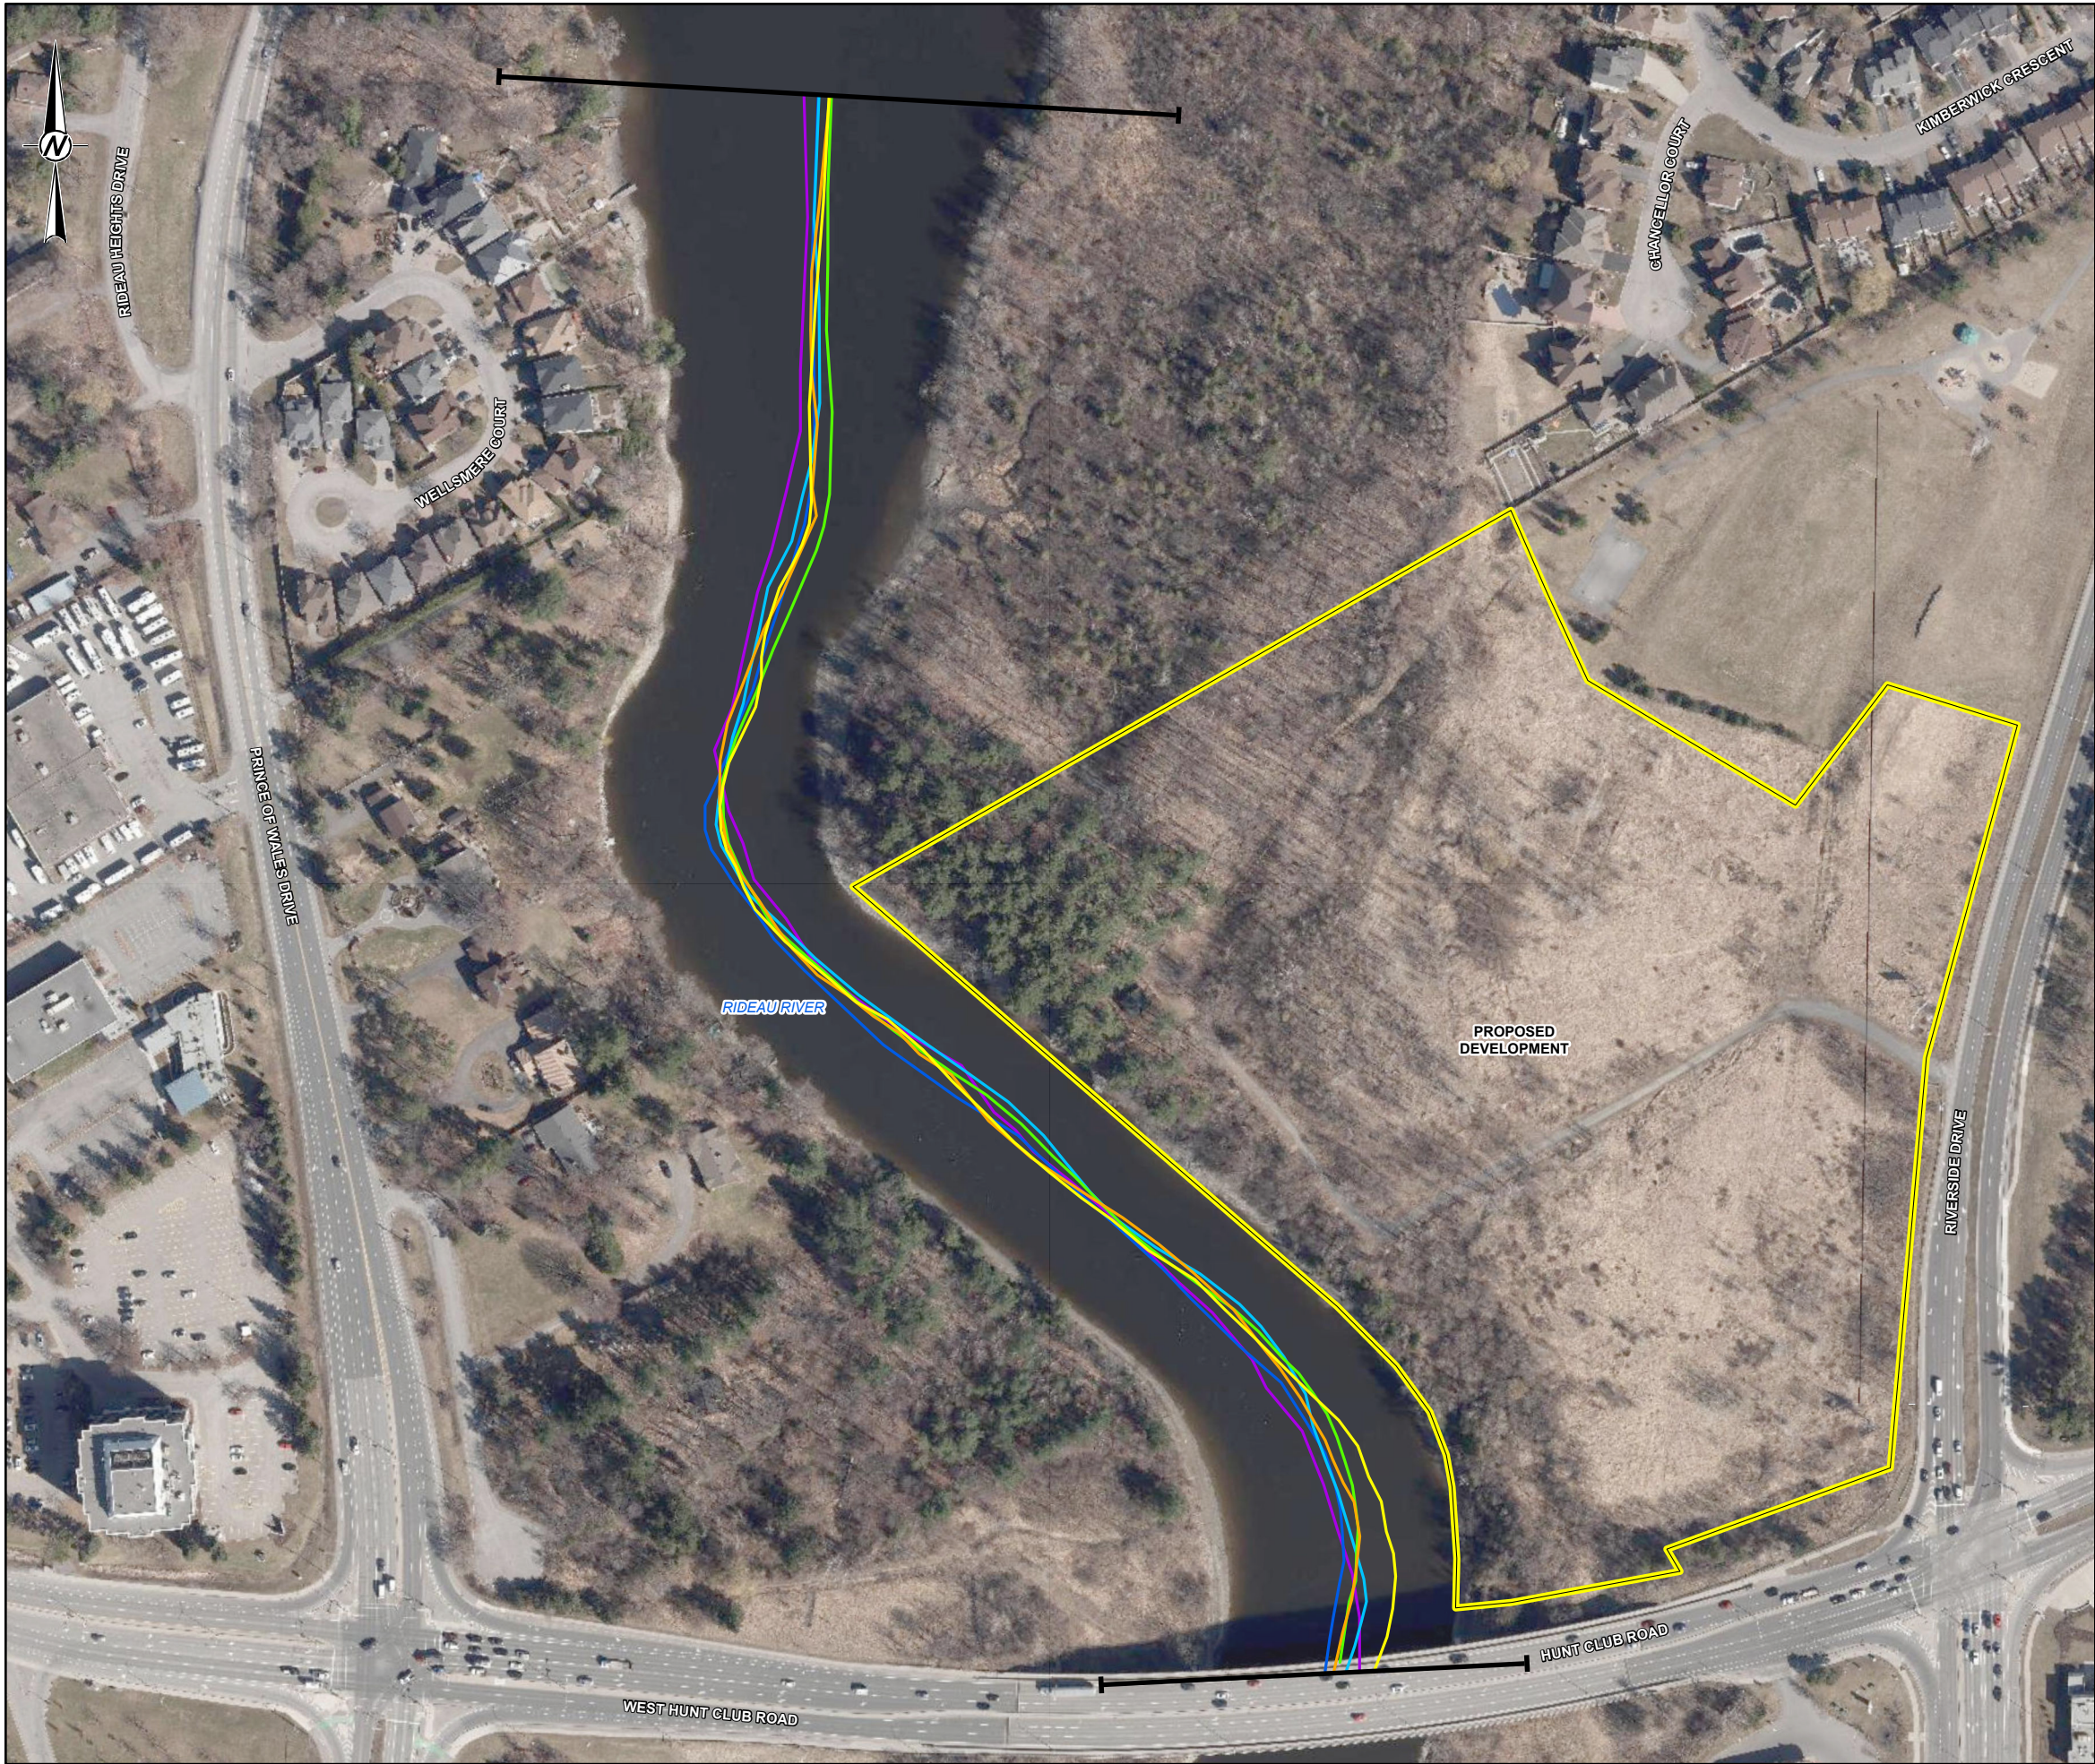
**SUMMARY OF OBSERVED CHANGES TO CHANNEL PLANFORM AT SUBJECT REACH BASED ON HISTORICAL AIR PHOTOGRAPH ANALYSIS**

The results of the air photograph analysis are illustrated in Figure 2. The key findings are as follows:

- **Changes in Land Use** – The review of the historical air photographs showed that land use in the vicinity of the reach length, as well as in the upstream catchment area, has been predominated by agriculture (i.e., cleared land) with some residential development since at least 1965. However, based on the general understanding of settlement patterns in the Rideau and Ottawa River Valleys, agriculture and associated land clearing has likely been the dominant land use in these catchments well before that time (over the past approximately 100 to 150 years). From 1965 onward, the air photos/images showed that land use in the local area continued to progressively transition to mostly urban development (residential with some commercial and light industry). This included the development of West Hunt Club Road and the associated bridge crossing at the river between 1965 and 1976.

- **Changes in Channel Planform** – The examination of the historical air photograph record demonstrated that the planform of the subject channel has been relatively stable for the past 40+ years (i.e., lateral movement of the channel has been relatively minimal). The most pronounced change in the channel pattern was limited to modest examples of planform shift between 1965 and 1975 and then again between 2011 and 2021 (e.g., modest straightening of the channel immediately downstream of the bridge crossing, slight widening and minor translation of the channel at the downstream-most meander bend). This suggests that the channel morphology has largely adjusted to past changes in land use (i.e., agriculture and associated land clearing followed by progressive urbanization) and reached a quasi-stable equilibrium (Annable & Watson, 2012). The analysis of the historical air photographs also identified the following examples of erosion-sedimentation processes:

- Well-sorted, longitudinal, depositional features (i.e., point bars) were identified at the river in the air photograph from 1965, noting that these features were shown to be progressively eroded away in subsequent air photographs; and

- Each of the available air photographs included instances of overhanging vegetation at the right (east) bank of the river, with the understanding that these observations are typically indicative of active bank erosion.

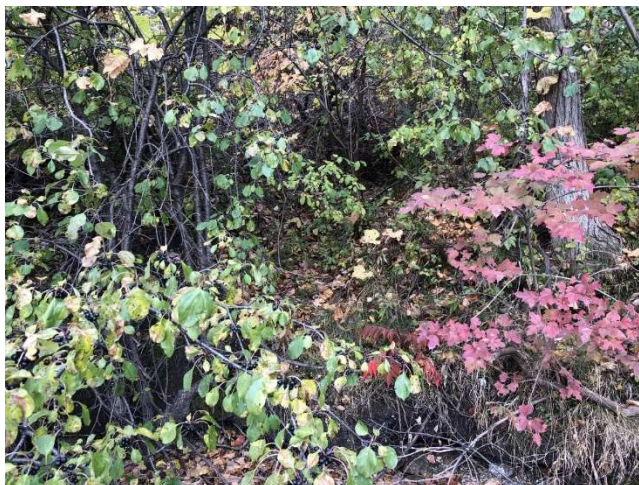
**Photo 12:** View looking at S12 (perpendicular to bank) on October 14, 2022, noting evidence of runoff pathways.
