TREE CONSERVATION REPORT

5872-5884 Hazeldean Road & 7
Savage Drive

Tree Conservation Report submitted as Partial
Requirements for a Site Plan Control Application.

December 3, 2024

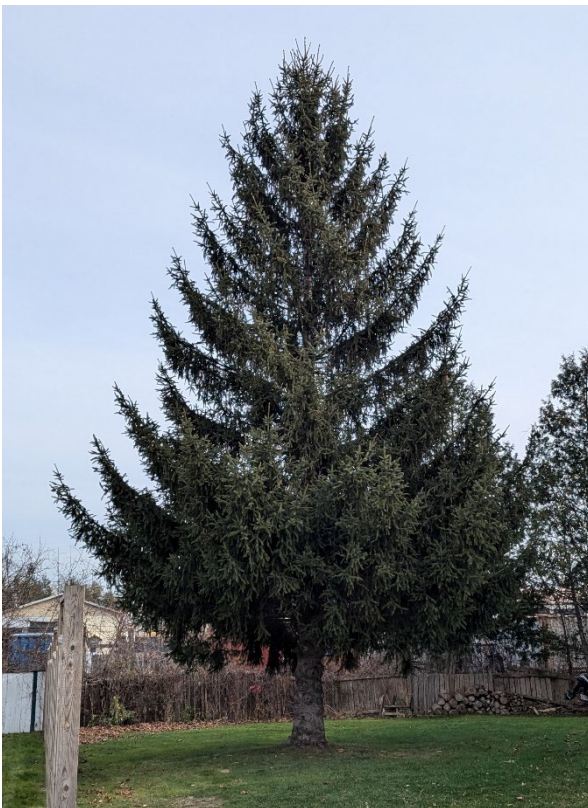
The amount of the defined Critical Root Zone of **Tree 3** that will be disturbed is minimal, and because the tree has good rooting space on the adjacent property, it is expected this tree will be able to endure construction.

Tree 3 - adjacent spruce to be retained.

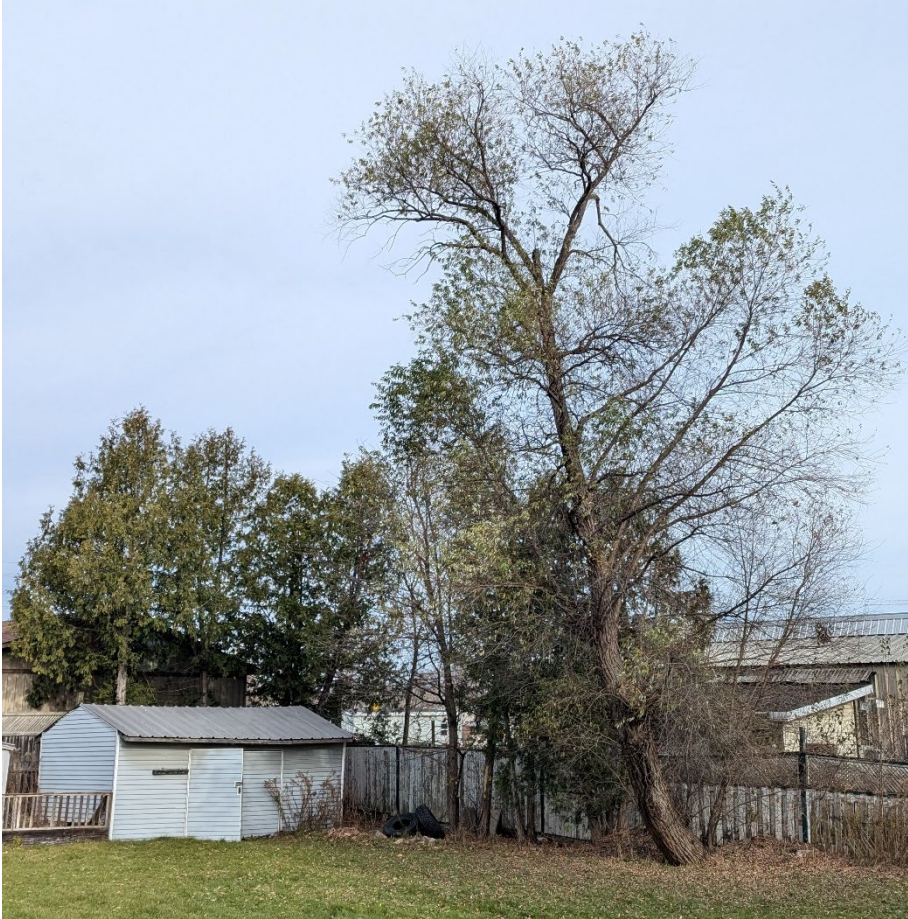
The proposed development includes 2 levels of underground parking covering a large majority of the lots. The required excavation will necessitate the removal of all private trees (specifically Trees **4-11 and 22-31**). Given these plans, it is unlikely engineering documents will change these recommendations.

Above left: Trees 4-11 - private trees to be removed.

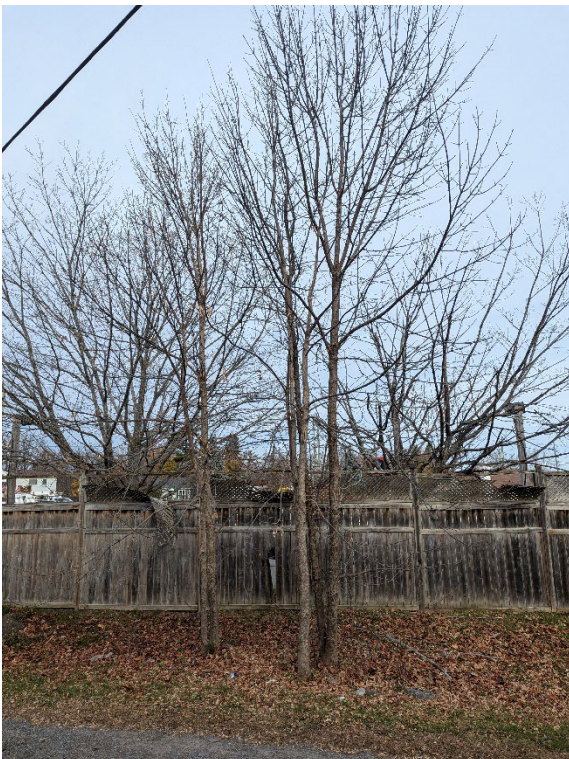
Tree 12 is a likely self-seeded cluster of young ash stems. These are showing signs of insect damage, and it is possible they have already been infested with Emerald Ash Borer. It is unlikely these trees will survive long, despite construction, and the stress of construction will further hasten their decline.

Below left: Tree 12 – cluster of ash stems to be removed.

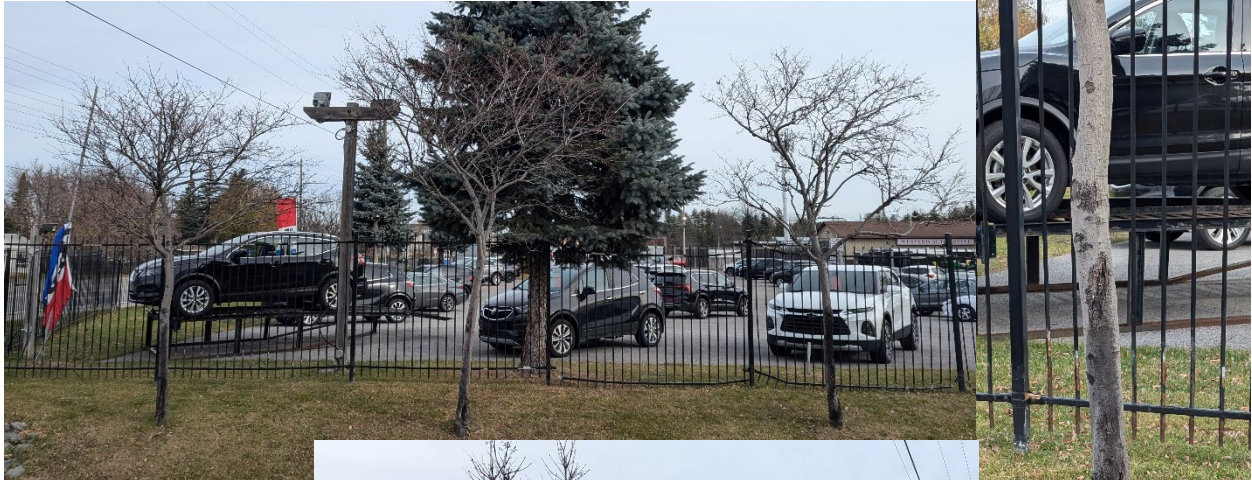
Above: City serviceberries and private spruce, all to be removed.

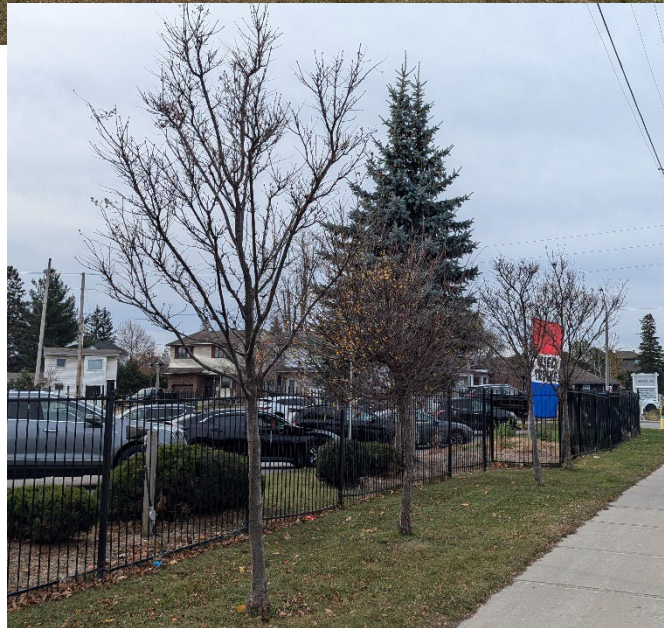
Trees 13-21 are in poor condition – large wounds around the bases of the trees are pathways for infections, and with the added stress of construction, regardless of protections, these trees are likely to decline very quickly. It is recommended they be removed and replaced with healthier specimens.

Far right: trunk of Tree 13 - typical wound and coloring of Trees 13-15.

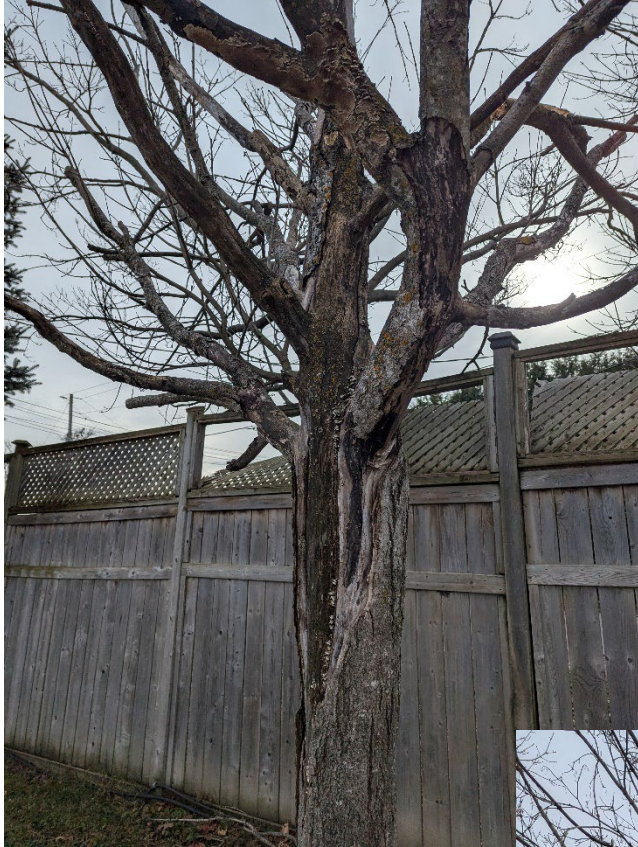
Above: Tree 32 - private sugar maple to be removed.

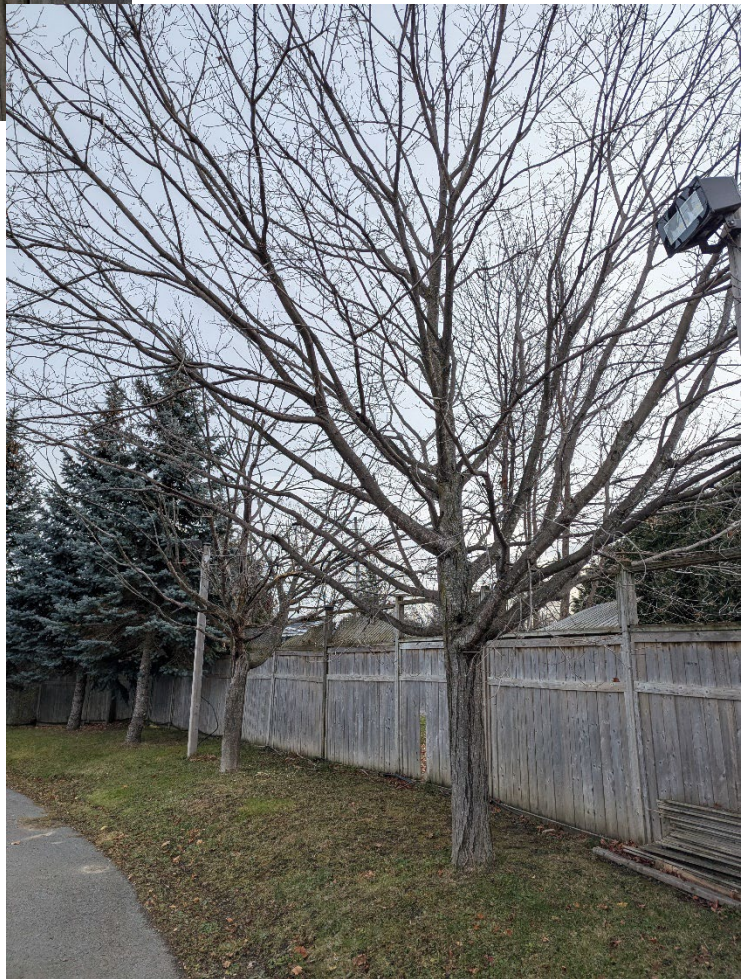
Right: Tree 33 - private sugar maple to be removed.
