September 15, 2025

RE: (REVISED) TREE CONSERVATION REPORT FOR 3055 RICHMOND ROAD, OTTAWA

Table 1. Species, condition, size, ownership and status of trees at 3055 Richmond Road.

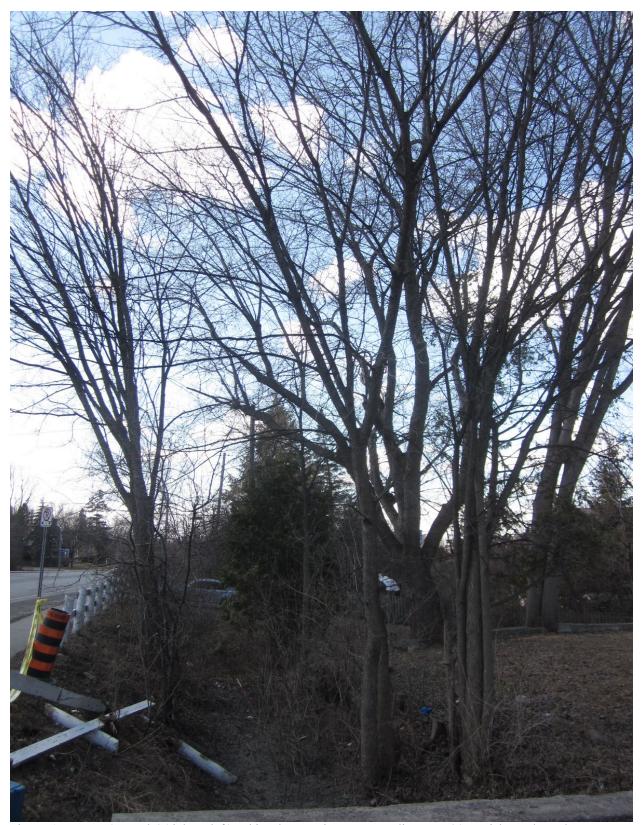
Picture 1. Trees #4, 5 and 6 (right to left), white elms on city property adjacent to 3055 Richmond Road

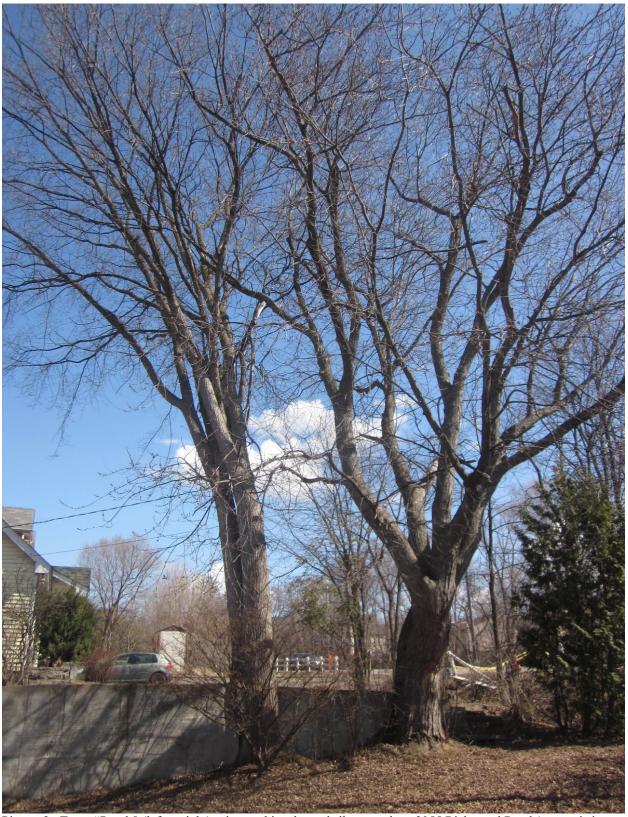
2.5m)		bisect at 5-5.5m - crown
					broadens above this height;
					growing into retaining wall
					(grade change of +/-1.5m);
					outward signs of DED; native
					species; to be removed (dead)
		ı	1		1 1-1-9 10 20 1-0110 (0300)

Picture 2. Trees #7 and 8 (left to right) private white elm and silver maple at 3055 Richmond Road (note existing grade change/retaining wall)

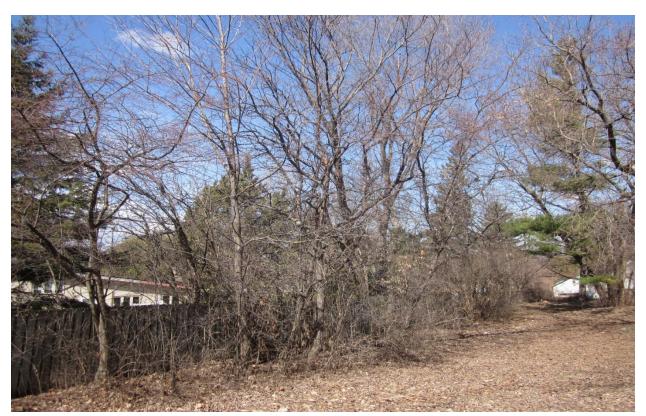
(Sorbus spp.)				but in advanced decline; native		
					species; to be removed		
					(conflicts with driveway		
					construction)		
17	Crab apple	Good	22.1	Private	Mature; tri-dominant stems at		
	(Malus spp.)				3.25m from grade; broad crown;		
					cultivar; to be removed		
					(conflicts with driveway		
					construction)		
18	Crab apple	Fair	20.5	Private	Mature; lower stem divergent		
	(Malus spp.)				and crown asymmetric towards		
					northeast due to influence of tree

#20; cultivar; to be removed		
					(conflicts with driveway		
					construction)

Picture 3. Trees #14-18 (left to right), private crab apples, Norway maple and mountain-ash at 3055 Richmond Road

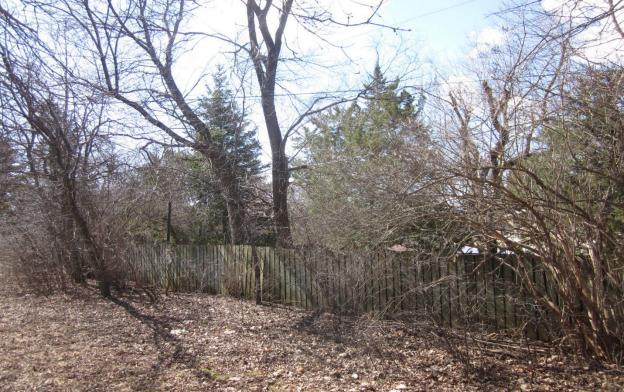
Picture 4. Trees #20 and 21 (centre, left to right), neighbouring Manitoba maple and Siberian elm adjacent to 3055 Richmond Road

As excavation will be within the CRZs of several trees, in particular trees #12, 13, 14, 15, 20 and 21, the following measures will be taken:

- 1. Air excavation along the edge of the driveway in proximity to the trees to carefully expose roots. Exposed roots will then be cleanly cut and sealed before being reburied. Excavation can then resume using traditional mechanical means. Sealing the cleanly cut root ends with a beeswax product will help prevent the loss of moisture and facilitate healing. An arborist and a City forestry inspector will be present during the air excavation and root pruning to assess the stability and viability of retained trees. If any trees are thought to be terminally impacted by the driveway and related grade changes, the neighbouring property owner will be alerted and their permission to remove them will be sought.

- 2. If the excavation is to be left open for any length of time a covering of at least three layers of moistened burlap is to be draped over the exposed face of excavation closet to the tree. A final covering of clear plastic or white tarp will help retain moisture within the burlap. The use of burlap and coverings will help reduce the loss of moisture from the soil surrounding the remaining roots.

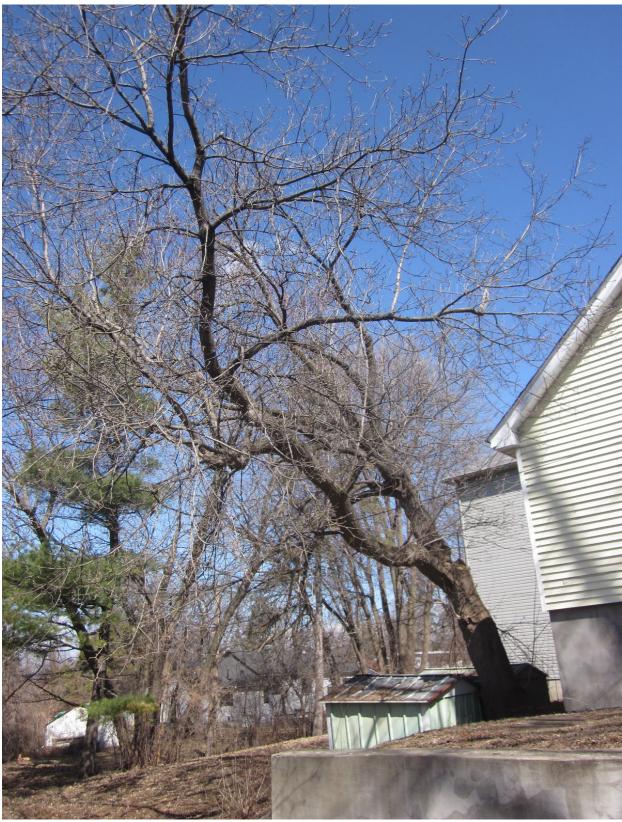
Picture 5. Tree #19, private Manitoba maple at 3055 Richmond Road

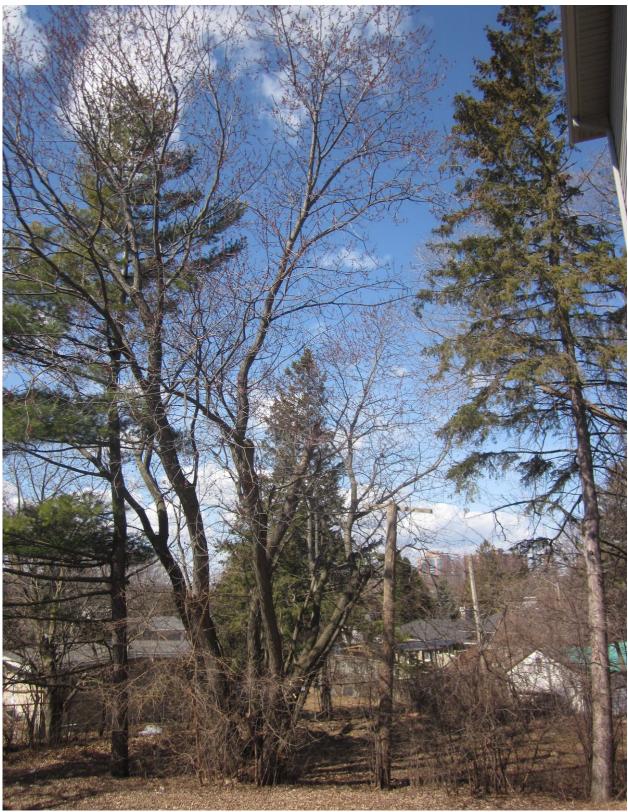
#26; fair crown density, annual
					increment and needle colour;
					native species; to be preserved
					and protected
26	Silver maple	Fair	41	Private	Mature; five stemmed at grade;
	(Acer		avg.		central stem broken at 9m, all
	saccharinum)				other stems all moderately
					divergent; native species; to be
					preserved and protected
27	White spruce	Fair	+/-40	Neighbour	Mature; living crown held at half
	(Picea glauca)				height due to influence of
					surrounding trees; some vine
					(Vitis spp.) growth into crown;
					fair crown density, annual
					increment and needle colour;
					native species; to be preserved
					and protected

Picture 6. Trees #25, 26 and 27 (left to right), private white pine, silver maple and neighbouring white spruce at 3055 Richmond Road
