TREE CONSERVATION REPORT

500 Edgeworth Ave

Tree Conservation Report submitted as Partial
Requirements for a Site Plan Control and Zoning
Bylaw Amendment Application, April 2, 2026

Tree Conservation Report

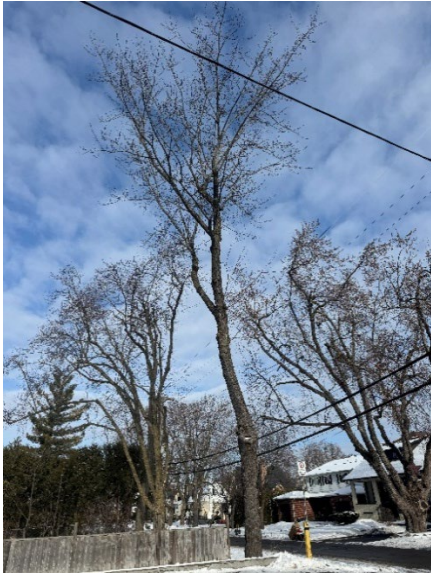
Picture 1: Tree 1, privately owned silver maple

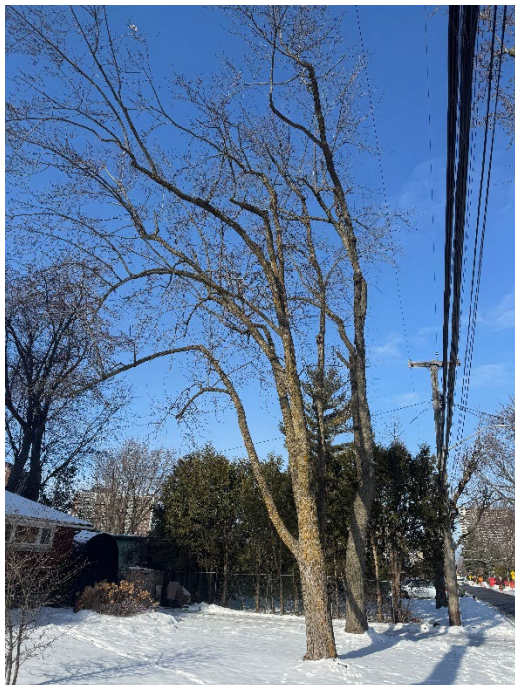
April 2 report update: *As requested by city forestry staff, the ownership of trees 1-3 were confirmed in the field using survey posts marking the property line. The edge of the tree trunks are set back 30-35 cm from the property line confirming that they are privately owned.*

Picture 2: Trees 2 and 3, privately owned silver maples

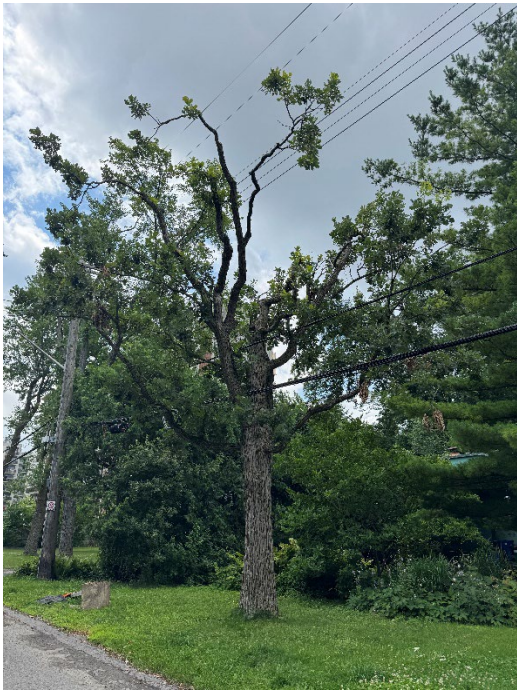
Picture 3: Tree 4, city-owned bur oak

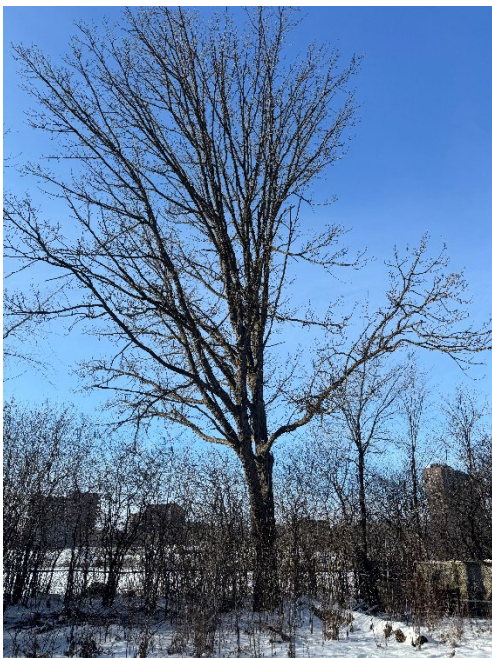
Picture 4: tree 10, bur oak at the rear of 508 Edgeworth

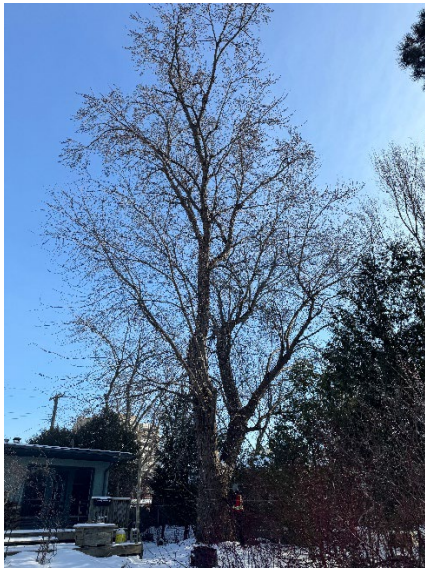
16	Sugar maple (<i>Acer saccharum</i>)	120	Subject properties	Poor/fair; old branch attachment wound, multi-stemmed	Remove due to excavation for parking lot
17	Siberian elm (<i>Ulmus pumila</i>)	23	Subject properties	Fair/good; vigorous growth, growing within fence	Remove due to excavation for parking lot
18	Siberian elm (<i>Ulmus pumila</i>)	31	Subject properties	Fair/good; growing within chain link fence	Remove due to excavation for parking lot
19	Siberian elm (<i>Ulmus pumila</i>)	32	Subject properties	Fair; growing within chain link fence	Remove due to excavation for parking lot
20	Siberian elm (<i>Ulmus pumila</i>)	10, 29, 16	Subject properties	Fair	Remove due to excavation for parking lot
21 ⁴	Manitoba maple (<i>Acer negundo</i>)	14	Subject properties	Good	Remove due to excavation for parking lot
22	Sugar maple (<i>Acer saccharum</i>)	31, 32, 34	Subject properties	Fair/good; lean	Remove due to excavation for parking lot

Picture 5: tree 16, large silver maple at 508 Edgeworth

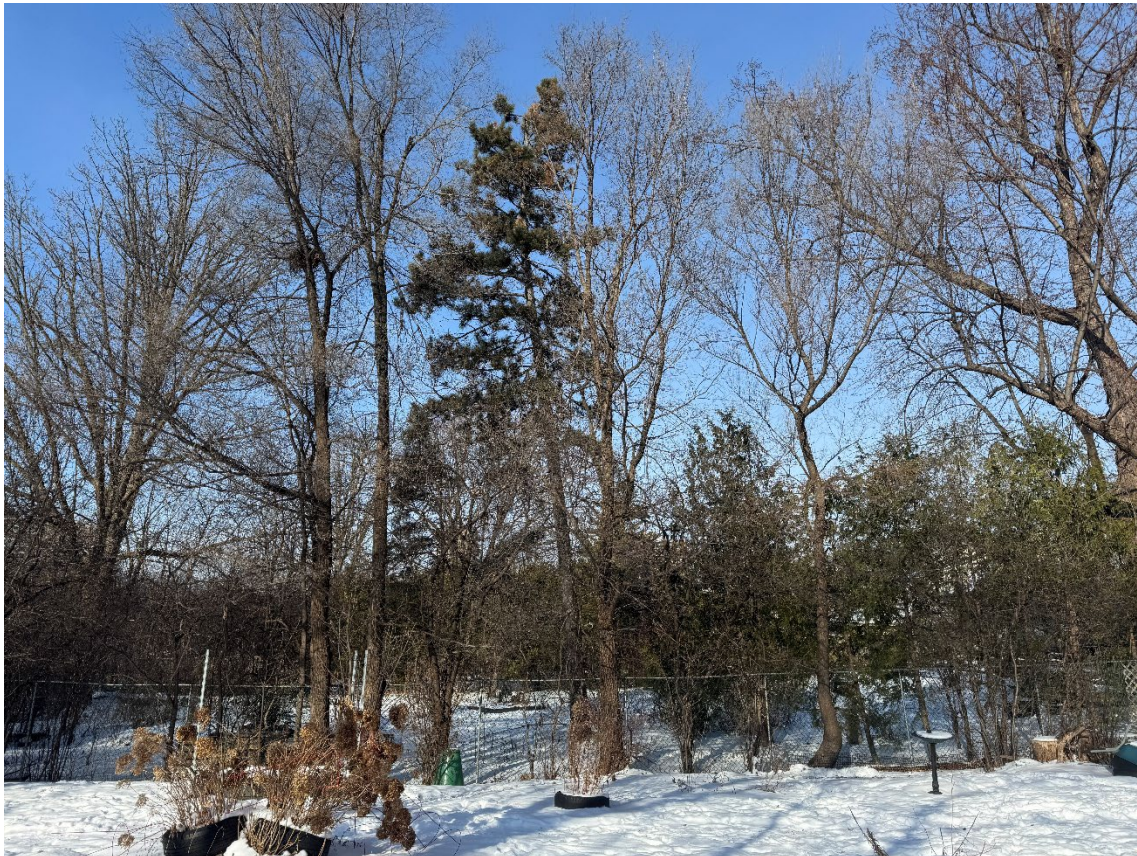
Picture 6: facing northwards from 500 Edgeworth - row of Siberian elms (trees 17-20)

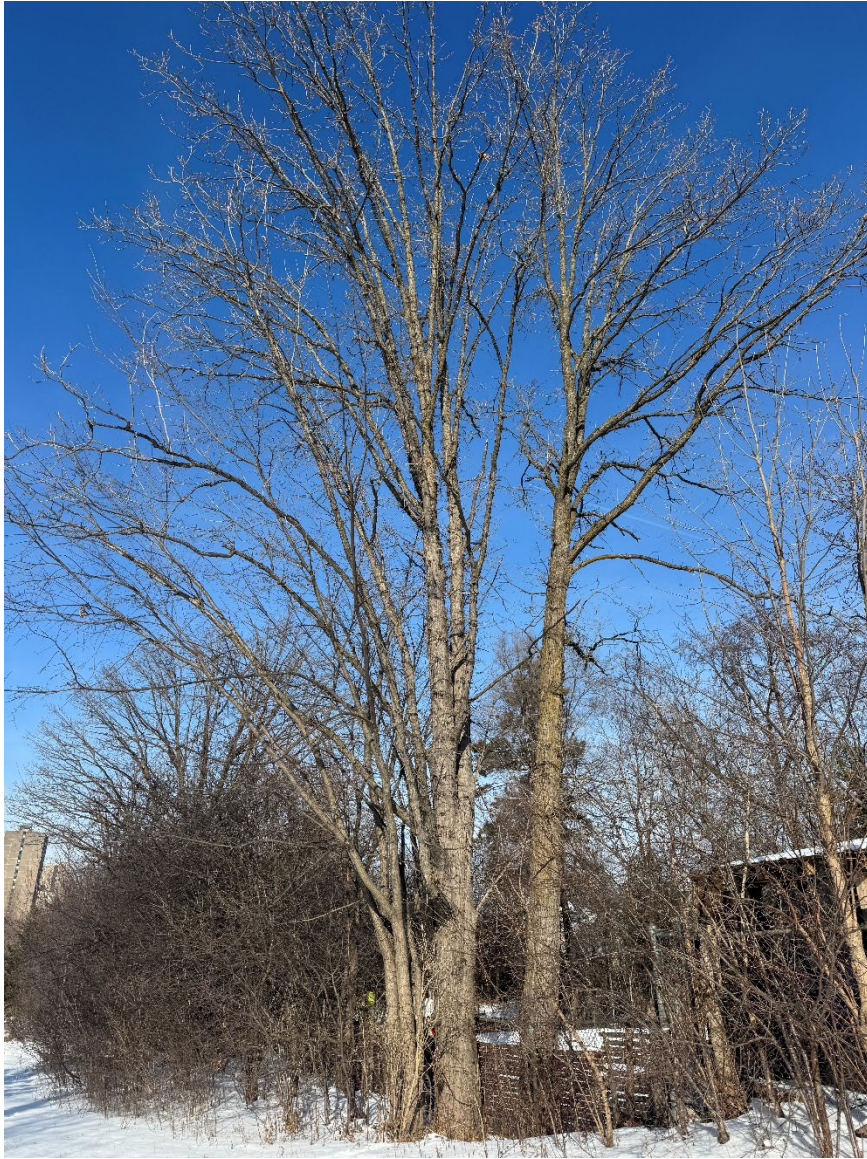
Picture 7: Trees 25 (right),bur oak on subject properties and 26 (left), bur oak on NCC property

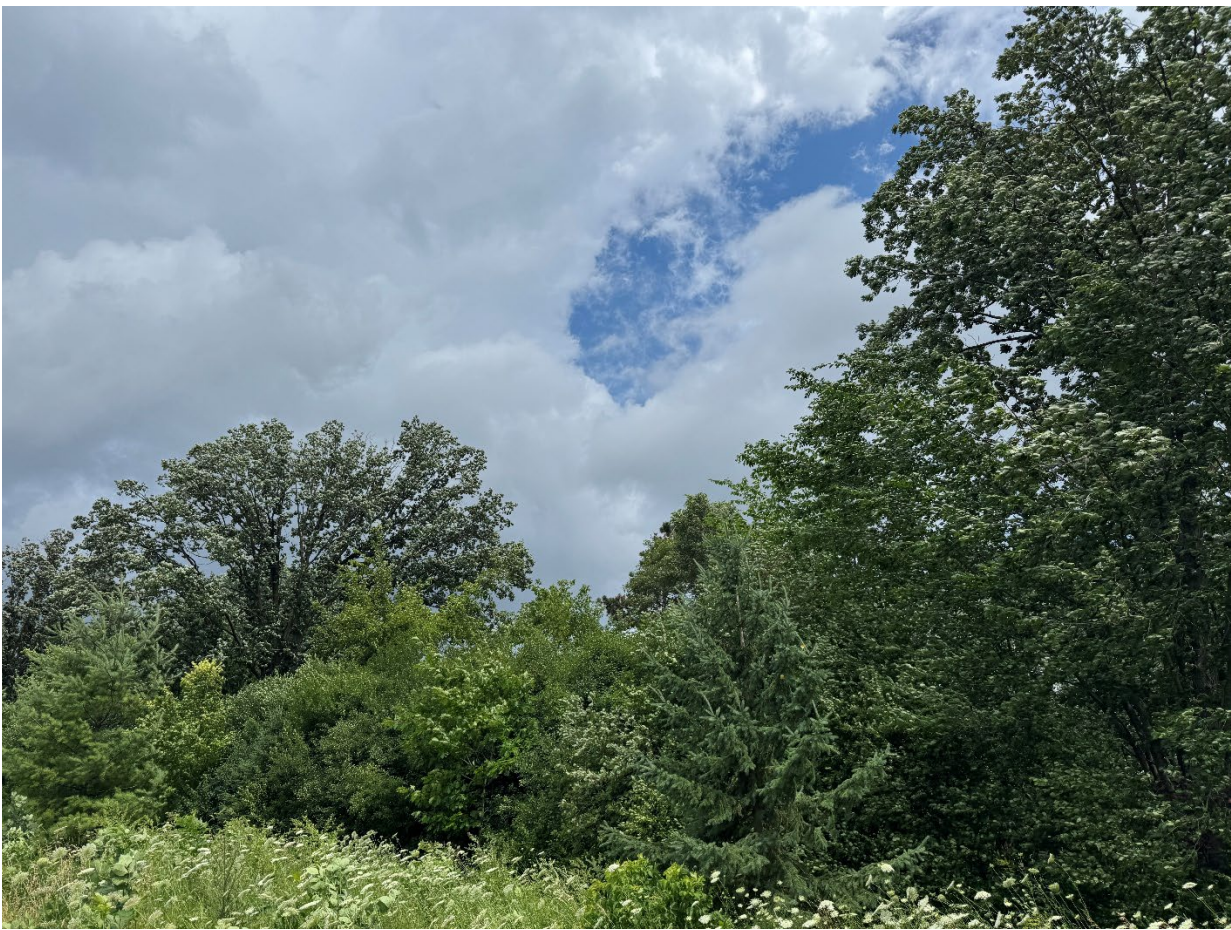
In addition to those trees identified on TCR maps, there is also a line of thick buckthorn shrubs along the edge of the NCC property. Due to their invasive nature, these should all be removed along with the trees that need to be removed to accommodate the excavation and make the area free of any risks of tree failures. During deep excavations such as this, the falling distance increases for those trees along the edge, resulting in higher consequences of failure for the construction crews working below.

Picture 8: Taken from the NCC property, row of buckthorn along the property line interspersed with recently planted trees along the west side

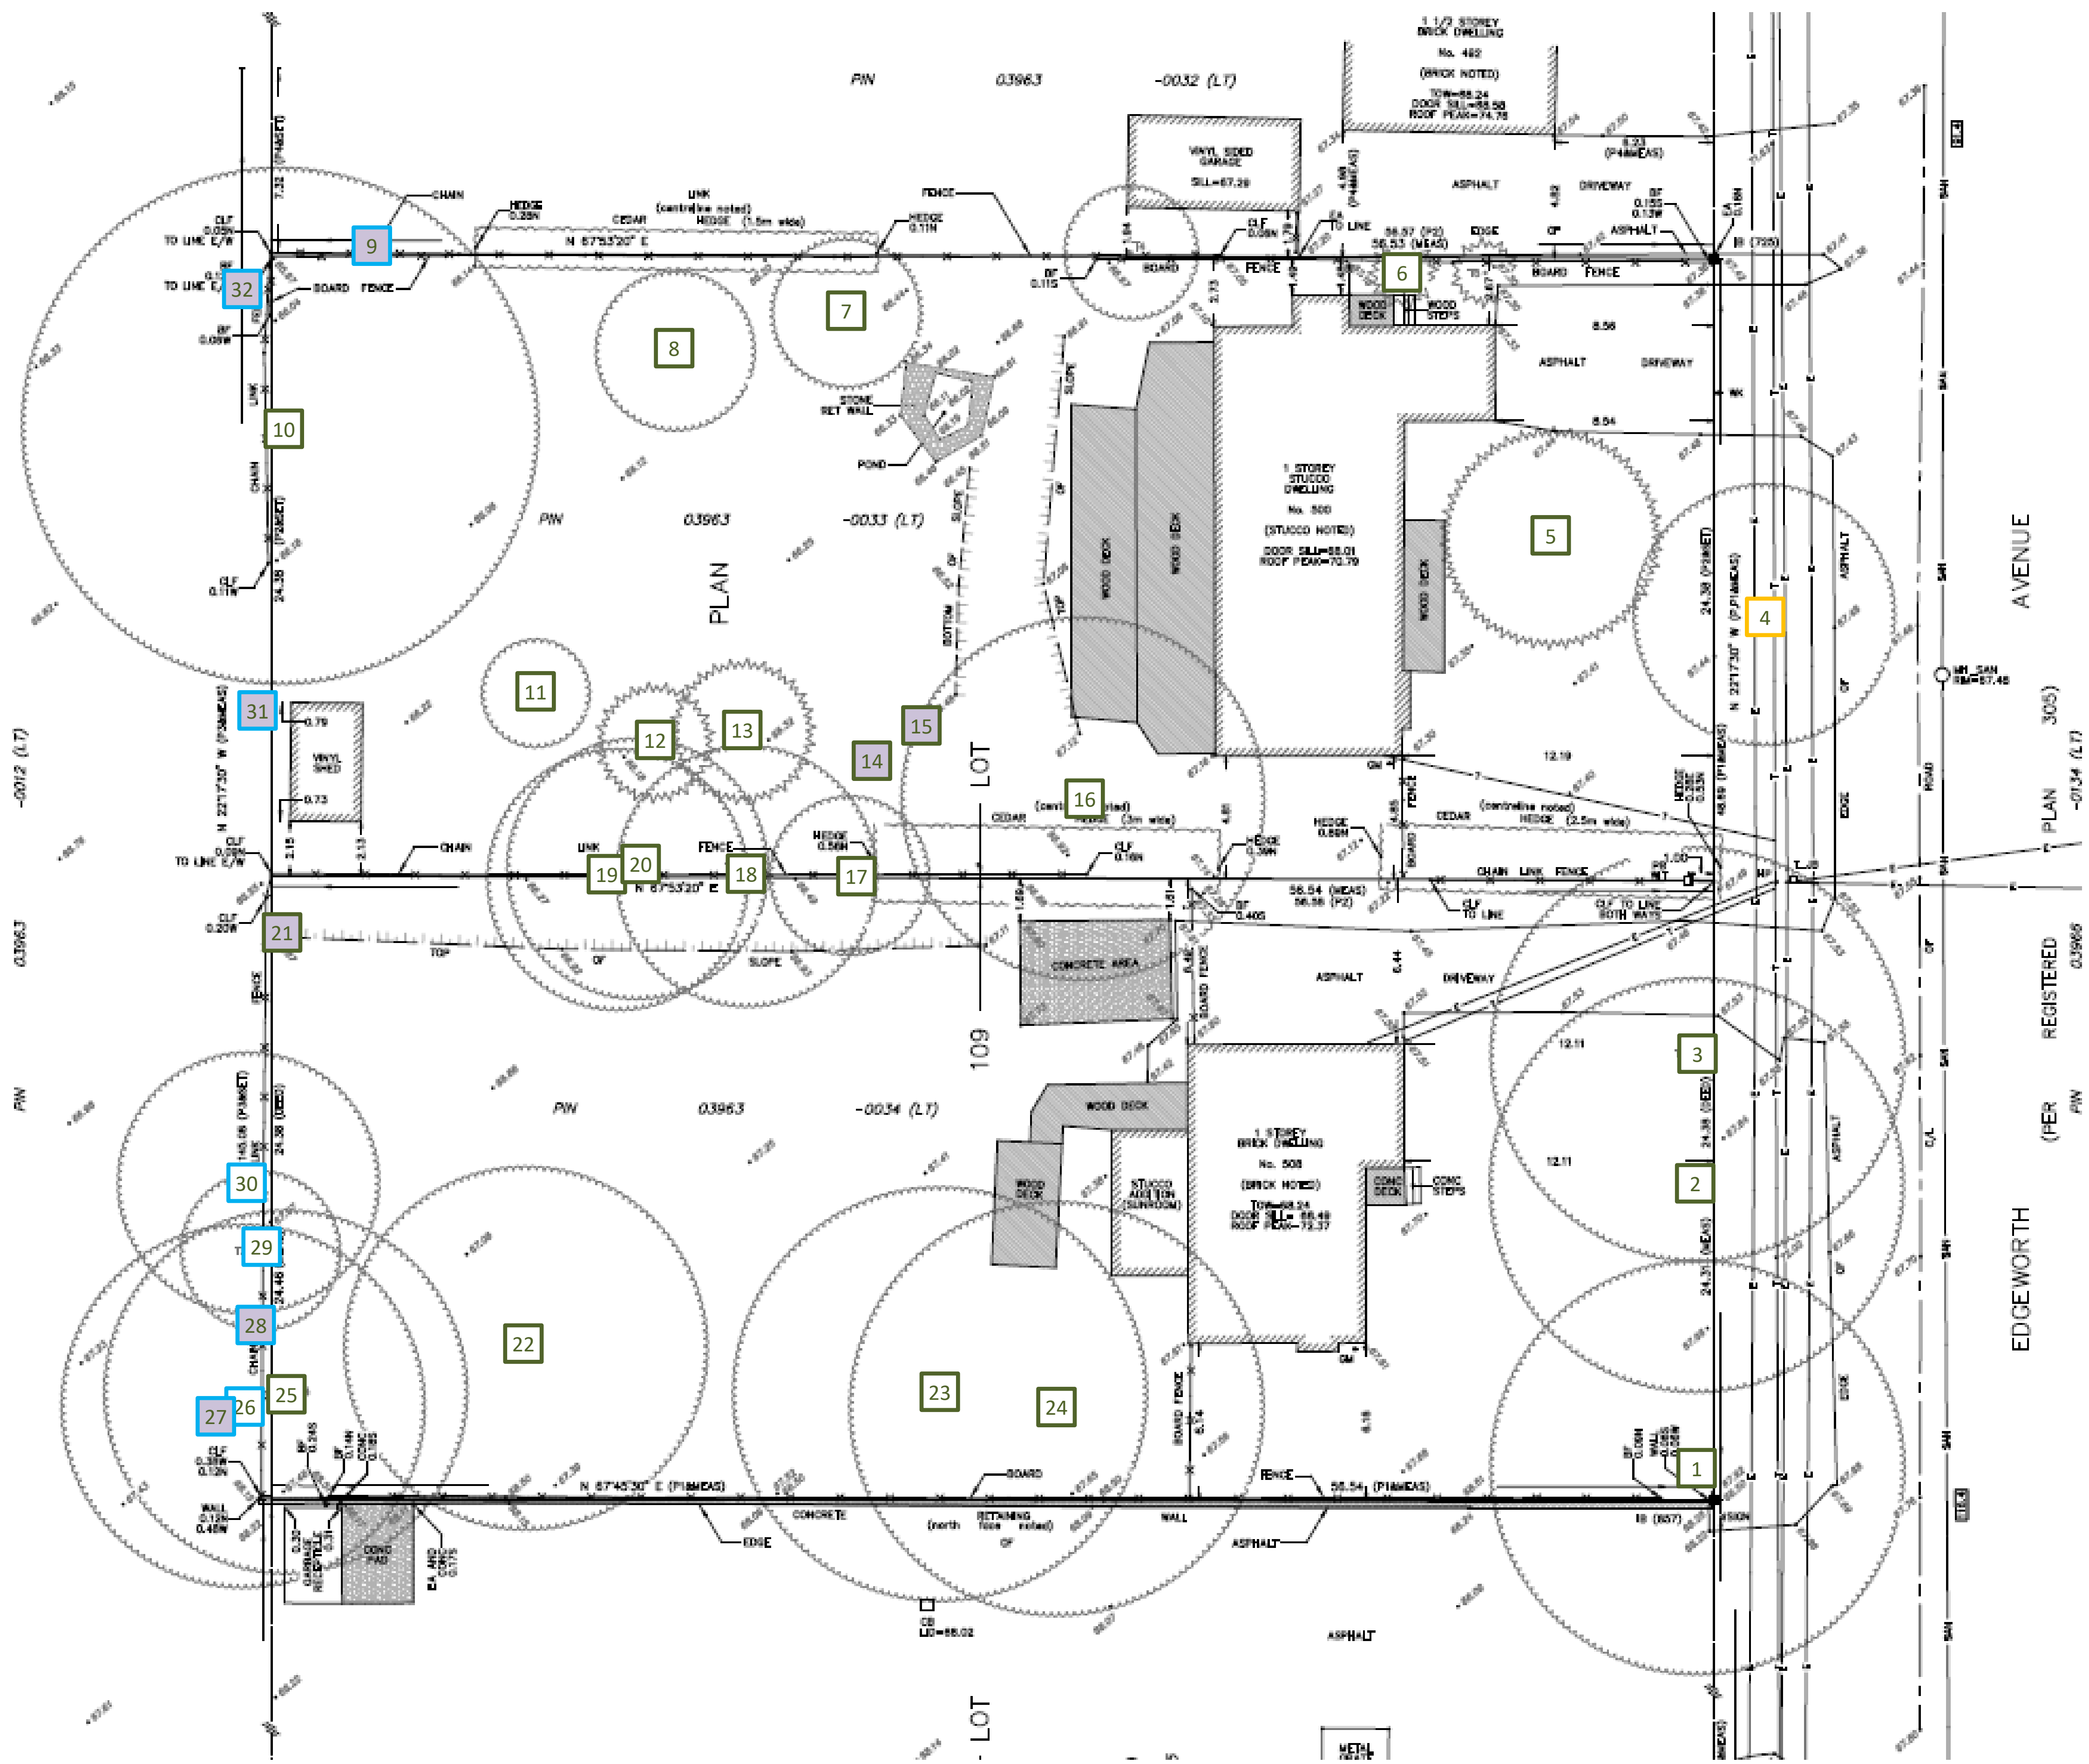
TCR Map#1: Existing Vegetation – 500 Edgeworth Ave

Tree#	Species	Diameter at breast height (cm)	Ownership ^{1,3}	Condition
1	Sugar maple (<i>Acer saccharum</i>)	59	Subject properties	Fair; pruned for hydro clearance, epicormic shoots, old branch attachment wound with decay at 4 m grade
2	Sugar maple (<i>Acer saccharum</i>)	55	Subject properties	Fair; pruned for hydro clearance, low vigour, epicormic shoots, decay in upper canopy
3	Sugar maple (<i>Acer saccharum</i>)	57	Subject properties	Fair; asymmetric crown
4	Bur oak (<i>Quercus macrocarpa</i>)	54	Subject properties	Fair; directly under hydro lines, woodpecker holes in centre stem
5	White pine (<i>Pinus strobus</i>)	43	Subject properties	Good/fair; slight lean at base, minor chlorosis
6	Eastern white cedar (<i>Thuja occidentalis</i>)	17, 19, 14, 15	Subject properties	Good/fair
7	White birch (<i>Betula papyrifera</i>)	18	Subject properties	Good
8	Apple (<i>Malus spp</i>)	24	Subject properties	poor; many epicormic shoots

9 ⁴	Manitoba maple (<i>Acer negundo</i>)	12 (est)	Adjacent property at 492 Edgeworth	Fair; heavy lean
10	Bur oak (<i>Quercus macrocarpa</i>)	78	Subject properties	Good; asymmetric crown, some deadwood
11	Apple (<i>Malus spp</i>)	16	Subject properties	Poor; epicormic shoots, significant decay
12	Scots pine (<i>Pinus sylvestris</i>)	13	Subject properties	Fair; thin top
13	Austrian pine (<i>Pinus nigra</i>)	41	Subject properties	Fair; thin crown with dieback, sapsucker holes,
14 ⁴	Eastern white cedar (<i>Thuja occidentalis</i>)	13	Subject properties	Good
15 ⁴	Eastern white cedar (<i>Thuja occidentalis</i>)	13	Subject properties	Good
16	Sugar maple (<i>Acer saccharum</i>)	120	Subject properties	Poor/fair; old branch attachment wound, multi-stemmed
17	Siberian elm (<i>Ulmus pumila</i>)	23	Subject properties	Fair/good; vigorous growth, growing within fence
18	Siberian elm (<i>Ulmus pumila</i>)	31	Subject properties	Fair/good; growing within chain link fence

19	Siberian elm (<i>Ulmus pumila</i>)	32	Subject properties	Fair; growing within chain link fence
20	Siberian elm (<i>Ulmus pumila</i>)	10, 29, 16	Subject properties	Fair
21 ⁴	Manitoba maple (<i>Acer negundo</i>)	14	Subject properties	Good
22	Sugar maple (<i>Acer saccharum</i>)	31, 32, 34	Subject properties	Fair/good; lean
23	Sugar maple (<i>Acer saccharum</i>)	29, 44	Subject properties	Fair; lean
24	Sugar maple (<i>Acer saccharum</i>)	43, 68	Subject properties	Fair/poor; topped, decay at base, old branch attachment wounds with decay
25	Bur oak (<i>Quercus macrocarpa</i>)	49	Subject properties	Good; asymmetrical crown
26	Bur oak (<i>Quercus macrocarpa</i>)	52	NCC	Good/fair; asymmetric crown, epicormic shoots
27 ⁴	American elm (<i>Ulmus americana</i>)	17, 18, 11, 9	NCC	Fair; multi-stemmed, included bark in unions
28 ⁴	American elm (<i>Ulmus americana</i>)	12	NCC	Good
29 ⁴	American elm (<i>Ulmus americana</i>)	18	NCC	Good

30	Oakleaf mountain ash (<i>Sorbus Thuringiaca</i>)	26	NCC	Poor; high level of decay, heavy lean, sapsucker holes
31 ⁴	American elm (<i>Ulmus americana</i>)	20	NCC	Good
32 ⁴	American elm (<i>Ulmus americana</i>)	22	NCC	Good
