June 3<sup>rd</sup>, 2019

RE: Woodlot S-23 Large Tree Inventory – Minto Communities and Valecraft Homes Kanata North  
Developments

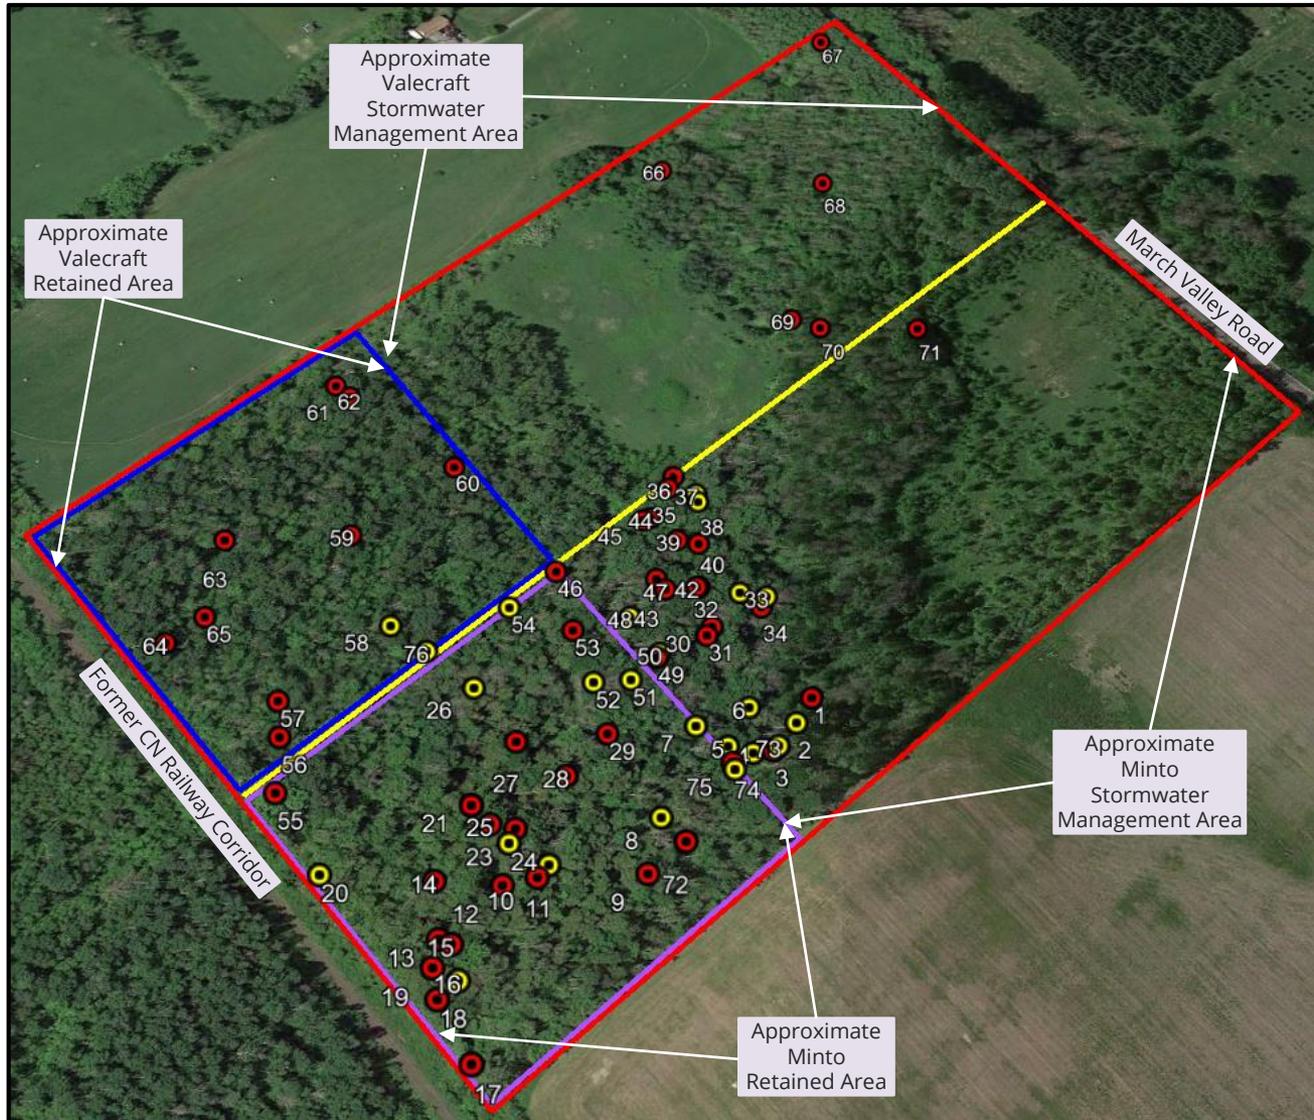
# FIGURE 3: LARGE TREE LOCATIONS

Please Note: This is not a legal land survey. All dimensions and locations are shown as approximate. Potentially retainable trees include those identified in Table A as being in good condition, Category 2 Butternut Trees, and Category 3 Butternut Trees. Non-retainable trees include those identified in Table A as dead, in poor condition, and Category 1 Butternut Trees.

Per the KNUEA EMP, it is recommended that all trees within the Study Area that occur outside of the limits of the future SWM pond blocks should be preserved. In addition, wherever feasible, trees that occur along the edge of the retained area should also be preserved. Based on the estimated limits of the SWM pond shown above in Figures 1 to 3, the only potentially retainable tree (healthy) that currently occurs along the edge of the SWM pond blocks is Tree #49, which is approximately 4 m from the edge of the anticipated retained area. If feasible and compatible with the SWM pond design, Tree #49 should be preserved adjacent to the edge of the retained area during the development of the SWM pond.

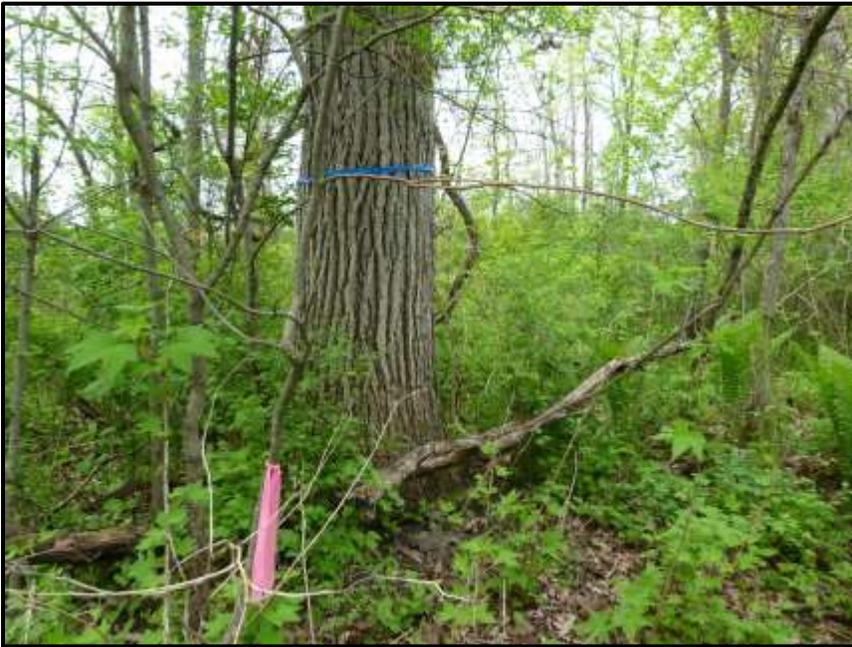
Photograph 1: Tree #1 – Bur Oak in good condition (May 27<sup>th</sup>, 2019).

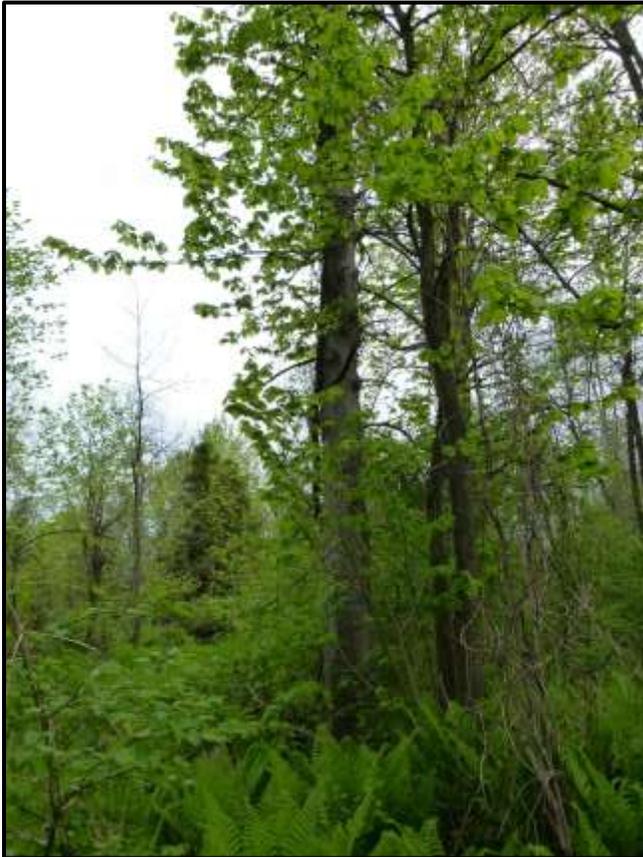
Photograph 2: Tree #2 – dead White Ash (May 27<sup>th</sup>, 2019).

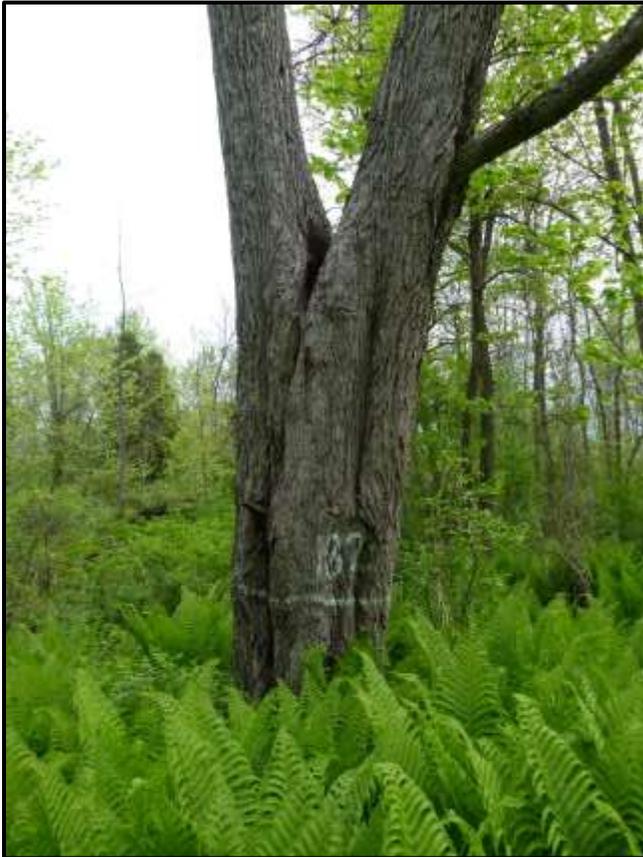
Photograph 3: Tree #3 – Category 3 Butternut Tree (May 27<sup>th</sup>, 2019).

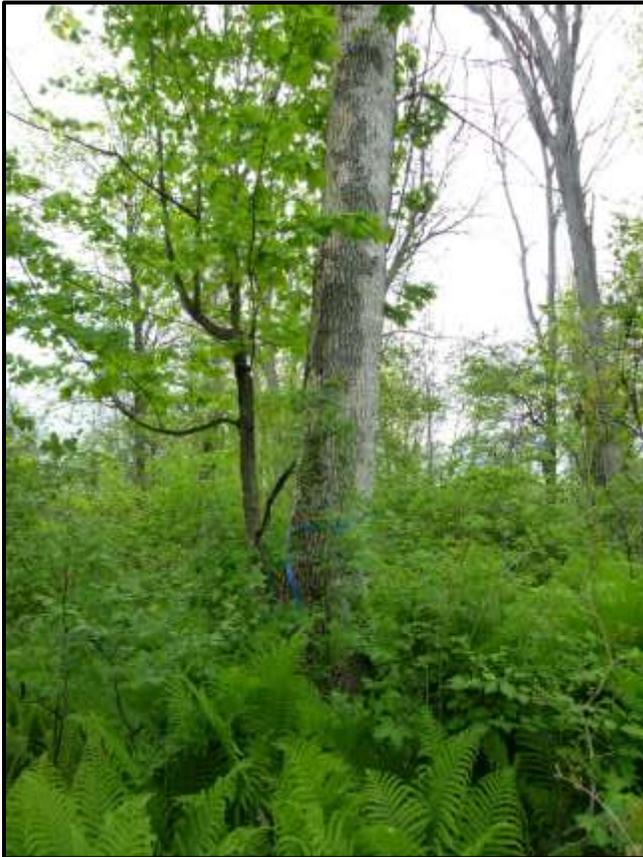
Photograph 4: Tree #4 – dead White Ash (May 27<sup>th</sup>, 2019).

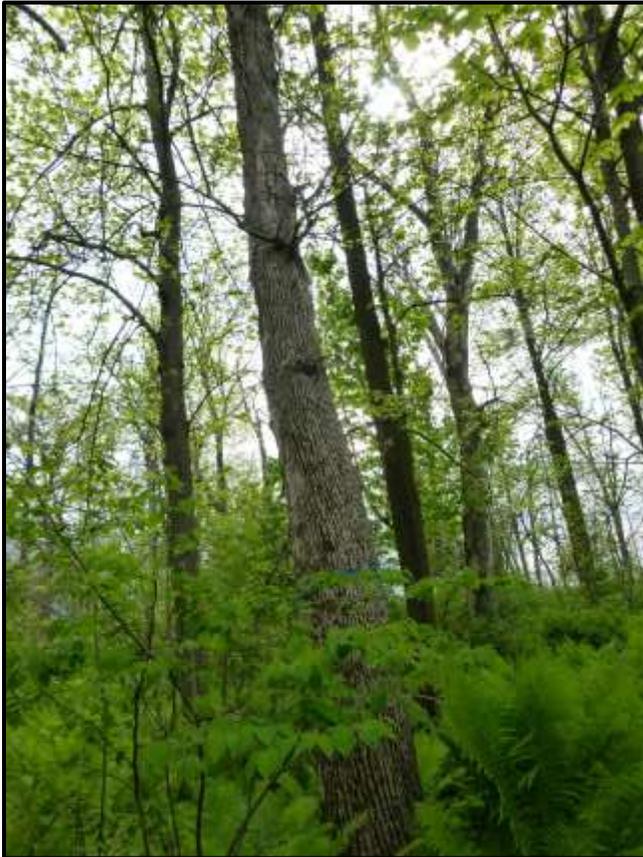
Photograph 5: Tree #5 – dead White Ash (May 27<sup>th</sup>, 2019).

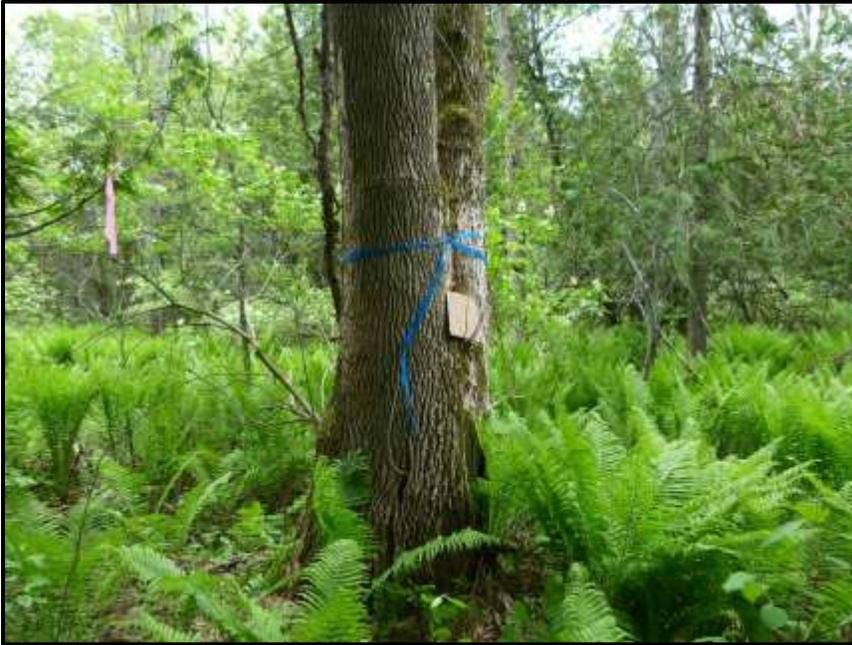
Photograph 7: Tree #8 – dead White Ash (May 27<sup>th</sup>, 2019).

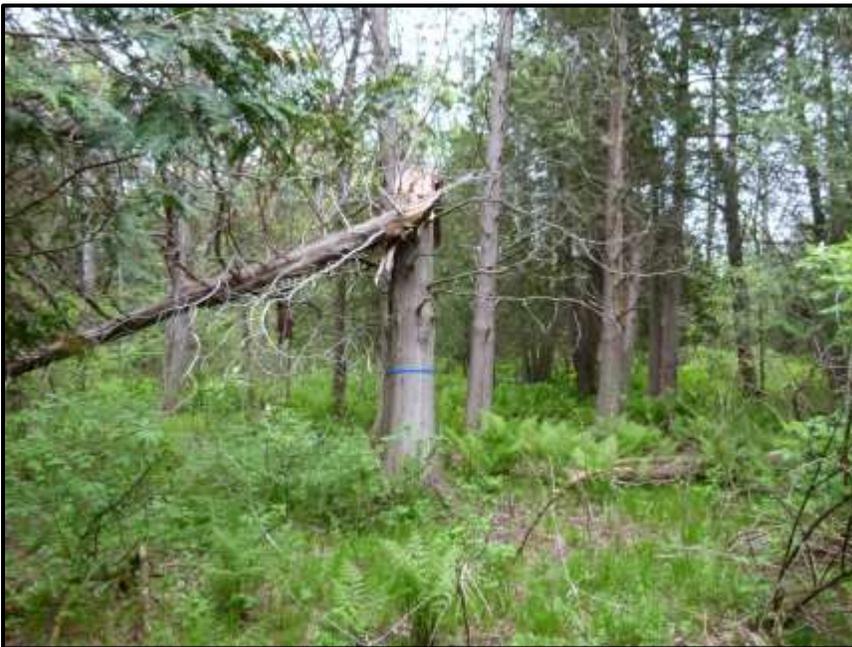
Photograph 10: Tree #11 – dead White Cedar (May 27<sup>th</sup>, 2019).

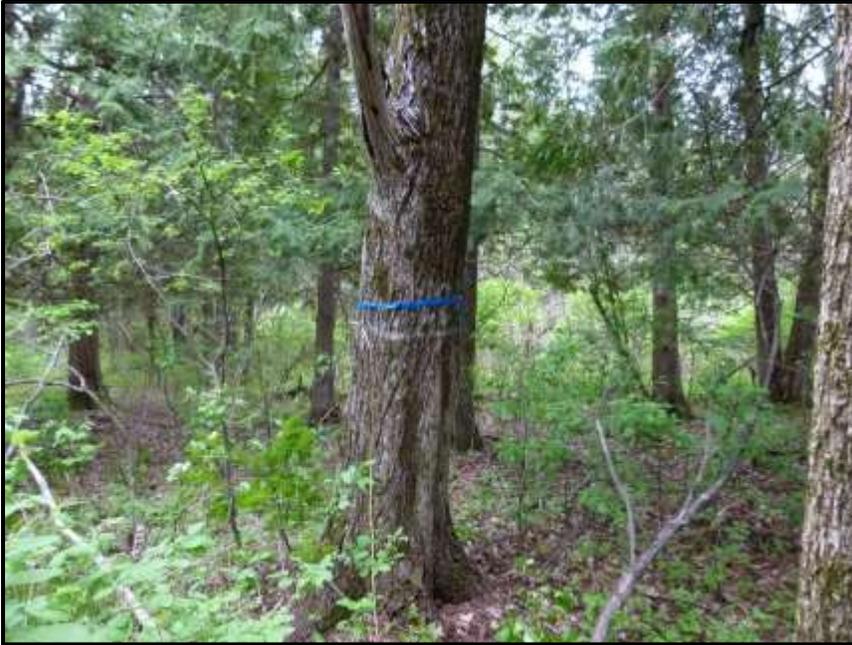
Photograph 15: Tree #16 - Category 1 Butternut (May 27<sup>th</sup>, 2019).

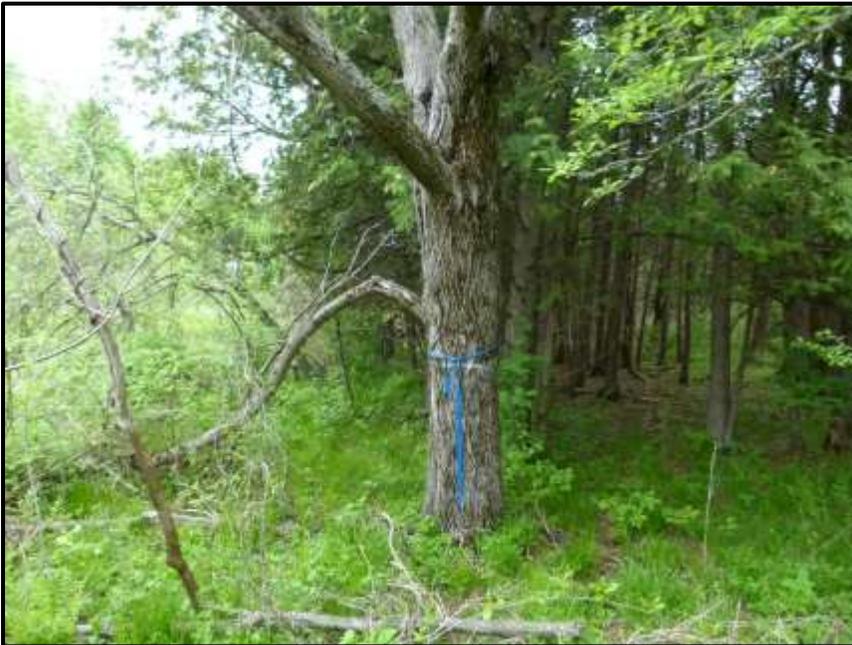
Photograph 17: Tree #18 – Category 2 Butternut (May 27<sup>th</sup>, 2019).

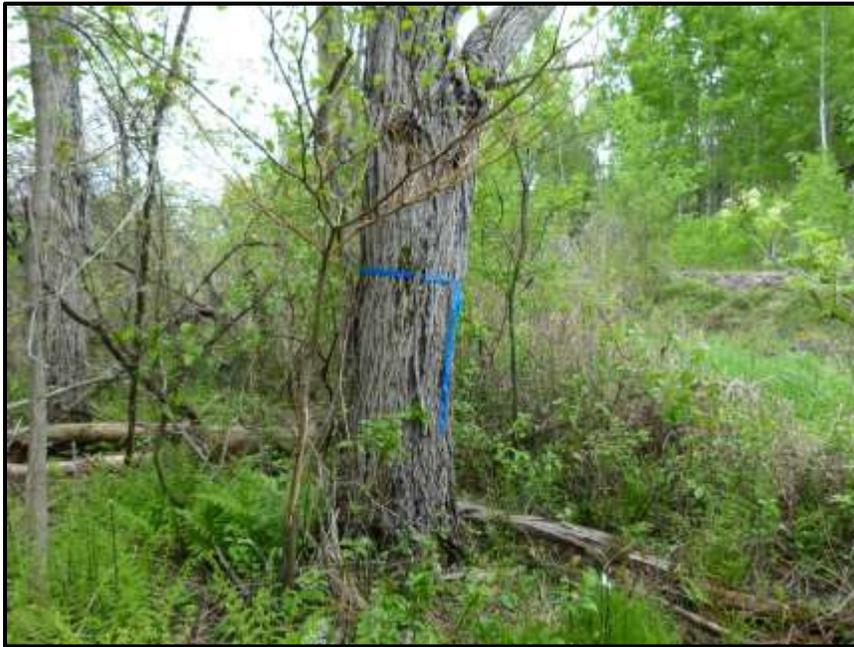
Photograph 19: Tree #20 – Category 1 Butternut (May 27<sup>th</sup>, 2019).

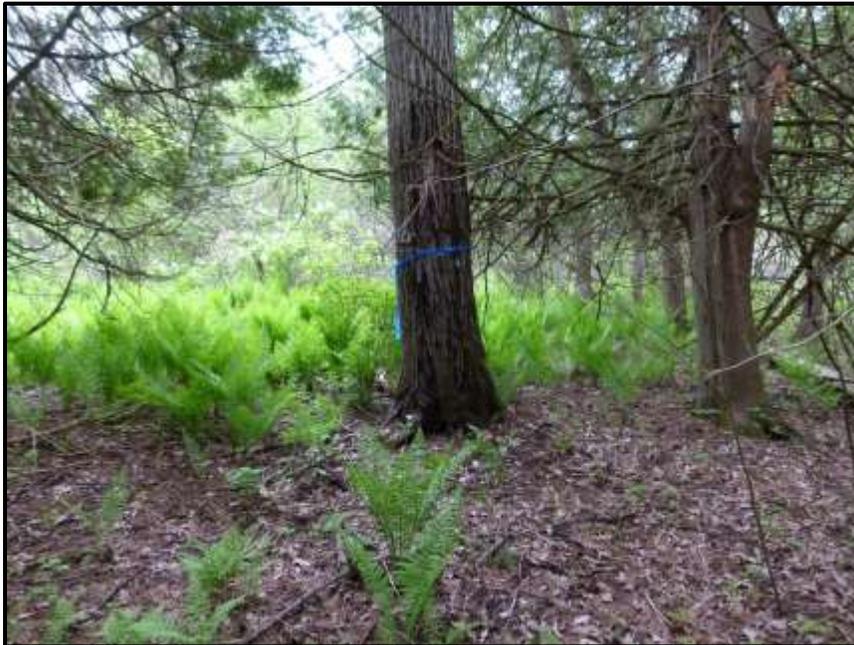
Photograph 23: Tree #24 – Category 1 Butternut Tree (May 27<sup>th</sup>, 2019).

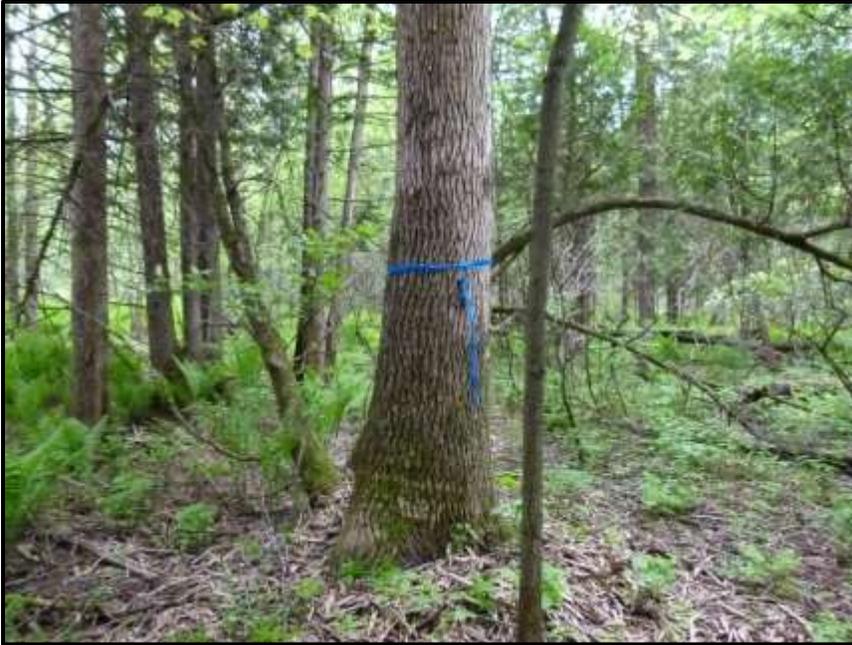
Photograph 25: Tree #26 – dead White Ash (May 27<sup>th</sup>, 2019).

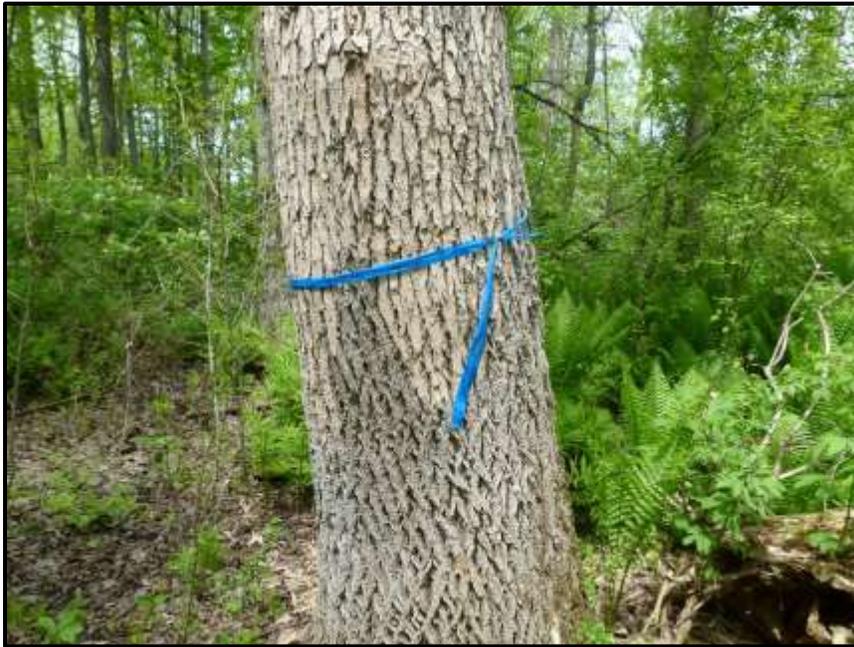
Photograph 31: Tree #32 – dead White Ash (May 27<sup>th</sup>, 2019).

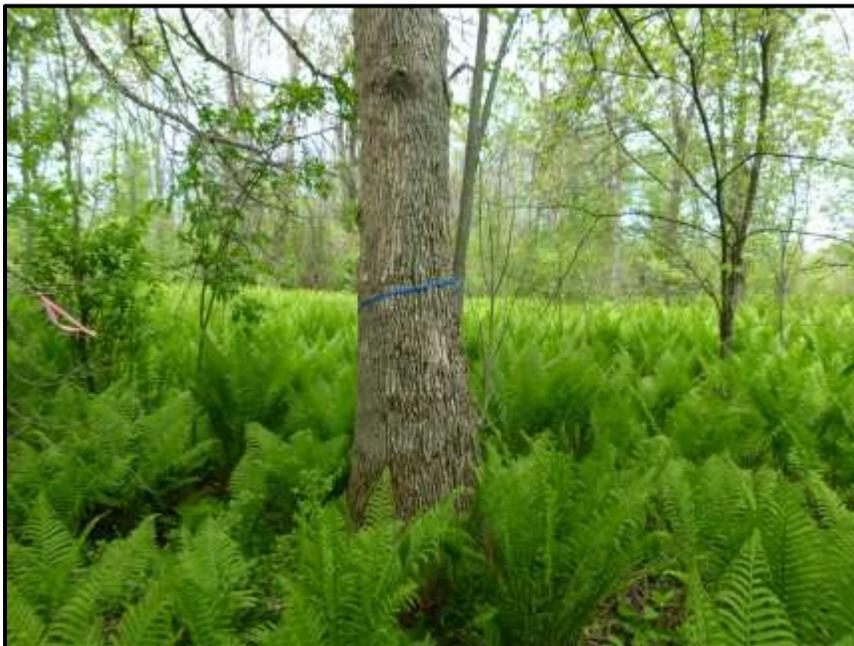
Photograph 32: Tree #33 – dead White Ash (May 27<sup>th</sup>, 2019).

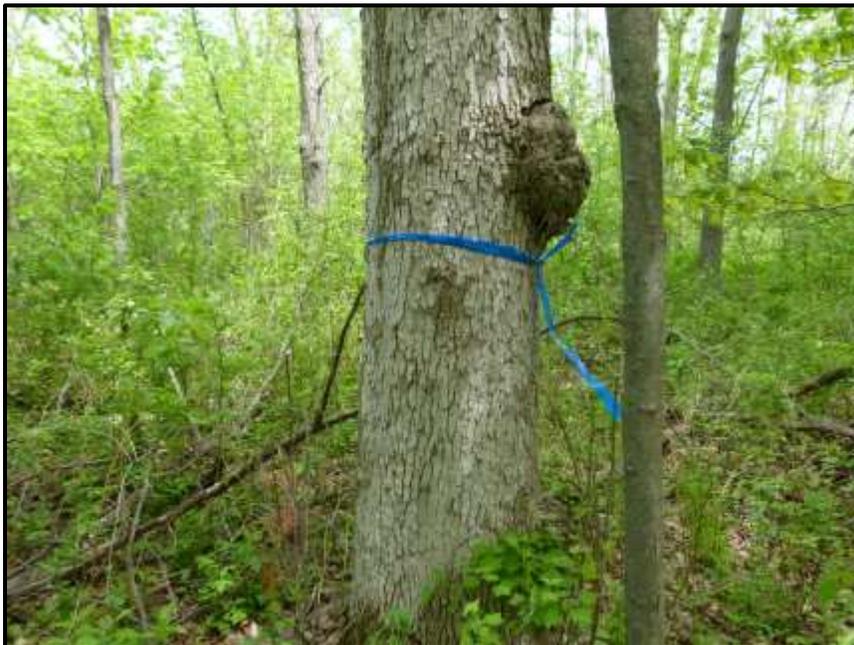
Photograph 36: Tree #37 – dead White Ash (May 27<sup>th</sup>, 2019).

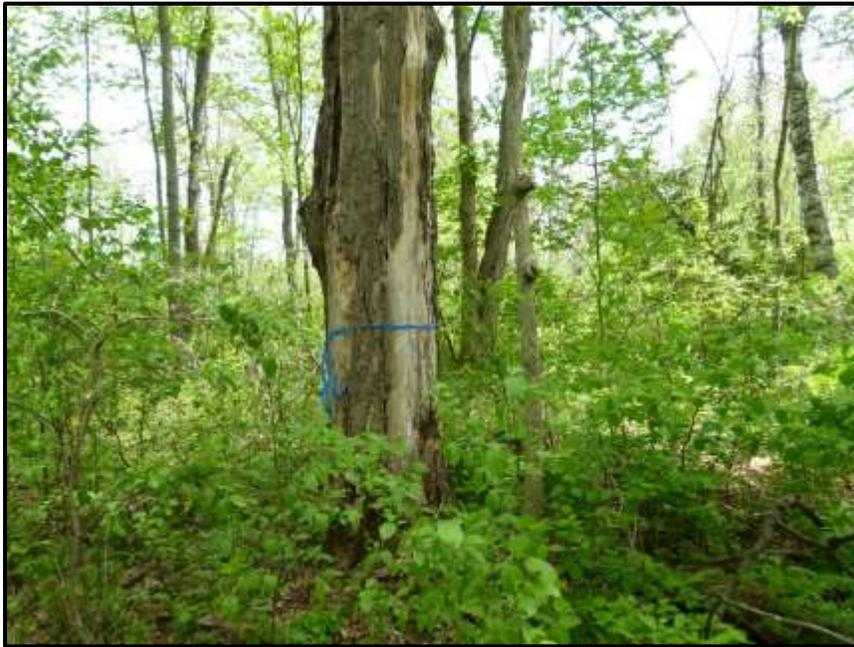
Photograph 37: Tree #38 – Sugar Maple in poor condition (May 27<sup>th</sup>, 2019).

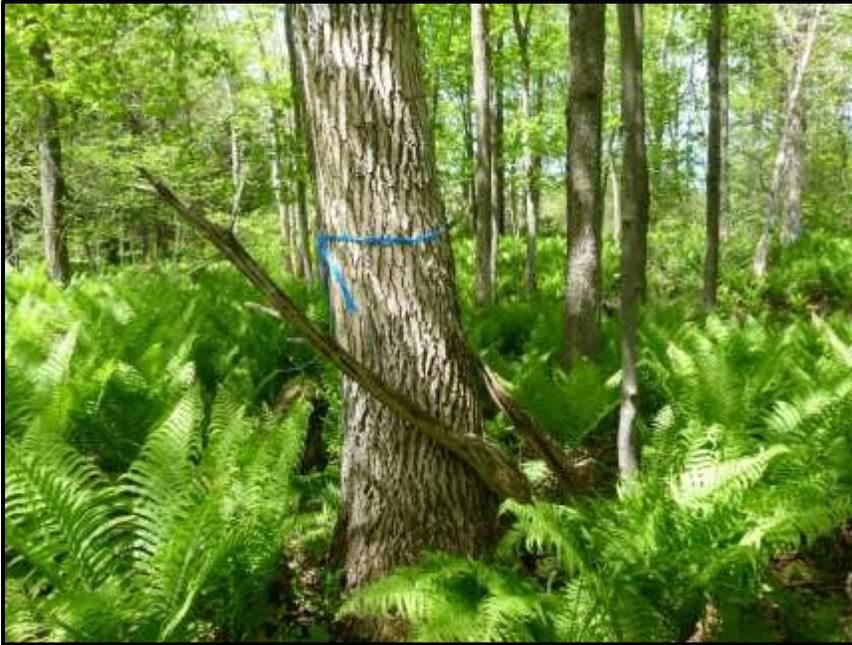
Photograph 47: Tree #48 – dead White Ash (May 27<sup>th</sup>, 2019).

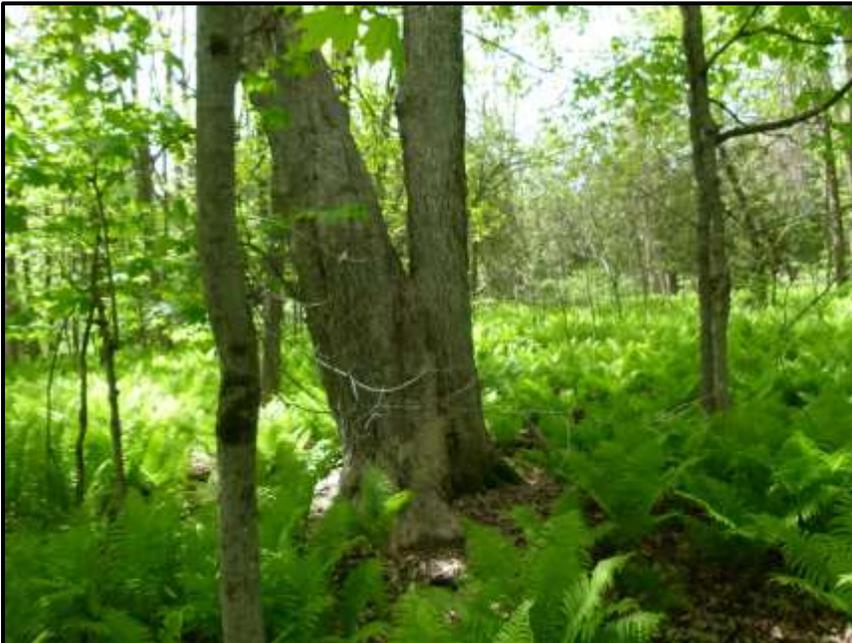
Photograph 48: Tree #49 – Sugar Maple in good condition (May 27<sup>th</sup>, 2019).

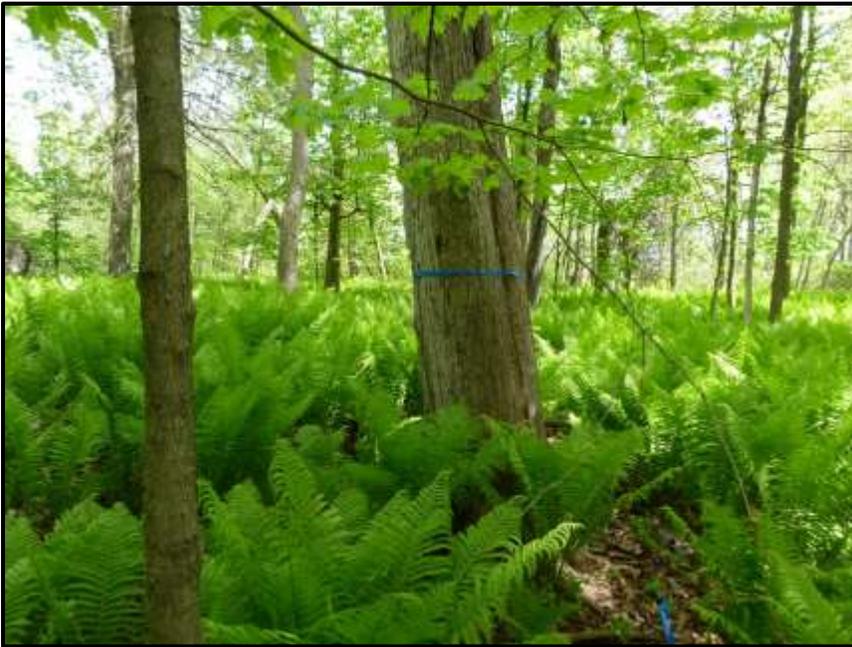
Photograph 49: Tree #50 – Basswood in poor condition (May 27<sup>th</sup>, 2019).

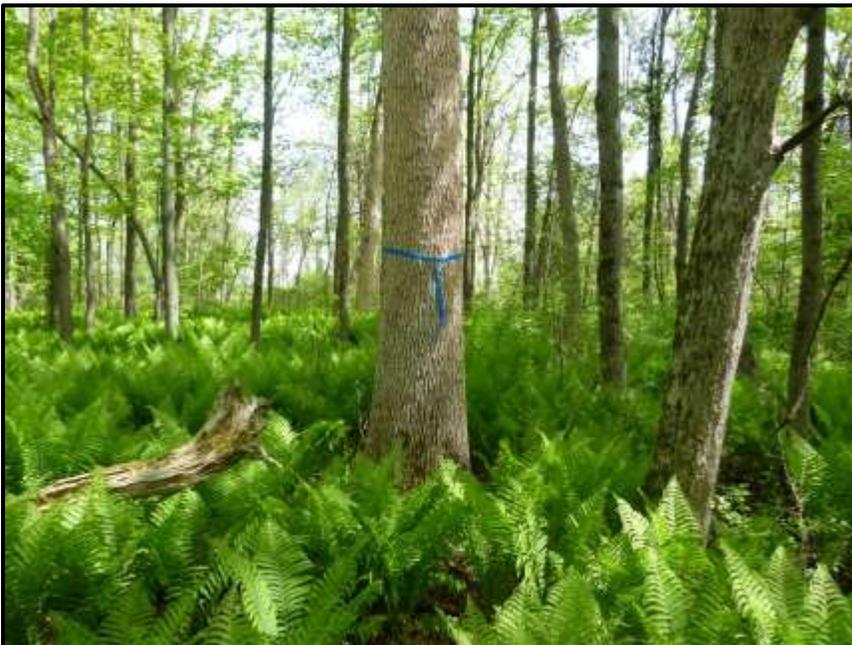
Photograph 50: Tree #51 – dead White Ash (May 27<sup>th</sup>, 2019).

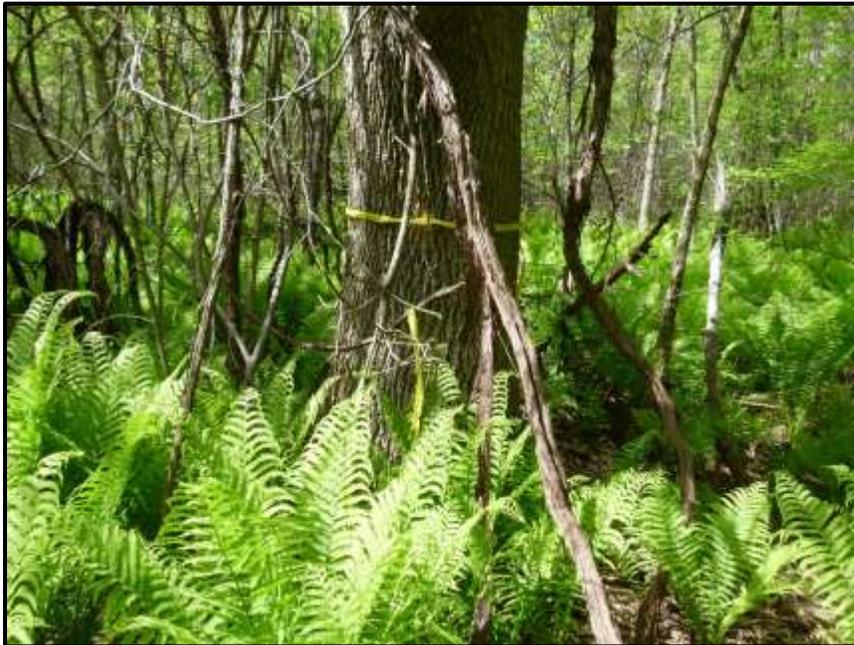
Photograph 53: Tree #54 – dead White Ash (May 30<sup>th</sup>, 2019).

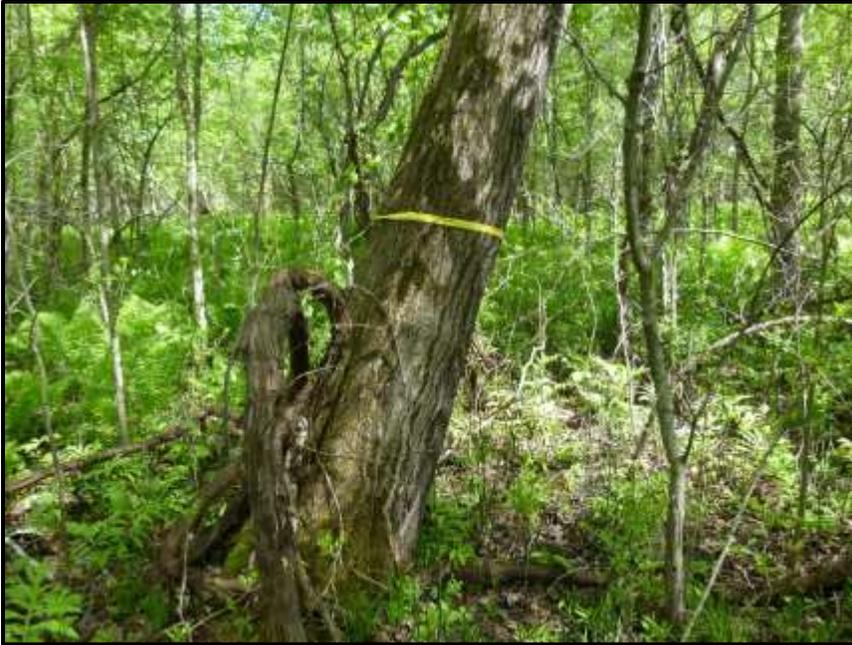
Photograph 57: Tree #58 – Trembling Aspen in poor condition (May 30<sup>th</sup>, 2019).
