July 7, 2020

**Re.: Tree Conservation Report for 6171 Hazeldean, Stittsville, Ontario**

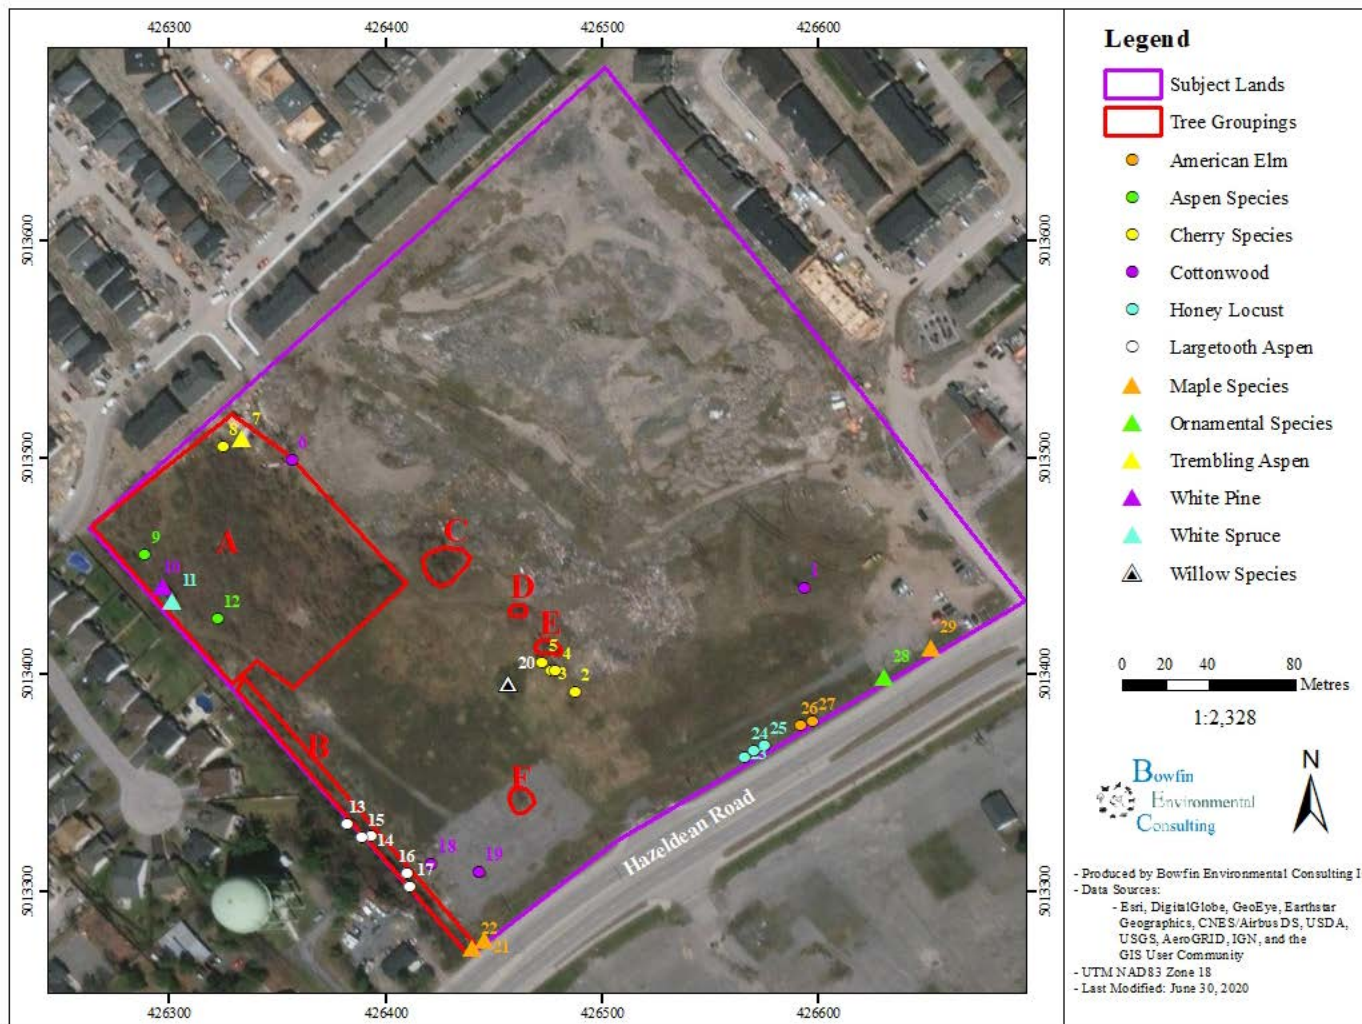
Map 1: Location of Existing Trees

This information is appended at the end of this letter and the locations of the individual trees are shown on Maps 1 and 2. One small stand along with a few copses and a windrow were placed into separate tree groupings with information on the larger trees in each grouping provided in Table 2.

In addition to six groupings of trees, there were 29 individual trees assessed on-site with a DBH of 10 cm or greater. The most common species were: gray birch, trembling and largetooth aspen. A summary of these is provided in Table 1. Most of the trees were healthy apart from some dead aspens.
