Limited Designated Substances and Hazardous Material Survey

OCHC Gladstone Avenue Complex

Ottawa Community Housing Corporation

11140575| E5 | Report No. 4 | March 12, 2018

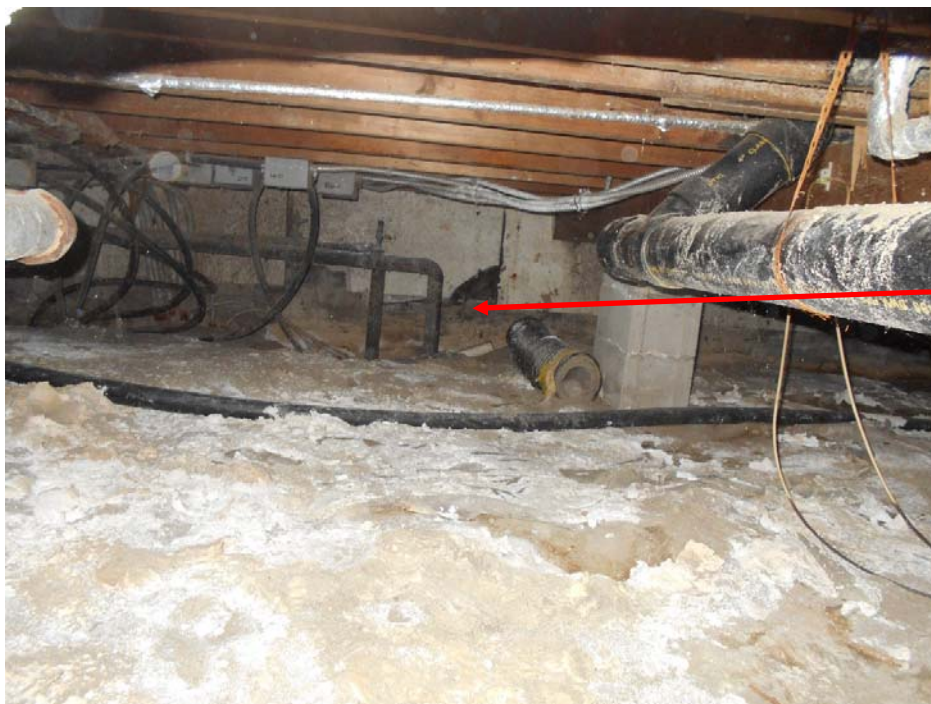
Photo 2 – North (Balsam) Building | Tar damp proofing on crawlspace walls behind Styrofoam panels

- Tar seal on foundation walls | Non-Friable black tar was present in the crawlspace, used to affix Styrofoam panels to the concrete block walls, and as damp proofing on the interior of the block walls. This material was identified to contain Chrysotile asbestos at concentrations above 0.5 percent.

34-CRAWL-W-
M1-B
Tar seal on
Walls
(ACM)

A contractor, certified for asbestos abatement, should be retained to complete asbestos abatement services prior to demolition of the buildings.

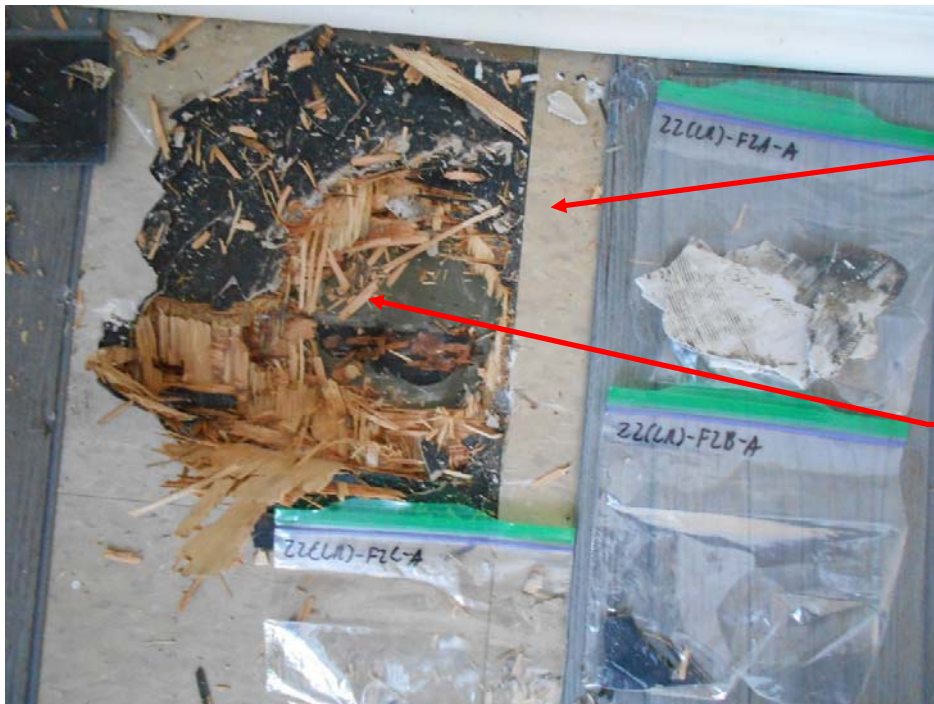
- Vinyl Floor Tile | Non-Friable vinyl floor tile (olive) submitted from unit 22 (living room) was identified to contain Chrysotile asbestos at concentrations above 0.5 percent.
Visually similar flooring to unit 22 (living room) was observed in unit 24 (utility room), unit 30 (entry), unit 24 (entry); these visually similar materials should also be treated as ACM.

22-LR-F2A-A
VFT – tan
streaked dark
brown
(ACM)

22-LR-F2C-C
VFT - olive
(ACM)

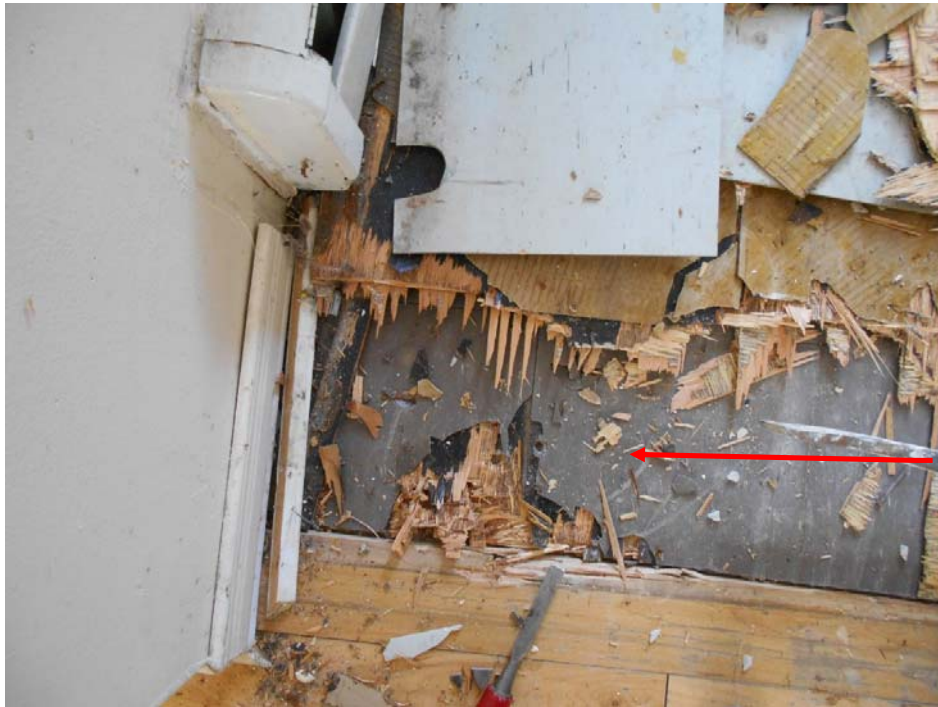
Photo 5 – North (Balsam) Building | VFT – 8"x8", brown with white streaks

- Vinyl Floor Tile | Non-Friable vinyl floor tile (12"x12", brown with dark brown streaks) submitted from unit 32 (utility room) was identified to contain Chrysotile asbestos at concentrations above 0.5 percent.
Visually similar flooring to unit 32 (utility room) was observed in unit 22 (entry); these visually similar materials should also be treated as ACM.

32-NE entry-
F2E-A
VFT – 8"x8",
brown streaked
white
(ACM)

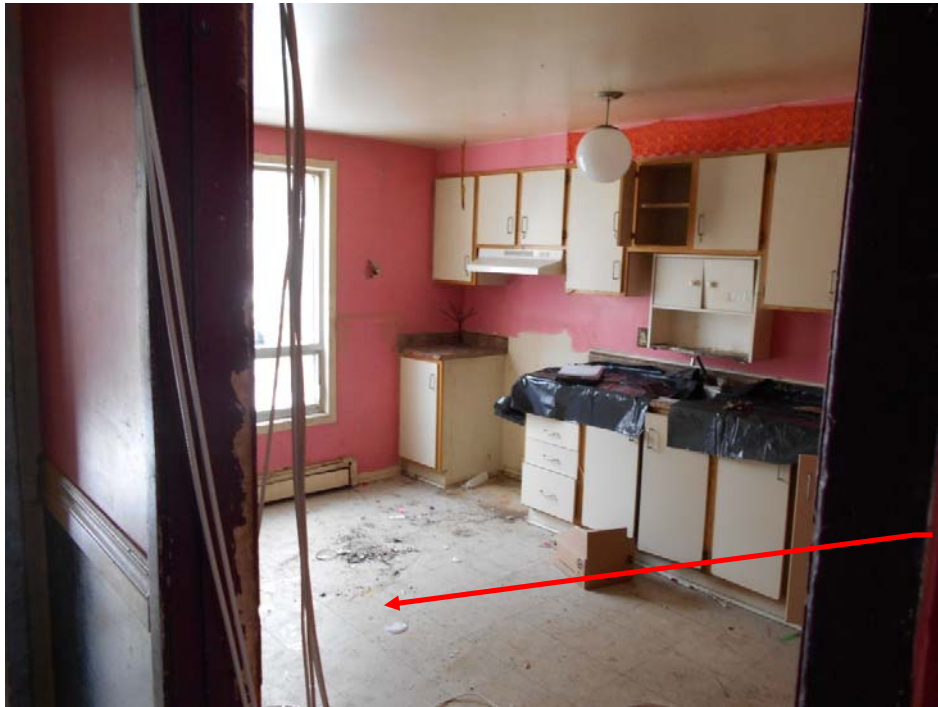
Photo 7 – West (Rochester) Building | VFT – 12"x12", battleship brown

283-1-K-F2A-A
VFT – 12"x12",
battleship brown
(ACM)

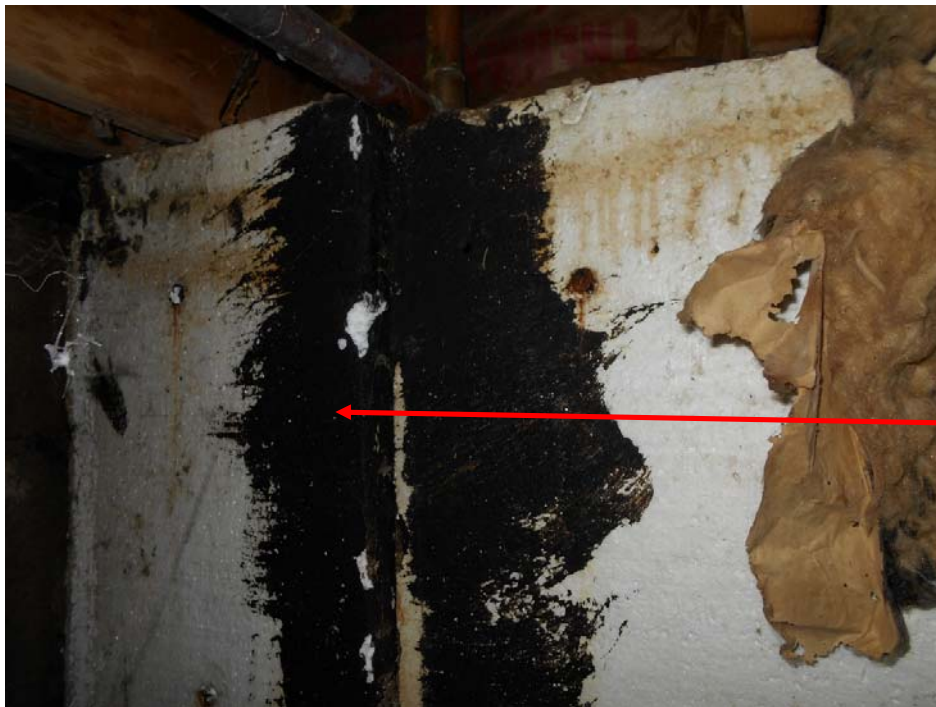
Photo 8 – West (Rochester) Building | black tar damp proofing holding Styrofoam to walls

- Tar seal on foundation walls | Non-Friable black tar was present in the crawlspace, used to affix Styrofoam panels to the concrete block walls, and as damp proofing on the interior of the block walls. This material was identified to contain Chrysotile asbestos at concentrations above 0.5 percent. Visually similar material was identified in all crawlspaces of the building; accordingly all black tar damp proofing in the building is assumed to be ACM.

275-CRAWL-
M4-B
Black tar on
walls
(ACM)

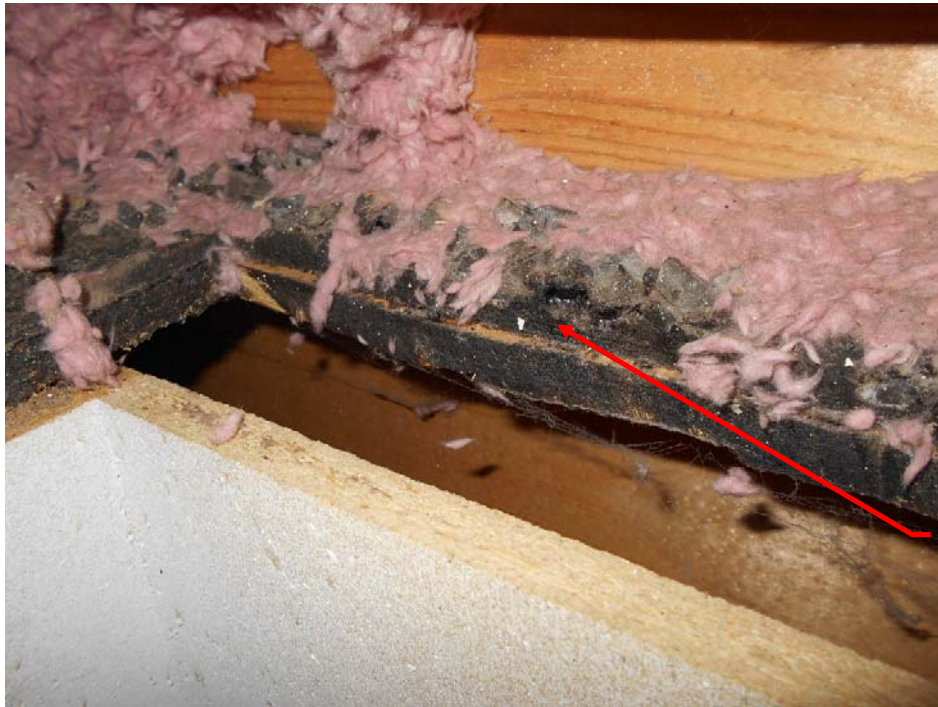
Photo 9 – South (Gladstone) Building | tar and gravel flat roof forming attic floor

- Flat Tar and Gravel Roof in Attic | Non-friable roofing materials comprising layers of tarpaper and kraft paper, bonded with layers of tar was observed on the floor of the attic above unit 811. This material was identified to contain Chrysotile asbestos at concentrations above 0.5 percent. It is assumed that this material is present throughout the building, and all tar and gravel flat roofing materials should be considered ACM.

811-2-BNW-R1-A
Tar and Gravel
flat roof
(ACM)

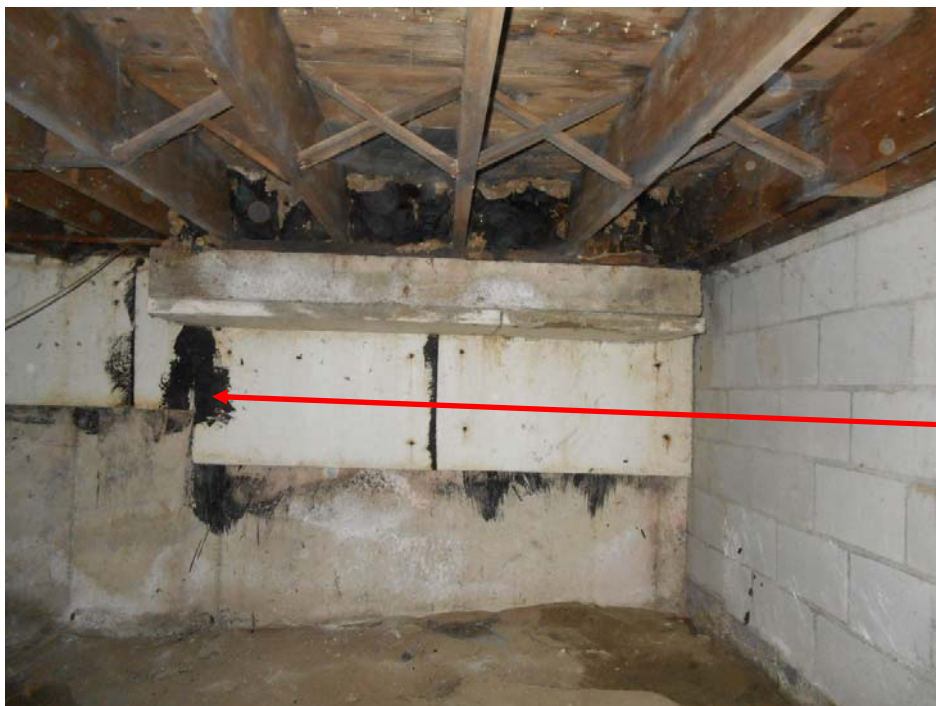
Photo 10 – South (Gladstone) Building | tar damp proofing used to attach Styrofoam panels to crawlspace walls

- Tar seal on foundation walls | Friable black tar was present in the crawlspace, used to affix Styrofoam panels to the concrete block walls, and as damp proofing on the interior of the block walls. This material was identified to contain Chrysotile asbestos at concentrations above 0.5 percent. Visually similar material was identified in all crawlspaces of the building; accordingly all black tar damp proofing in the building is assumed to be ACM.

279-CRAWL-M4-A
Tar damp
proofing
(ACM)

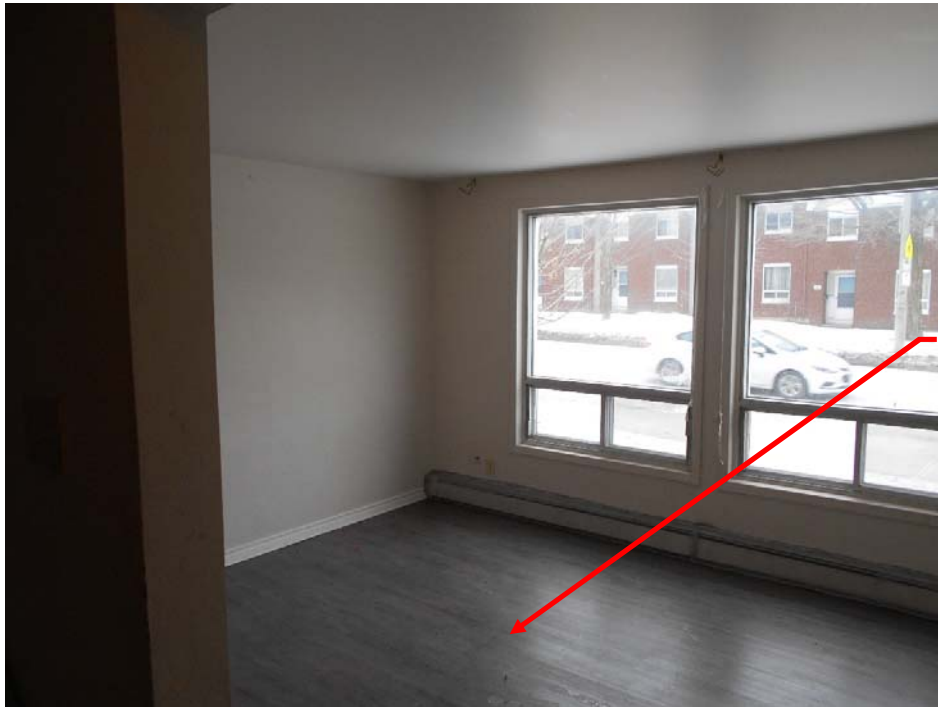
Photo 11 – South (Gladstone) Building | VFT – olive grey tiles under laminate floor

Visually similar flooring to unit 289 (living room) was observed in unit 821 (kitchen); these visually similar materials should also be treated as ACM.

289-1-LR-
F2A-B
VFT – olive
grey (under
laminate floor)
(ACM)

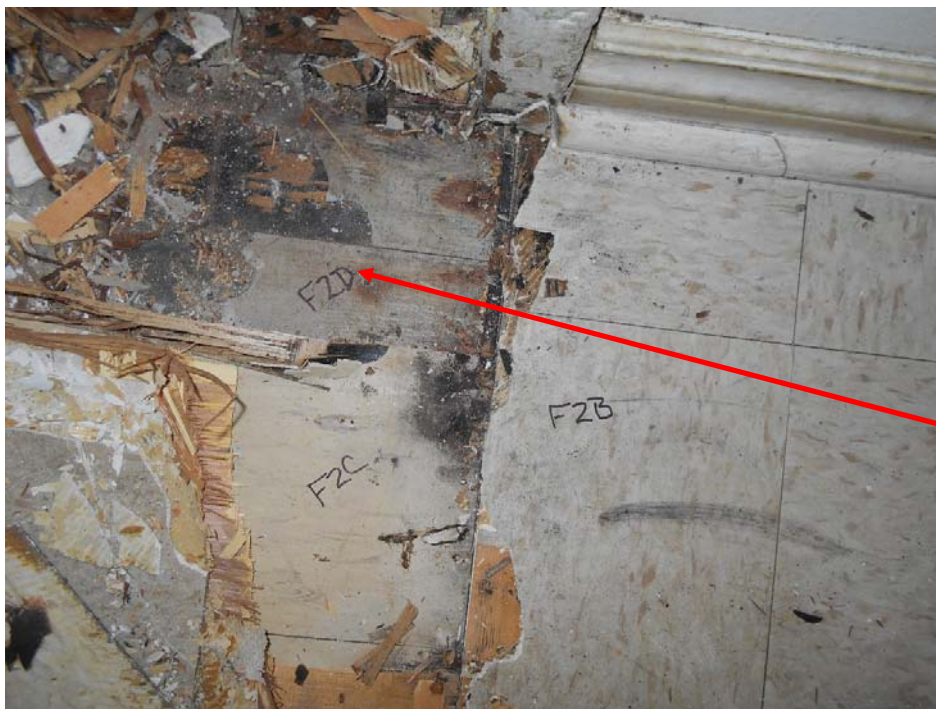
Photo 12 – South (Gladstone) Building | VFT – brown streaked white

289-1-K-
F2D-C
VFT-brown
streaked white
(ACM)

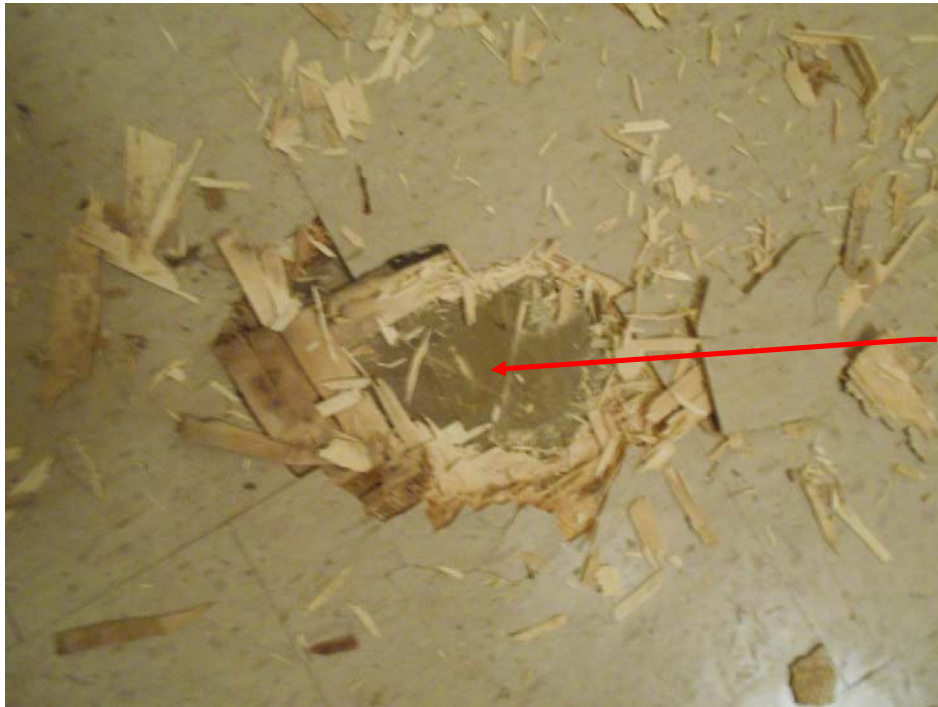
Photo 13 – South (Gladstone) Building | VFT – olive grey tiles under laminate floor

Visually similar flooring to unit 829 (ground floor hallway) was observed in unit 819 (utility room), unit 289 (kitchen), and unit 289 (utility room); these visually similar materials should also be treated as ACM.

819-1-K
F2C-B
VFT – olive
brown with
white streaks
(ACM)
