Phase Two Environmental Site Assessment 133 Forward Avenue, Ottawa, Ontario

Phase Two Environmental Site Assessment

OTT-25011403-A0

2025-10-06

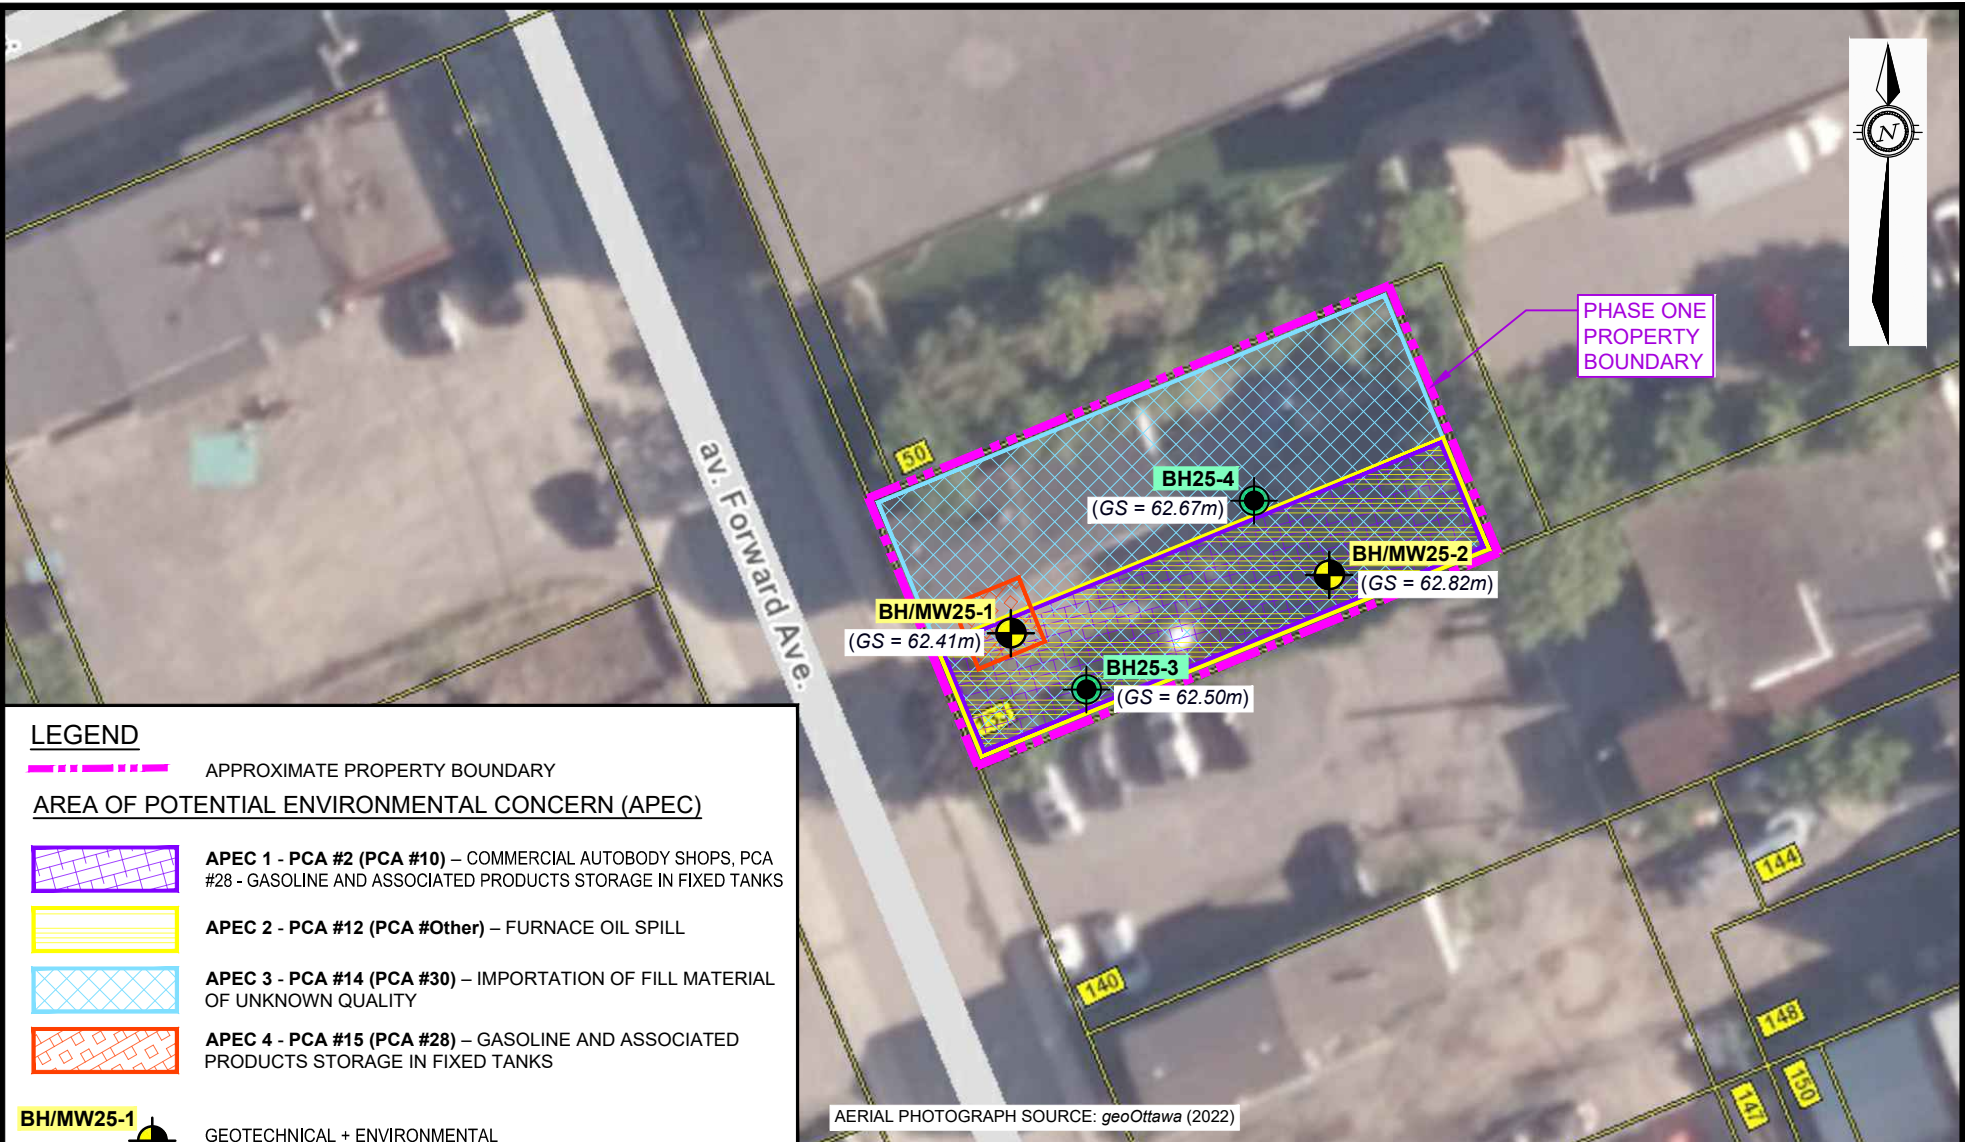
- APPROXIMATE PROPERTY BOUNDARY
- AREA OF POTENTIAL ENVIRONMENTAL CONCERN (APEC)**
- APEC 1 - PCA #2 (PCA #10)** – COMMERCIAL AUTOBODY SHOPS, PCA #28 - GASOLINE AND ASSOCIATED PRODUCTS STORAGE IN FIXED TANKS
- APEC 2 - PCA #12 (PCA #Other)** – FURNACE OIL SPILL
- APEC 3 - PCA #14 (PCA #30)** – IMPORTATION OF FILL MATERIAL OF UNKNOWN QUALITY
- APEC 4 - PCA #15 (PCA #28)** – GASOLINE AND ASSOCIATED PRODUCTS STORAGE IN FIXED TANKS

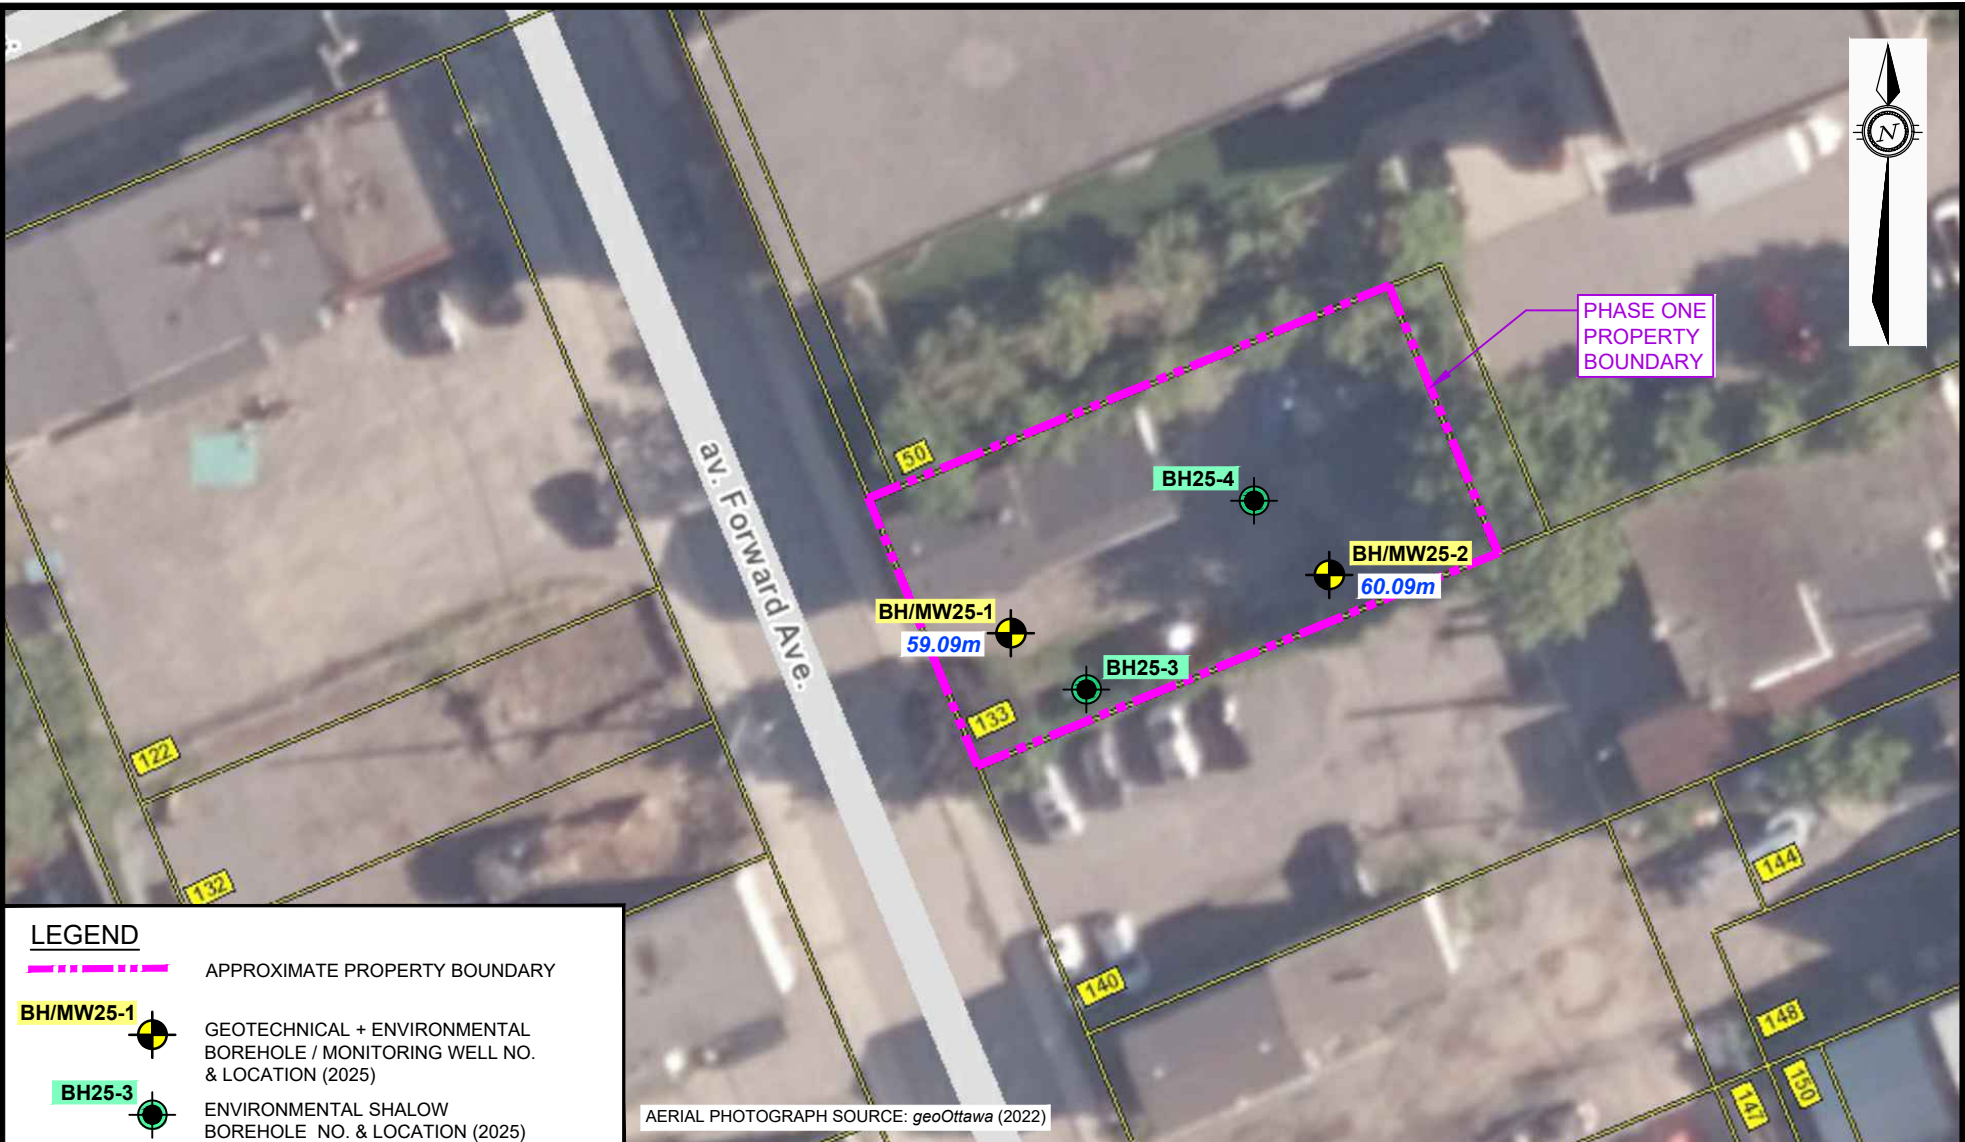
DATE SEPTEMBER 2025		PROJECT: PHASE TWO ENVIRONMENTAL SITE ASSESSMENT 133 FORWARD AVENUE, OTTAWA, ONTARIO		project no. OTT-25011403-A0	
DESIGN LW	CHECKED CK	TITLE: PHASE ONE CONCEPTUAL SITE MODEL		scale 1:3,000	
DRAWN BY AS				FIG 3

A copy of the Phase One conceptual site model is provided as Figure 3 in Appendix A.

The PCAs are shown in Figure 3.

The Phase One Conceptual Site Model is provided as Figure 3.
