**Phase One Environmental
Site Assessment
4190, 4200, 4210, 4236
Fallowfield Road and 2740
Cedarview Road,
Ottawa, Ontario**

OTT-00243143-A0

EXP Services Inc.
100-2650 Queensview Drive
Ottawa, ON K2B 7H6 Canada

March 29, 2018

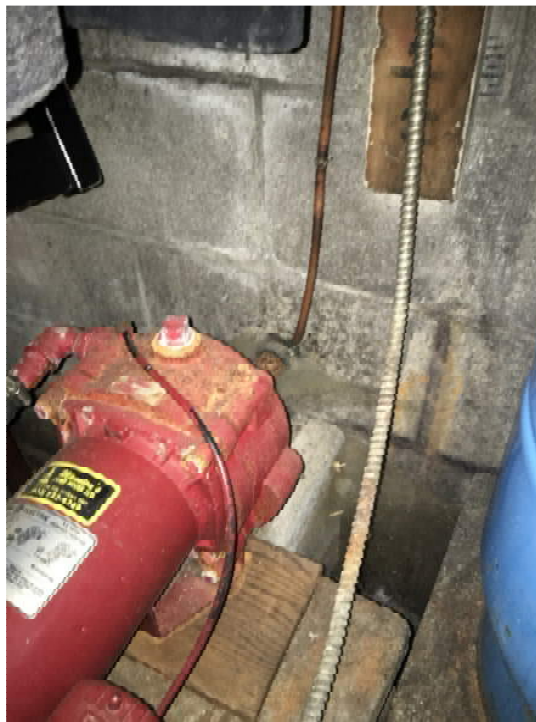
Photograph No. 10

View of the potential fuel supply line at 4190 Fallowfield Road

The site representative indicated they had no knowledge of underground storage tanks (USTs) at the site. EXP did observe evidence of a potential UST during the site reconnaissance at 4190 Fallowfield Road. A potential fuel line was observed in the basement which could be from a former furnace oil UST located in the front of the residential dwelling (Photograph 10 and 11, Appendix E). This is considered to be a potentially contaminating activity PCA 2 (PCA#28 – Gasoline and Associated Products Stored in Fixed Tanks).

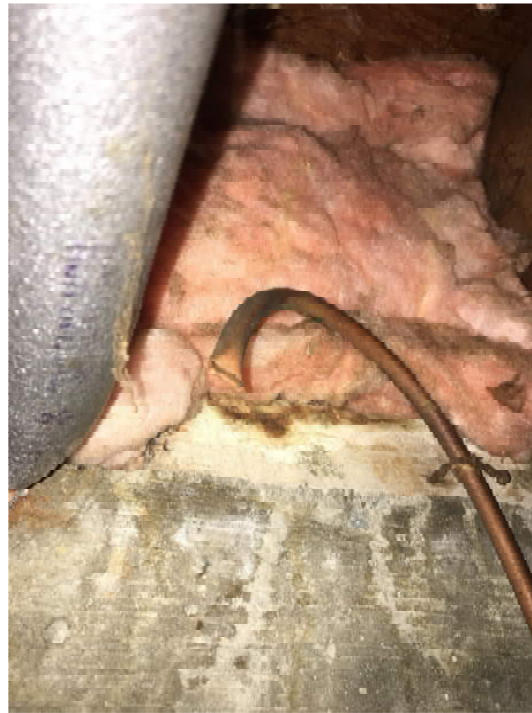
Photograph No. 11

View of the potential fuel supply line cut off at 4190 Fallowfield Road

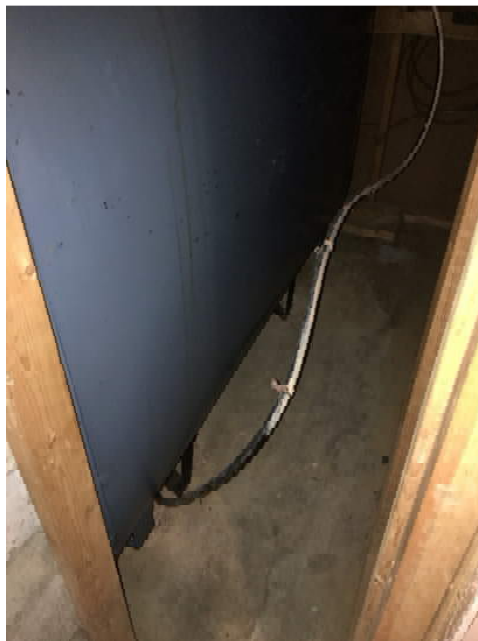
Photograph No. 12

Both ASTs were located in the basement on a concrete floor, in good condition with no staining. The AST-1 (PCA 3) was empty and no longer used. There were no reports of spills/leaks associated with this tank. (Photograph 12, Appendix E). The AST-2 (PCA 4) has a secondary containment, and serviced by a licensed contractor, there were no reports of spills/leaks associated with this tank (Photograph 13, Appendix E). In addition, there may have been a heating oil AST at 4236 Fallowfield Road, however during the interview process the owner said that the house has been heated electrically for at least the last 40 years.

View of AST-1 at 4200 Fallowfield Road

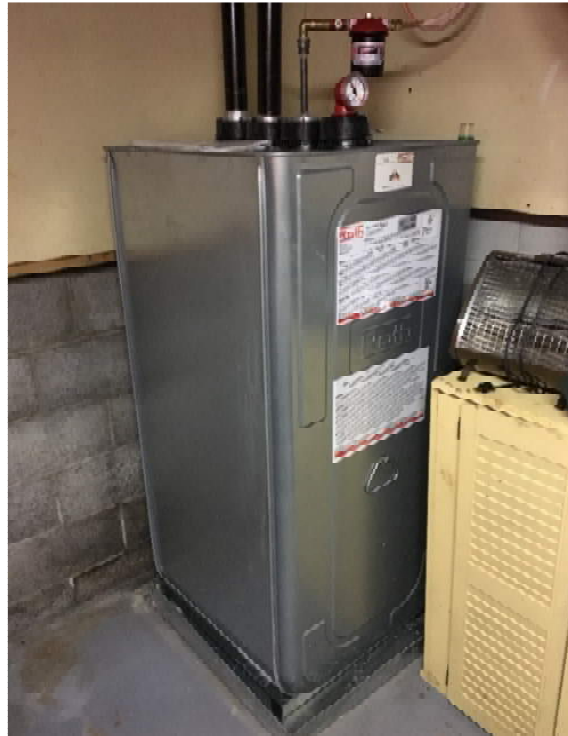
Photograph No. 13

View of AST-2 at 2740 Cedarview Road

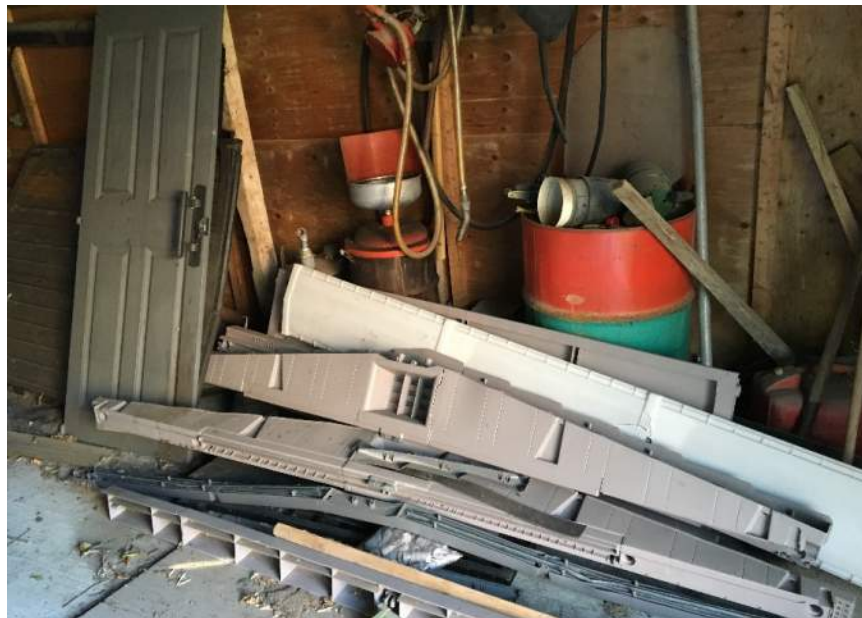
Photograph No. 14

A small private not commercial operations vehicle and equipment maintenance area was observed at 4236 Fallowfield Road located in the barn at the south part of the property (Photograph 14 and 15, Appendix E). There was a small waste oil drums located on a concrete floor, in good condition with no staining. This is not considered to be an APEC. No spills or leaks were reported by the owner.

View of vehicle and equipment maintenance area at 4236 Fallowfield Road

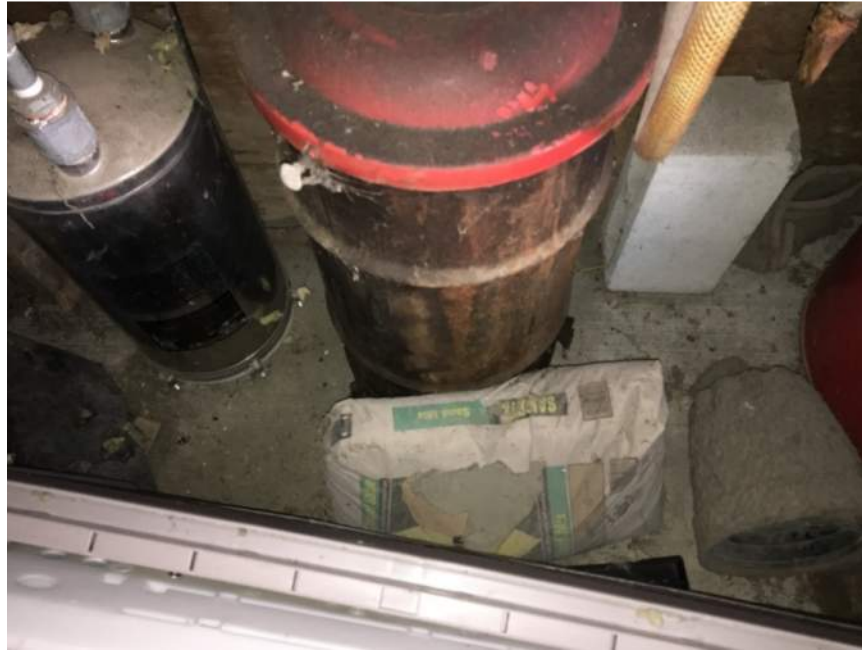
Photograph No. 15

View of vehicle and equipment maintenance area floor at 4236 Fallowfield Road

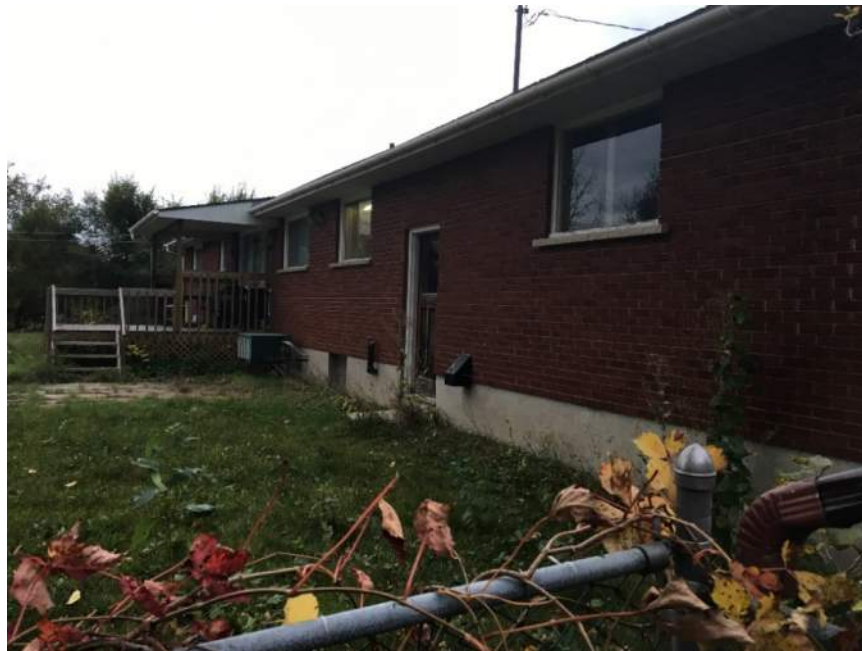
Photograph No. 16

View of AST fill and vent pipes at the adjacent property at 4192 Fallowfield Road
