Phase Two Environmental Site Assessment 4190, 4200, 4210, 4236 Fallowfield Road and 2740 Cedarview Road, Ottawa, Ontario

OTT-00243143-B0

April 10, 2018

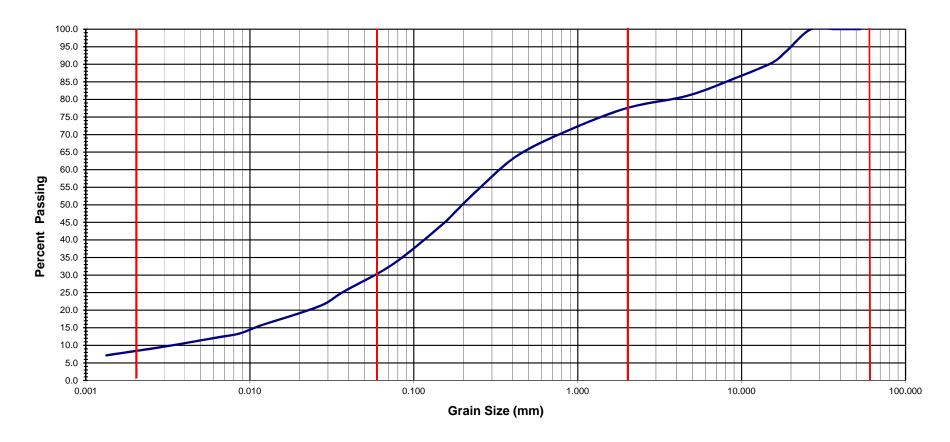
Exp Project No.: OTT-00243143-A0		Project Name :	osed Residential Development			
Client : Phoenix Homes Group of Companies Project Location : Fallowfield & Cedarview Road, Ottawa, ON						
Date Sampled :	October 23, 2017	Bore Hole/Test Pit No.:	1	Sample No.: SS4	Depth (m): 2.3-2.9	
Sample Descrip	otion :	Silty to Gravelly Sand	Figure: 6

The results of the six grain-size analyses performed on selected samples of the glacial till are shown on the grain size distribution curves in Appendix A. Based on the results of the grain size analysis, the glacial till may be described as a silty gravelly sand till. The grain size analyses showed that less than 50% of the soil had a grain size of silt or finer. This indicates that the native soil is coarse grained. The results of the grain size analyses are found in Appendix E.

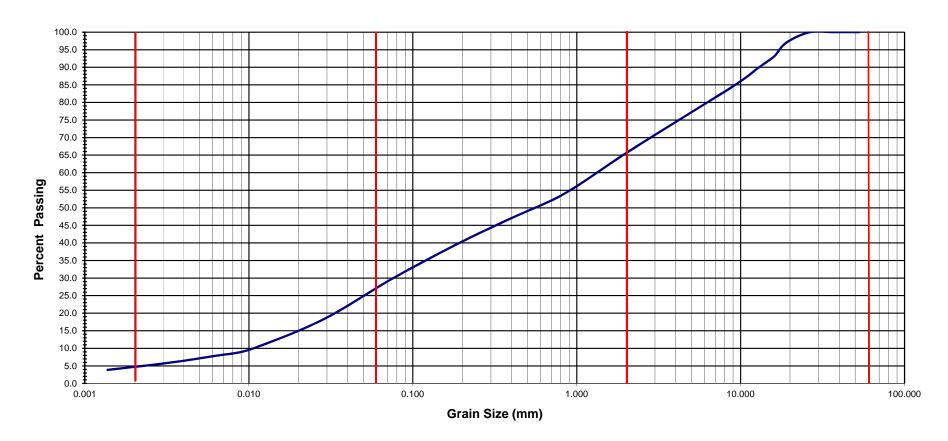
Exp Project No.: OTT-00243143-A0		Project Name :	Preliminary Geotechnical Investigation. Proposed Residential Development								
Client :	DCR Phoenix Group of Companies	Project Location :	Fallowfield & Cedarview Road, Ottawa, ON								
Date Sampled :	October 23, 2017	Bore Hole/Test Pit No.:	3	Sample No.:	SS6	Depth (m):	3.8-4.4				
Sample Description :		Silty Gravelly Sand	Trace Clay			Figure :	7

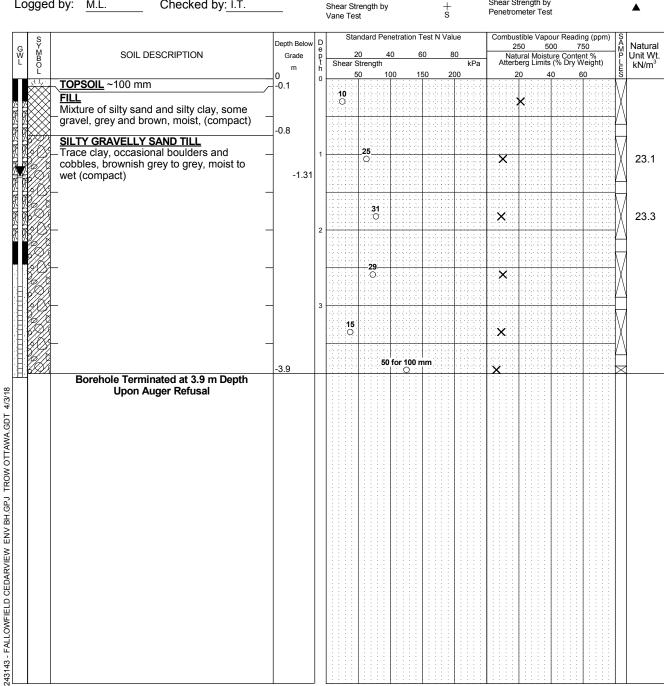
Log of Borehole BH17-1

Log of Bor	ehole <u>BH</u>	<u> 17-1</u>	_	exp
Project No:	OTT-00243143-A0		-	Tigura Na 3	
Project:	Phase Two Environmental Site Assessment		r	Figure No. 3	'
Location:	4190, 4200, 4210, 4236 Fallowfield Rd and 2740	Cedarview Rd, Ottawa		Page. <u>1</u> of <u>1</u>	_
Date Drilled:	'October 23, 2017	Split Spoon Sample	\boxtimes	Combustible Vapour Reading	
Drill Type:	CME-55 Trackmount	Auger Sample SPT (N) Value	■	Natural Moisture Content Atterberg Limits	X ⊢—⊙
Datum:	Depth Below Grade	Dynamic Cone Test —— Shelby Tube	_	Undrained Triaxial at % Strain at Failure	\oplus
Logged by:	M.L. Checked by: I.T.	Shear Strength by Vane Test	+ s	Shear Strength by Penetrometer Test	A

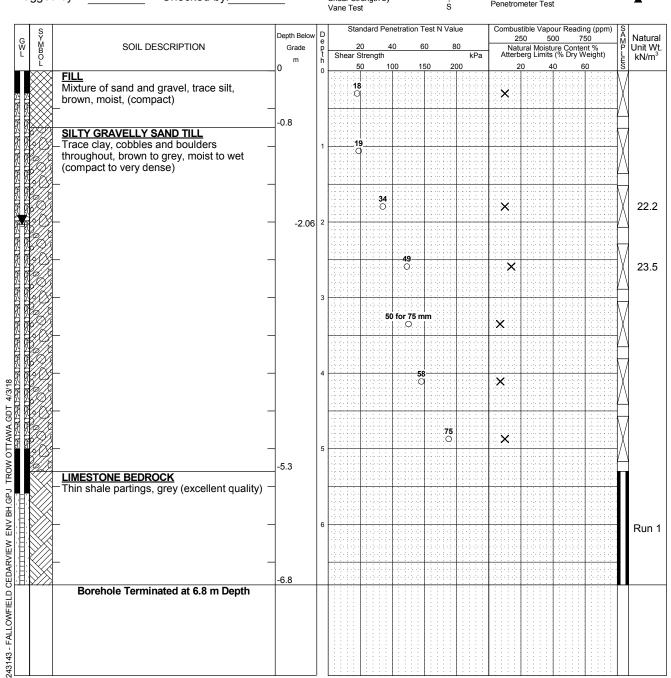
Log of Borehole BH17-3

Log of B	orehole <u>B</u>	H17	<u>-3</u>	exp
Project No:	OTT-00243143-A0			Figure No. 6	
Project:	Phase Two Environmental Site Assessmen	t		Figure No5_ Page. 1 of 1	
Location:	4190, 4200, 4210, 4236 Fallowfield Rd and	2740 Cedarview Rd, Ottaw	/a	raye. <u>1</u> 01 <u>1</u>	_
Date Drilled:	'October 23, 2017	Split Spoon Sample	\boxtimes	Combustible Vapour Reading	
Drill Type:	CME-55 Trackmount	Auger Sample		Natural Moisture Content	×
Dilli Type.	CIVIE-55 Trackinount	SPT (N) Value	0	Atterberg Limits	\longrightarrow
Datum:	Depth Below Grade	Dynamic Cone Test Shelby Tube		Undrained Triaxial at % Strain at Failure	\oplus
Logged by:	M.L. Checked by: I.T.	Shear Strength by	+	Shear Strength by	A

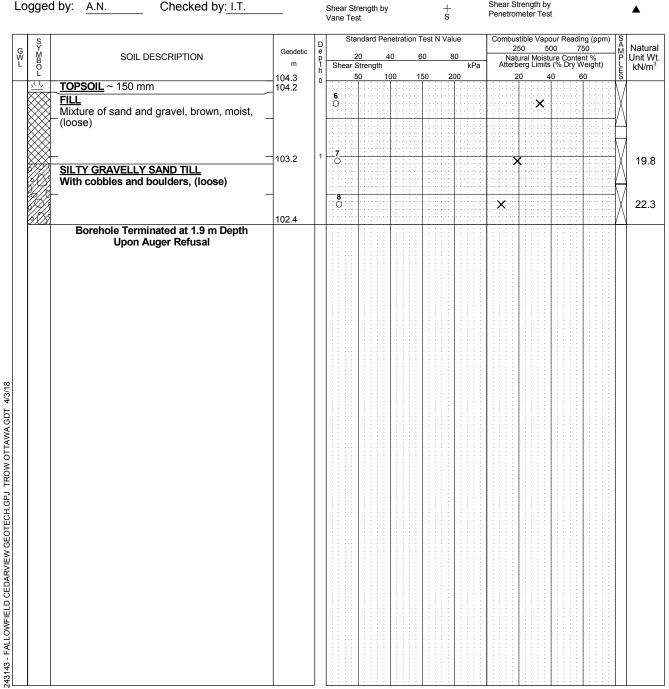
Log of Borehole BH18-5

1 011010 <u>D11</u>	<u> </u>	<u> </u>	-x
Project No:	OTT-00243143-A0				
Project:	Preliminary Geotechnical Investigation. Propos	ed Residential Development	t	Figure No7	
Location:	Fallowfield and Cedarview Roads, City of Ottav	va, Ontario		Page. <u>1</u> of <u>1</u>	_
Date Drilled:	'March 6, 2018	Split Spoon Sample	\boxtimes	Combustible Vapour Reading	
Drill Type:	CME-55 Trackmount	Auger Sample — SPT (N) Value	■	Natural Moisture Content Atterberg Limits	× ⊢—⊖
Datum:	Geodetic	Dynamic Cone Test ————————————————————————————————————	_	Undrained Triaxial at % Strain at Failure	\oplus
Logged by:	A.N. Checked by: I.T.	Shear Strength by	+ s	Shear Strength by Penetrometer Test	A

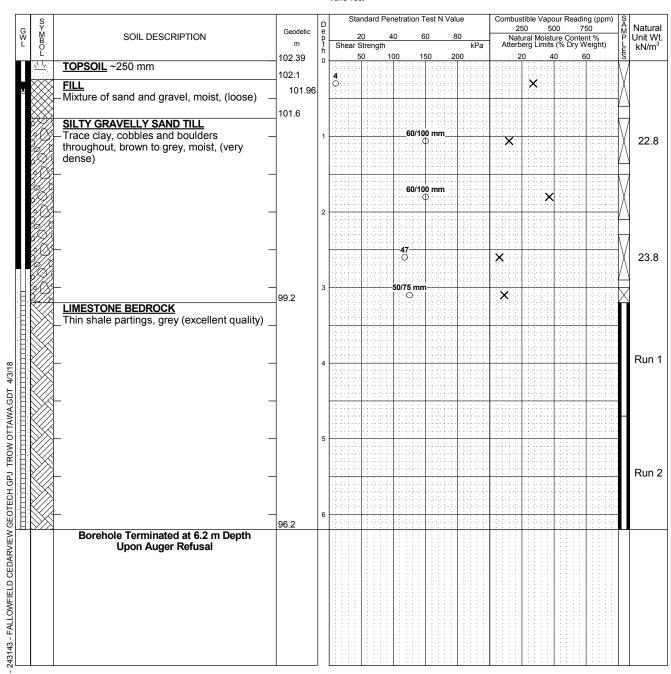
Log of Borehole BH18-7A

Log of Dor	CHOIC <u>Biii</u>	<u> </u>	<u>^</u>	· (-	- X
Project No:	OTT-00243143-A0					//\
Project:	Preliminary Geotechnical Investigation. Proposed	d Residential Development		Figure No11		
Location:	Fallowfield and Cedarview Roads, City of Ottawa		Page. <u>1</u> of <u>1</u>	_		
Date Drilled:	'March 6, 2018	Split Spoon Sample	\boxtimes	Combustible Vapour Reading		
Drill Type:	CME-55 Trackmount	Auger Sample SPT (N) Value	■	Natural Moisture Content Atterberg Limits	—	× ⊕
Datum:	Geodetic	Dynamic Cone Test Shelby Tube	_	Undrained Triaxial at % Strain at Failure		\oplus
Logged by:	A.N. Checked by: I.T.	Shear Strength by Vane Test	_ + s	Shear Strength by Penetrometer Test		•

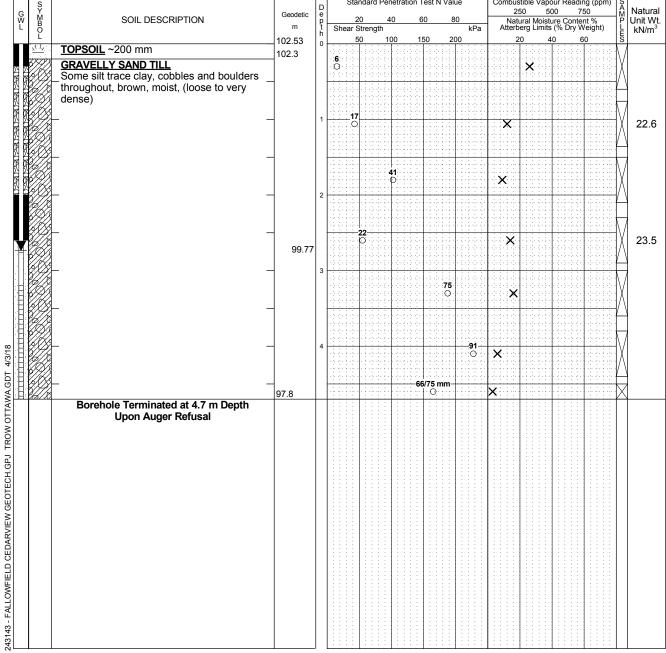
Log of	Boı	re	ehole <u>E</u>	3H	18-8		:	•	λ	r
Project No:	OTT-00243143-A0						=	11		//\	٢
Project:	Preliminary Geotechnical Investigation.	Propose	d F	Residential Devel	opment		igure No.	11	1		ı
Location:	Fallowfield and Cedarview Roads, City	of Ottawa	а, (Ontario			Page.	_1_ of	<u></u>		
Date Drilled:	'March 5, 2018			Split Spoon Sample		\boxtimes	Combustible V	apour Reading			
Drill Type:	CME-55 Trackmount			Auger Sample SPT (N) Value			Natural Moistu Atterberg Limit		—	X →	
Datum:	Geodetic			Dynamic Cone Test Shelby Tube		_	Undrained Tria % Strain at Fai			\oplus	
Logged by:	A.N. Checked by: I.T.			Shear Strength by Vane Test		+ s	Shear Strength Penetrometer			•	
G Y M B O L	SOIL DESCRIPTION	Geodetic m	D e p t h	Standard Penetrat 20 40 Shear Strength 50 100	60 150	Value 80 kPa 200	250 Natural Me	/apour Reading (500 750 oisture Content omits (% Dry Weig 40 60	6 F	Unit V	٧t.
Y I TOPS	SOIL ~200 mm	102.33	0		- 100			Ĭ

VELLY SAND TILL e silt trace clay, cobbles and boulders			Ö			×			$\langle $

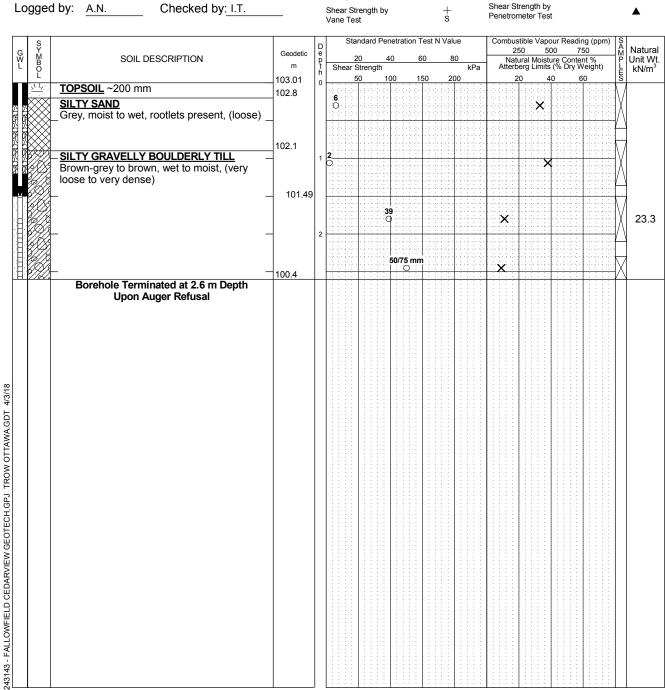
Log of Borehole BH18-9

Log of Doi	CHOIC DIT	U-3		$^{\bullet}$	'X
Project No:	OTT-00243143-A0			- -: 12		//
Project:	Preliminary Geotechnical Investigation. Proposed	d Residential Development	I	Figure No12_		
Location:	Fallowfield and Cedarview Roads, City of Ottawa	ı, Ontario		Page. <u>1</u> of <u>1</u>	_	
Date Drilled:	March 5, 2018	Split Spoon Sample	\boxtimes	Combustible Vapour Reading		
Drill Type:	CME-55 Trackmount		II 0	Natural Moisture Content Atterberg Limits	<u> </u>	× ⊕
Datum:	Geodetic	Dynamic Cone Test Shelby Tube	_	Undrained Triaxial at % Strain at Failure		\oplus
Logged by:	A.N. Checked by: I.T.	Shear Strength by Vane Test	+ \$	Shear Strength by Penetrometer Test		•
	T	Standard Popotration Tost N.V.	/alue	Combustible Vancus Deading (n	nm\ e

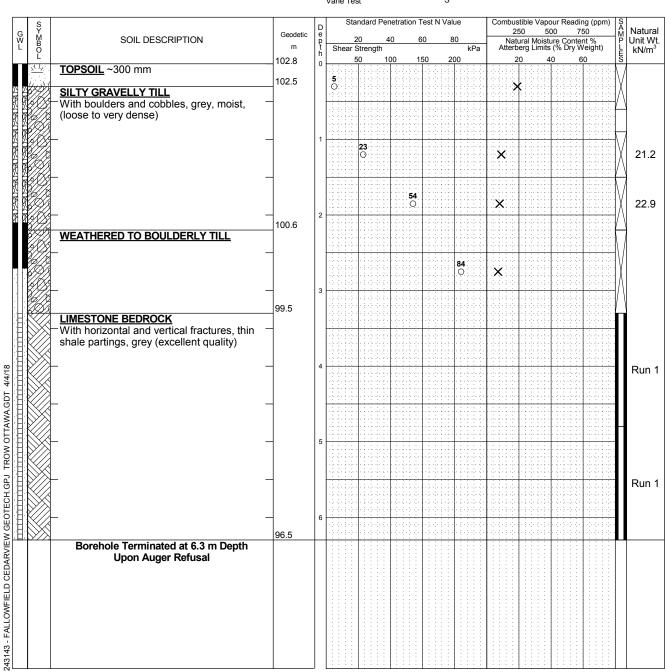
Log of Borehole BH18-10

3	o.o <u></u>	<u> </u>			7X
Project No:	OTT-00243143-A0			E: 12	_	,,,
Project:	Preliminary Geotechnical Investigation. Proposed	Residential Development		Figure No13		
Location:	Fallowfield and Cedarview Roads, City of Ottawa	, Ontario		Page. <u>1</u> of <u>1</u>	-	
Date Drilled:	'March 5, 2018	Split Spoon Sample	\boxtimes	Combustible Vapour Reading		
Drill Type:	CME-55 Trackmount	Auger Sample		Natural Moisture Content		×
Dilli Type.	CIVIE-55 Trackinount	SPT (N) Value	0	Atterberg Limits	-	$-\!\!\!-\!\!\!\!-$
Datum:	Geodetic	Dynamic Cone Test —	_	Undrained Triaxial at		\oplus
		Shelby Tube		% Strain at Failure		•
Logged by:	A.N. Checked by: I.T.	Shear Strength by Vane Test	+ s	Shear Strength by Penetrometer Test		•

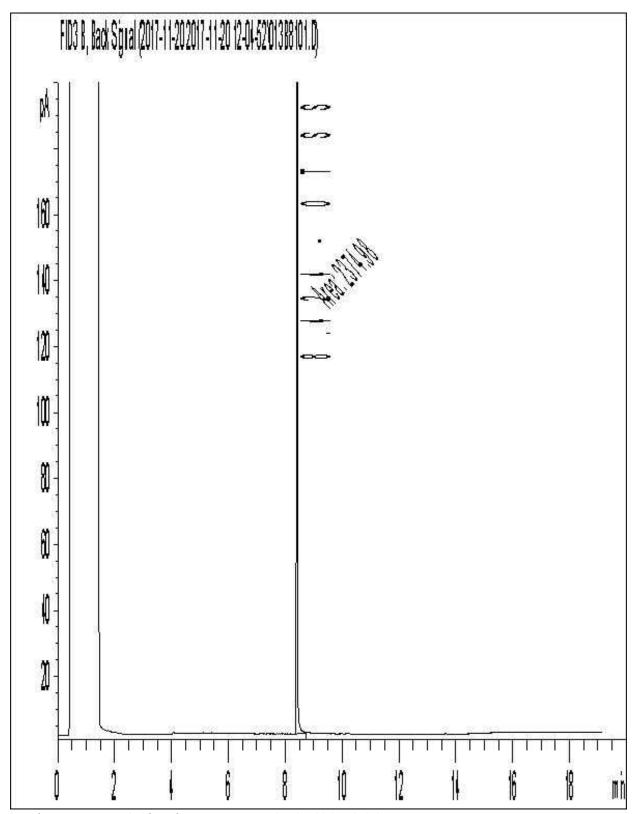
Client ID: BH 4-2

Petroleum Hydrocarbons F2-F4 in Soil Chromatogram

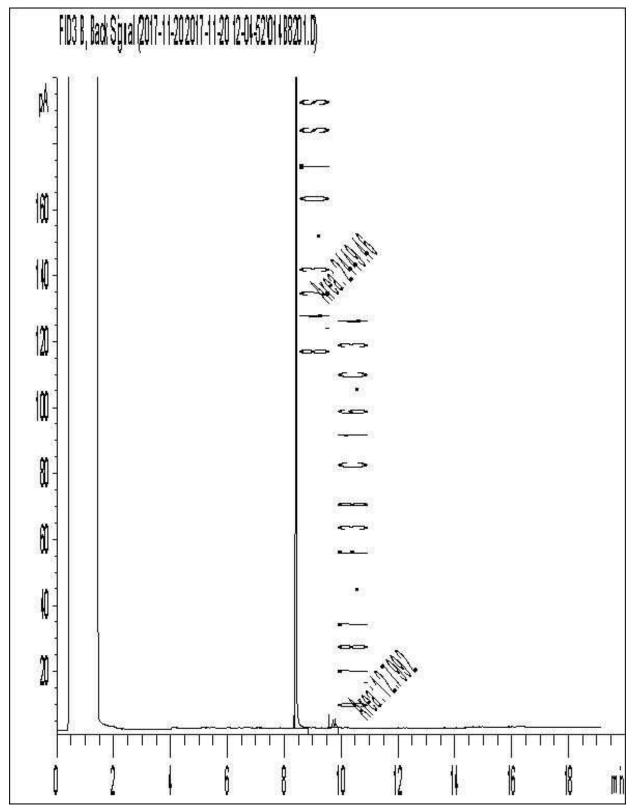
Client ID: BH 5-1

Petroleum Hydrocarbons F2-F4 in Soil Chromatogram

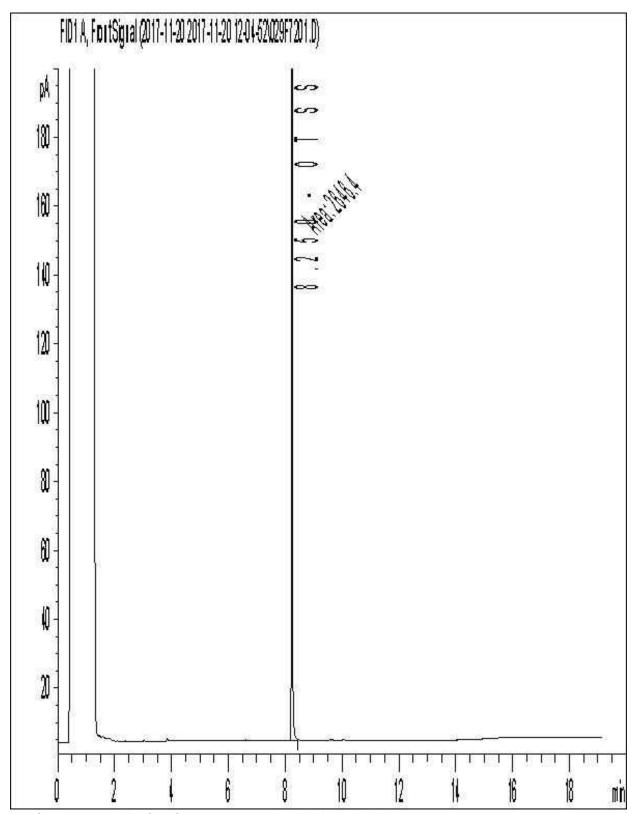
Client ID: BH 5-11

Petroleum Hydrocarbons F2-F4 in Soil Chromatogram

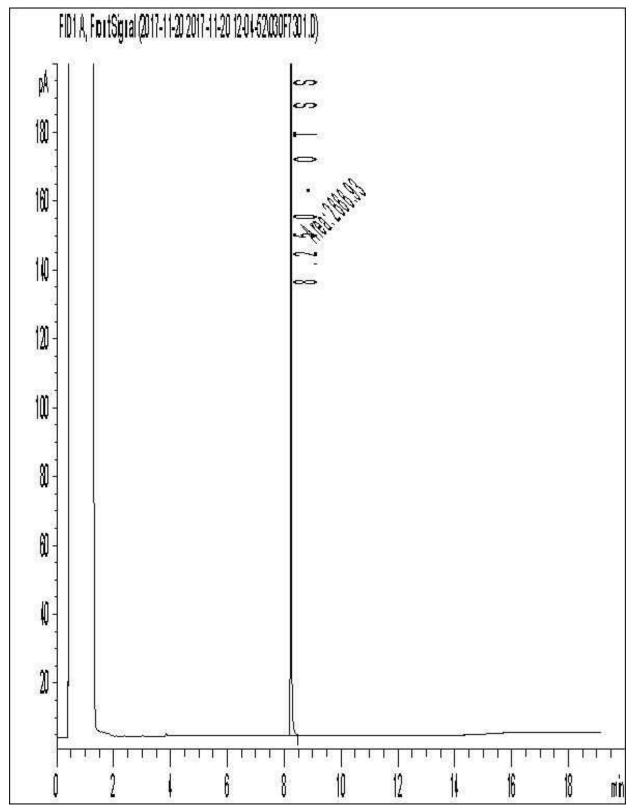
Client ID: BH 6-1

Petroleum Hydrocarbons F2-F4 in Soil Chromatogram

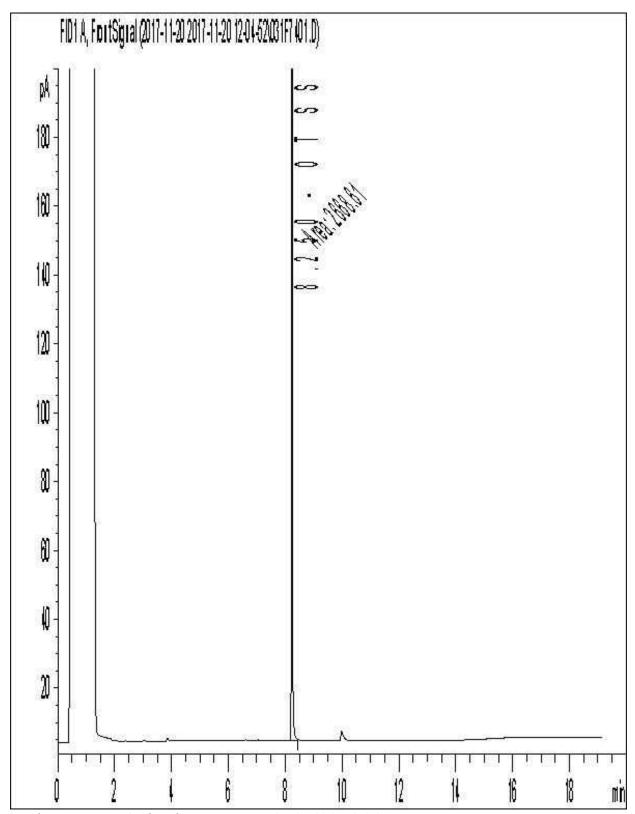
Client ID: BH 6-1

Petroleum Hydrocarbons F2-F4 in Soil Chromatogram

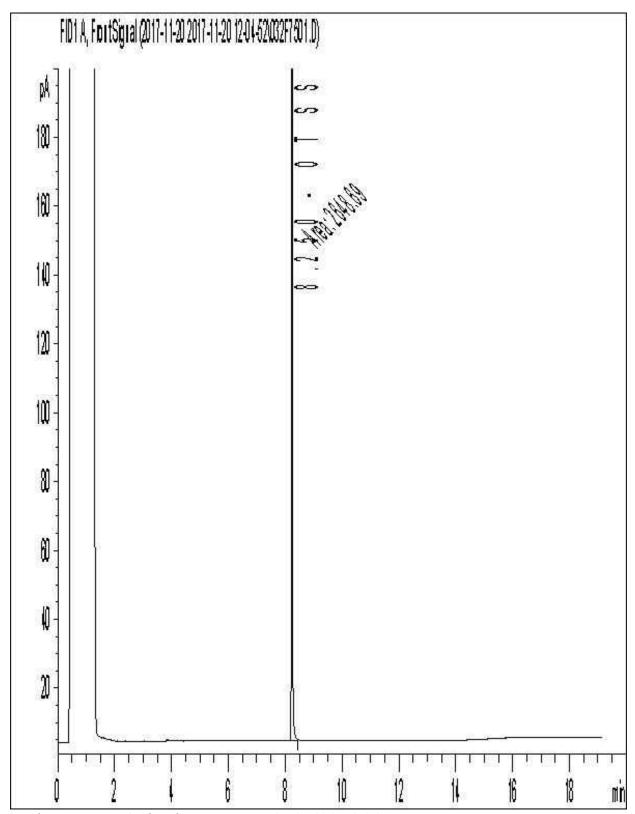
Client ID: BH 7-1

Petroleum Hydrocarbons F2-F4 in Soil Chromatogram
