FINAL REPORT

## Phase One Environmental Site Assessment

*Part of 100 Bayshore Drive, West of Bayshore Shopping Mall, Ottawa, Ontario*

19134931

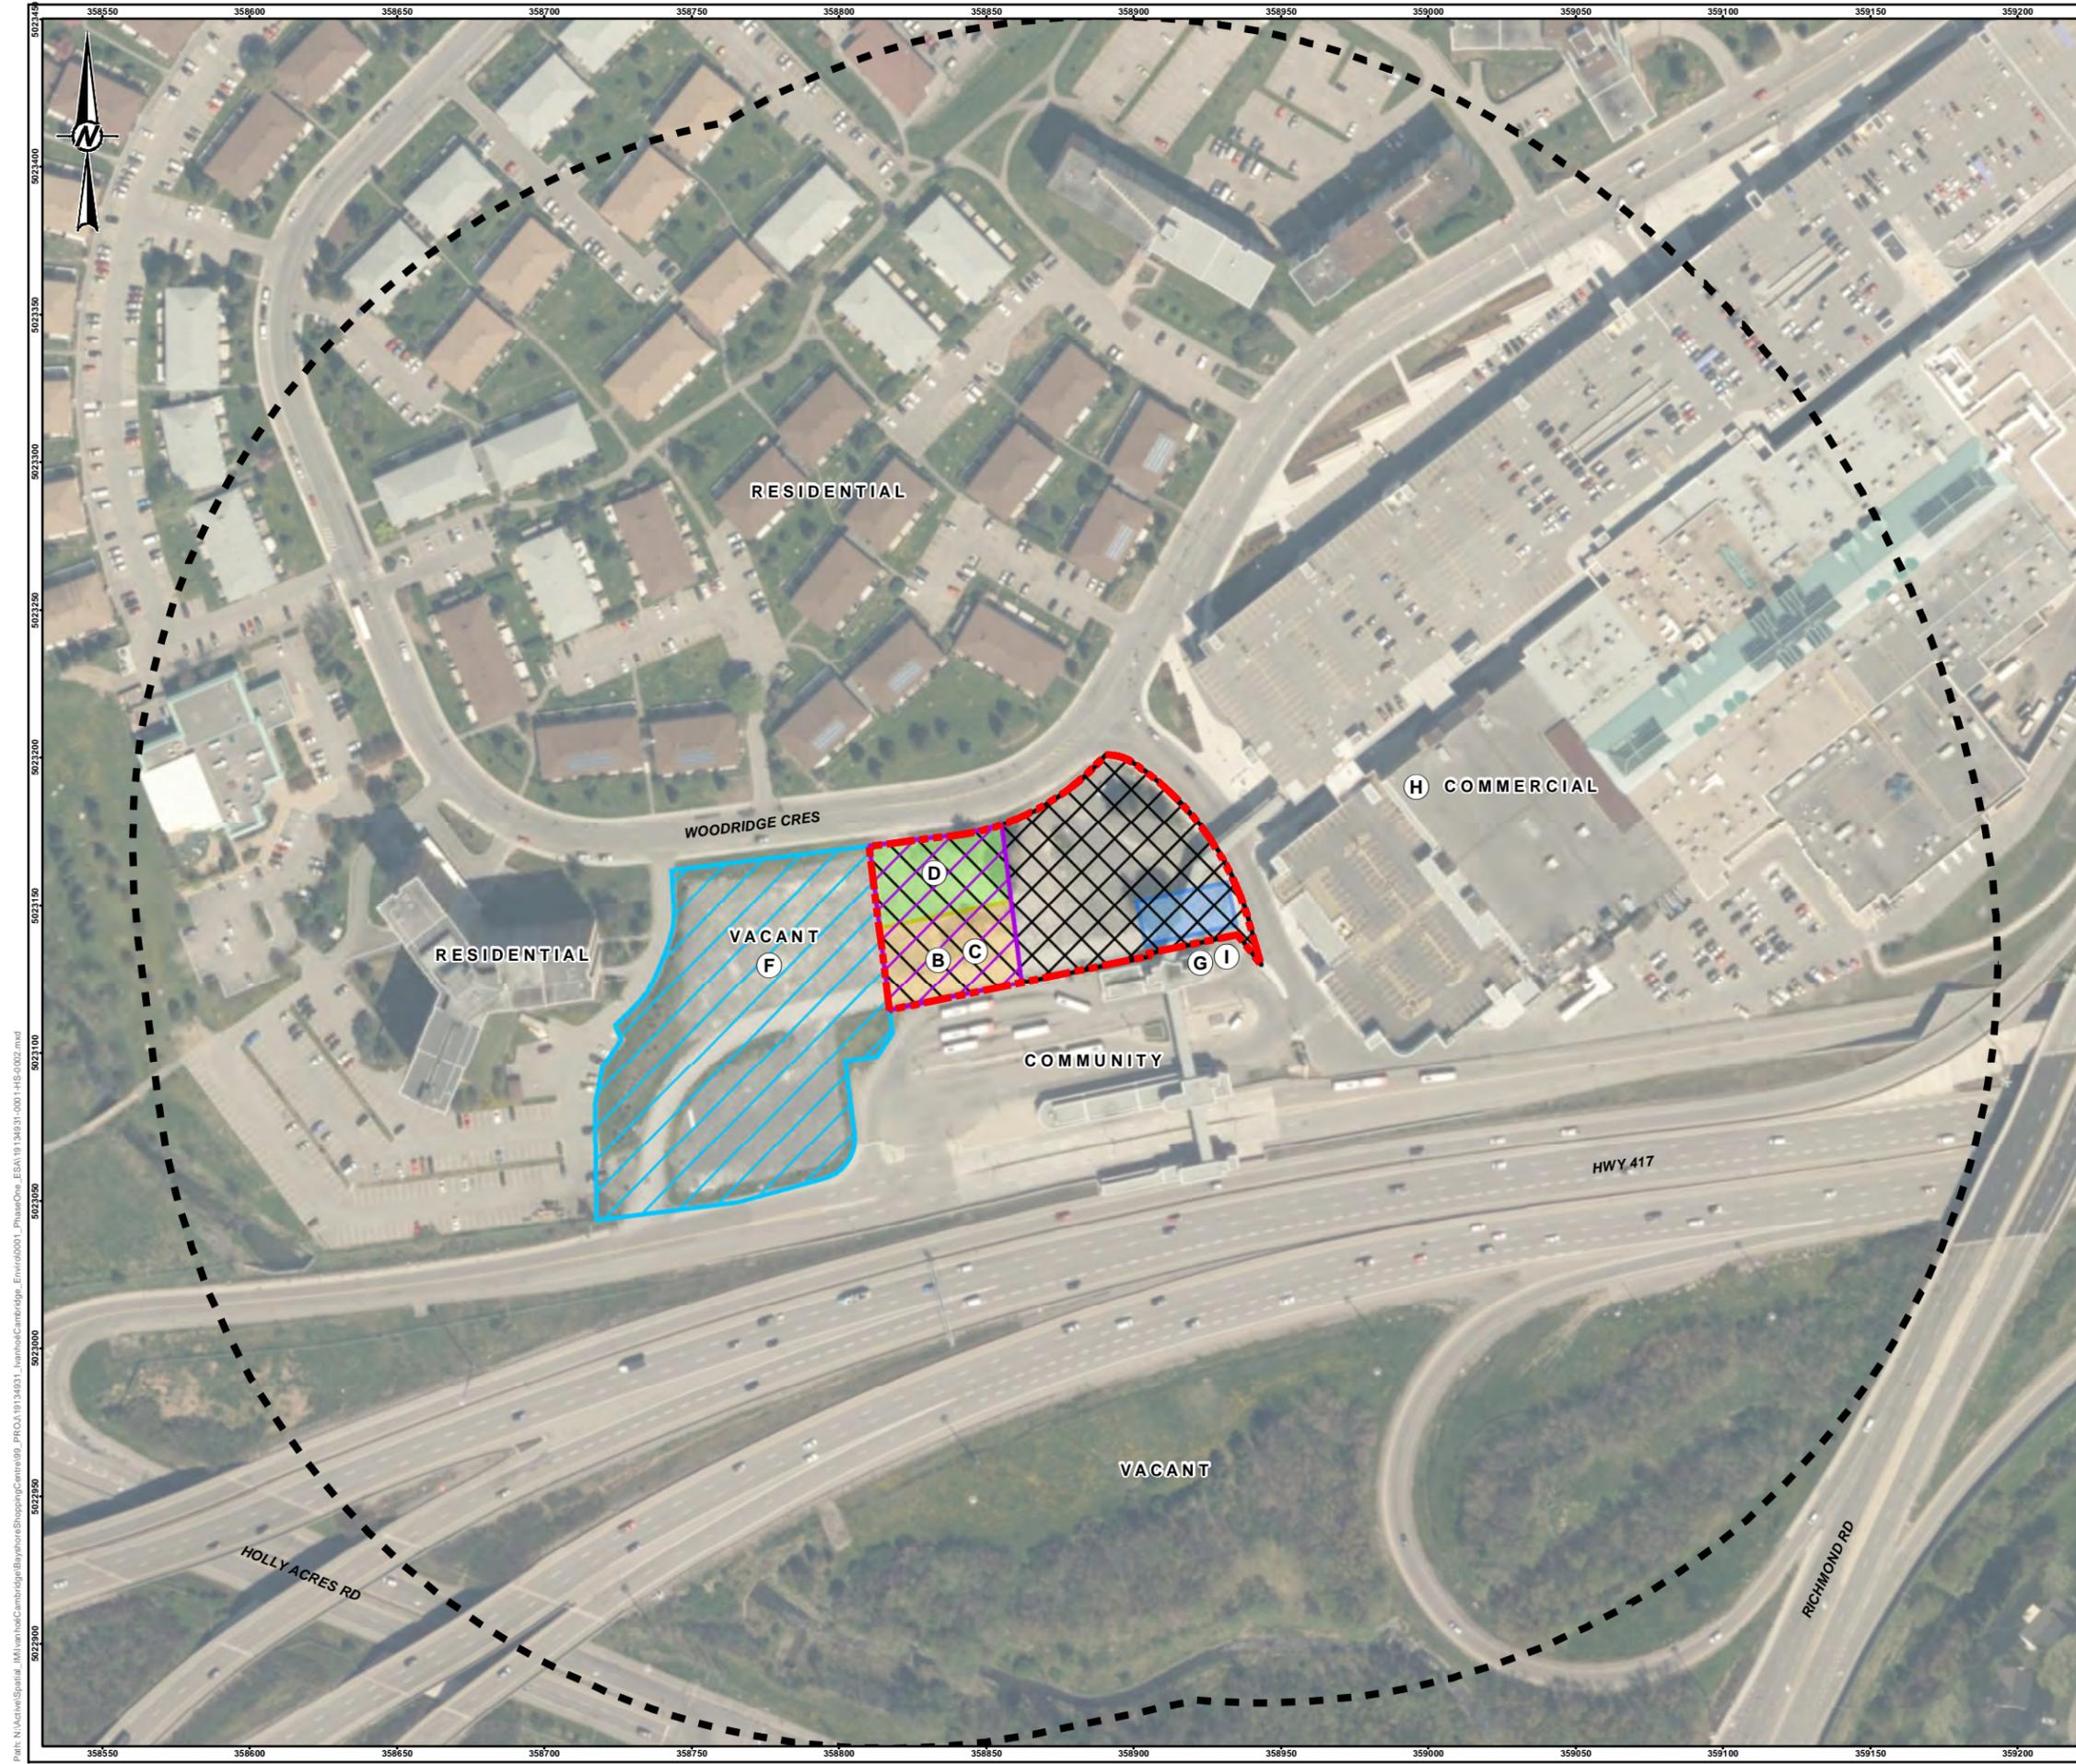
PROJECT NO. 19134931 CONTROL 0001 REV. 0 FIGURE 2

- APEC 1 & PCAA
- APEC 2
- APEC 3
- APEC 4
- APEC 5
- PCA E
- PHASE ONE SITE
- PHASE ONE STUDY AREA

Any Potentially Contaminating Activity (PCA) on the Phase One Property or in the Phase One Study Area may require the identification of an area of potential environmental concern ("APEC") and trigger the need for a Phase Two ESA to support the filing of a Record of Site Condition. The following PCAs were identified on the Phase One Property or in the Phase One Study Area, also shown on Figure 2:

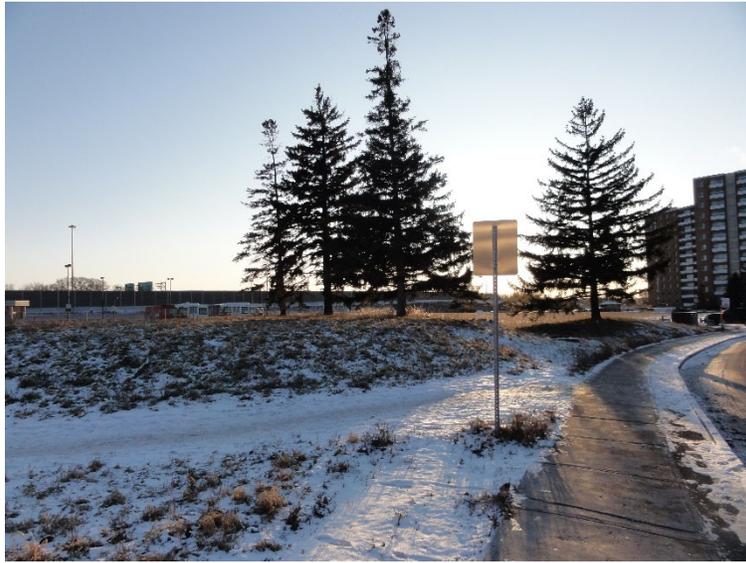
Photo 3 – View of the north portion of the Site with uneven terrain, looking southwest.

General topography of the Site was flat except for some uneven terrain on the eastern portion, likely resulting from regrading activities. Likely presence of imported fill in the uneven terrain and probably across the entire Site is a PCA that is considered an APEC for the Site; however, snow cover on the ground restricted visibility to observe ground conditions. A concrete pad mounted transformer was located on the northern portion of the Site and is also an on-Site PCA which is considered an APEC for the northern portion of the Site.

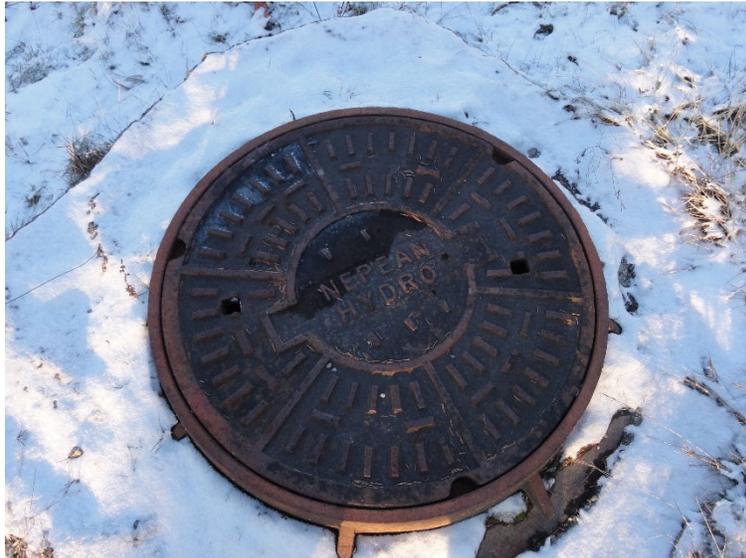
Photo 6 – View of evidence of hydro and sewer connections at the Site.

<b>Storm Water Flow</b>	Storm water infiltrates through open vegetated area.	Site observations and Site Representative
<b>Storm Sewer Connection</b>	Storm sewer easement located on-Site, hence the Site is serviced by municipal storm sewer system.	Site observations and Site Representative
<b><u>Interior of Structures</u> Entry and Exit Points for Site Buildings</b>	Not applicable; no buildings were present on-Site.	Site observations
<b>Existing and Former Heating System(s) (include fuel type / source)</b>	Not applicable; no buildings were present on-Site.	Site observations
<b>Existing and Former Cooling System(s) (include fuel type / source)</b>	Not applicable; no buildings were present on-Site.	Site observations
<b>Drains, Pits, and Sumps (include current use, if any, and former use)</b>	Not applicable; no buildings were present on-Site.	Site observations
<b>Unidentified Substances</b>	None identified.	Site observations

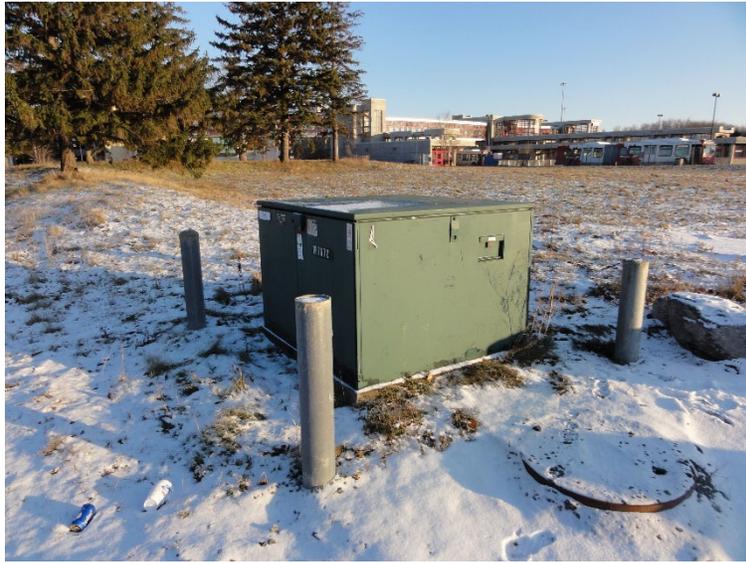
Photo 7 – View of pad-mounted transformer located on the north portion of the Site (adjacent to Woodridge Crescent).

<p><b>Polychlorinated Biphenyls (PCB) Containing Materials and Equipment</b></p>	<p>A concrete pad mounted transformer was observed on the northern portion of the Site; however, no evidence of stains or spills were observed based on limited visibility due to snow cover on the ground. No other evidence was observed during the Site visit to indicate former presence of PCB containing materials or equipment. Given that no permanent buildings were present at the Site, PCB-containing electrical caulking and equipment are likely not present on-Site.</p> <p>Another concrete pad mounted transformer was located adjacent southeast of the Site.</p>	<p>Site observations</p>
<p><b>Asbestos-Containing Materials (ACMs)</b></p>	<p>Given that no buildings or structures were present at the Site, ACMs are not considered to be an issue of concern at the Site.</p>	<p>Site observations</p>

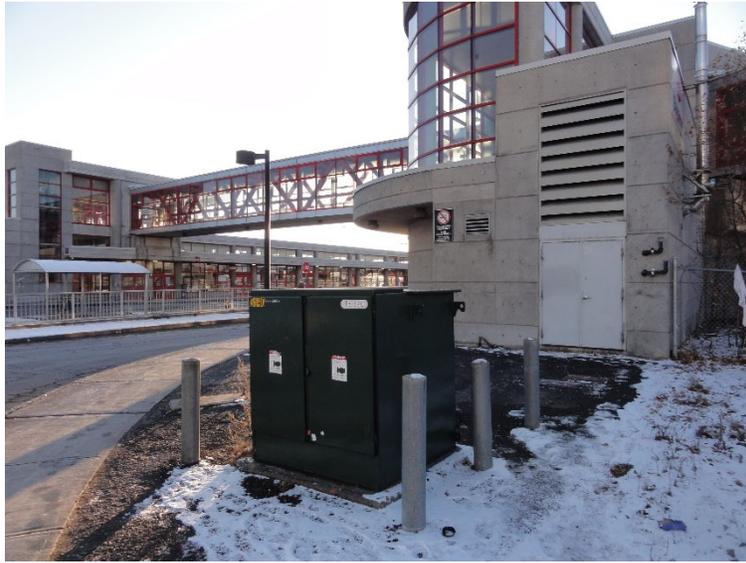
Photo 13 –View of pad-mounted transformer located adjacent southeast of the Site (adjacent to OC-Transpo Station).

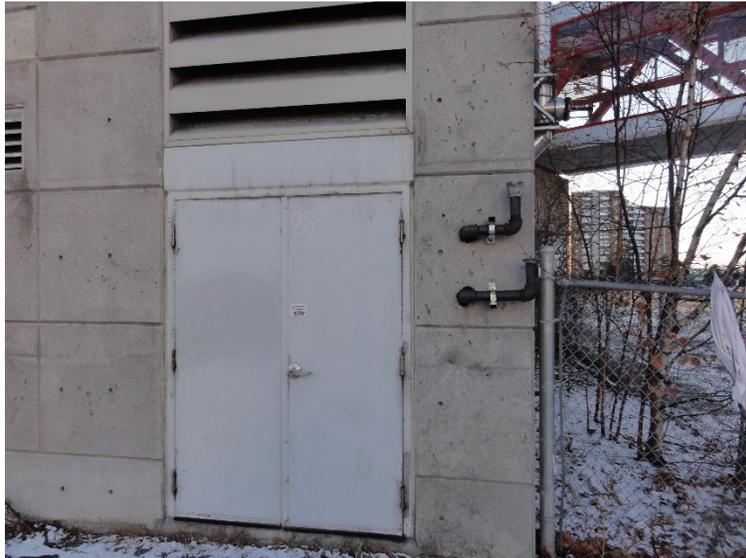
Photo 14 – View of vent and fill pipes associated with back-up power generator located adjacent southeast of the Site, associated with OC-Transpo station .
