**Phase II Environmental Site Assessment**

861 Clyde Avenue  
Ottawa, Ontario

DOODH Milk Limited

Report: PE4936-2

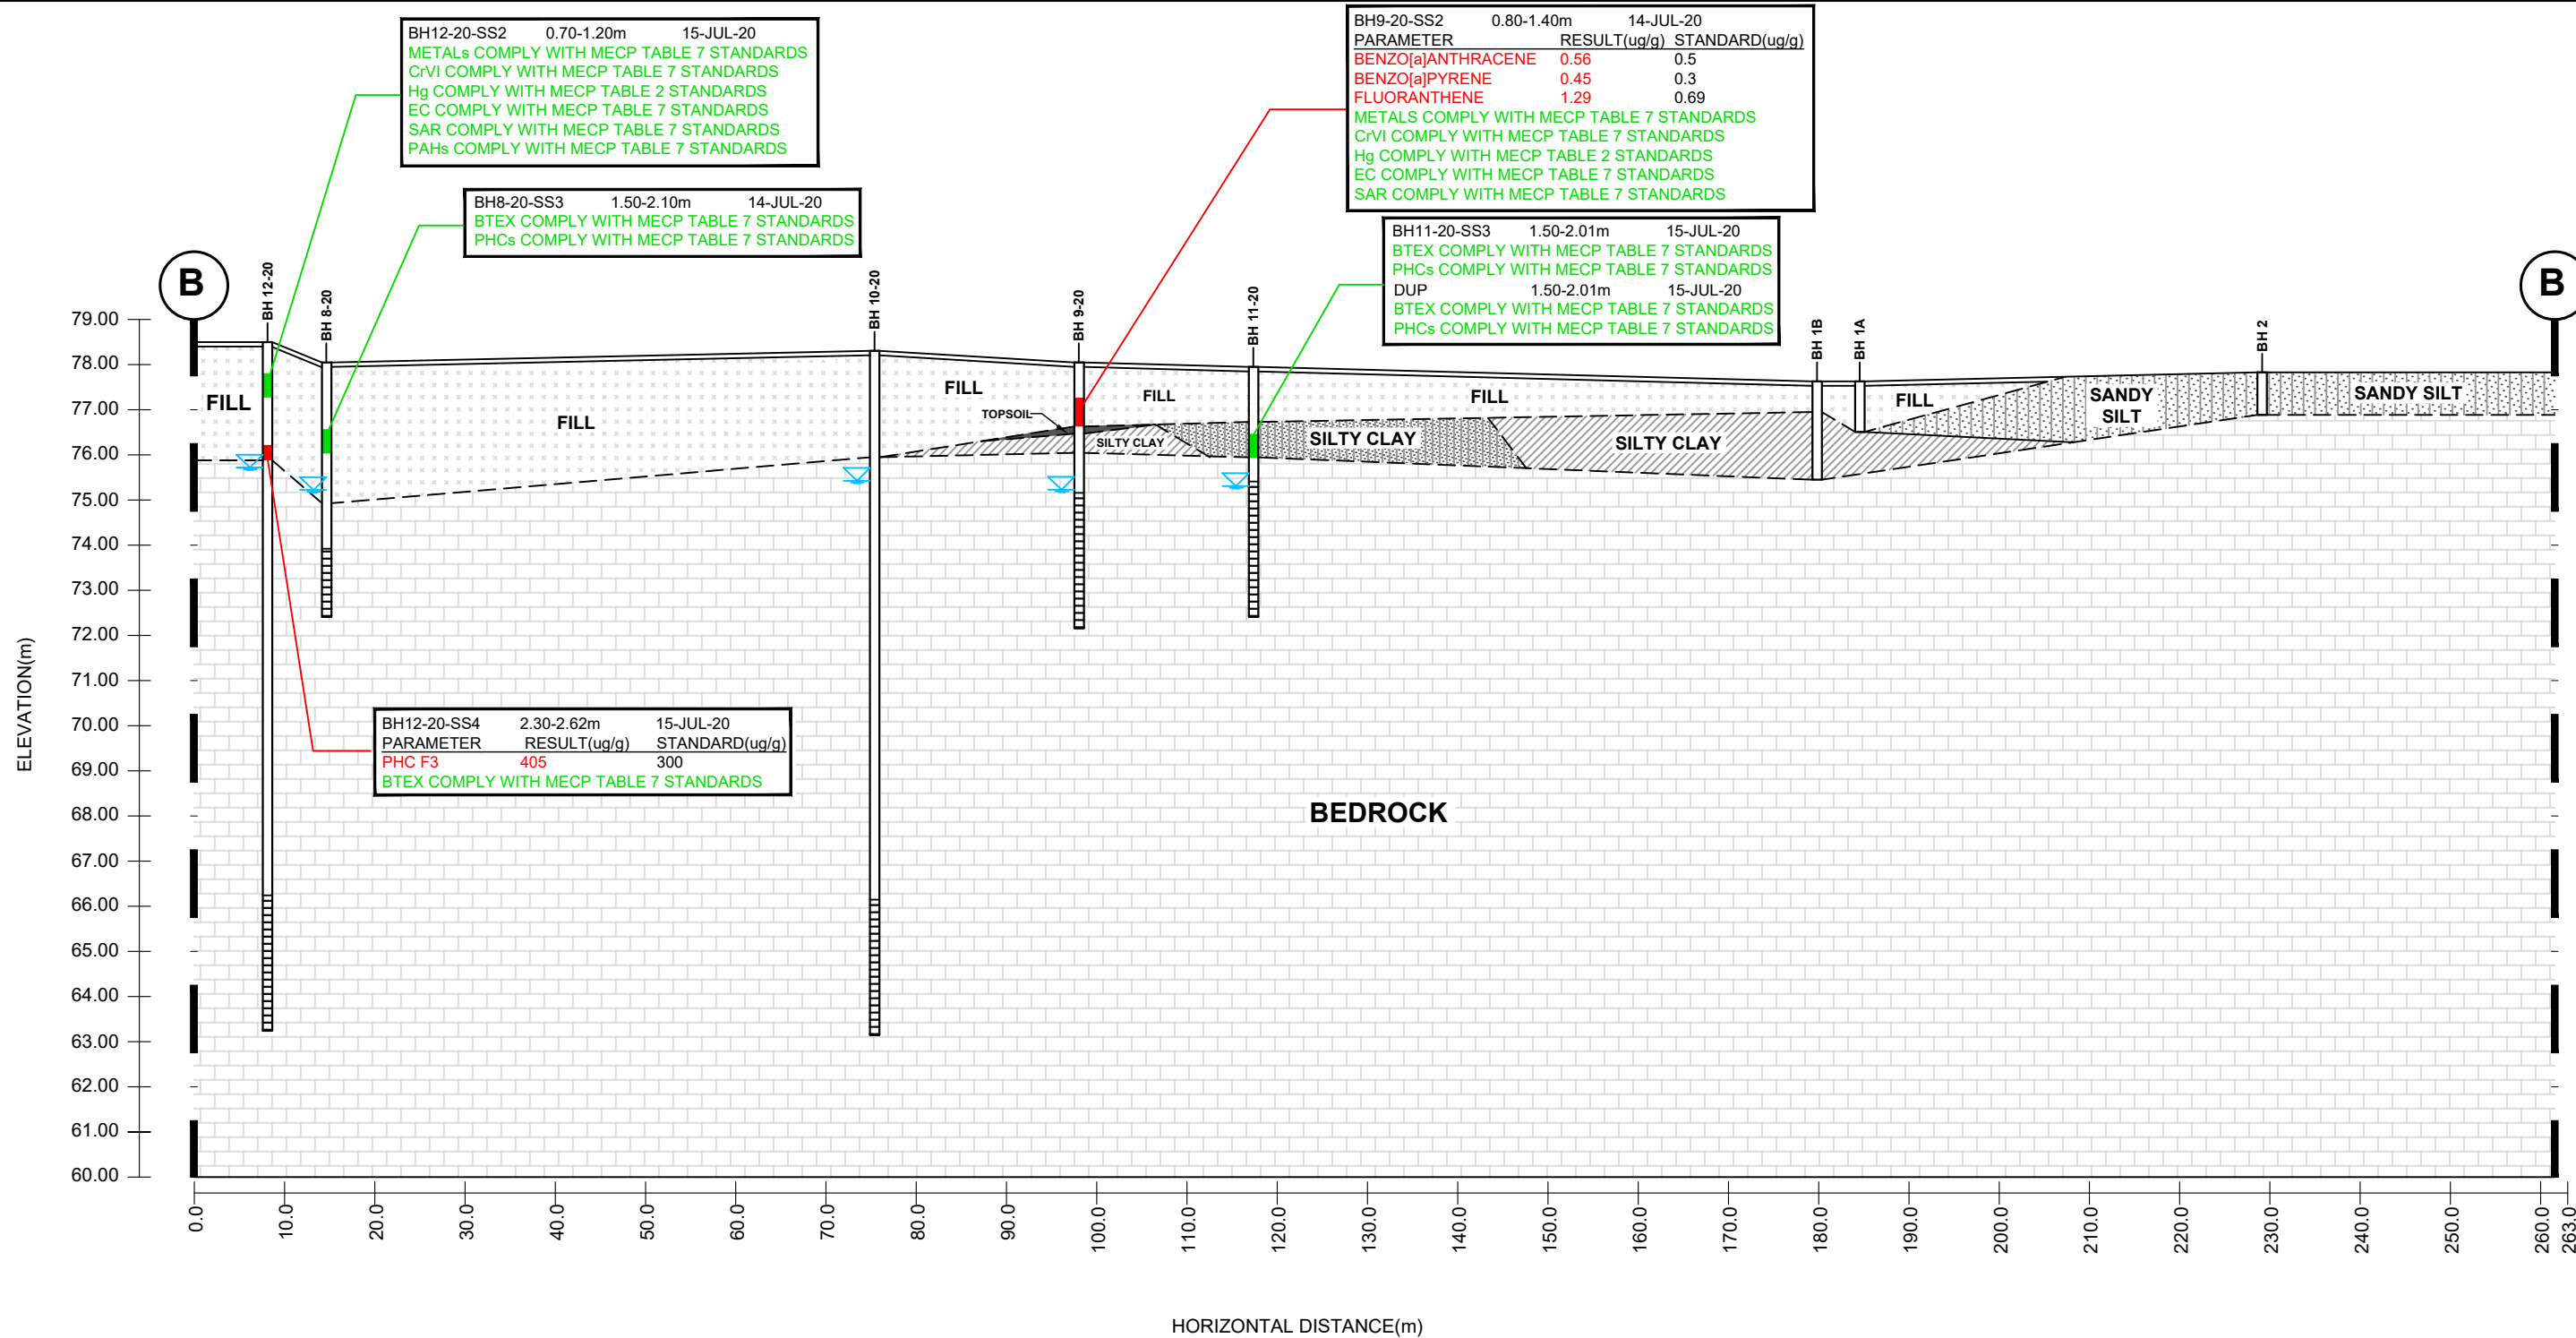
**CROSS SECTION B-B' - SOIL**

SOIL RESULTS COMPLY WITH MECP TABLE 7 STANDARDS

SOIL RESULTS EXCEEDS MECP TABLE 7 STANDARDS

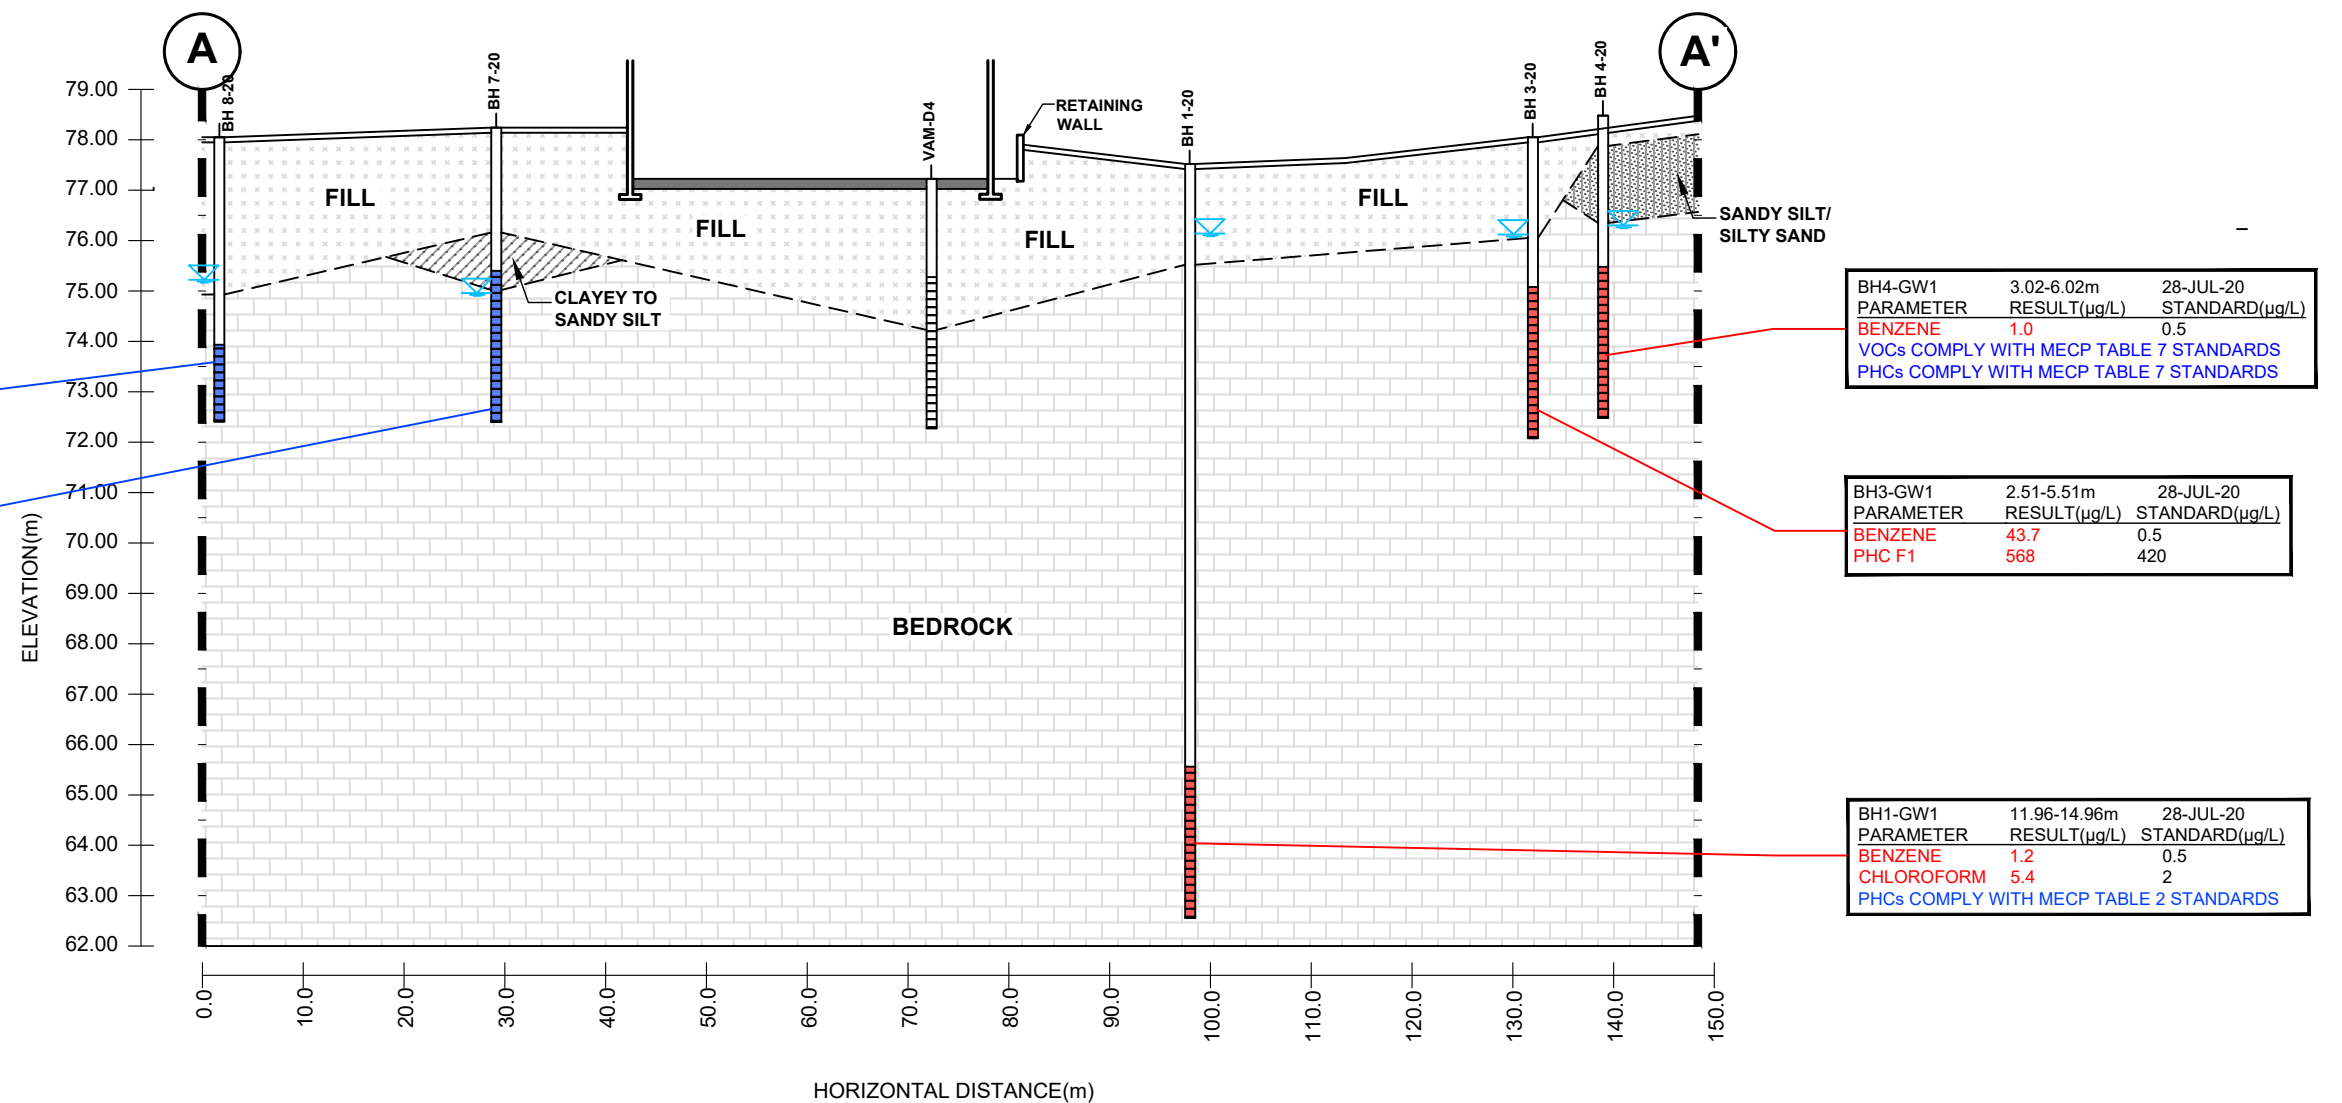
CLARIDGE HOMES PHASE II - ENVIRONMENTAL SITE ASSESSMENT 861 CLYDE AVENUE	
OTTAWA, Title:	ONTARIO
CROSS SECTION A-A' - GROUNDWATER

GROUNDWATER RESULTS COMPLY WITH MECP TABLE 7 STANDARDS

GROUNDWATER RESULTS EXCEEDS MECP TABLE 7 STANDARDS
