Prepared for:
11684663 Canada Inc.

July 27, 2020

Figure 1: Key Plan
 Phase One Environmental Site Assessment
 729 Ridgewood Avenue, Ottawa, Ontario
 11684663 Canada Inc.

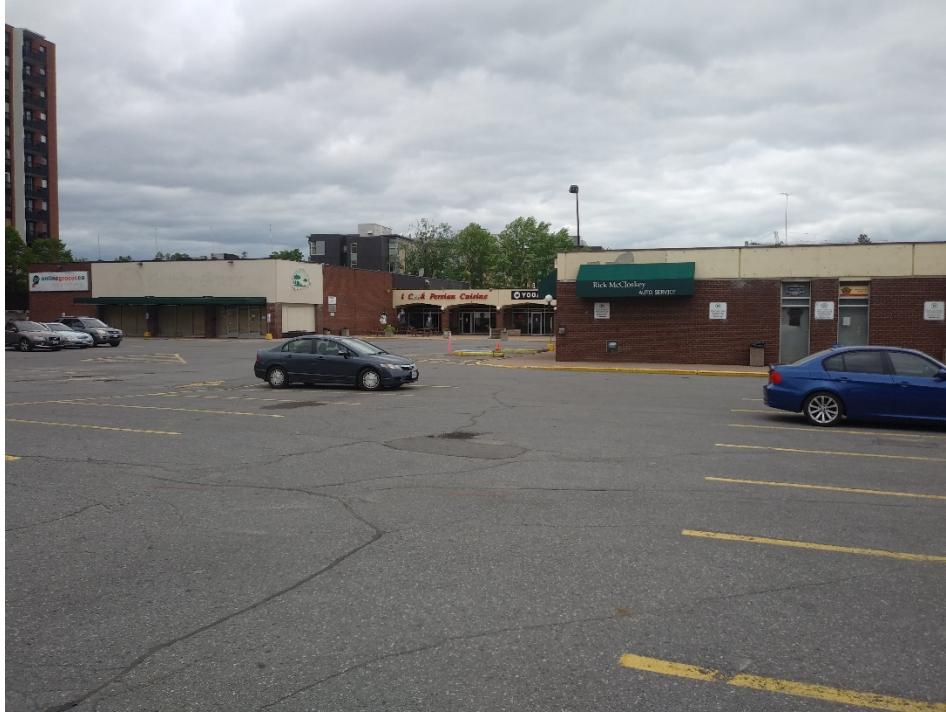
Photograph 1: View of Phase One Property looking north from Ridgewood Drive. View shows the north (right side) and south (left side) commercial buildings at the Property. The automotive service garage is visible in this view.

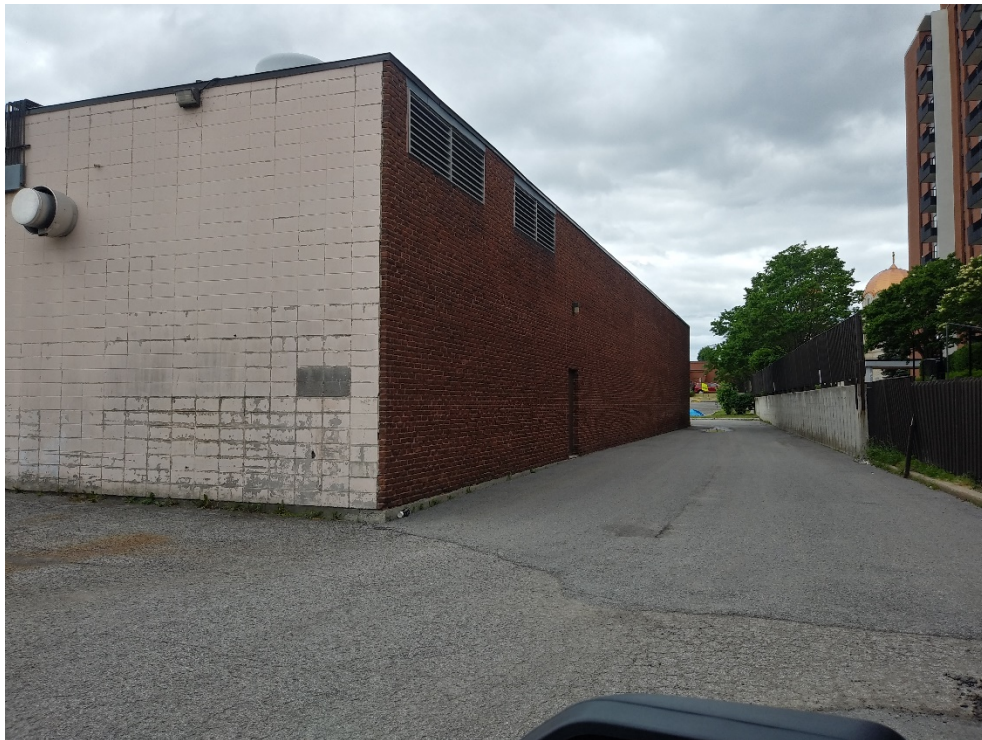
Photograph 4: View of the west side of the Phase One Property looking south. View shows the west side of the north commercial building.

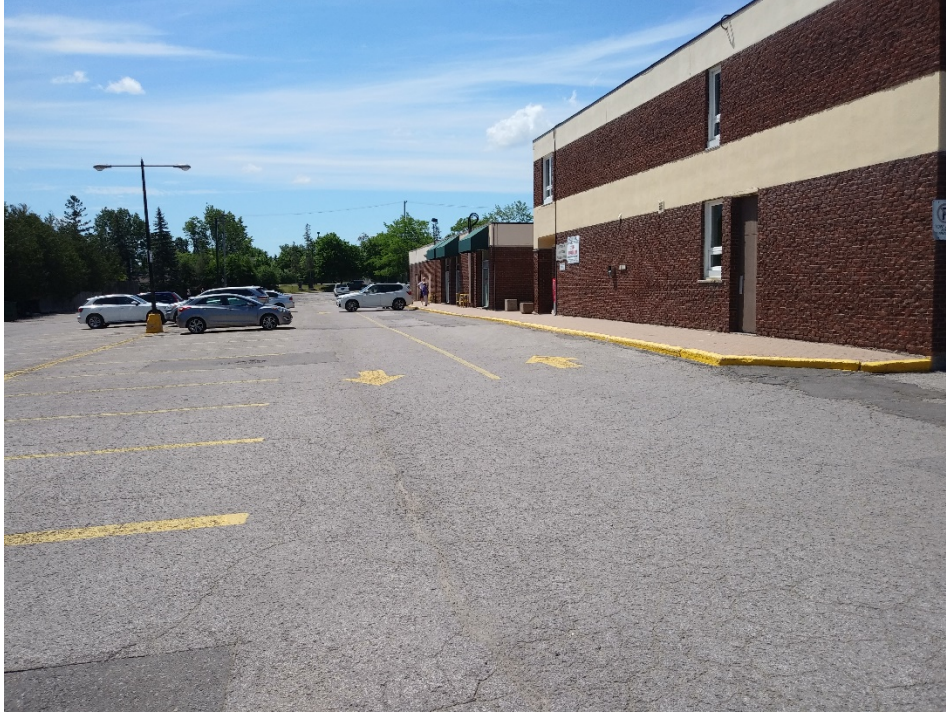
Photograph 5: View of the east side of the Phase One Property looking south. View shows the east sides of the north and south commercial buildings.

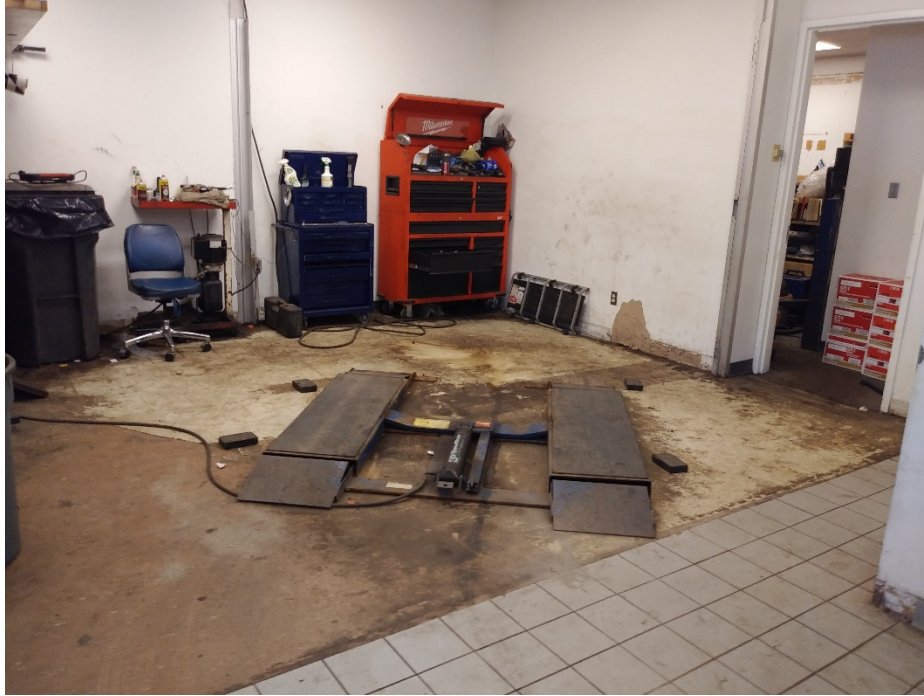
Photograph 7: View of the interior of the automotive service garage in the south unit of the south commercial building. View shows an aboveground hoist and some equipment storage.

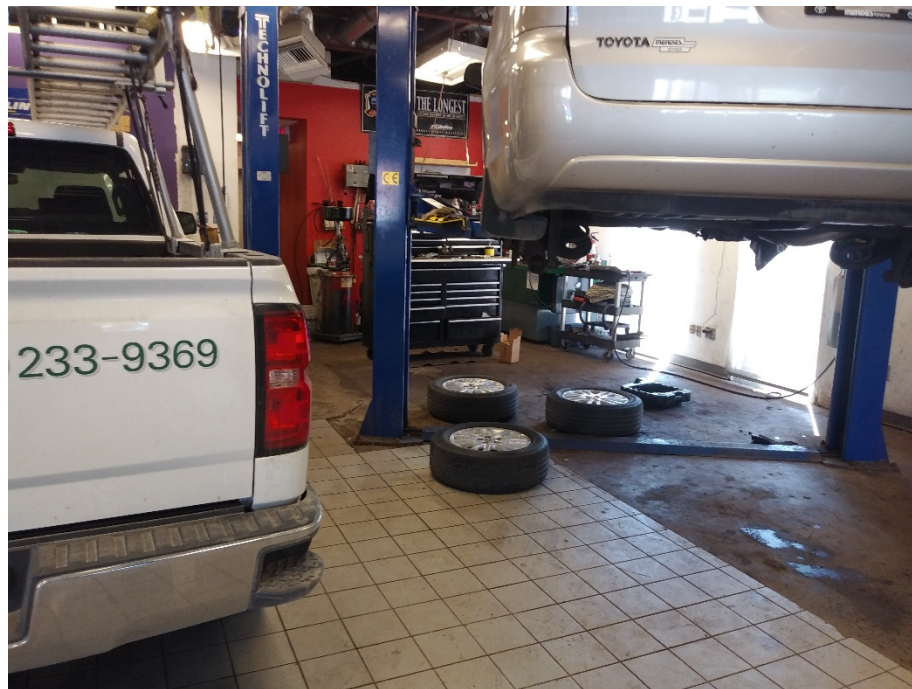
The presence of an active automotive service garage was observed on the central portion of the Phase One Property at the time of the Site Investigation. Although this garage has only been operating for a short time period (2018 to present), these operations are a PCA which represents an APEC for the Property. Based on the observations at this automotive garage, the contaminants of potential concern are considered to be PHCs and BTEXs.

Photograph 8: View of interior of the automotive service garage in the south unit of the south commercial building. View shows two of the aboveground hoists and general operations inside the garage.

Based on the identification of APECs at the Phase One Property, it is recommended that a Phase Two Environmental Site Assessment be completed to assess the soil and/or groundwater quality in the vicinity of the APECs.

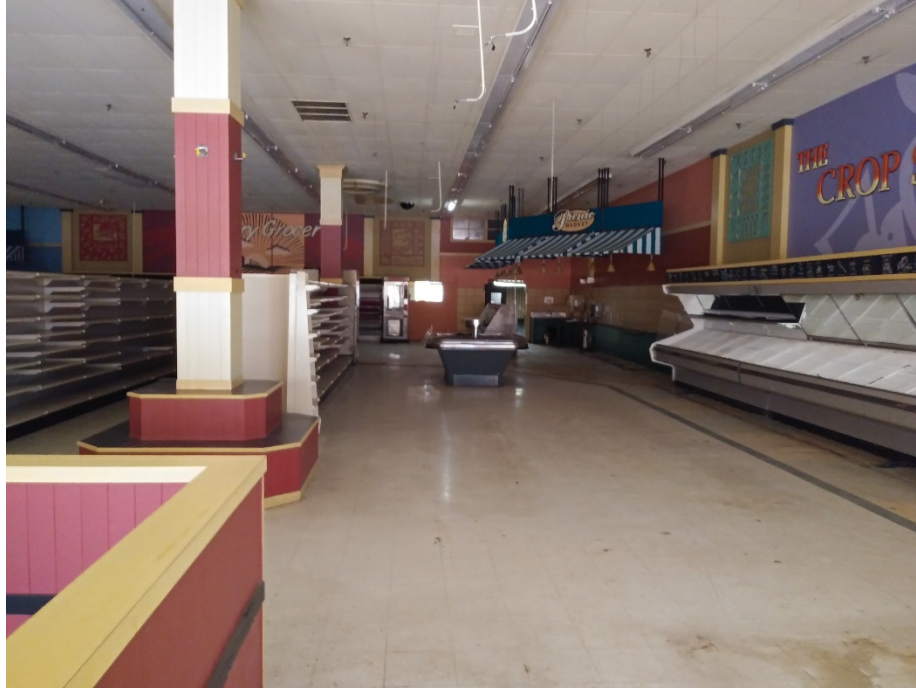
Photograph 11: View of interior of the former grocery store in the northwest portion of the north commercial plaza building.

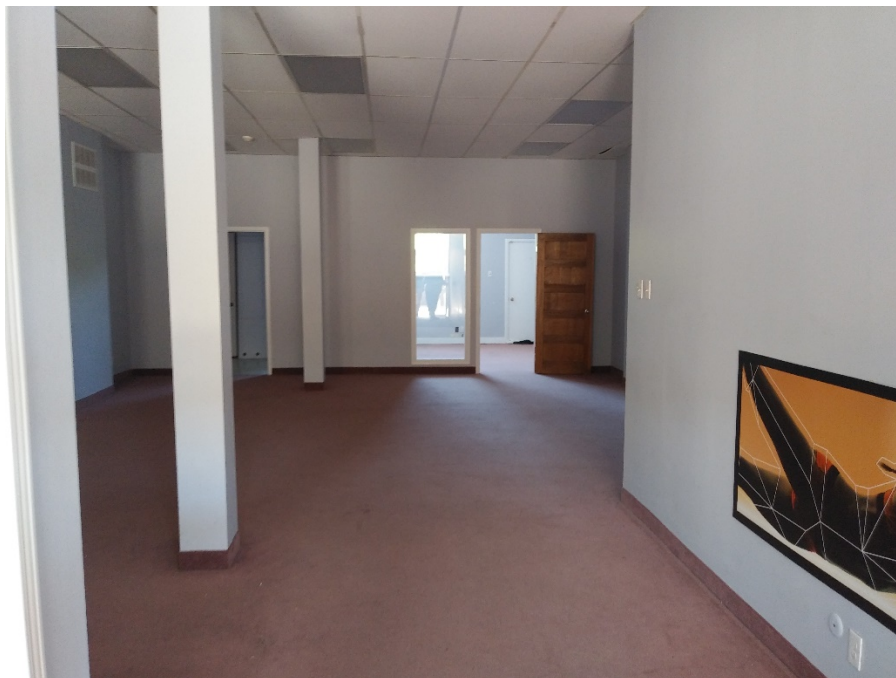
Photograph 12: View of the interior (typical) of one of the commercial units in the north commercial plaza building.
