1186-1194 Wellington Street West, Hintonburg

HERITAGE CONSIDERATIONS REVIEW

WELLDAL LIMITED PARTNERSHIP
JUNE 25, 2021 100% SUBMISSION

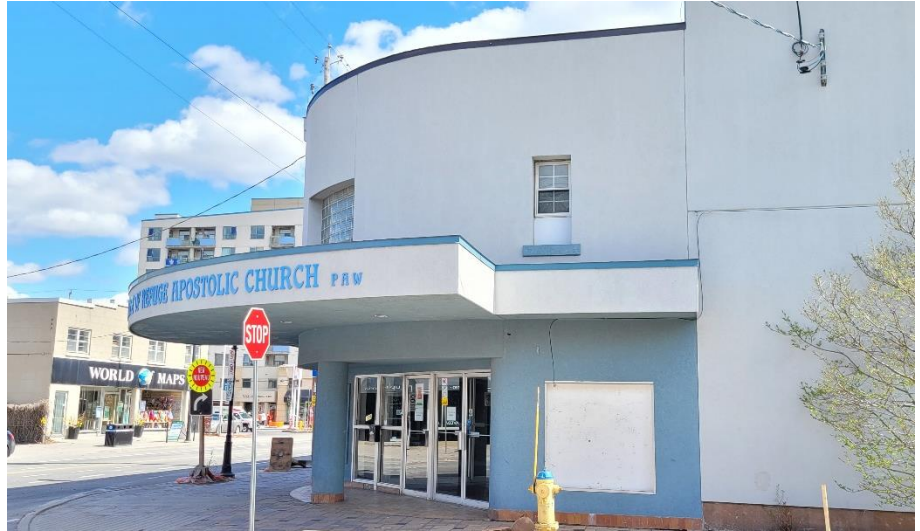
- 2 Cornerstone House of Refuge Apostolic Church, former Elmdale Theatre, corner of Wellington St W and Hamilton Avenue North. MTBA.

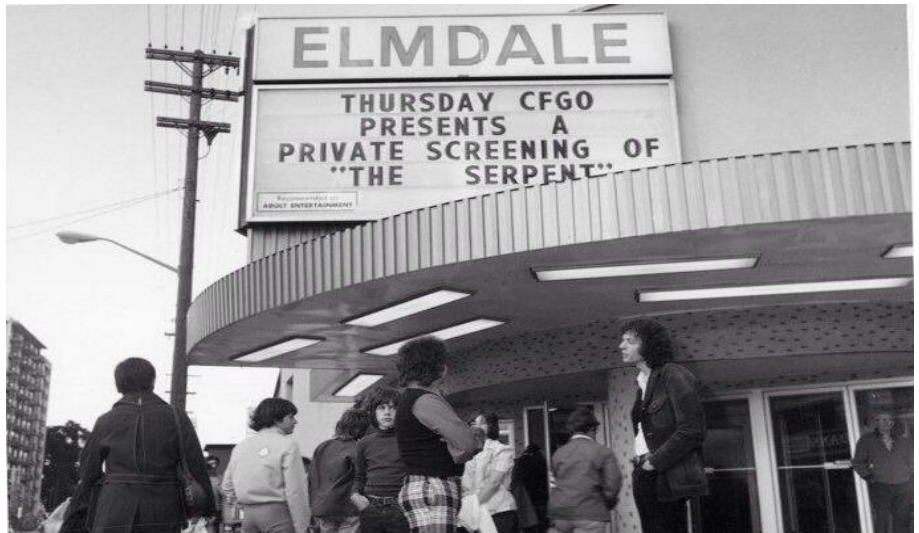
20 Elmdale Theatre c. 1973, showing early renovations that removed the original heritage fabric. *Flickr.*

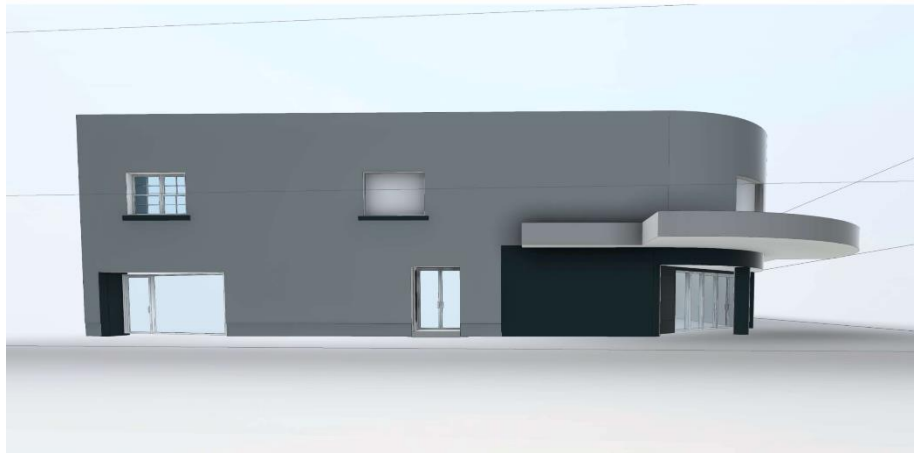
- 24 Photo capture of 3D Building Information Model (BIM) of the property, Wellington elevation. *If/Then Architecture Inc.*

As part of the site investigations of heritage assets, MTBA retained subconsultants If/Then Inc, to scan the existing conditions of the site. Using 3D laser scanning technology, If/Then provided MTBA with point clouds and a 3D model. This process allows for an accurate recording of ‘as-is’ condition of the property and its heritage assets.

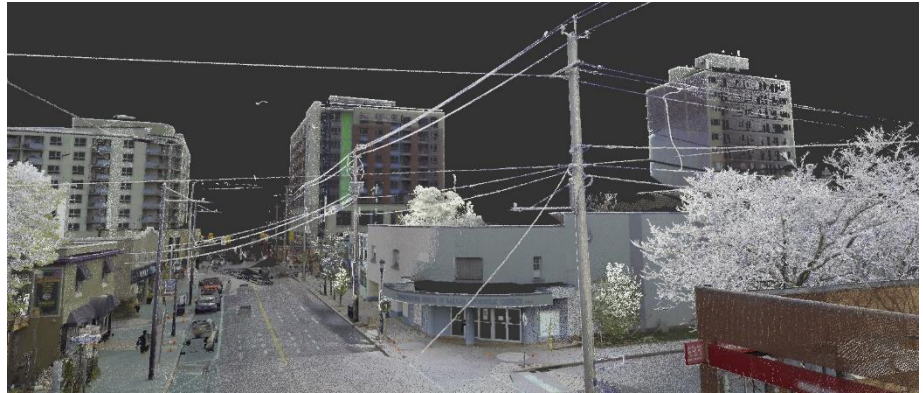
- 1 3D Scan of site looking east along Wellington St W. *If/Then Architecture Inc.*

As part of the site investigations of heritage assets, MTBA retained subconsultants If/Then Inc, to scan the existing conditions of the site. If/Then provided MTBA with point clouds and a 3D BIM (Building Information Model) model using 3D laser scanning technology. Laser scanning allows for an accurate recording of 'as-is' conditions of the property and its heritage assets. The scans then generate point clouds of information that can be used as a baseline for the creation of a BIM model.

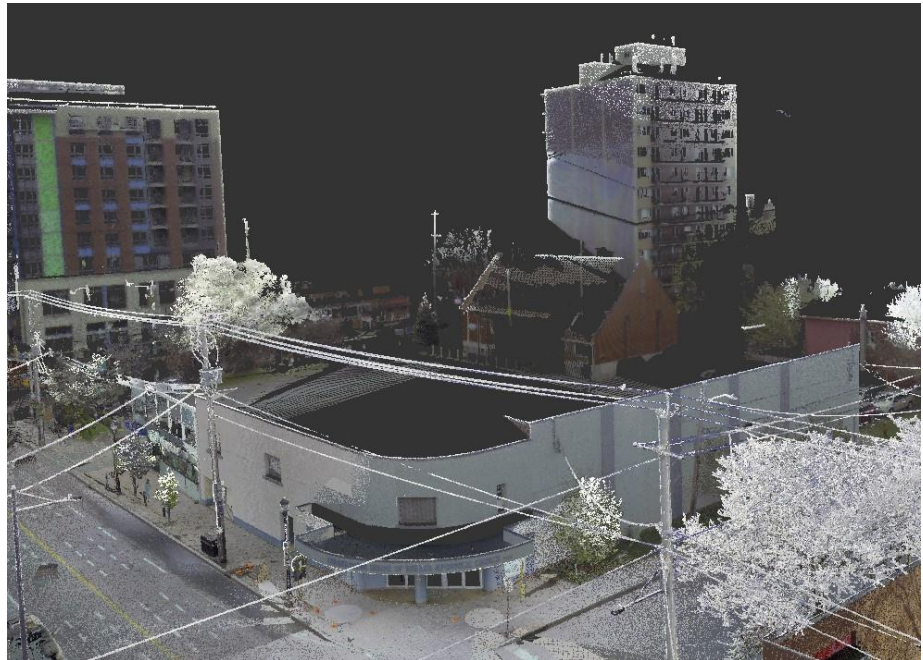
- 2 3D Scan of site looking southeast at corner of Wellington St W and Hamilton Ave N. *If/Then Architecture Inc.*

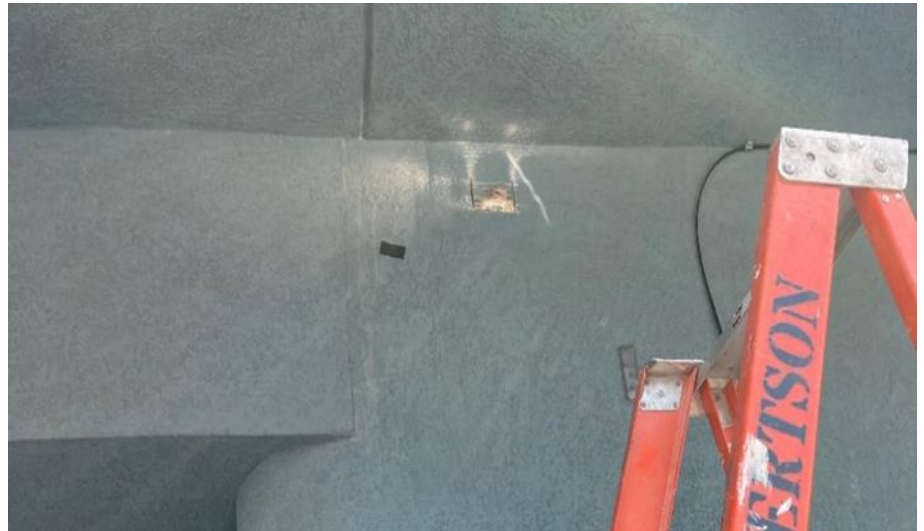
5 Canopy Fascia Upper Wall (Investigation 4 & 5): Location of Opening.

4/5	Investigative opening of Upper Wall to determine if hard polished finish, or vitrolite remains behind parging. Investigative opening done in one section to limit the amount of damage to existing parging and post investigation repair. Upper Wall, central portion examined. No original fabric observed.	5, 6	May 11, 2021
6	Investigative opening done on Column to determine if any original hard polished finish, or vitrolite remains behind parging. Small opening made in existing parging revealed tiles under parging layer. Opening in tile, revealed concrete backing and no original granite. Tile part of previous renovation work. No original fabric observed.	7, 8	May 11, 2021
7	Similar investigative purpose as investigation 6, Lower Wall at base was examined to determine if hard polished "Vitrolite" wall cladding remains behind parging, under Southwest Signage Board. Wood framing was revealed, no remaining scalloped or fluted wall material observed. Additionally, no original fabric observed from Southwest Signage Board (Investigation 8).	9, 10	May 11, 2021

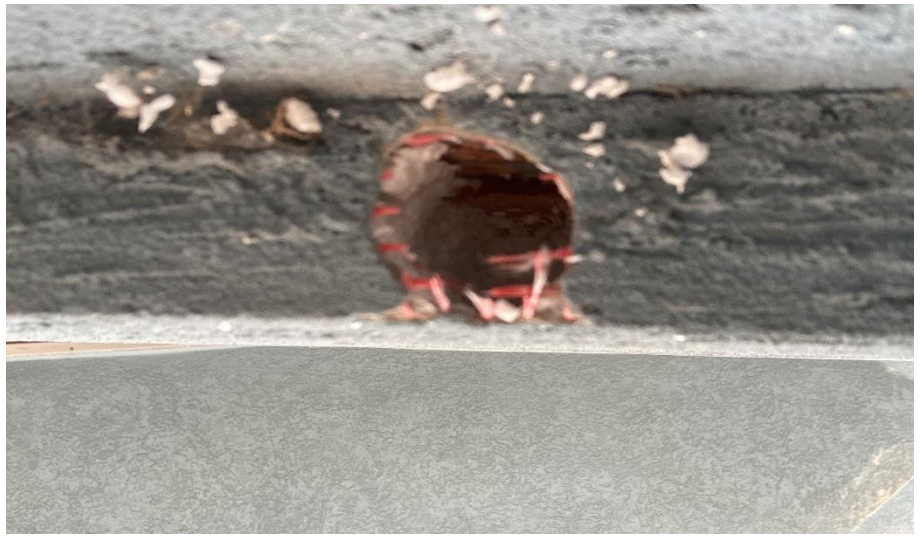
- 13 Former Ticket Booth
(Investigation 9): Removal of
parging revealed mesh and
Styrofoam with wood board.

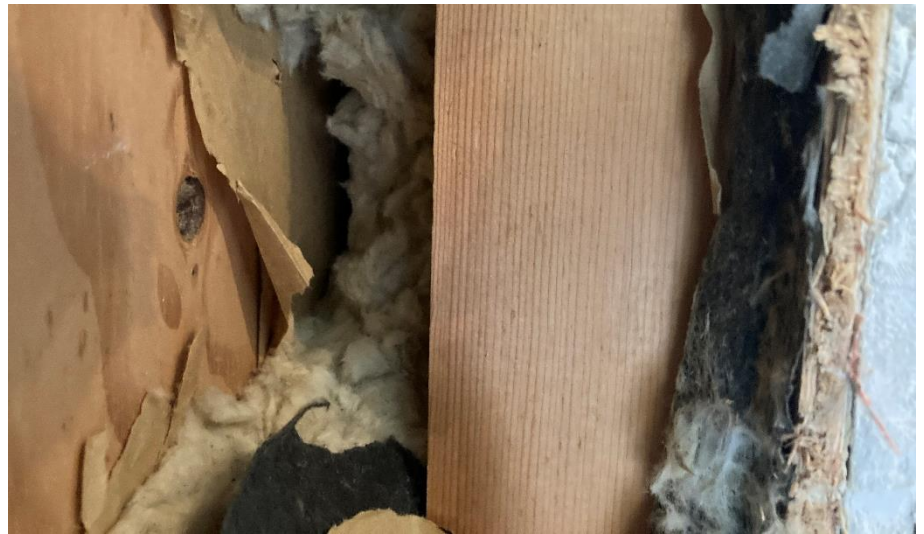
- 17 Former Ticket Booth Interior (Investigation 9): Wood framing examined. No original material found.

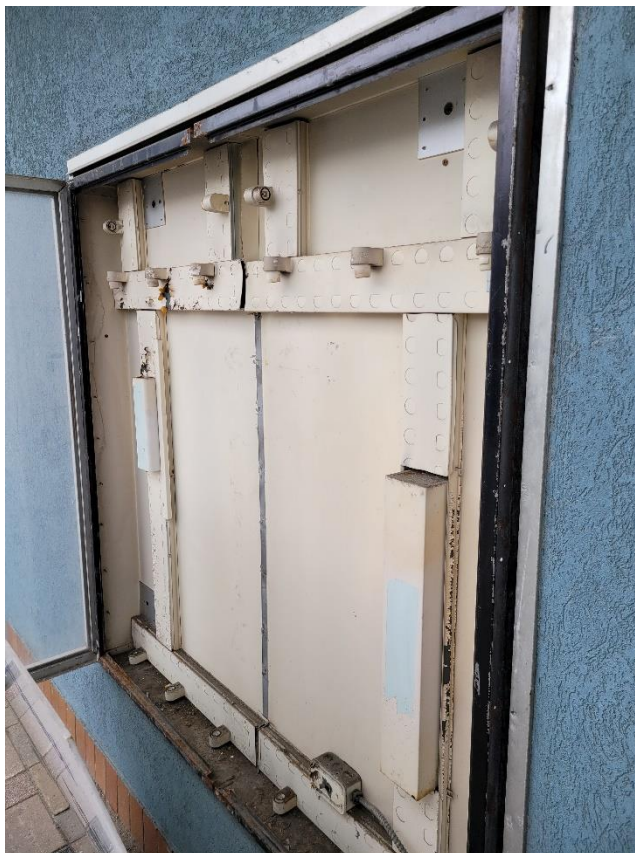
- 18 Eastern Signage Board
(Investigation 10): Investigation
10): Remaining original fabric
limited to lighting.

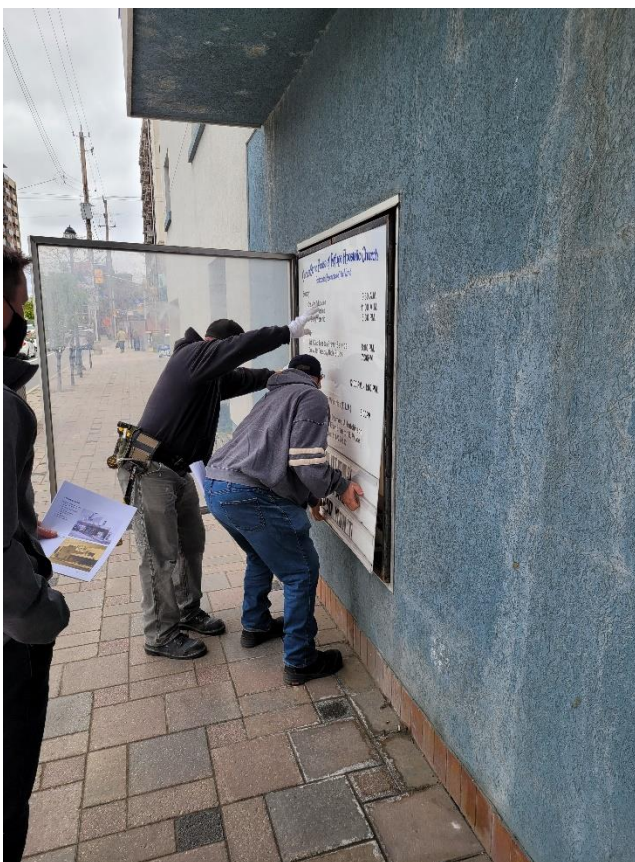
- 19 Eastern Signage Board
(Investigation 10): Removal of
existing signage to investigate if
original fabric including lighting
fixtures, the metal, expressive
hardware and polished finish
remain.
