## **Phase I-Environmental Site Assessment**

1400 Bank Street  
Ottawa, Ontario

Report: PE4632-2

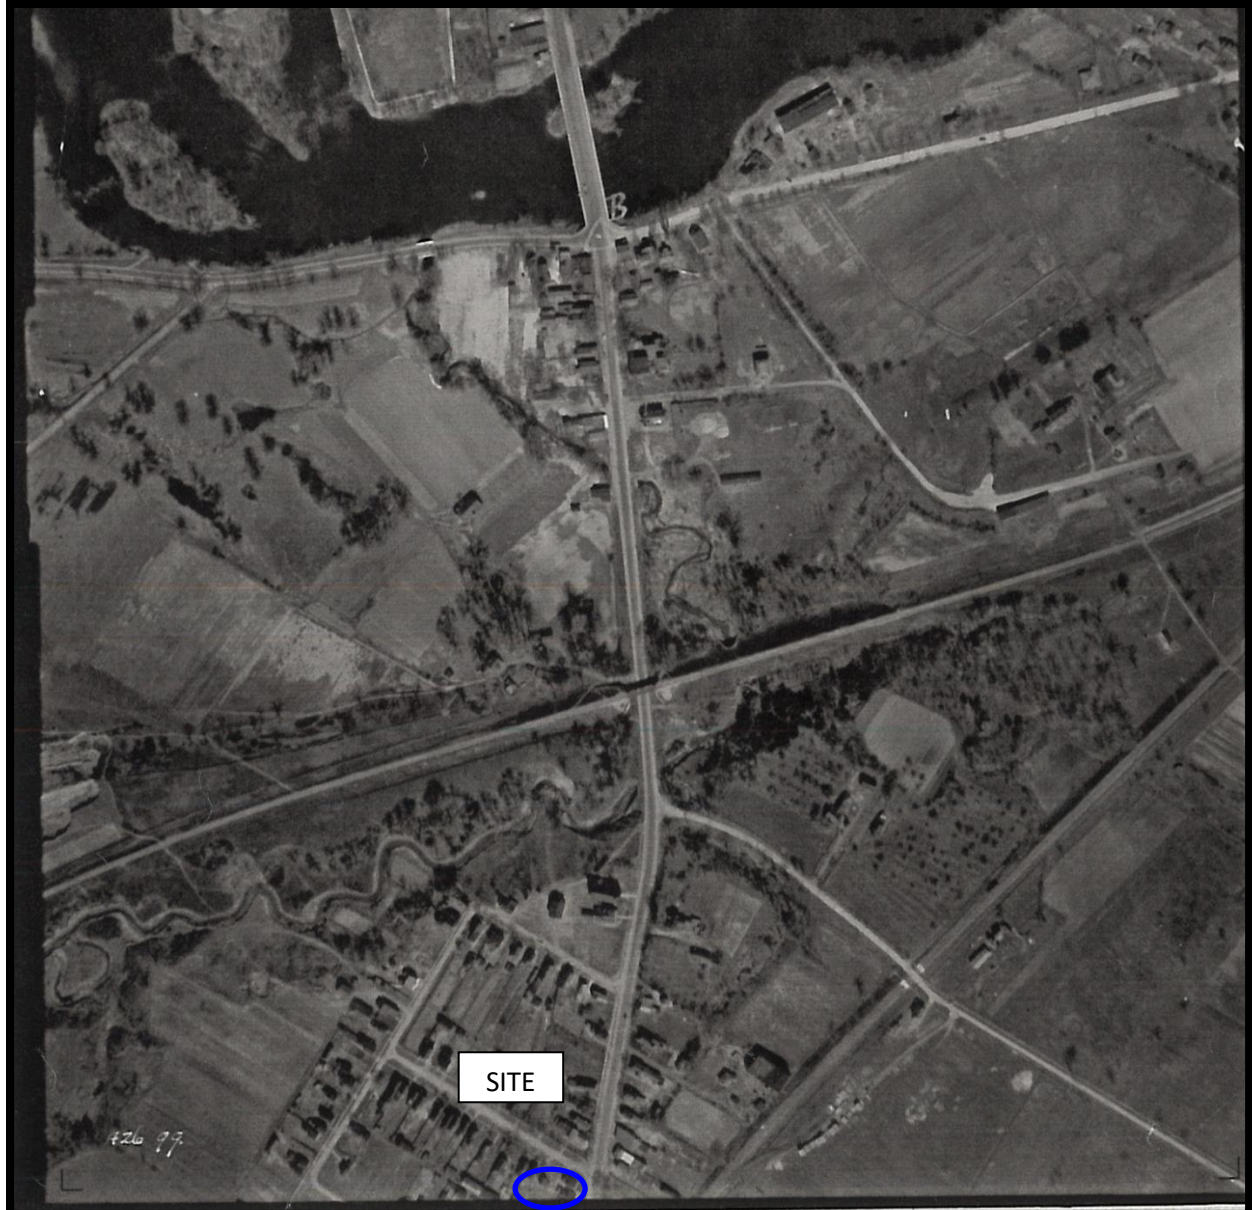
AERIAL PHOTOGRAPH  
1928

| <b>Table 1: Land Use History – 1400 Bank Street<br/>Part Lots 50, 51, 52 and part Alley, Plan 149, Parts 3 and 4 on 4R3367<br/>(PIN: 04147-0007)</b> | | | | |
|---|---|---|---|---|
| 1916-1928 | Estate of Moise Lemire | Residential dwelling | Residential use | 1928 aerial photograph shows a residential style building on-site. |

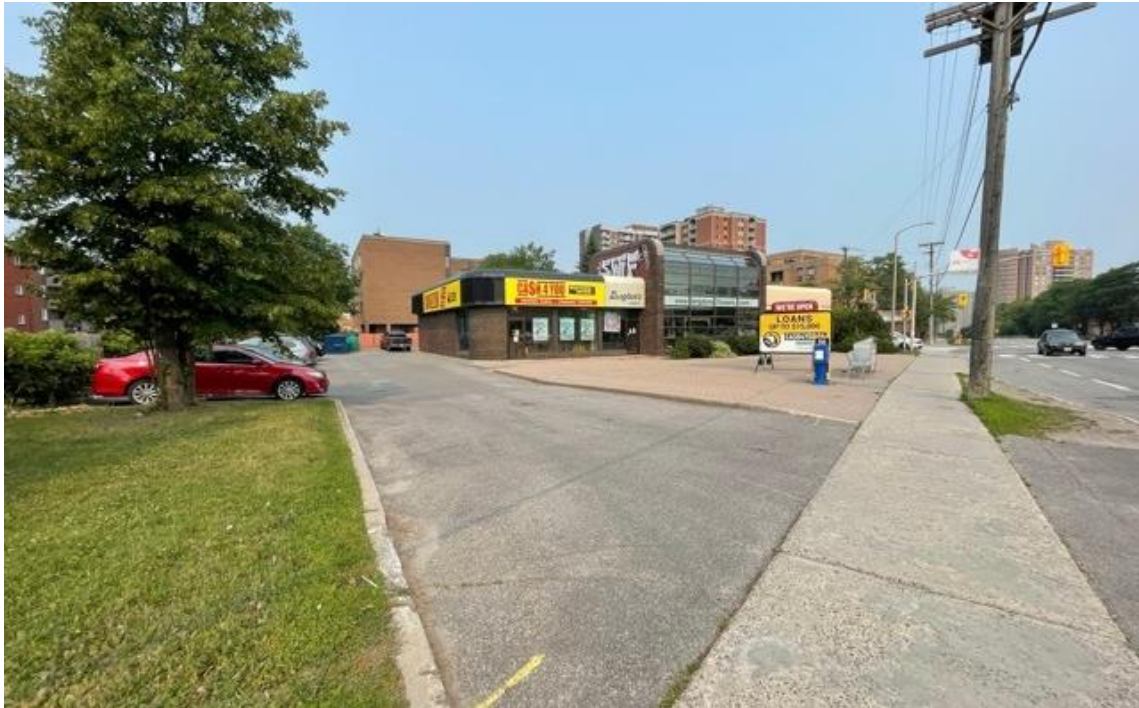
Photograph 1: View of the southeastern and eastern portions of the Phase I Property. Photograph taken from Bank Street, looking north.

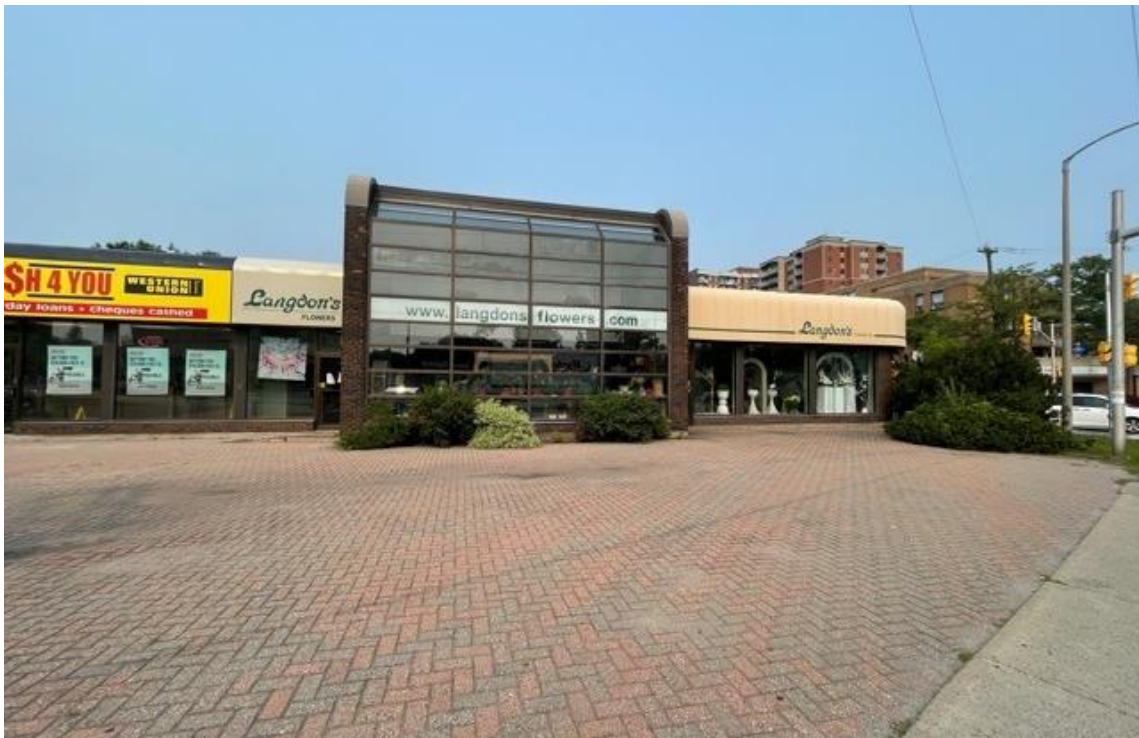
Photograph 2: View of the store fronts of the subject building . Photograph taken looking northwest.

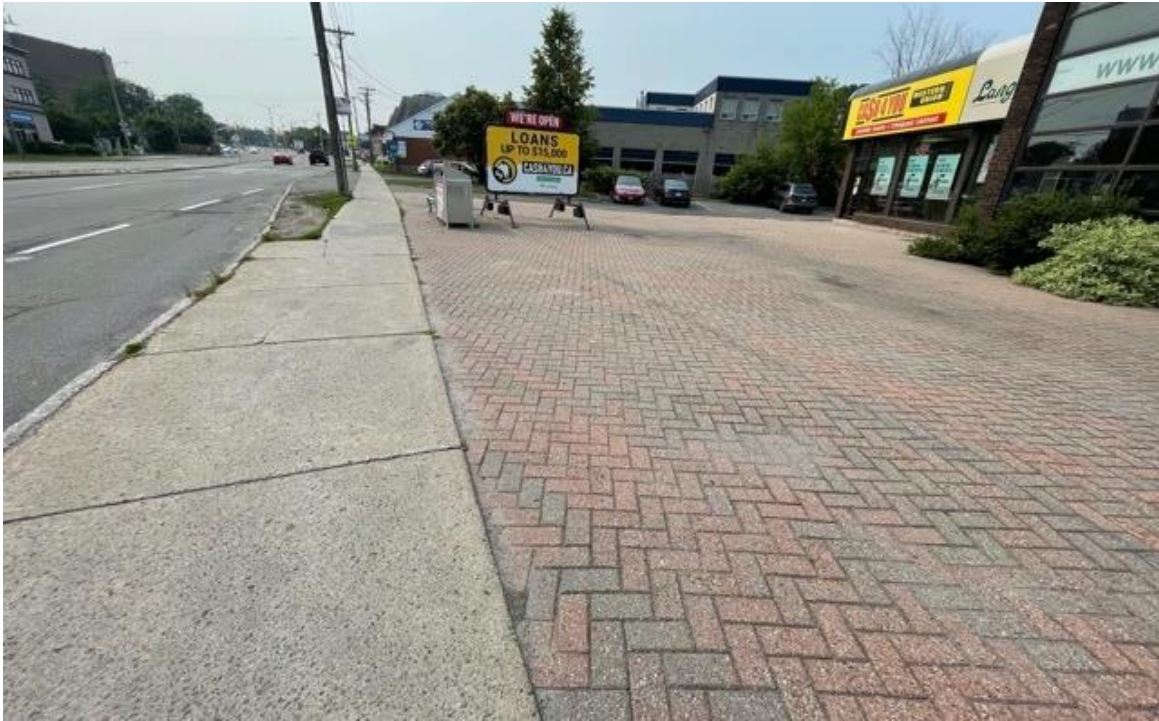
Photograph 3: View of the eastern half of the Phase I Property. Photograph taken looking south.

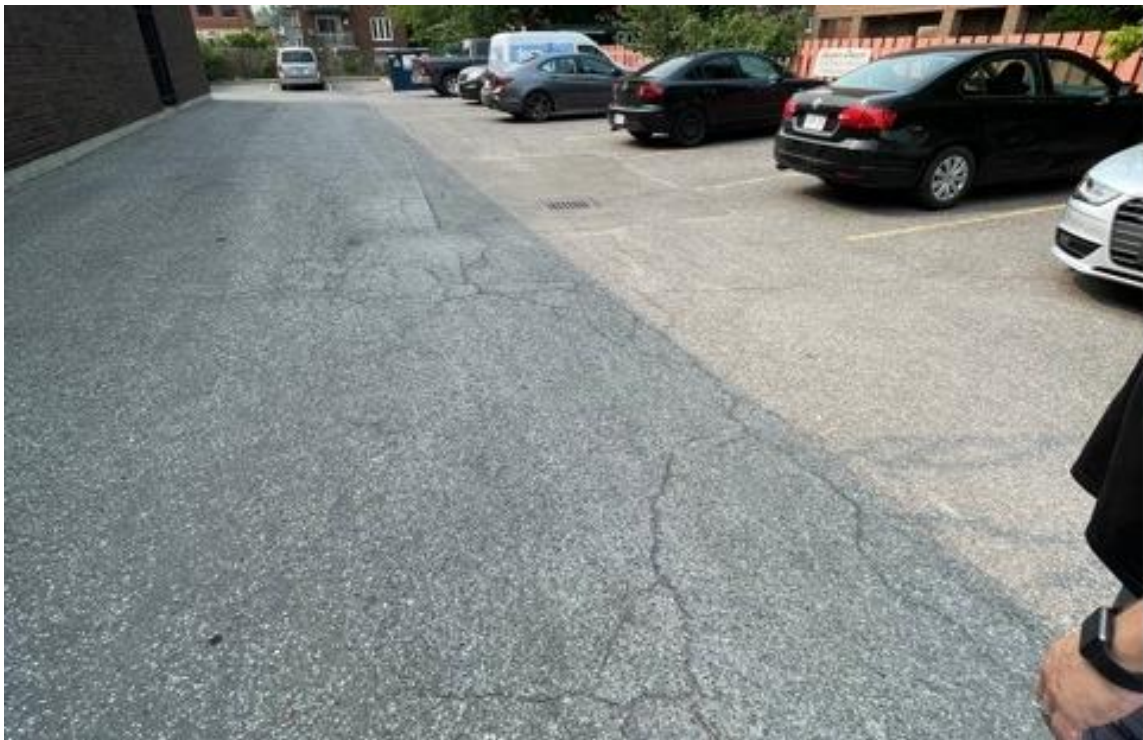
Photograph 4: View of the \western half of the Phase I Property. Photograph taken looking south.
