Environmental Impact Statement

Proposed Site Redevelopment – Stillwater Station,
1987 Robertson Road, Ottawa, Ontario

CIMA+ file number: A001177- 080
29 March 2023 – Review 03

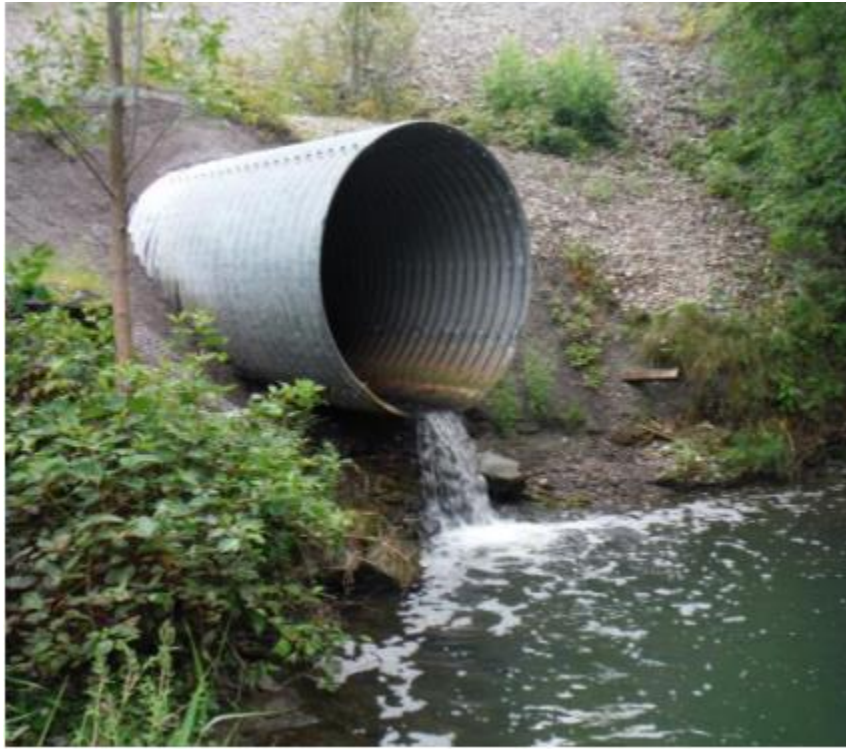
Photo 2: Perched culvert that conveys flow of Stillwater Creek under the Beachburg railway (RVCA, 2015)

The RVCA's City Steam Watch Stillwater Creek 2015 Summary Report notes the known locations of migratory obstructions within the watershed because these features can prevent fish from accessing important spawning and rearing habitat. Fish migration is currently being impacted by the perched culvert identified on the main channel of the creek at the tributary east of Moodie Drive at the Beachburg railway. Refer to **Photo 2** below to view the perched culvert directly north of the Study Area.

Stillwater Creek flows north through a narrow channel within the Study Area. Surface drainage is managed by a large CSP culvert that extends under the abandoned railway. The water was slow moving and clear at the time of the Site visit, and no aquatic vegetation was observed within the channel. There were no visible signs of bank erosion along the Stillwater Creek both north and south of the railway however erosion was observed at points along the western side of the valley associated with stormwater runoff channels from parking lots, etc. Passage through the culvert running under the abandoned rail line was unobstructed; however, the culvert running under the active Beachburg Rail line to the north of the Site was observed to be perched on its north side by approximately 1 meter which presents a major barrier to upstream passage (Refer to **Figure 1** above).

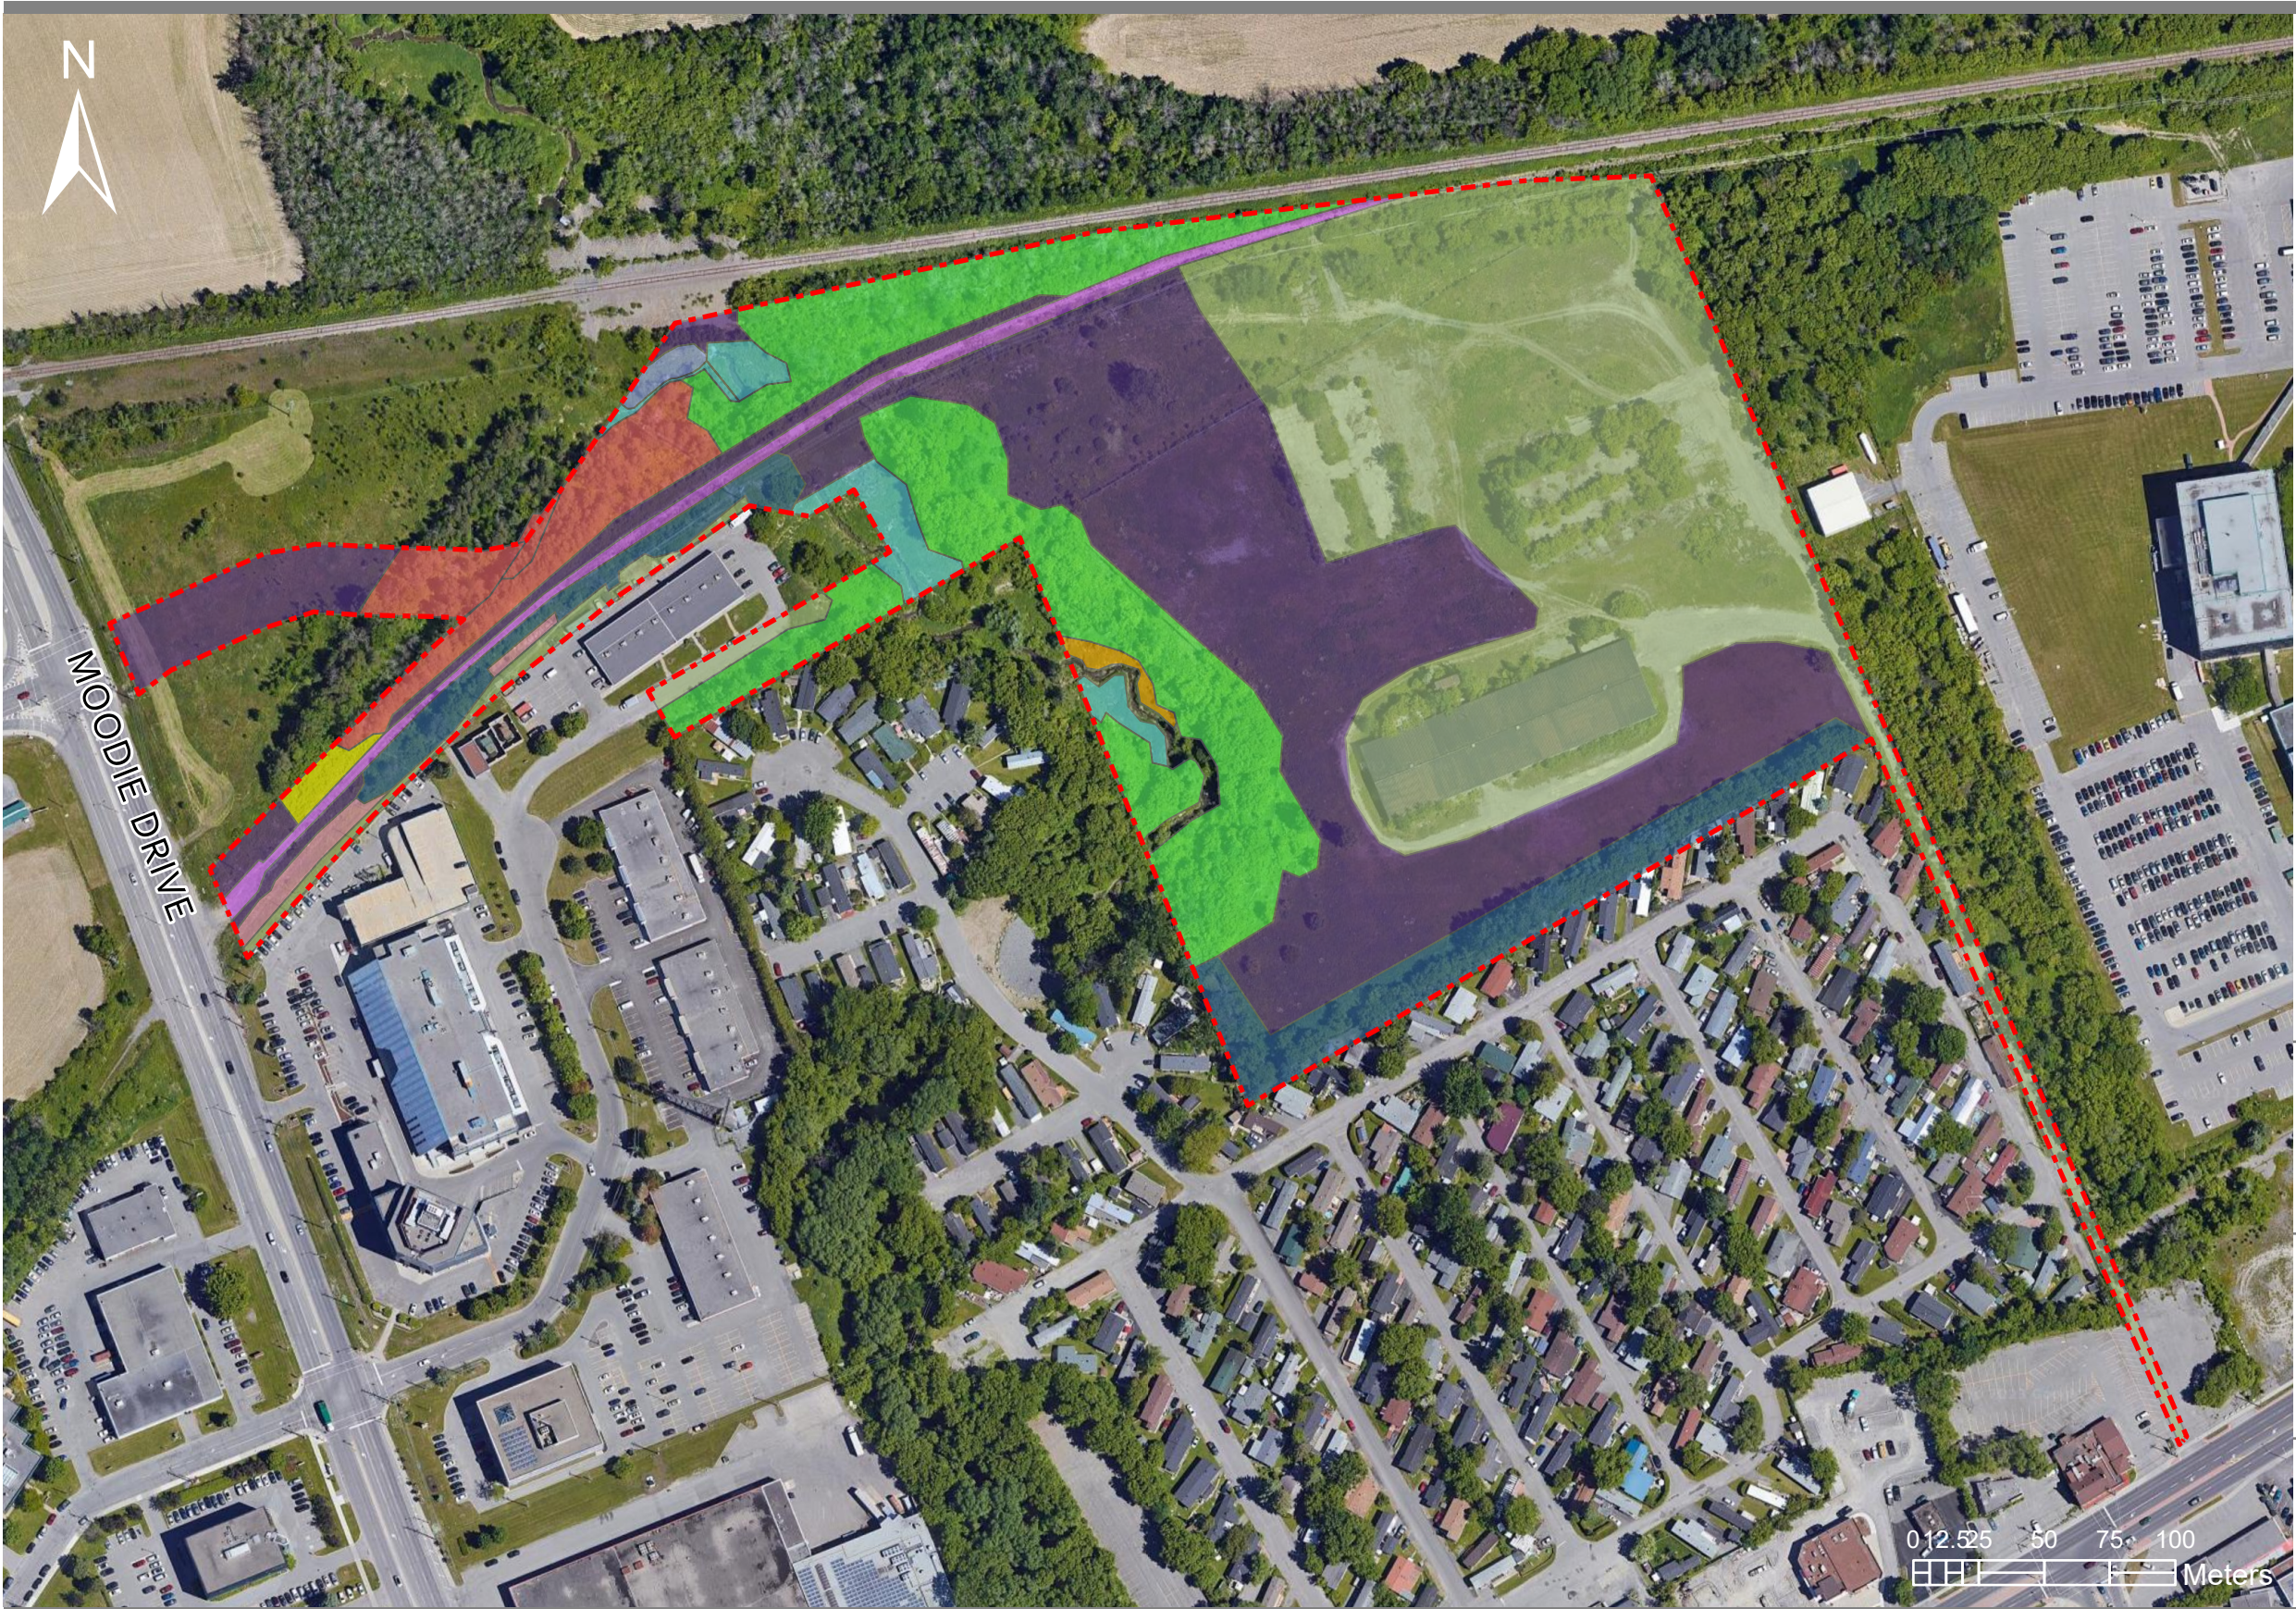
ELC Communities

Eleven (11) ELC community classes were identified within the Site. A summary of community class findings is outlined in **Table 3**, and the locations of the various vegetation communities present within the Site are outlined in **Appendix A – Figure 5**. No rare vegetation species or SAR plants were observed within the Study Area. Refer to **Appendix E** for the full vascular plant inventory and **Appendix F** for a photographic log of the ELC communities on Site.

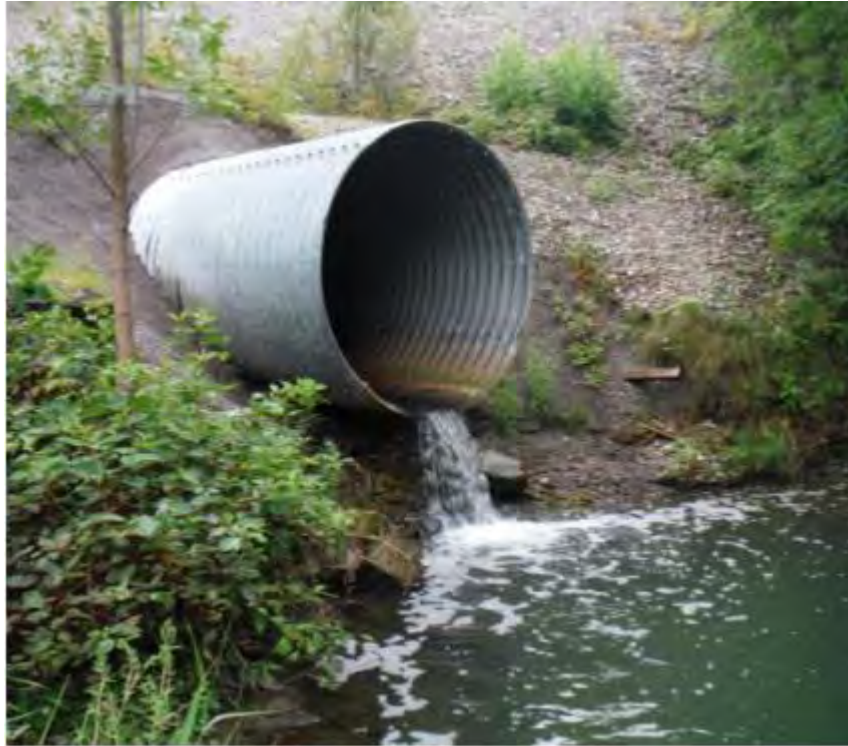
Figure 1: Photo of perched culvert that conveys flow of Stillwater Creek under the Beachburg Rail line (RVCA, 2015)

It is assumed that the perched culvert directly north of the CN rail line likely poses migratory obstructions for any turtles attempting to move upstream (Figure 1). In addition, the large CSP culvert that extends under the abandoned railway is over 40 m long. Based on the *Best Management Practices for Mitigating the Effects of Roads on Amphibian and Reptile SAR in Ontario* (MNRF, 2016), the recommended tunnel length for adequate SAR amphibian and reptile passage is less than 25 m. Therefore, it is assumed that SAR turtle passage through this structure is unlikely.

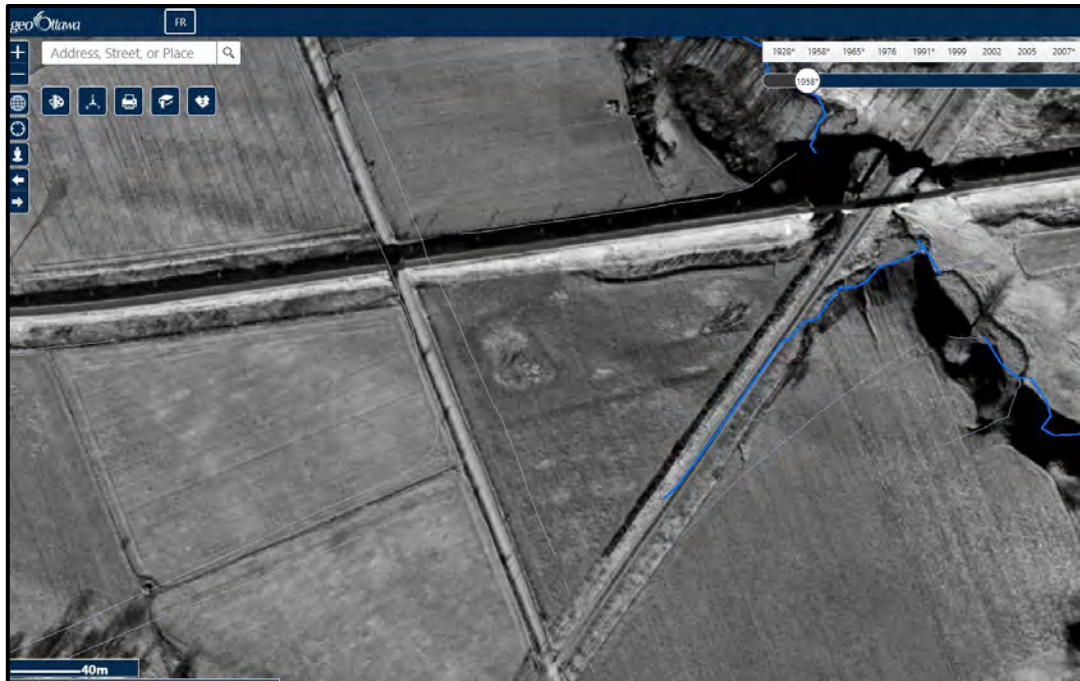
Figure 3: GeoOttawa 1958 image of the project area with conifers planted along the northwest side of the rail.

A review of historic aerial imagery (geoOttawa, 1958 – 2019) was completed to understand the evolution of the site in relation to the wetland feature currently mapped as 'swamp'. The earliest imagery of the site was recorded in 1958 which displays the active Beachburg rail spur lined with planted conifers on the northwest side (i.e. Scots Pine, Figure 3). By 1976, the conifers have matured and appear to have established on the southeast side of the now abandoned rail spur (Figure 4). The image generated in 2007 exhibits a mature Scots Pine plantation both northwest and southeast of the abandoned rail spur (Figure 5).

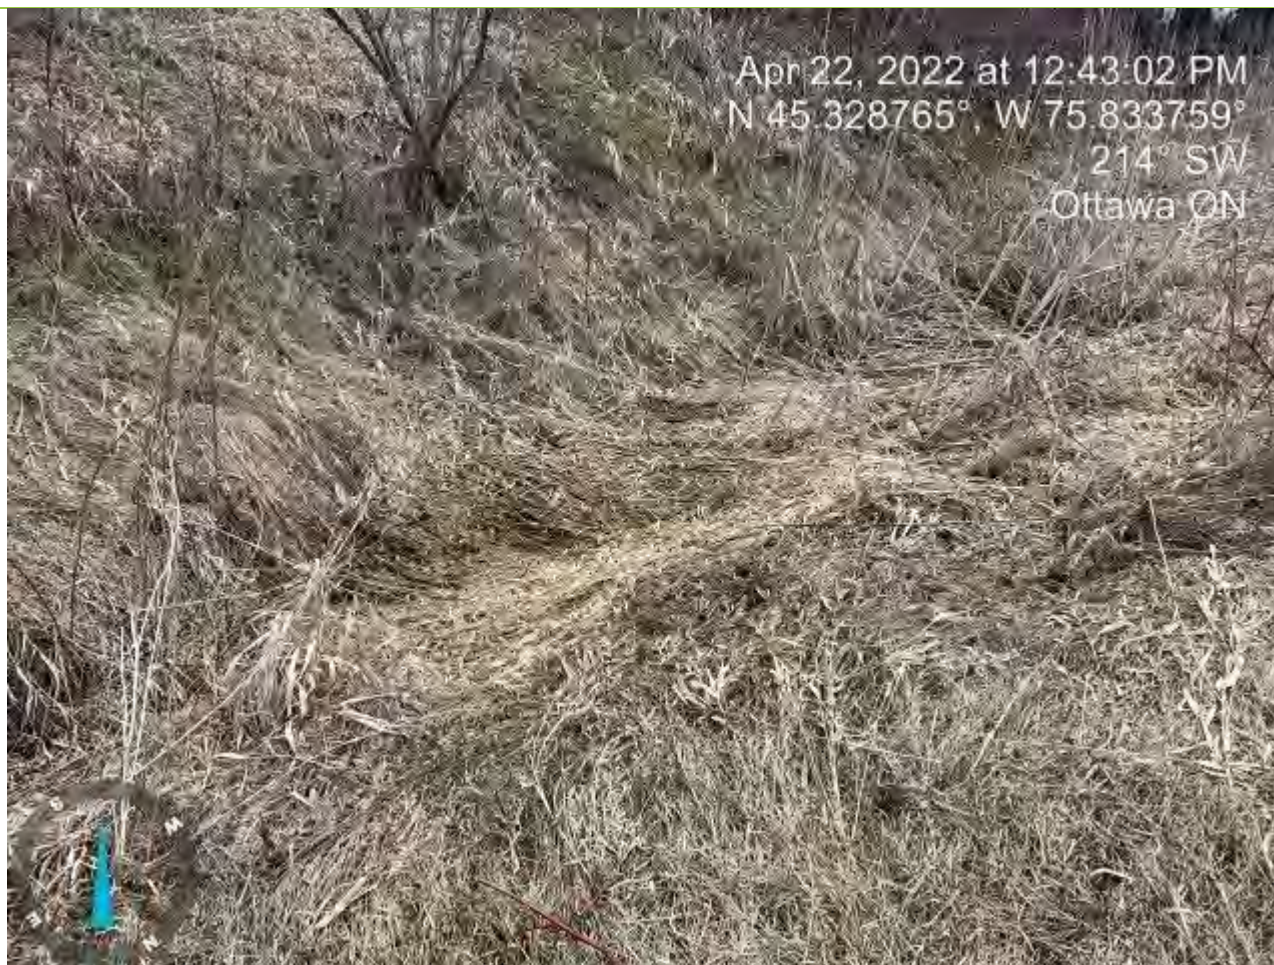
View of the Mixed Meadow
ecosite along the abandoned
railway off Moodie Drive during
the 2021 field investigations.

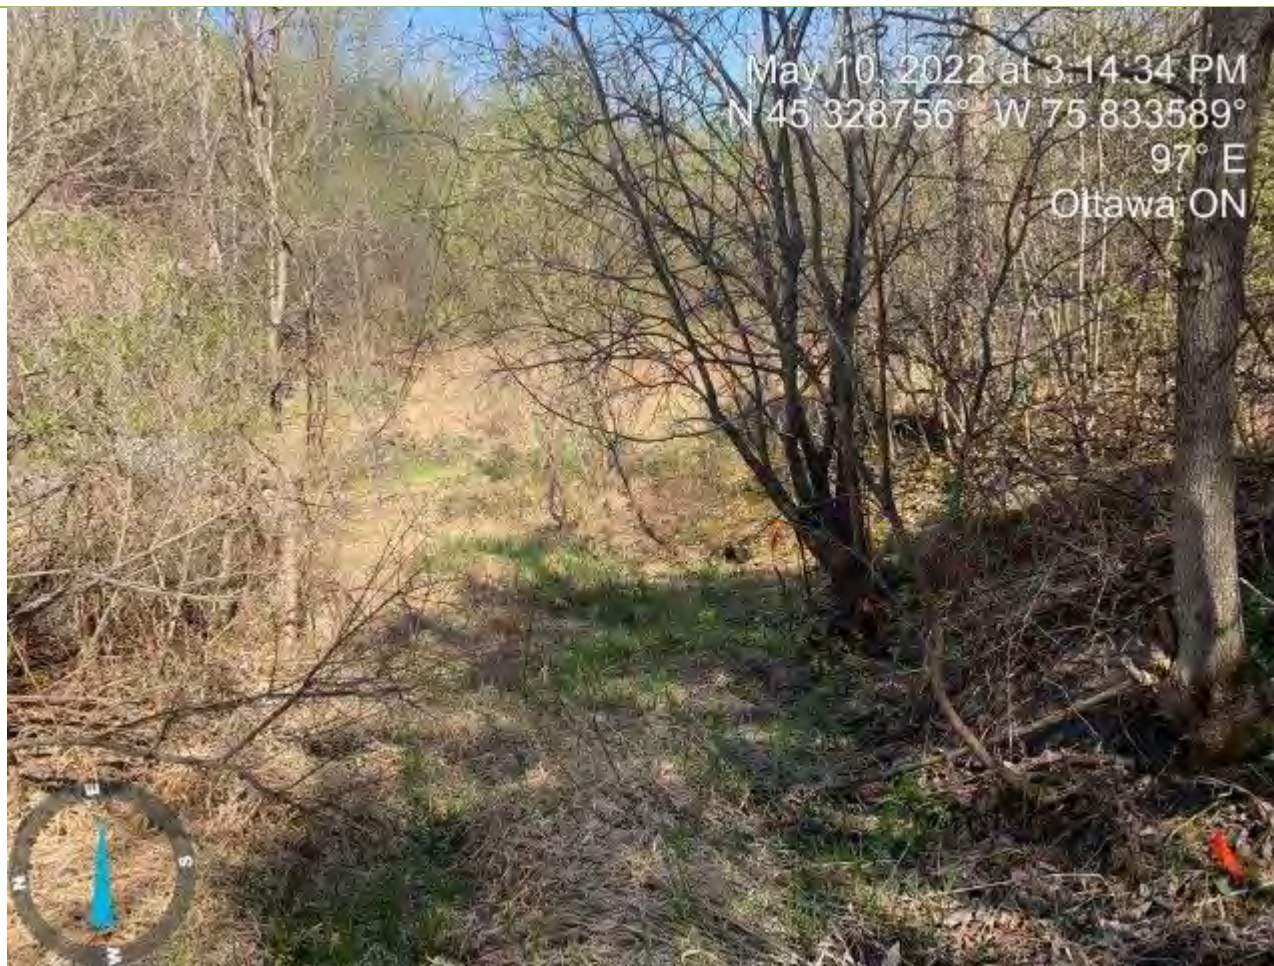
View of the culvert outlet along the eastern extent of the wetland boundary during the 2022 assessment.

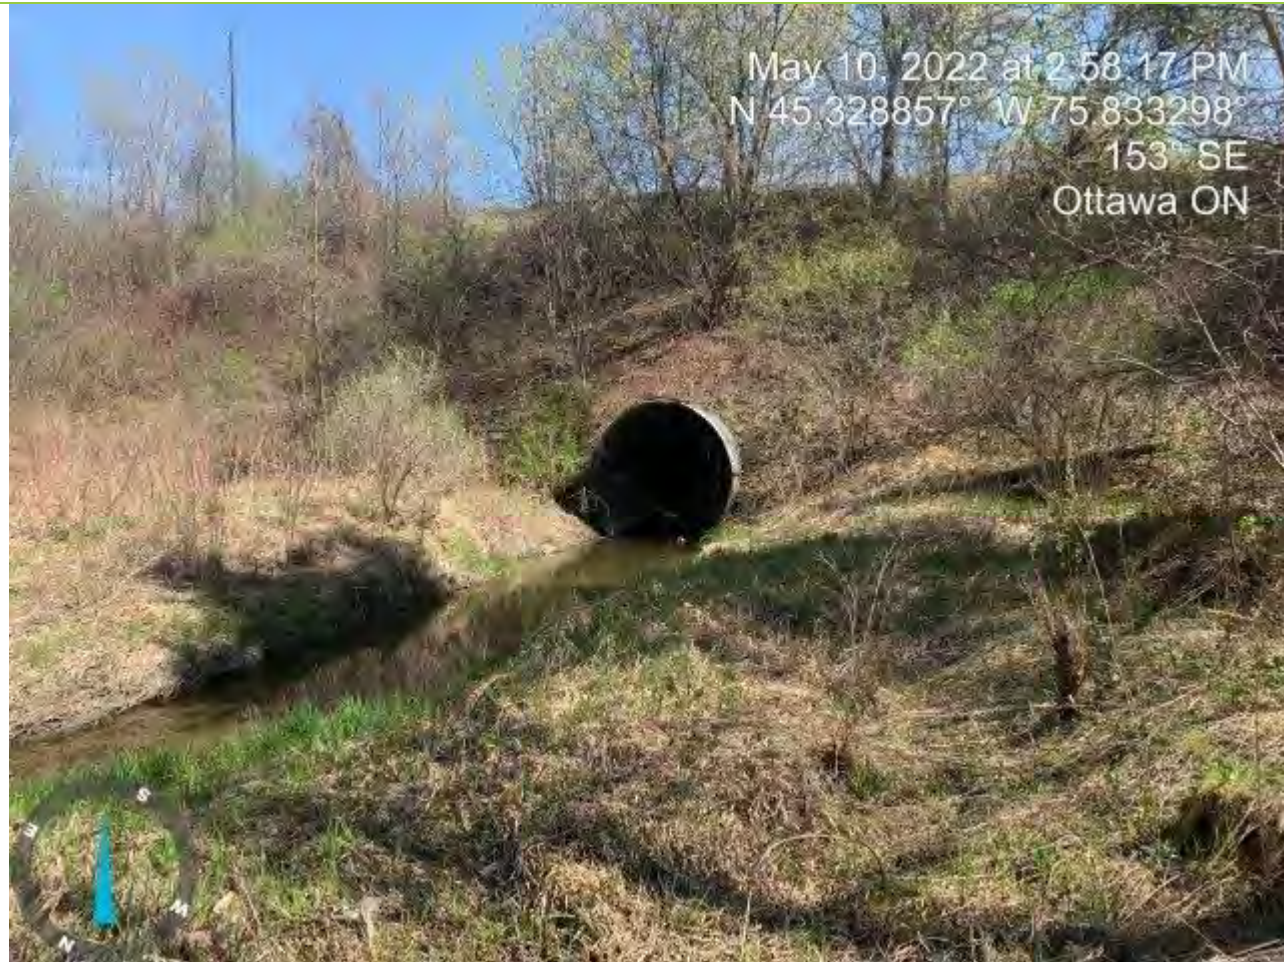
View of the culvert inlet along the eastern extent of the wetland boundary during the 2022 assessment.

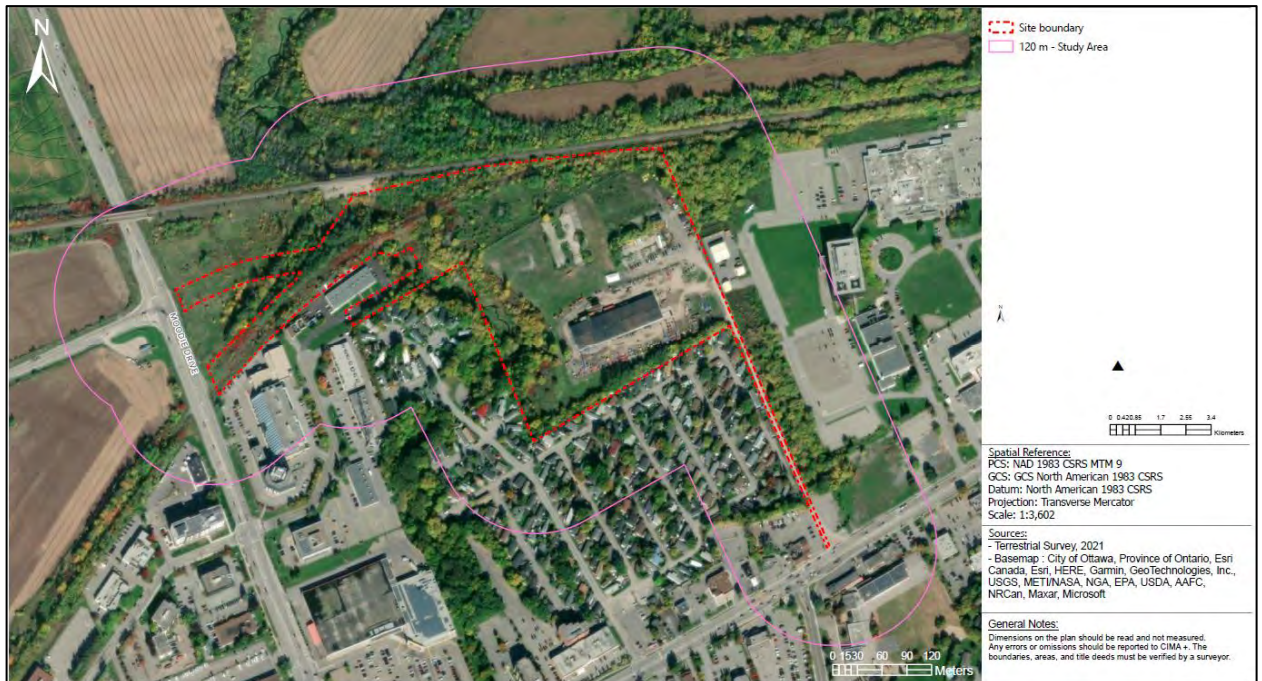
Figure 1: Site Location Map

The 1987 Robertson Road property is currently occupied by an equipment rental service. At present, there is a one-storey warehouse building, paved and gravelled surfaces for parking and access, and grass covered areas.

The northern portion of the site also encompasses an old rail spur which has been decommissioned.

The Project Site is defined as the area where changes or disturbances will occur related to the project (e.g., construction, operation, and maintenance) hereinafter referred to as the “Site” (Figure 1). The Site consists of the 1987 Robertson Road property and has an approximate area of 95,830 m². The Site is bounded by the Bellwood Estates community to the south and west, Beachburg Rail Corridor to the north, Moodie Drive to the west, and the General Dynamics Mission Systems campus to the east. The “Study Area” consists of the adjacent (i.e., within 120 meters (m)) land around the perimeter of the Site. The discrete legal and property description information follows in the **Table 3** below.

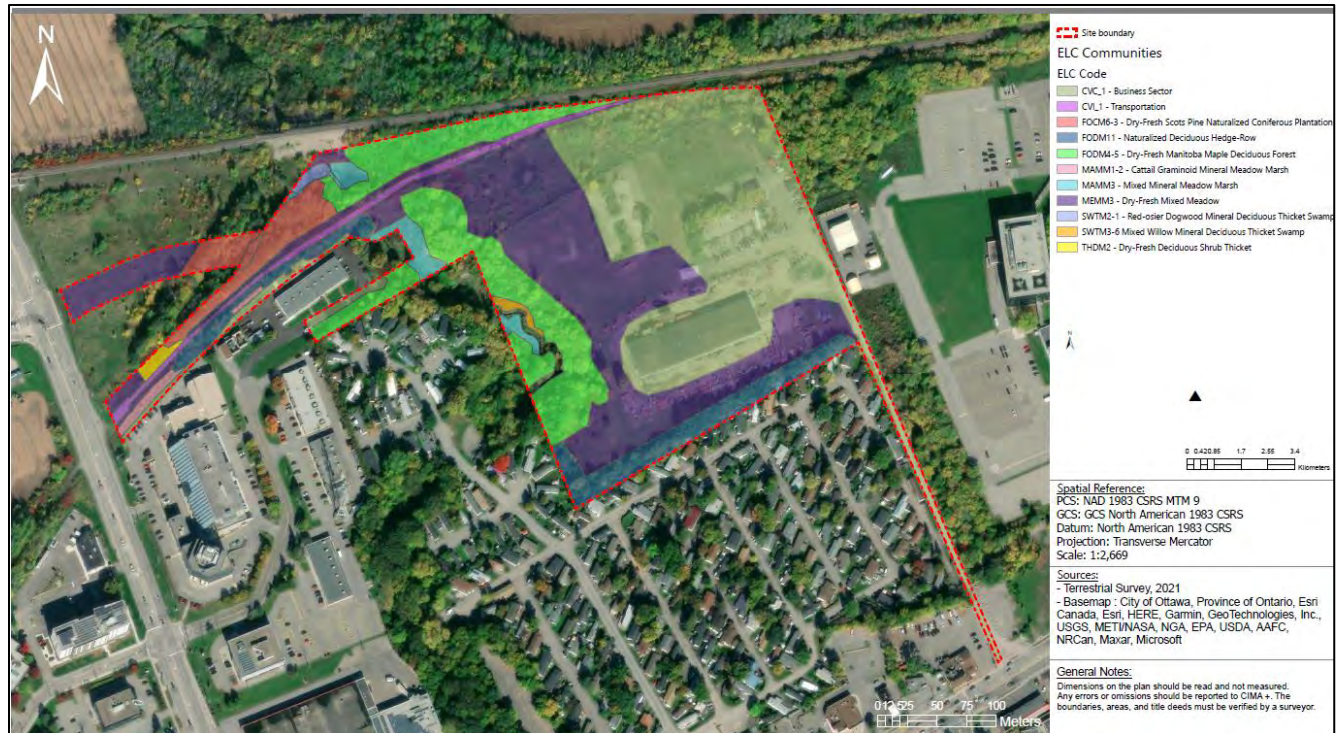
Figure 2: Ecological Land Classification of the Stillwater Station Site

ELC Community	Dominant Vegetation Species	Approximate Area Onsite (m ²)
MAMM3 – Mixed Mineral Meadow Marsh	The Mixed Meadow Marsh communities within the Site are dominated by Joe Pye weed, Narrow-leaved Cattail, and Reed Canary Grass. This community is situated along Stillwater Creek, both north and south of the railway, as well as north of the naturalized Scots Pine plantation where the entrance to the Site is planned.	2,124
MEMM3 – Dry-Fresh Mixed Meadow	The Mixed Meadow communities within the Site are comprised of a mix of common grass-like and broadleaf species dominated by Smooth Brome, Wild Carrot, Bird's-foot trefoil, Common Mugwort, Goldenrod, vetch, dandelion, and bedstraws.	32,836
SWTM2-1 – Red-Osier Dogwood Mineral Deciduous Thicket Swamp	A Thicket Swamp dominated by Red-osier Dogwood is present east of the meadow marsh and adjacent to Stillwater Creek north of the railway.	311
SWTM3-6 – Mixed Willow Mineral Deciduous Thicket Swamp	The Mixed Meadow Marsh community located south of the railway and adjacent to Stillwater Creek transitions into a Mixed Willow Thicket Swamp along the eastern banks of the creek.	315

THDM2 – Dry-Fresh Deciduous Shrub Thicket	This Deciduous Shrub Thicket is located east of Moodie Drive, along the north side of the rail line. It is dominated by Red-osier Dogwood (<i>Cornus sericea</i>) and Staghorn Sumac.	422

Eleven (11) ELC community classes were identified within the Site. A summary of community class findings is outlined below in **Table 4**, and the locations of the various vegetation communities present within the Site are displayed in **Figure 2**. No rare vegetation species or SAR plants were observed within the Study Area.

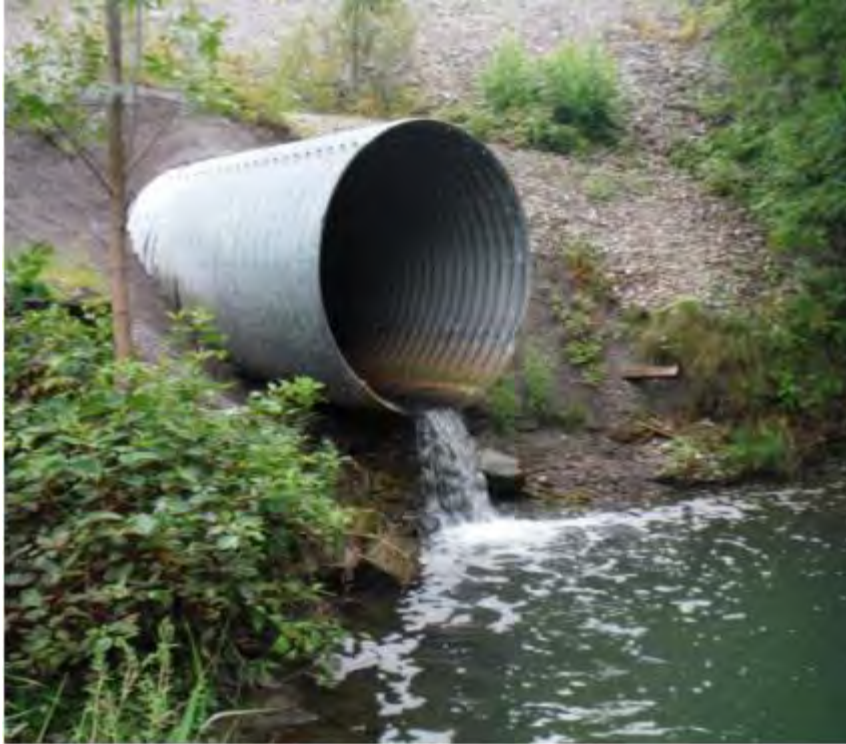
Figure 3: Photo of perched culvert that conveys flow of Stillwater Creek under the Beachburg railway (RVCA, 2015)

Stillwater Creek provides suitable habitat for SAR turtle foraging, mating, thermoregulation, summer inactivity, and movement. There was no suitable nesting habitat observed for at-risk herpetofauna within the creek as it is comprised of an abundance of vegetation cover and lacks the presence of loose soils (COSEWIC, 2016). The railway embankment may provide suitable nesting habitat for at-risk turtles, but the steep slopes in this area may reduce the likelihood of nesting suitability. It is assumed that the perched culvert under the active Beachburg railline, directly north of the Site (**Figure 3**), likely poses migratory obstructions for any turtles attempting to move upstream.

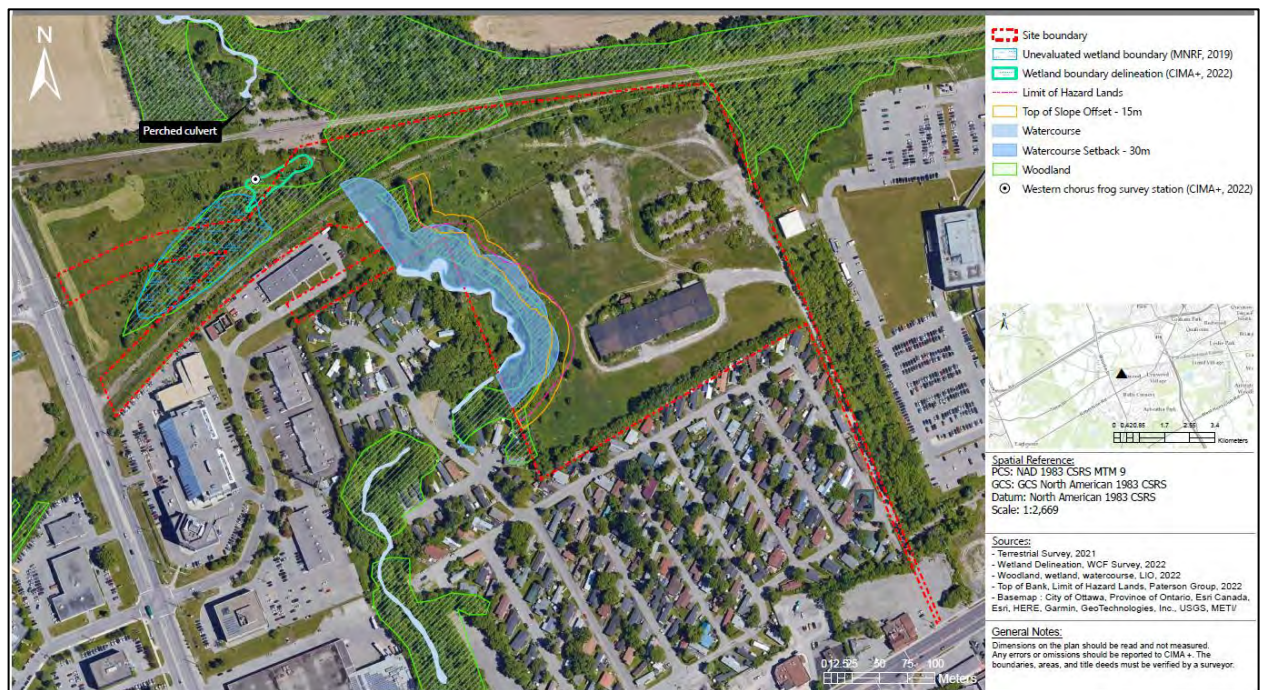
Figure 4: Mapped Natural Heritage Features within the Stillwater Station Site

Refer to **Figure 4** below for a view of the mapped natural heritage features within the Site.

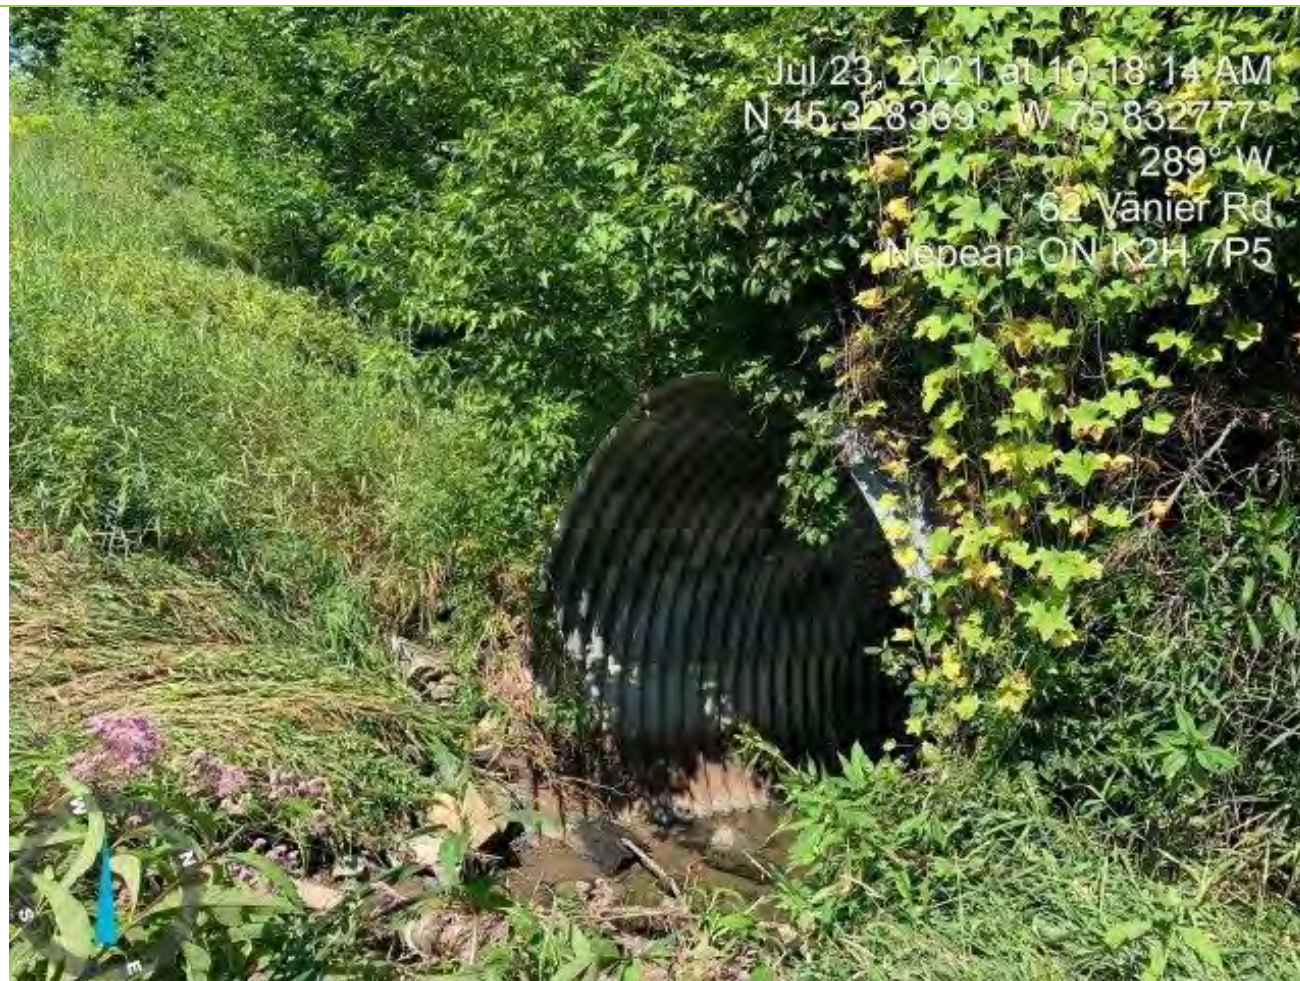
View of the CSP culvert conveying flow of Stillwater Creek under the abandoned railway.

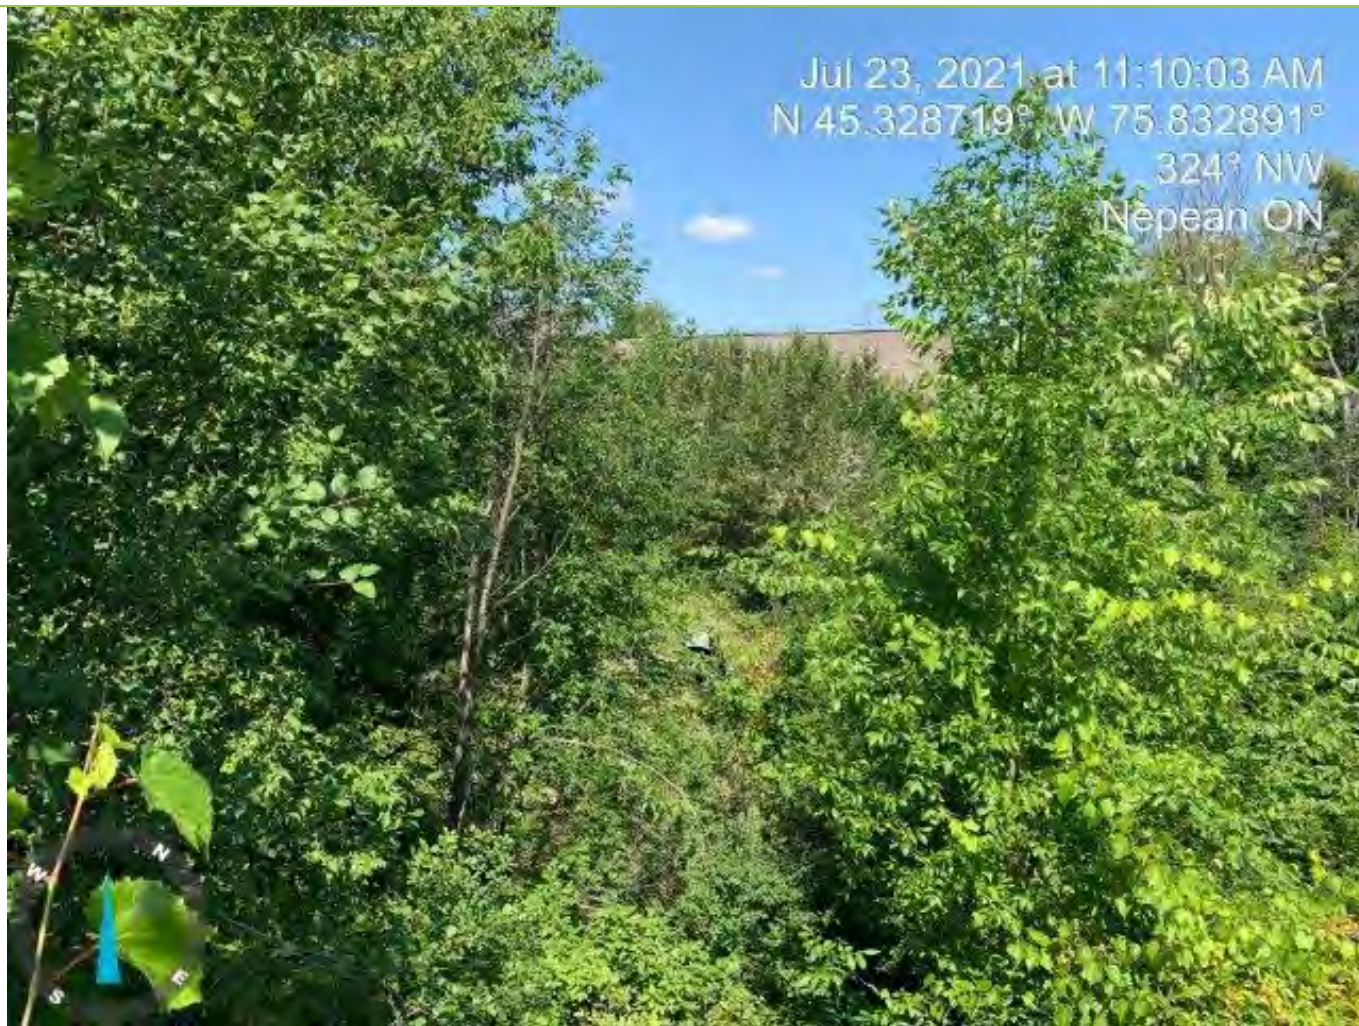
View of the culvert inlet which conveys flow of Stillwater Creek under the 2nd railway north of the Site, from the 1st abandoned railway tracks.

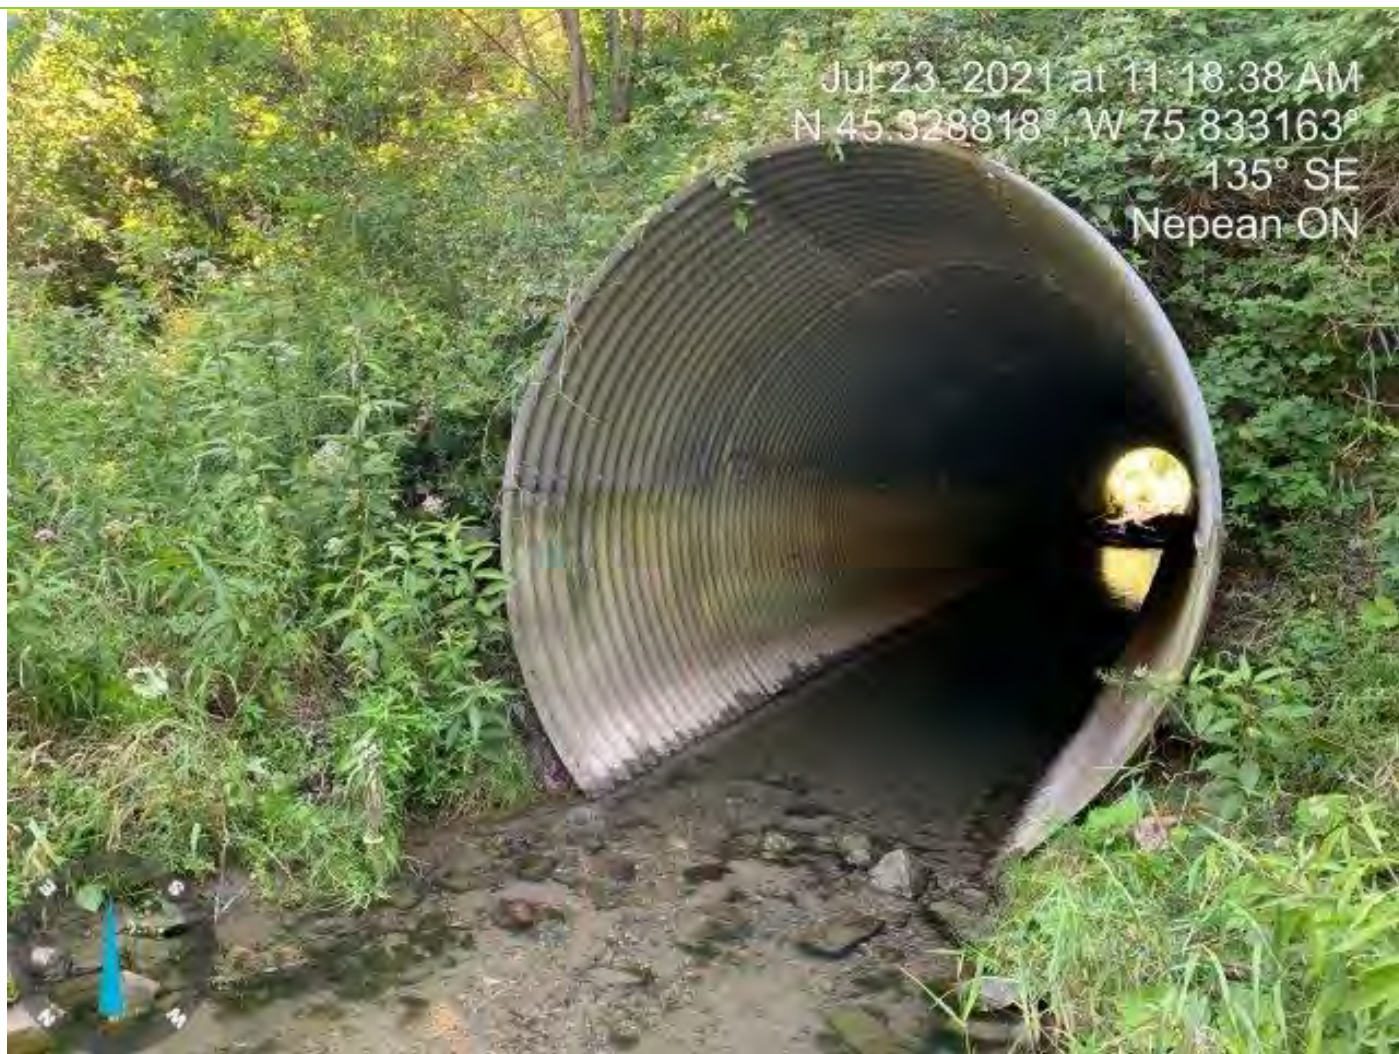
View of the culvert outlet which conveys flow of Stillwater Creek northwards under the 1st abandoned railway tracks.

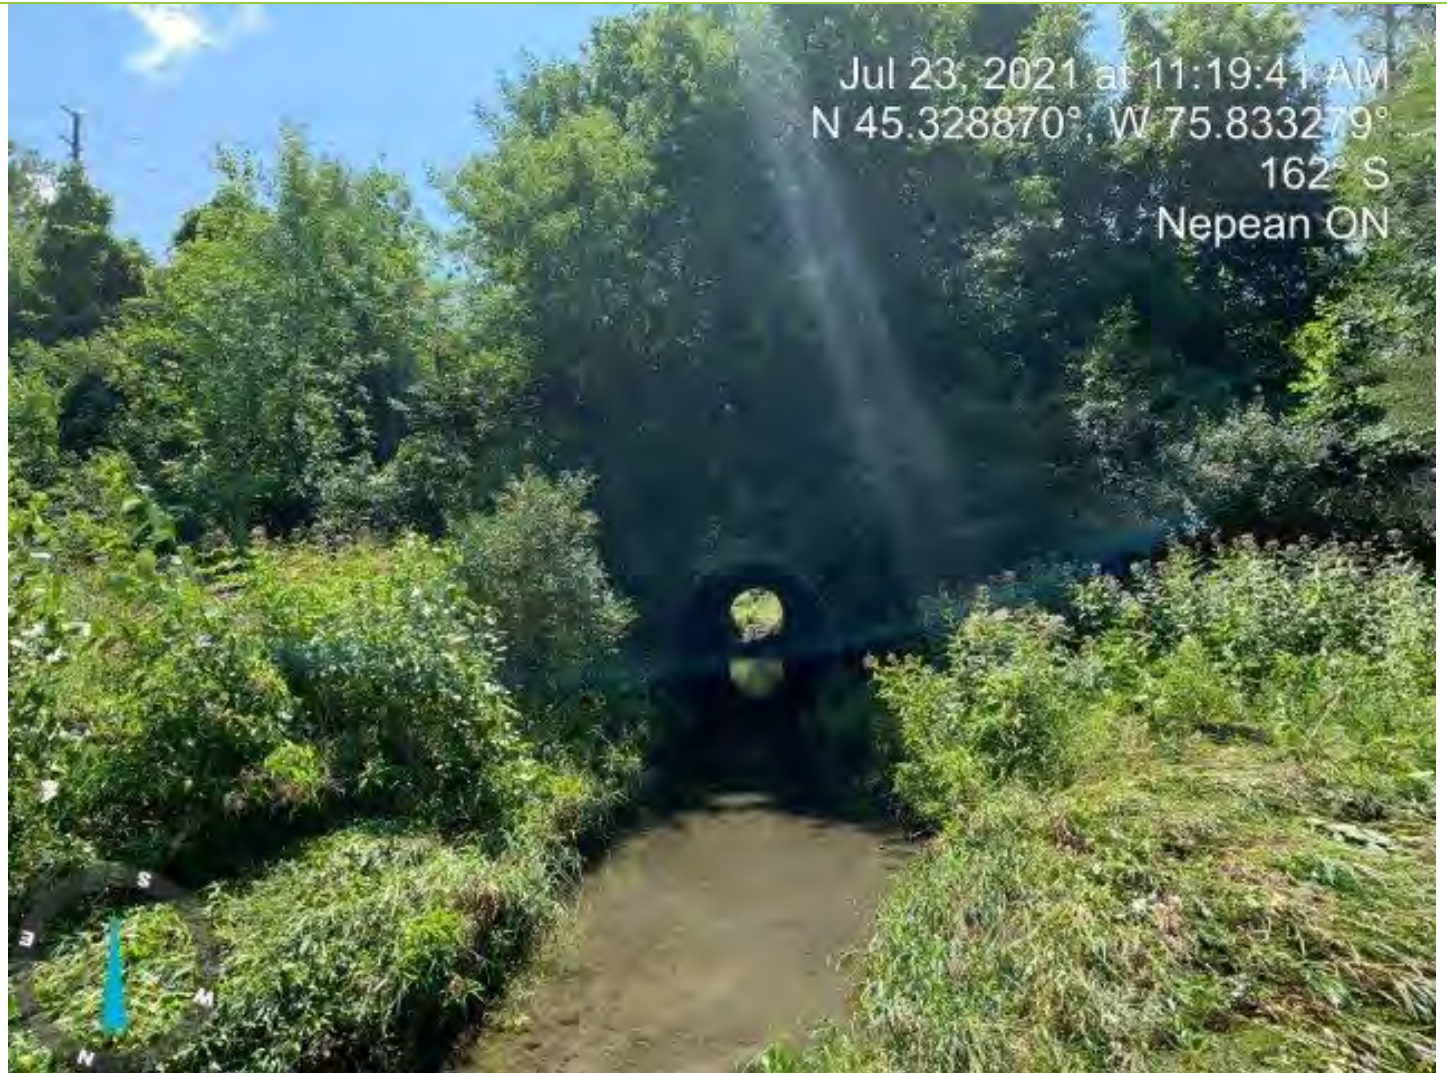
View of the culvert outlet conveying flow of Stillwater Creek northwards under the 1st abandoned railway tracks, lined with a Mixed Meadow Marsh on either side.

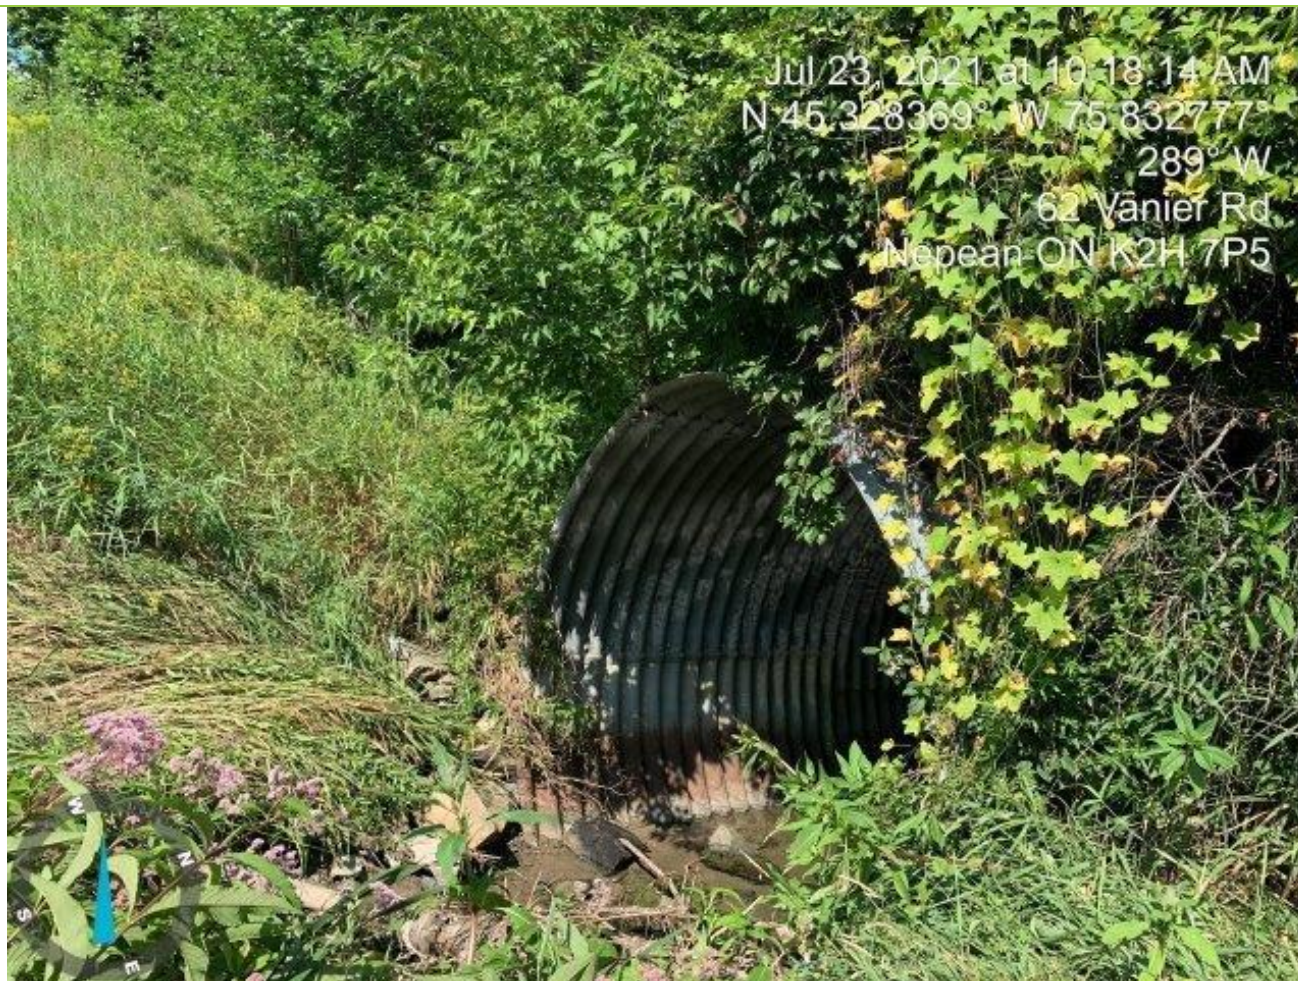
View of the CSP culvert conveying flow of Stillwater Creek under the abandoned railway.
