Environmental Impact Statement

Proposed Site Redevelopment – Stillwater Station,
1987 Robertson Road, Ottawa, Ontario

CIMA+ file number: A001177- 080
29 March 2023 – Review 03

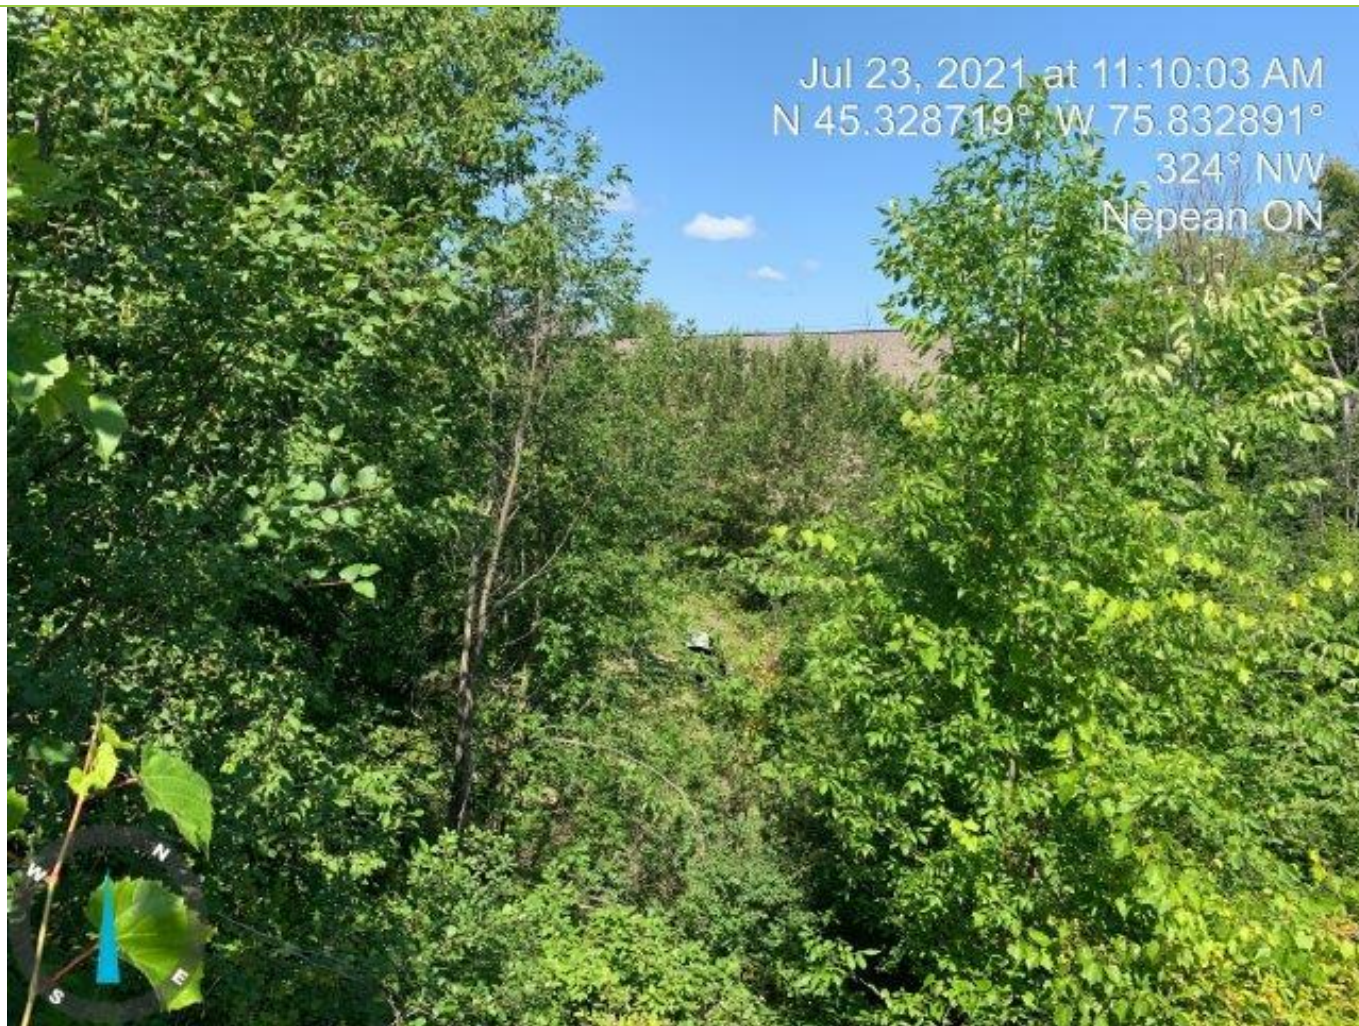
View of the culvert inlet which conveys flow of Stillwater Creek under the 2nd railway north of the Site, from the 1st abandoned railway tracks.

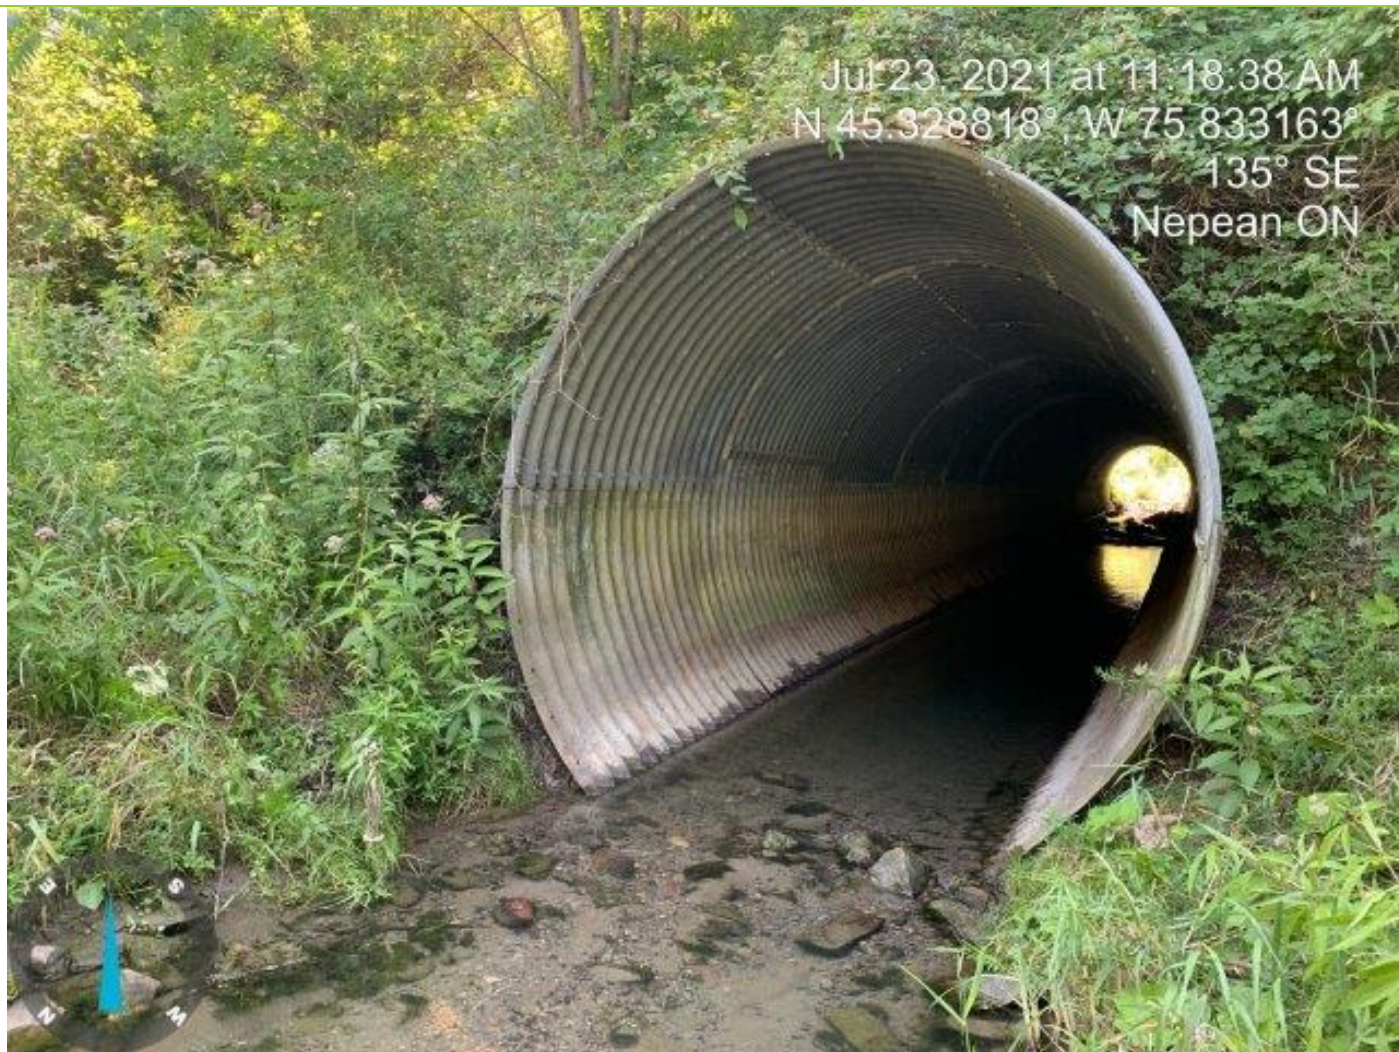
View of the culvert outlet which conveys flow of Stillwater Creek northwards under the 1st abandoned railway tracks.

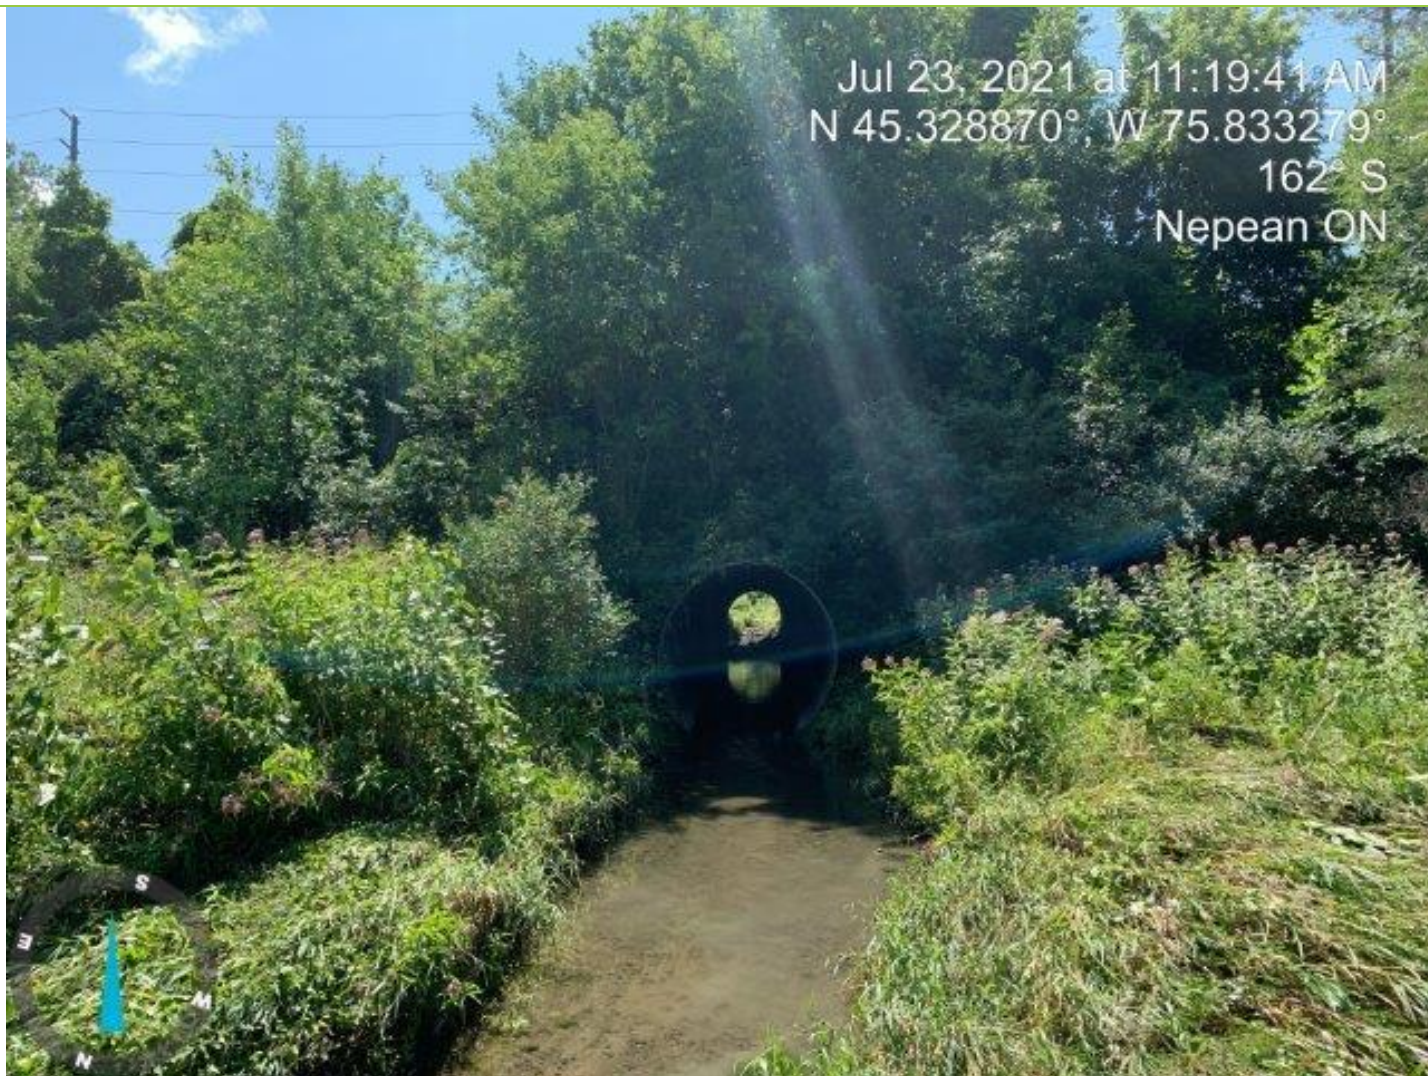
View of the culvert outlet conveying flow of Stillwater Creek northwards under the 1st abandoned railway tracks, lined with a Mixed Meadow Marsh on either side.
