Phase One Environmental Site Assessment

8599 & 8600 Jeanne D'Arc Boulevard Ottawa, Ontario

Prepared for: 3223701 Canada Inc.

October 12, 2022 LOP22-024A

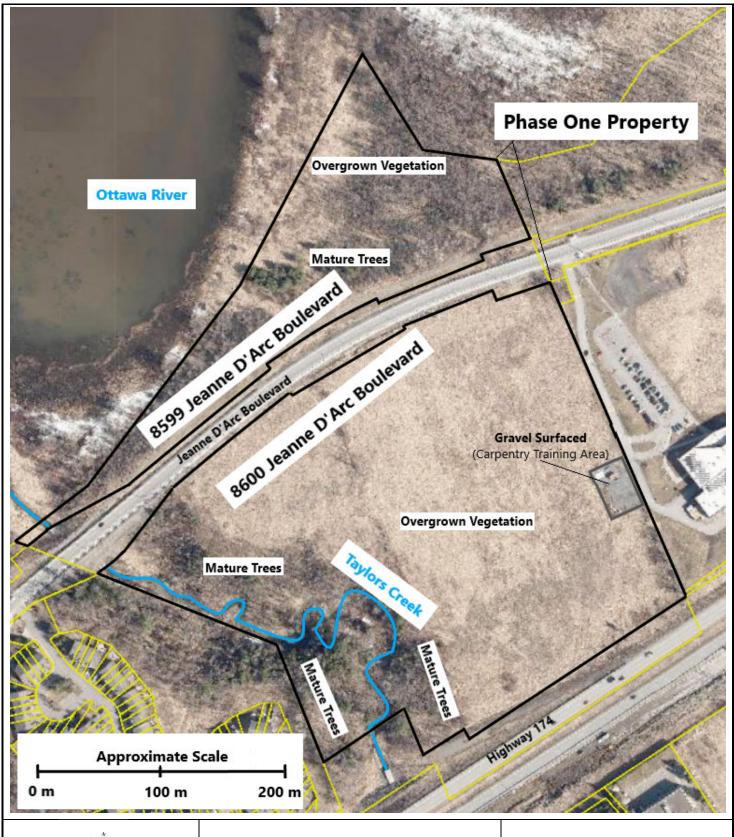
Figure 2: Site Plan
Phase One Environmental Site Assessment
8599 & 8600 Jeanne D'Arc Boulevard, Ottawa, Ontario
3223701 Canada Inc.

Three Figures are provided to visually depict the Conceptual Site Model. Figure 1: Key Plan shows the location of the Phase One Property within the City of Ottawa. Figure 2: Site Plan depicts the current general conditions and environmentally significant features at the Phase One Property. Figure 3: Surrounding Land Use shows the current uses of properties in the Phase One Study Area, and the location of PCAs.

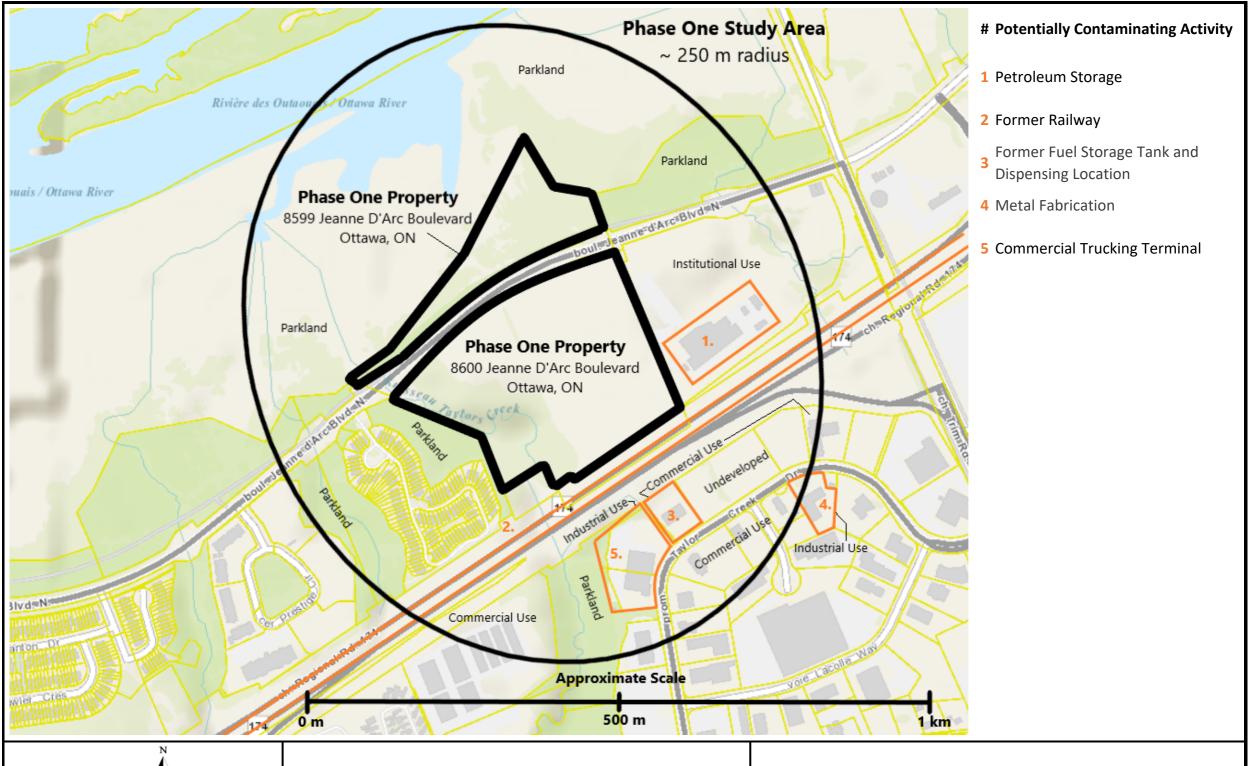
Figure 3: Surronding Land Use

Neighbouring land uses are shown on Figure 3: Surrounding Land Use. One PCA was observed during the review of land use in the Phase One Study Area.

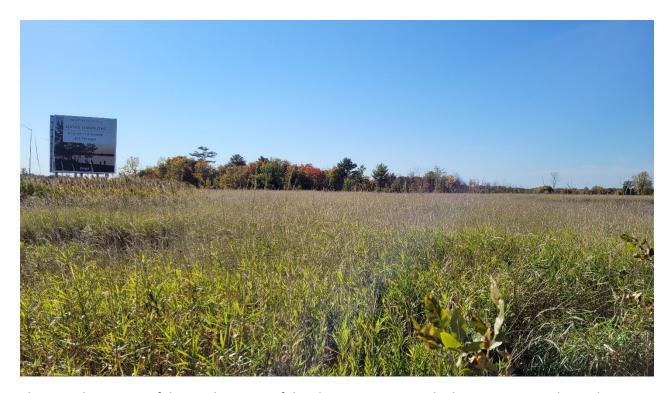
Photograph 1: View of the south portion of the Phase One Property looking west. View shows the Phase One Property to be overgrown with vegetation.

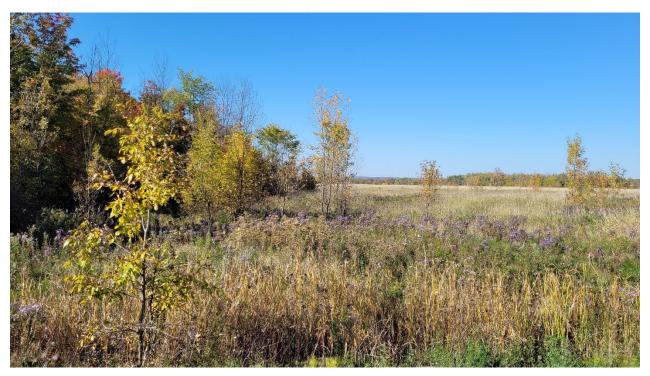
Photograph 2: View of the west side of the Phase One Property looking north. Mature trees can be observed on the left side of the photograph, which is the top of an embankment leading to Taylors Creek.

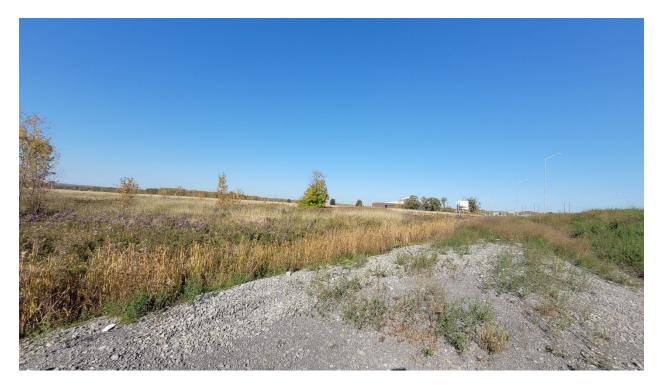
Photograph 3: View of the south side of the Phase One Property, looking east. La Cite Collegial can be see in the distance; La Cite borders the east Property limits.

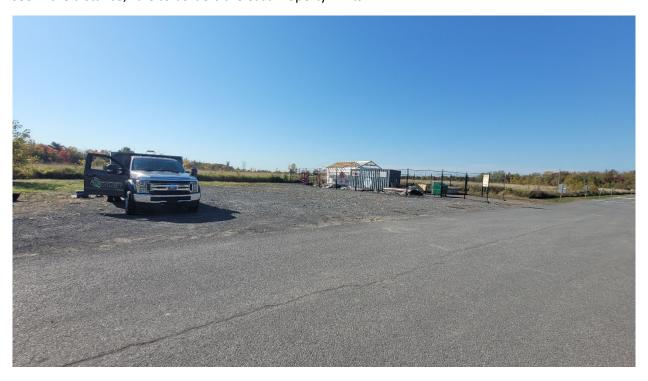
Photograph 4: View of a gravel pad and carpentry training area for La Cite Collegial on the east portion of the Phase One Property.

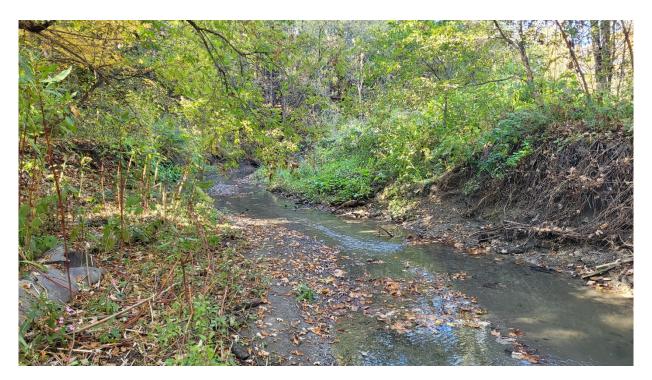
Photograph 5: View of Taylors Creek on the west portion of 8600 Jeanne D'Arc Boulevard; view is looking north.

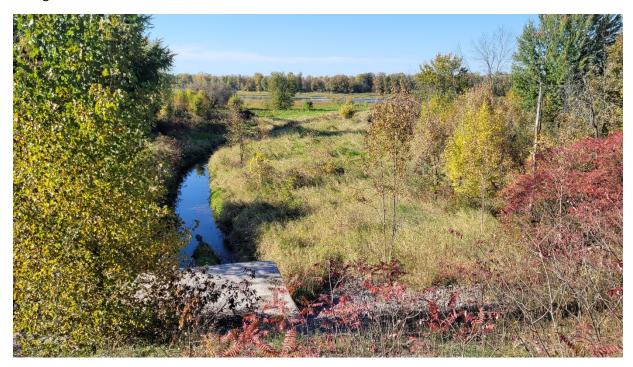
Photograph 6: View of Taylors Creek on the west portion of 8599 Jeanne D'Arc Boulevard; view is looking north towards the Ottawa River.

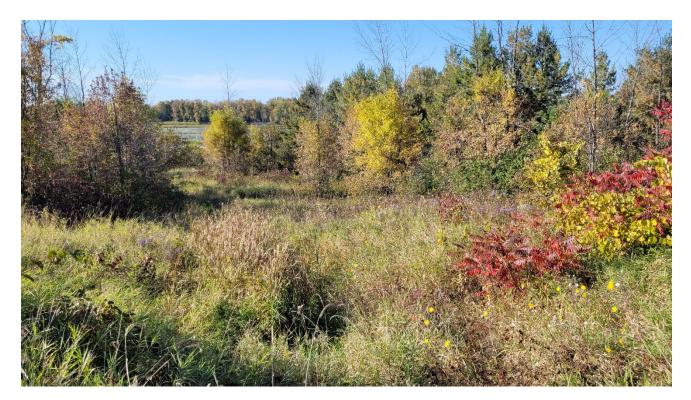
Photograph 7: View of the north portion of the Phase One Property (8599 Jeanne D'Arc), looking north. The Ottawa River can be seen further north of the Property.

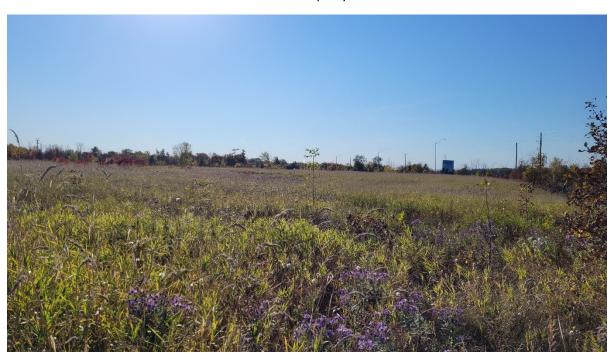
Photograph 8: View of the north portion of 8600 Jeanne D'Arc looking west. Jeanne D'Arc Boulevard is present on the left side of the photograph.
