November 14, 2023 File: PE4576-LET.01

Subject: Phase I-Environmental Site Assessment Update

1104 Halton Terrace

Ottawa, Ontario

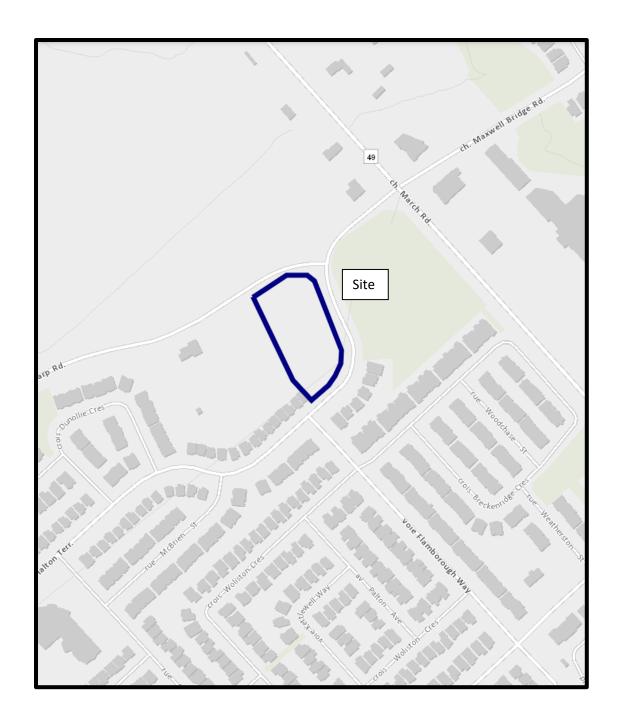
FIGURE 1 KEY PLAN

The Phase I Property is currently vacant land and is located on the southwest corner of the Carp Road and Halton Terrace intersection, in the City of Ottawa, Ontario. The Phase I property is an irregular shaped lot with a footprint of approximately 8980.61 square meters in a R3X- Residential Third Density Zone. The property is generally surrounded by residential properties, with commercial properties present further east of the Phase I Property. The Phase I Property is situated in an area where adjacent lands are currently serviced by private wells and sewage systems. An updated configuration of the Phase I Property is shown on Drawing PE4576-3 - Site Plan, which is appended to this report.

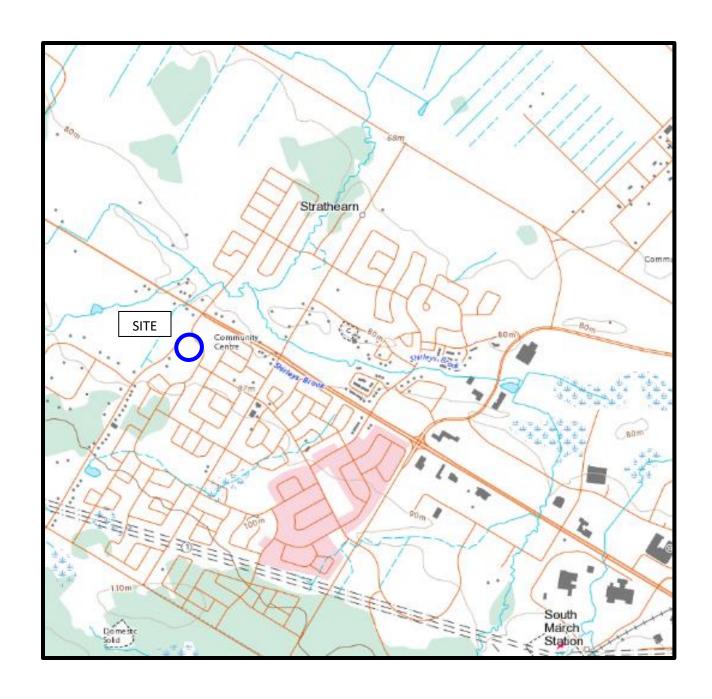
FIGURE 2 TOPOGRAPHIC MAP

The site is largely vacant with some trees on the central portion. No buildings or temporary structures are on-site. Site drainage consists primarily of infiltration. The site topography appeared to be somewhat at grade with Halton Terrace and Old Carp Road. The regional topography slopes down in a north-easterly direction towards Shirley's Brook.

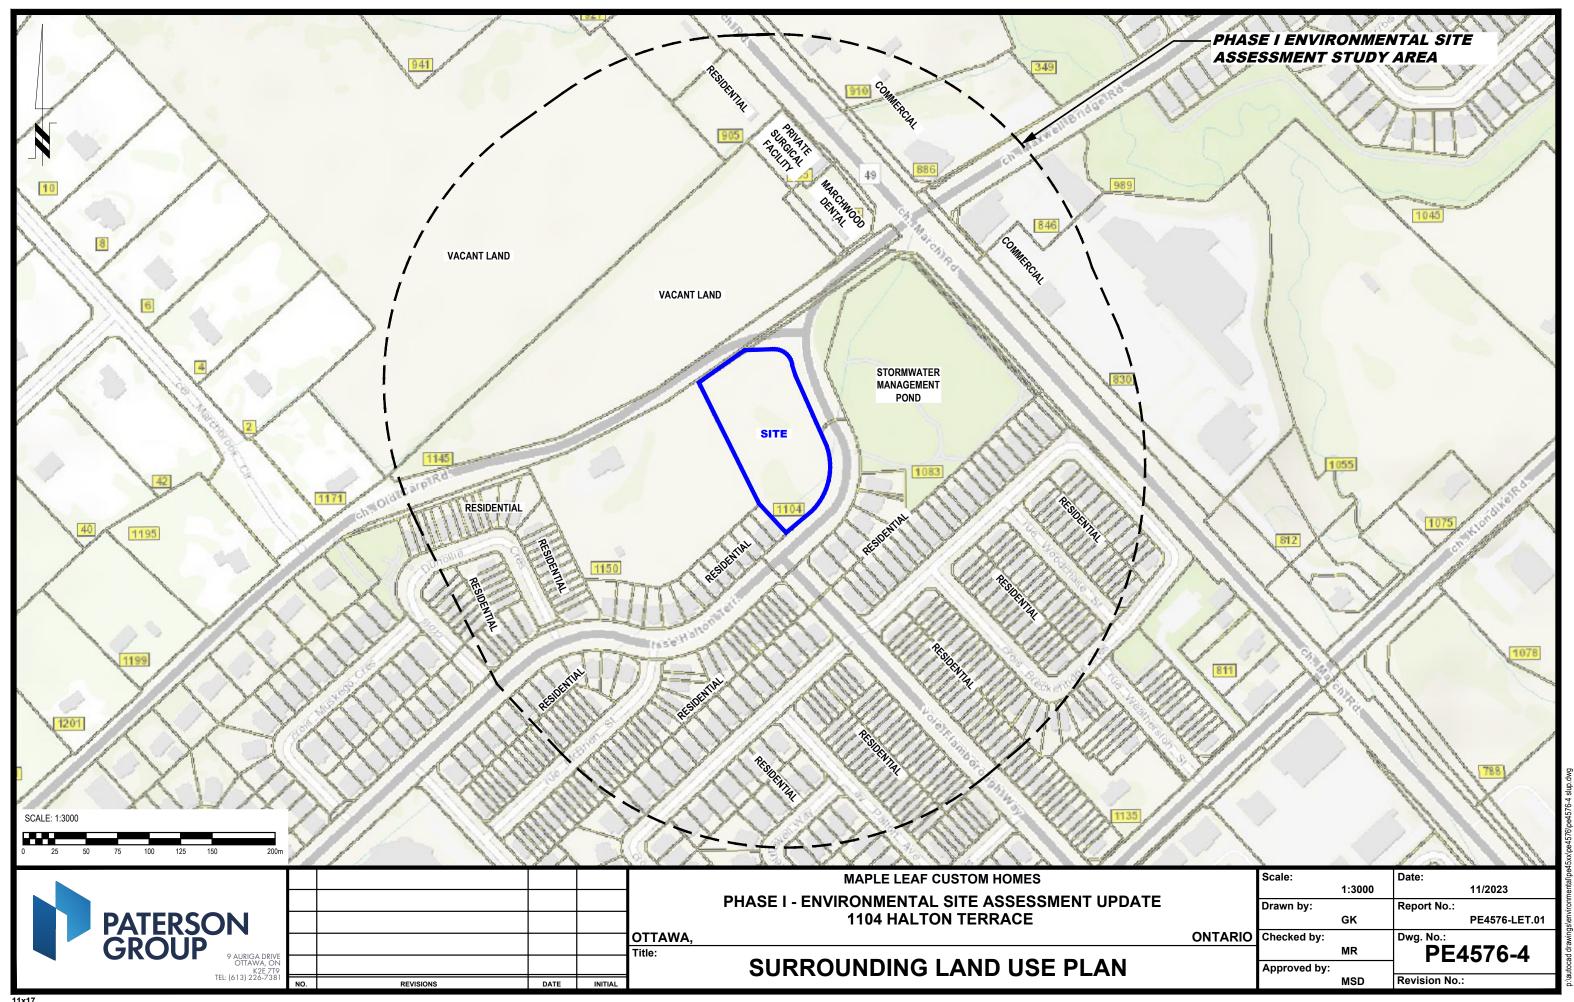
No underground utilities were noted on-site. No drains or private sewage systems were observed at the subject property at the time of the site visit. No evidence of current or former railway or spur lines was observed on the subject property at the time of the site visit. The surrounding properties were also observed during the site visit and are shown on Drawing PE4576-4 - Surrounding Land Use Plan.
