# Stillwater Station Ltd.

## Environmental Impact Statement

Proposed Site Redevelopment – Stillwater Station,  
1987 Robertson Road, Ottawa, Ontario

CIMA+ file number: A001177- 080  
February 28, 2024 – Revision 004

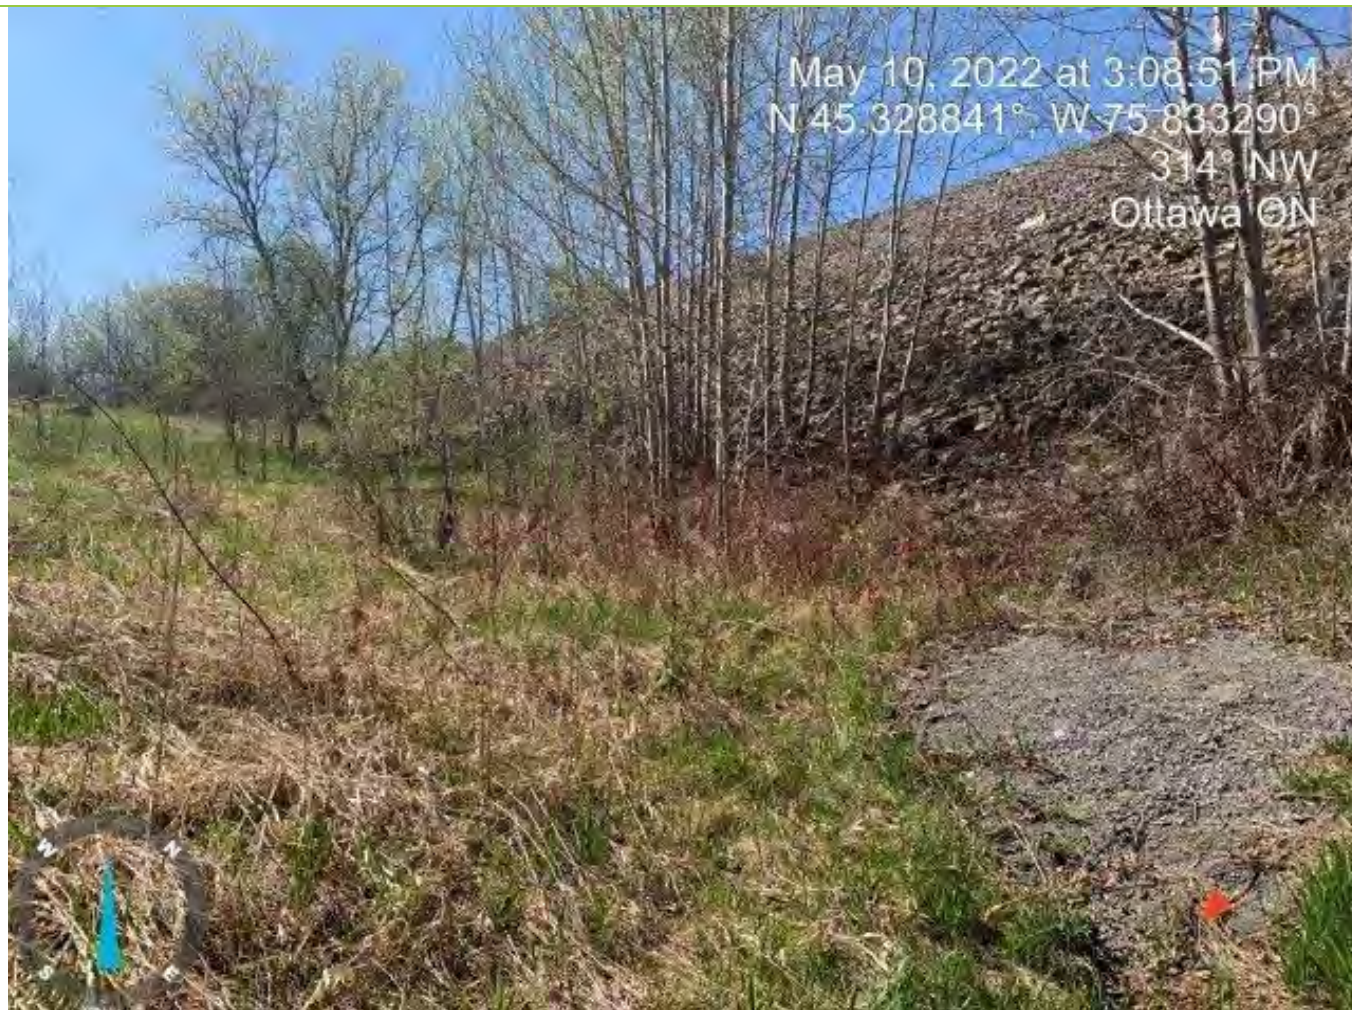
View of the eastern extent of the wetland boundary displaying the Red-osier Dogwood Thicket Swamp during the 2022 assessment.

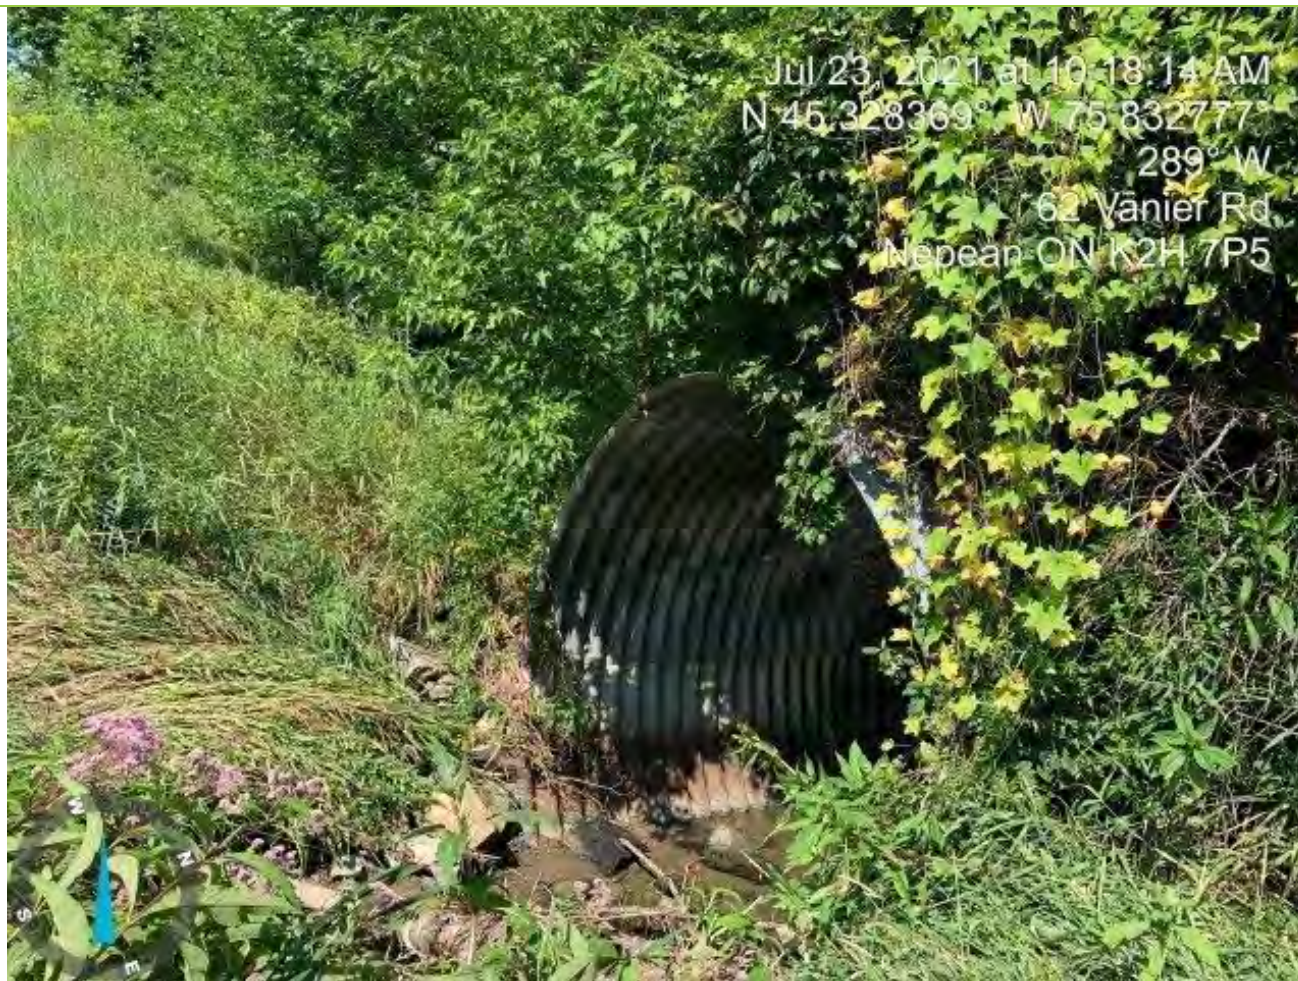
View of the CSP culvert conveying flow of Stillwater Creek under the abandoned railway.

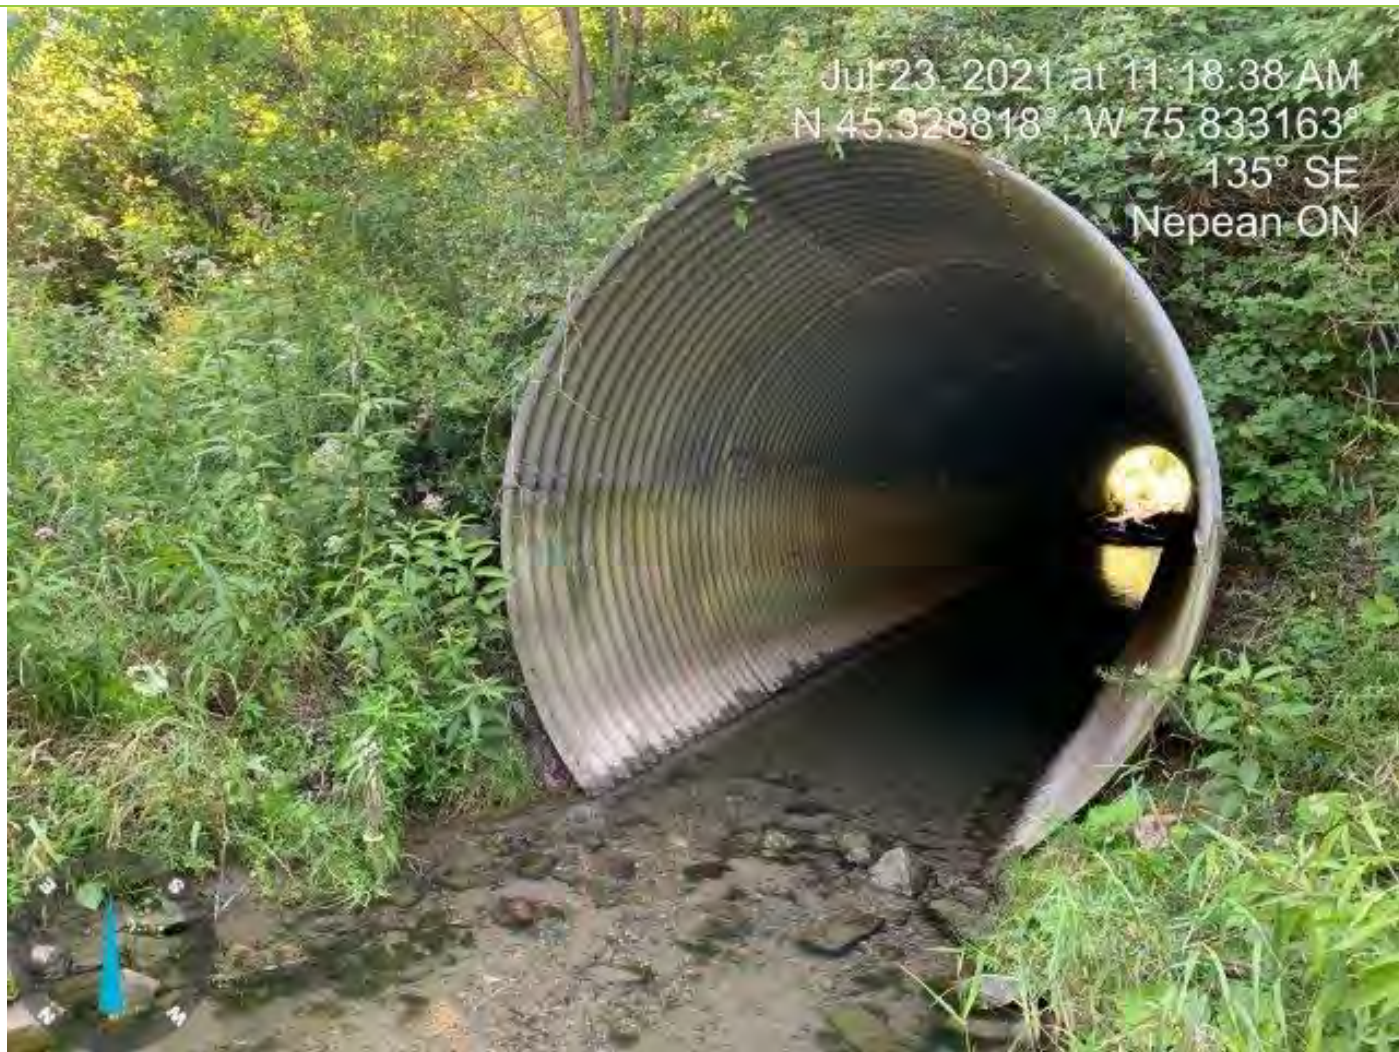
View of the culvert outlet which conveys flow of Stillwater Creek northwards under the 1<sup>st</sup> abandoned railway tracks.

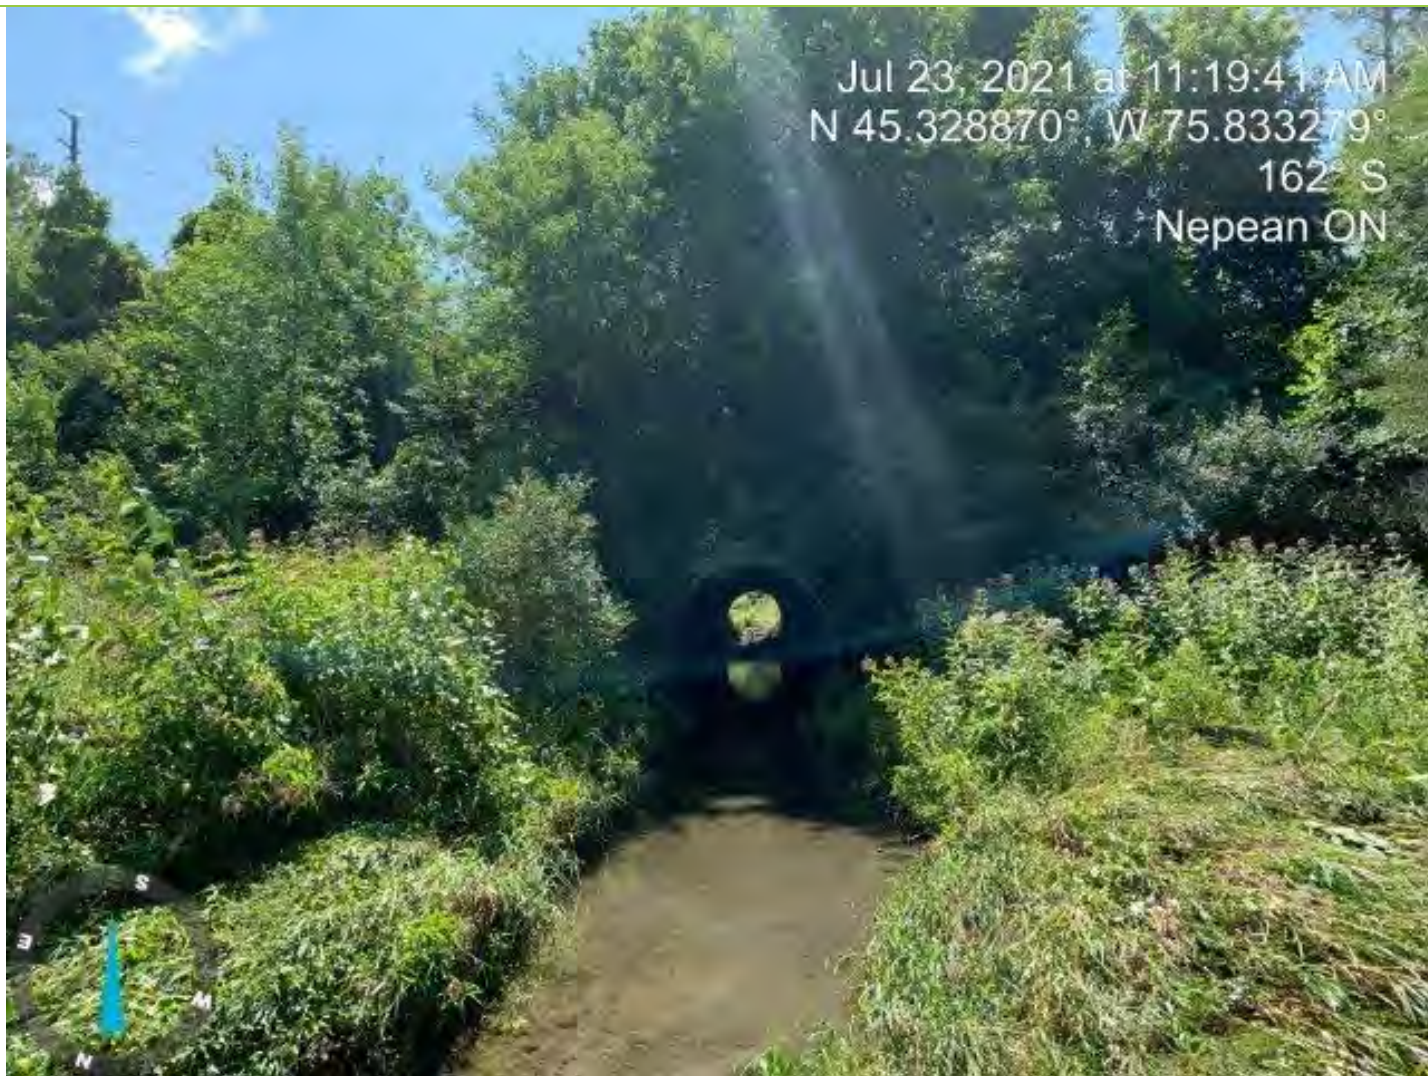
View of the culvert outlet conveying flow of Stillwater Creek northwards under the 1<sup>st</sup> abandoned railway tracks, lined with a Mixed Meadow Marsh on either side.

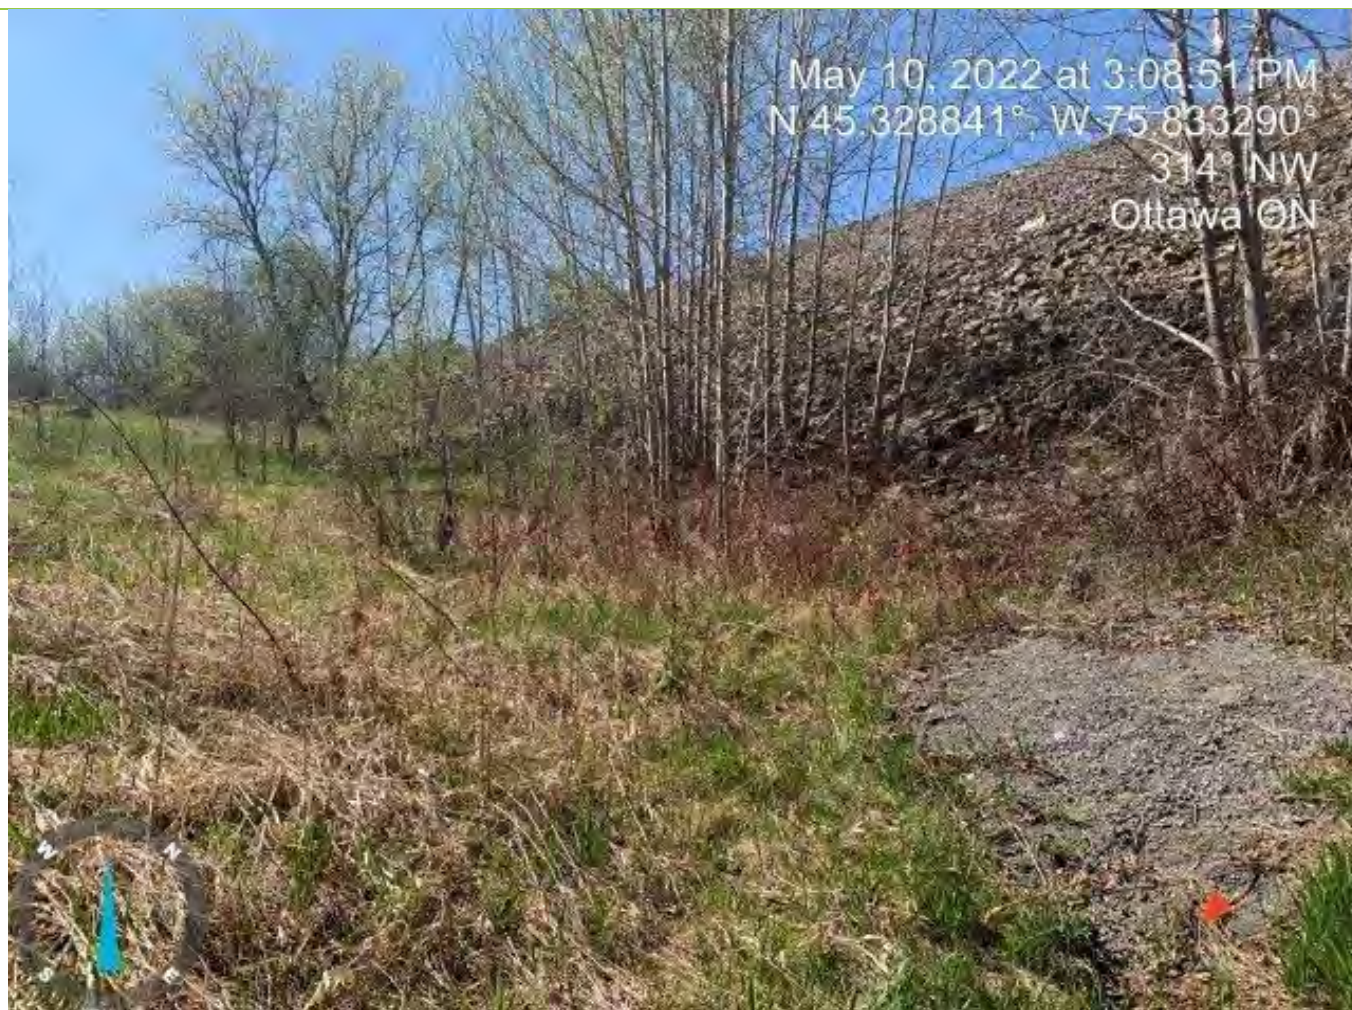
View of the eastern extent of the wetland boundary displaying the Red-osier Dogwood Thicket Swamp during the 2022 assessment.

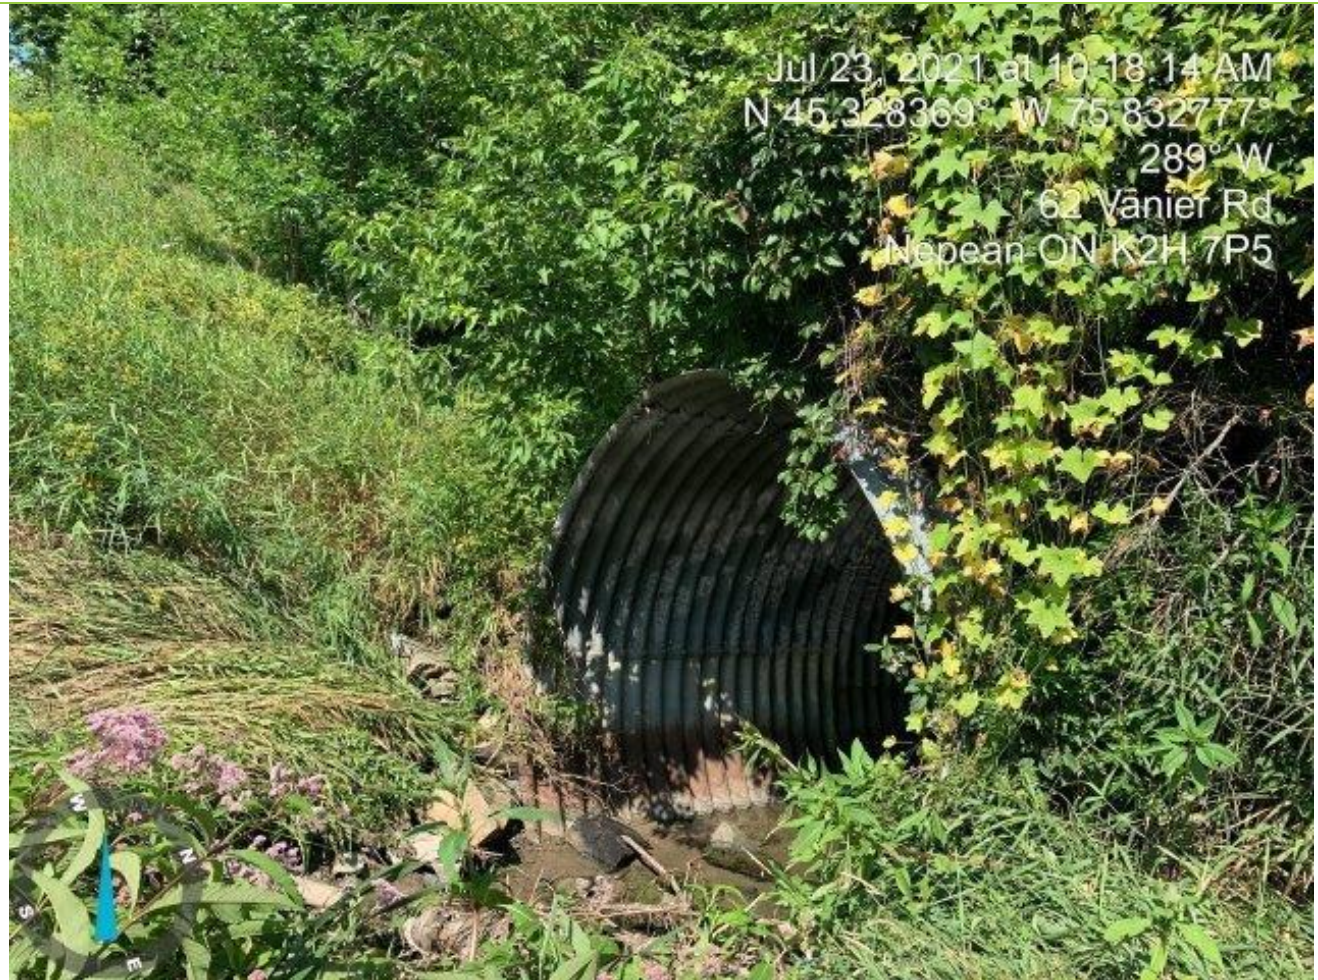
View of the CSP culvert conveying flow of Stillwater Creek under the abandoned railway.

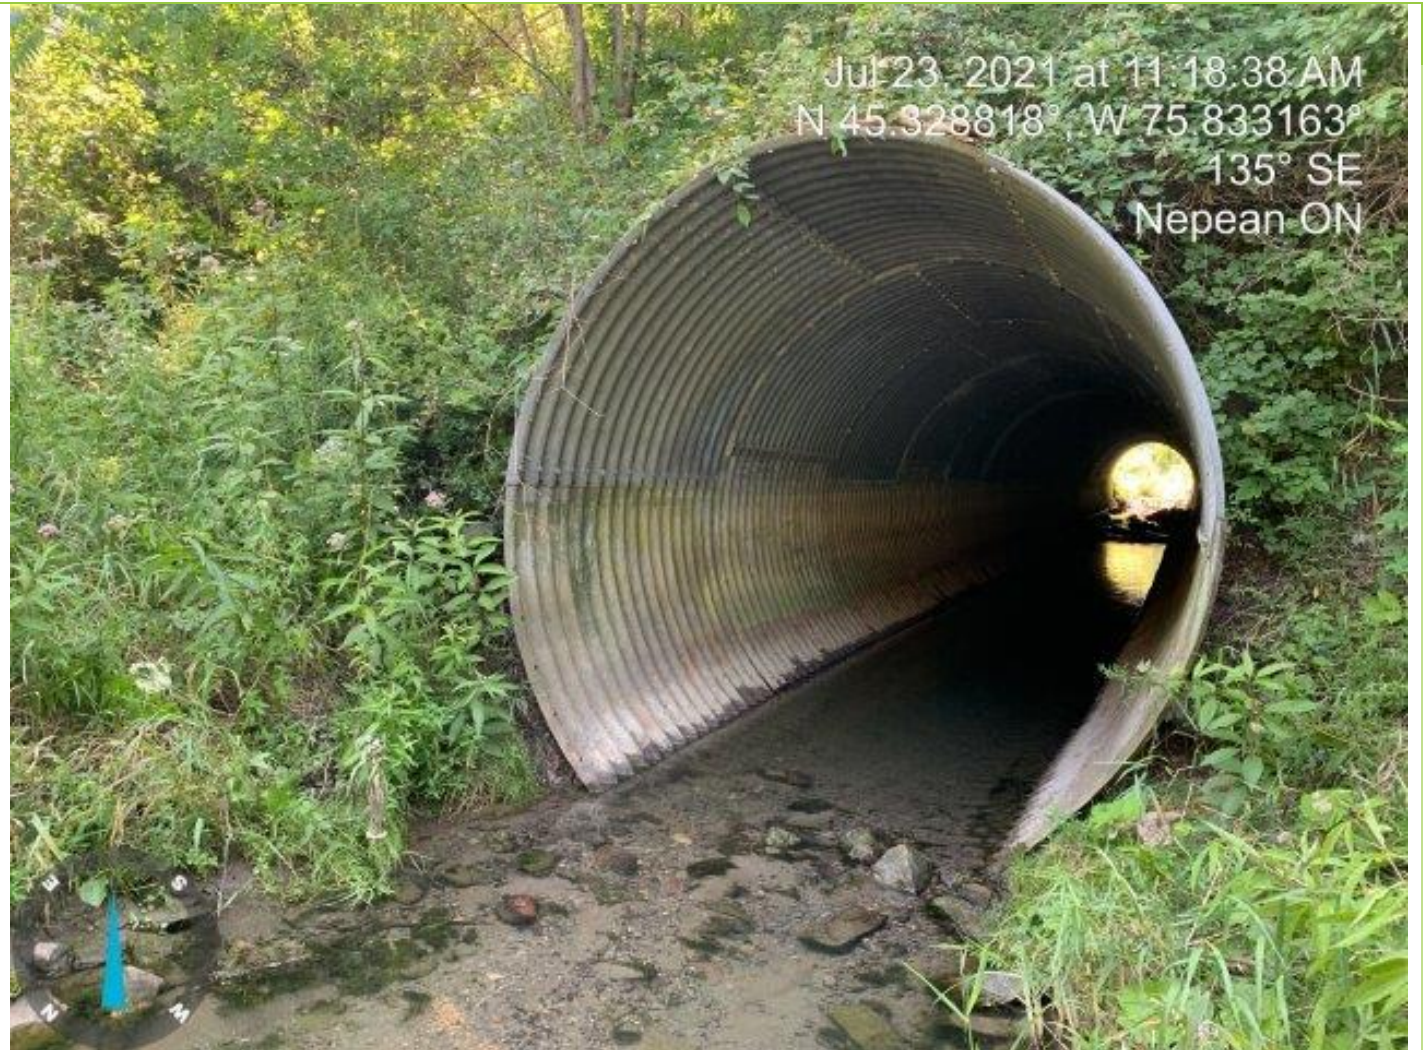
View of the culvert outlet which conveys flow of Stillwater Creek northwards under the 1<sup>st</sup> abandoned railway tracks.

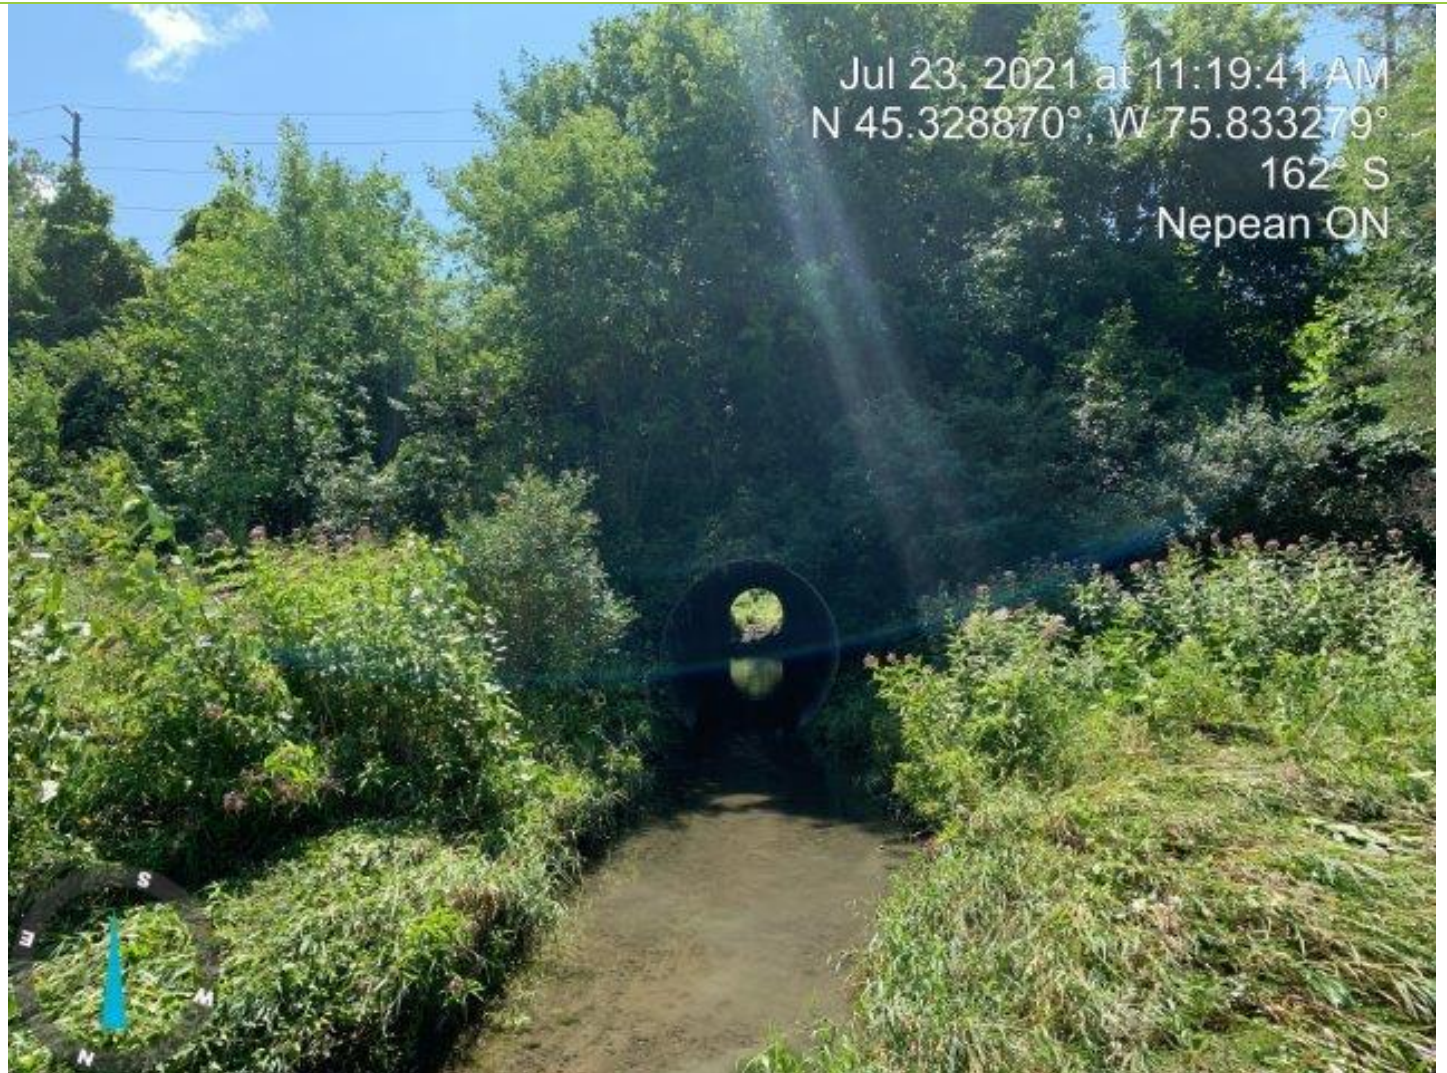
View of the culvert outlet conveying flow of Stillwater Creek northwards under the 1<sup>st</sup> abandoned railway tracks, lined with a Mixed Meadow Marsh on either side.

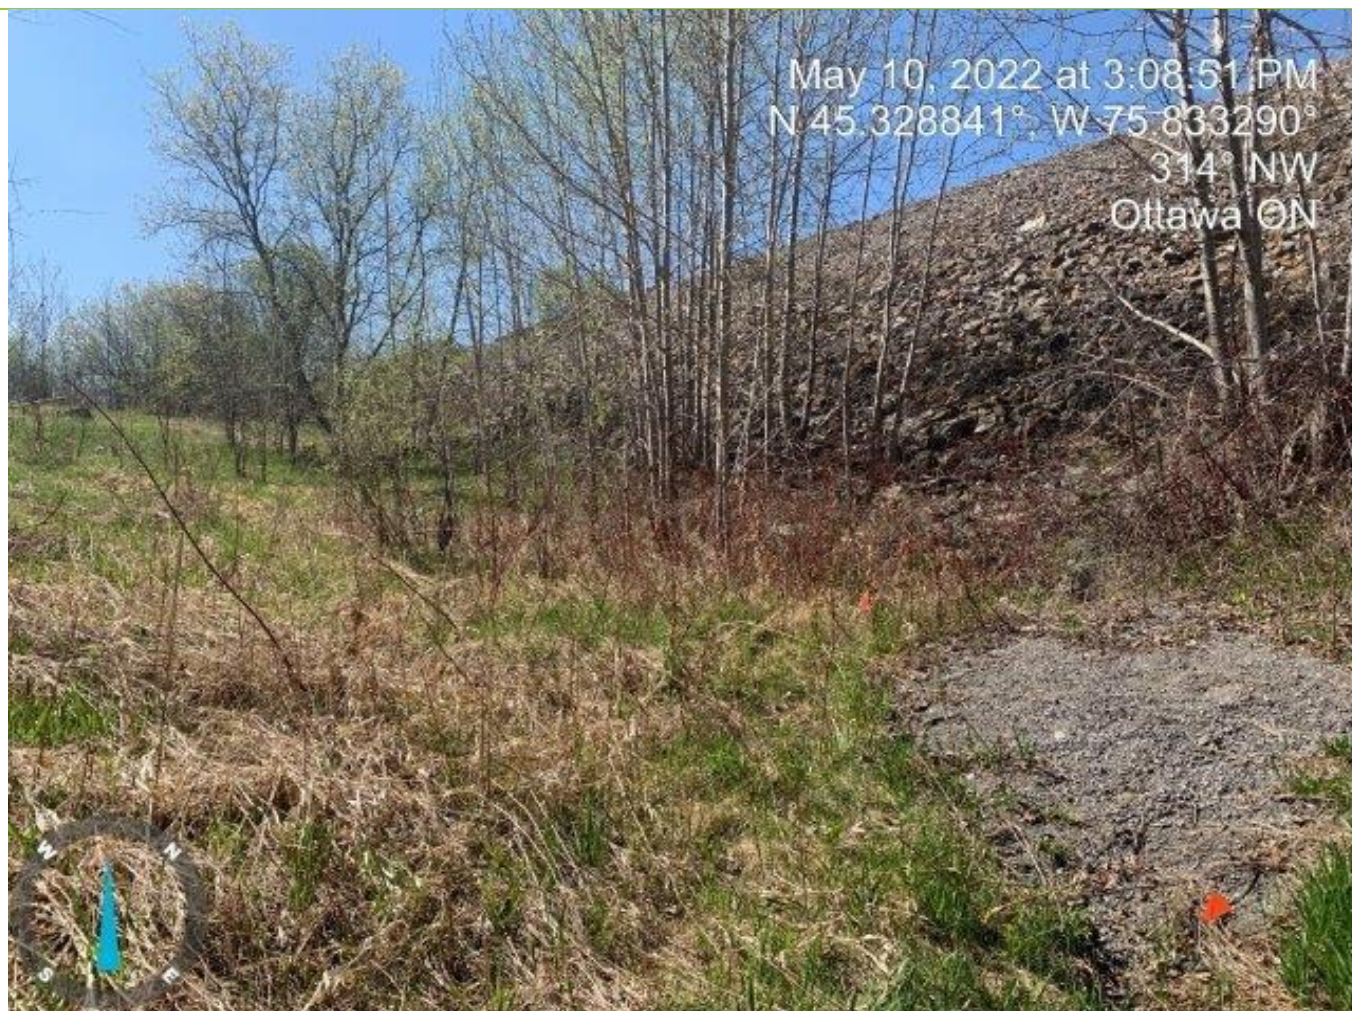
View of the eastern extent of the wetland boundary displaying the Red-osier Dogwood Thicket Swamp during the 2022 assessment.
