Phase I Environmental Site Assessment

50 Bayswater Avenue and 1088 Somerset Street West
Ottawa, Ontario

Prepared for Manor Park Management

Report: PE5971-1
Date: July 6, 2023

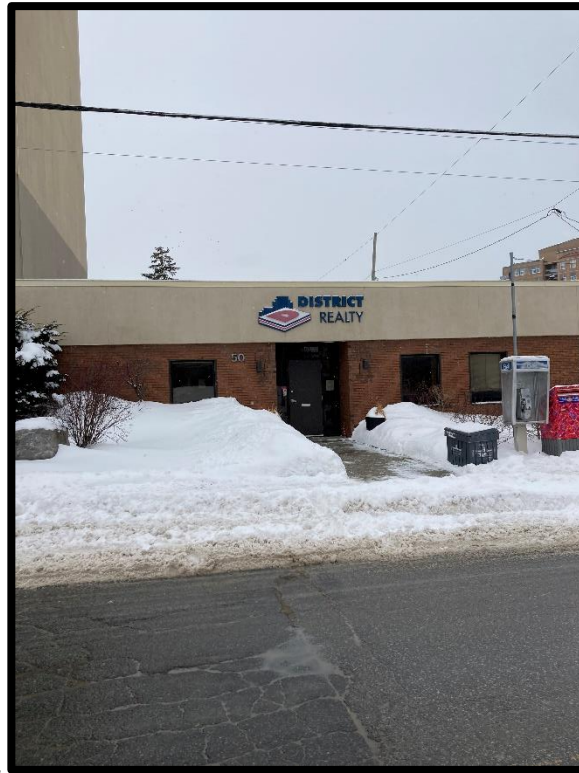
Photograph 1: View of the front of the 50 Bayswater Avenue office building, facing west.

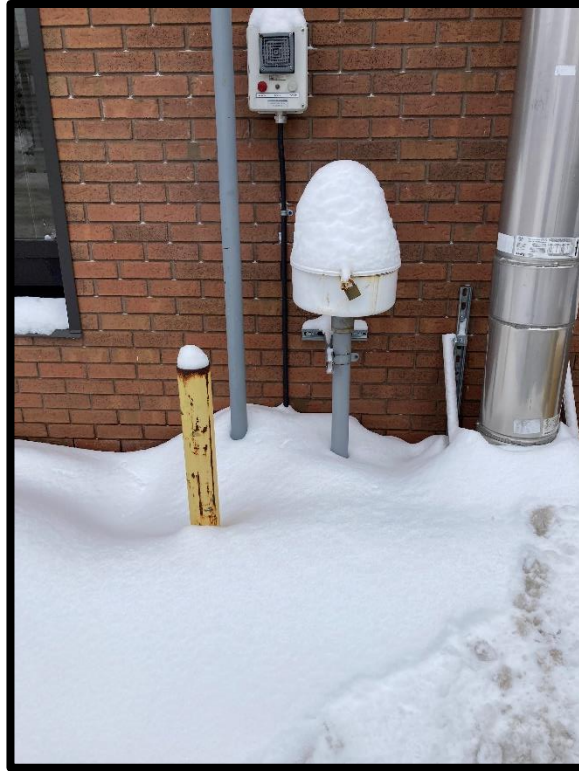
Vent and fill pipes were observed on the exterior of the 50 Bayswater Avenue building (along the west face) at the time of the site visit. The vent and fill pipes and the ground beneath them were noted to be in good condition, with no visual or olfactory signs of contamination noted.

Photograph 3: View of the vent and fill pipes along the back wall of the 50 Bayswater Avenue office building, facing east.

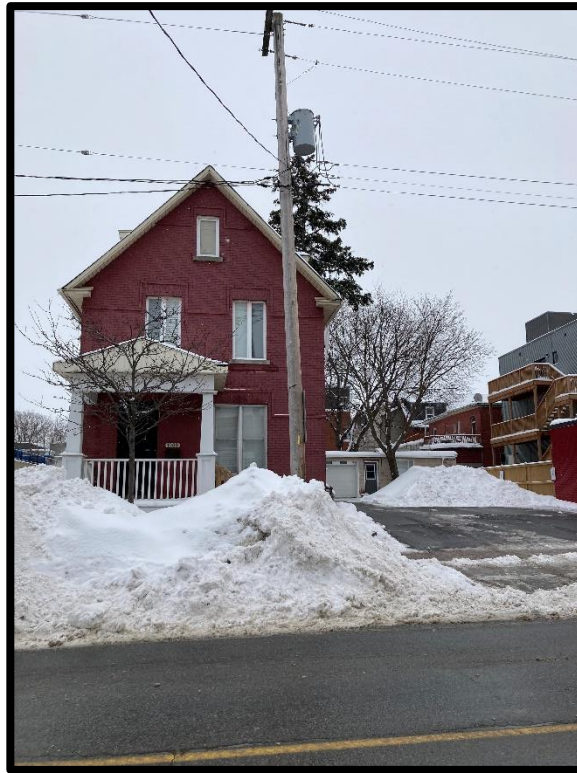
The portion of the Phase I Property addressed 1088 Somerset Street West is currently occupied by a three-storey (with one basement level) mixed used commercial art gallery and residential dwelling. The building is constructed with a stone foundation and is finished on the exterior with brick and vinyl siding in addition to a sloped and shingled roof. The building, constructed sometime prior to 1888, is currently heated via natural gas furnace located in the basement.

Photograph 5: View of the front of 1088 Somerset Street West residential dwelling/commercial building, facing south.

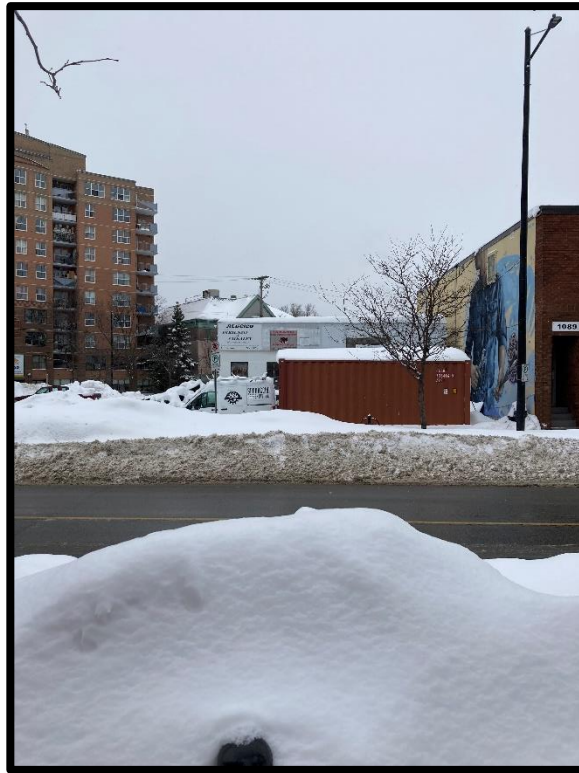
Photograph 7: View of the automotive service garage on the 1 Spadina Avenue property from the northwest corner of the Phase I Property, facing north.
