Stittsville South W4 Future Neighborhood Area: Environmental Impact Study

Updated Report

October 8, 2024

CAIVAN

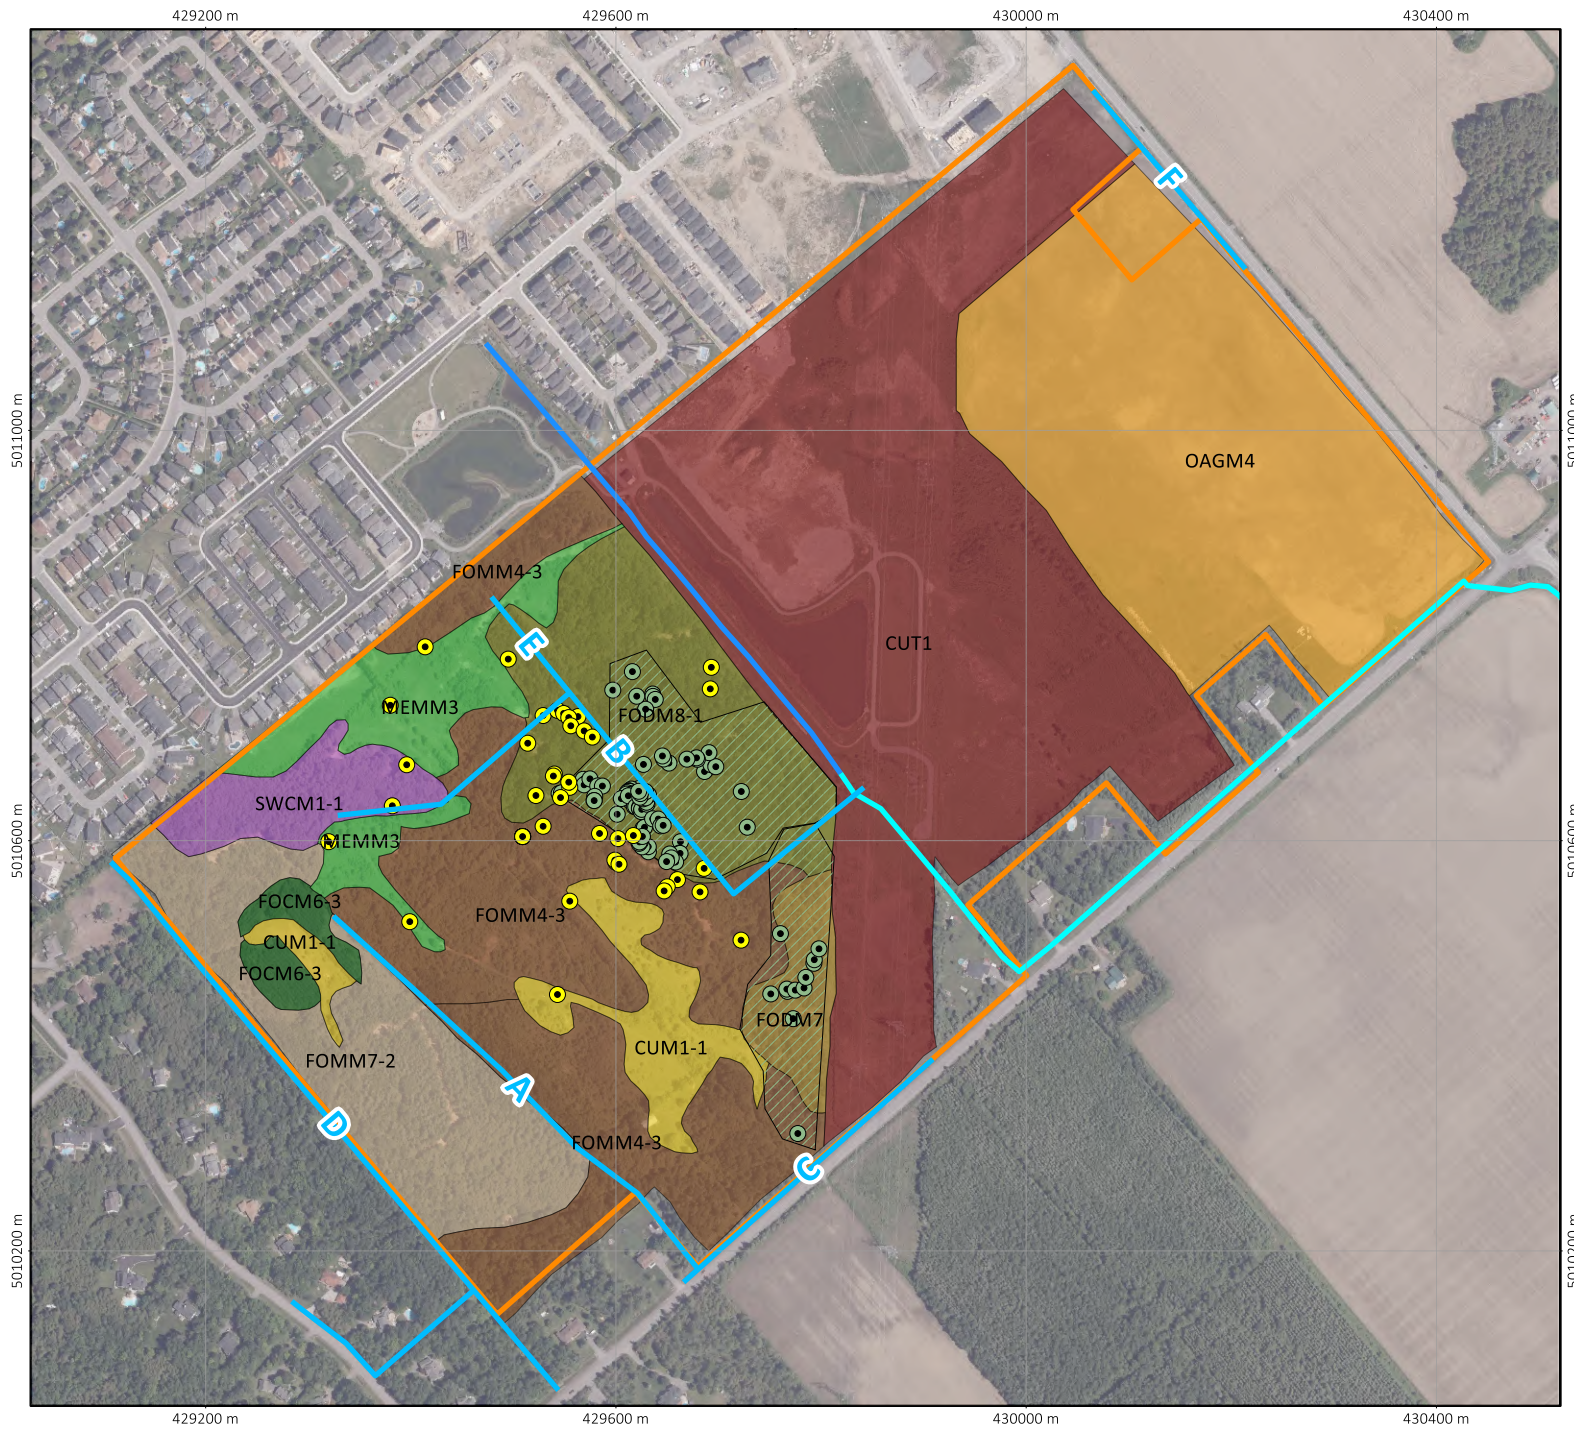
A total of ten distinct landcovers or ELC units were delineated on the Site (Figure 3). The majority of the western portion of the Site is a mixed Eastern White Cedar forest, a Poplar dominant deciduous forest, and meadow areas, with smaller areas of Scots Pine plantation and an Eastern White Cedar Swamp. The eastern portion of the Site is dominated by a thicket community and open agricultural lands. KAL Biologists were not permitted direct access to the small, residential parcels along Flewellyn Road as they are privately-owned. Road-side and aerial image reviews, however, indicate land cover on the small parcels (other than of the manicured spaces directly associated with houses and lawns) to correspond with the adjacent landcover of the Site. For each ELC unit identified, the dominant species observed, and any SAR plant species (highlighted in the descriptions below with an asterisk) are discussed in the following sections. An exhaustive list of all plant species observed in each ELC unit as well as tree sizes (DBH), where applicable is included in Appendix E.

A total of 45 Butternuts were observed on the Site (Figure 3). These were the individuals that remained following the 2022 derecho event; a number of toppled and dead Butternuts were evident during the BHA assessment, but these were not considered. All 45 remaining trees were determined to be Category 2 or 3 and are thus protected as SAR under the ESA (Appendix C). These trees were located predominantly within the central FODM8-1 forest ecosite, which is the most mature forested area on the property.

A total of 102 Black Ash >8 DBH were observed on the Site (Figure 3). Black Ash were located predominantly within the FODM7 and FODM8-1 forest ecosites. Of the 102 Black Ash observed, 73 were determined to be healthy, while 29 were determined to be unhealthy. Healthy trees have a canopy condition rating of 1, 2 or 3, and mortality is unlikely within five years based on severity of stressors. Unhealthy trees have a canopy condition rating on 3, 4 or 5, and mortality is expected within five years based on the severity of stressors. Approximately, over 2,000 Black Ash that do not meet the size requirements for protection under the ESA were observed on the Site.

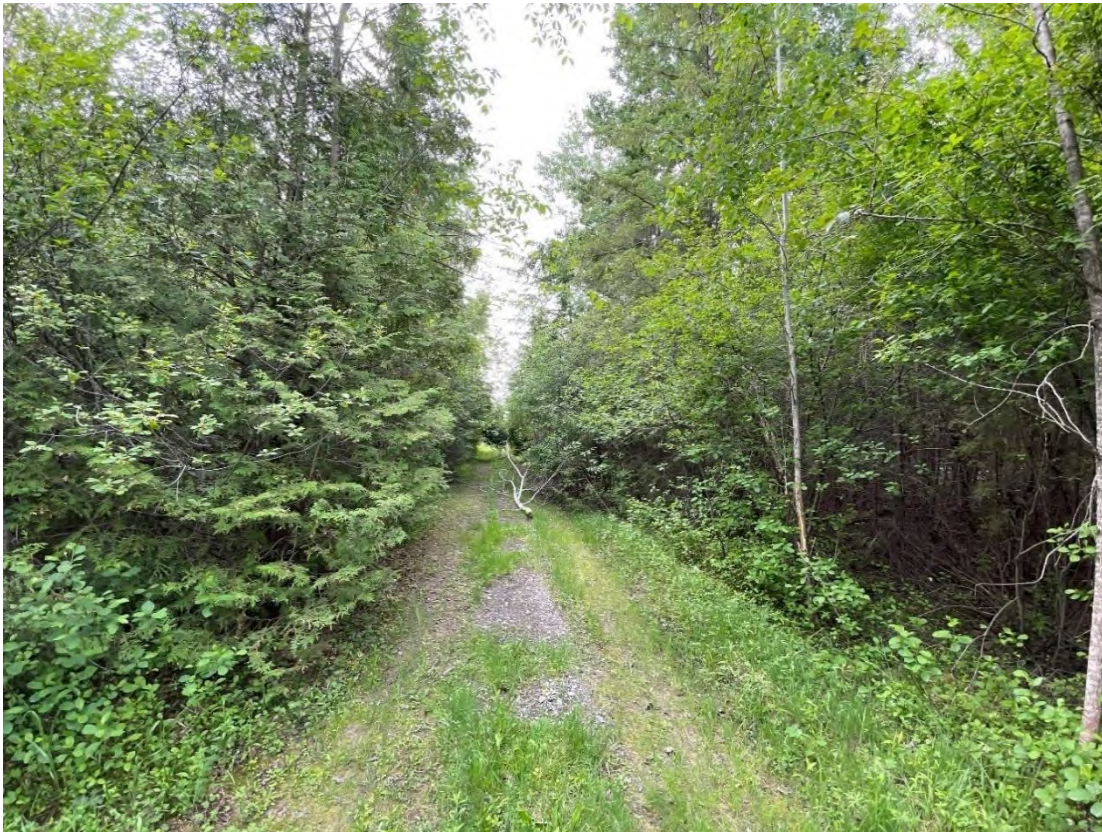
Figure 4. Dry - Fresh White Cedar – Hardwood Mixed Forest Type (FOMM4-3)

A broad swath of the western portion of the Site is characterized as a Dry - Fresh White Cedar – Hardwood Mixed Forest Type (FOMM4-3) community (Figure 4). It is dominated by Eastern White Cedar (*Thuja occidentalis*; 10-20 cm DBH), Trembling Aspen (*Populus tremuloides*; 10-20 cm DBH), Green Ash (*Fraxinus pennsylvanica*; 10-15 cm DBH), Large tooth Aspen (*Populus grandidentata*; ~15 cm DBH), White Spruce (*Picea glauca*; 30 cm DBH), White Pine (*Pinus strobus*; 25 cm DBH), Larch/Tamarack (*Larix laricina*; 15-20 cm DBH), American Beech (*Fagus grandifolia*; 10-15 cm DBH), and American Elm (*Ulmus americana*). Butternut* (*Juglans cinerea*; 20-50 cm DBH) were observed scattered throughout this community.

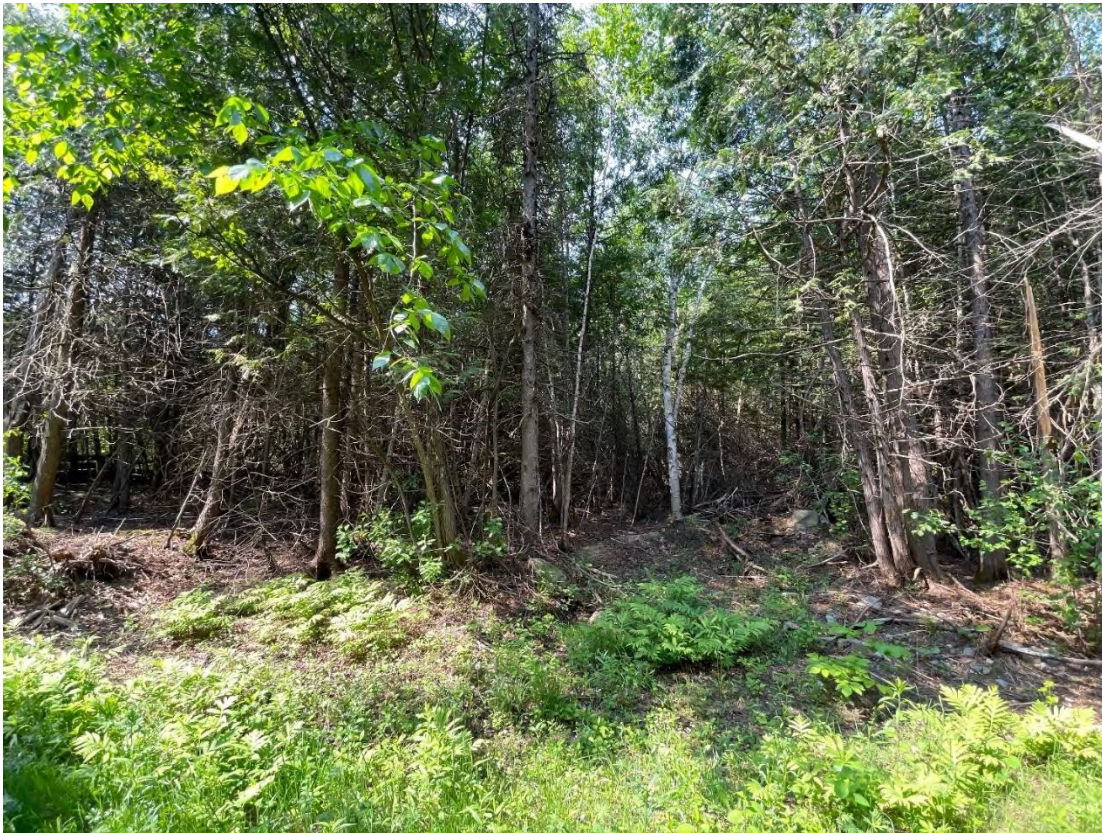
Figure 5. Fresh - Moist White Cedar - Hardwood Mixed Forest Type (FOMM7-2)

The western-most extent of the Site is characterized as a Fresh - Moist White Cedar - Hardwood Mixed Forest Type (FOMM7-2) community (Figure 5). It is dominated by Eastern White Cedar (*Thuja occidentalis*; 5-15 cm DBH), White Birch (*Betula papyrifera*; 10-20 cm DBH), Trembling Aspen (*Populus tremuloides*; 10-35 cm DBH), White Ash (*Fraxinus americana*; 5-8 cm DBH), White Spruce (*Picea glauca*; ~10 cm DBH), and Balsam Fir (*Abies Balsamea*) tree species.

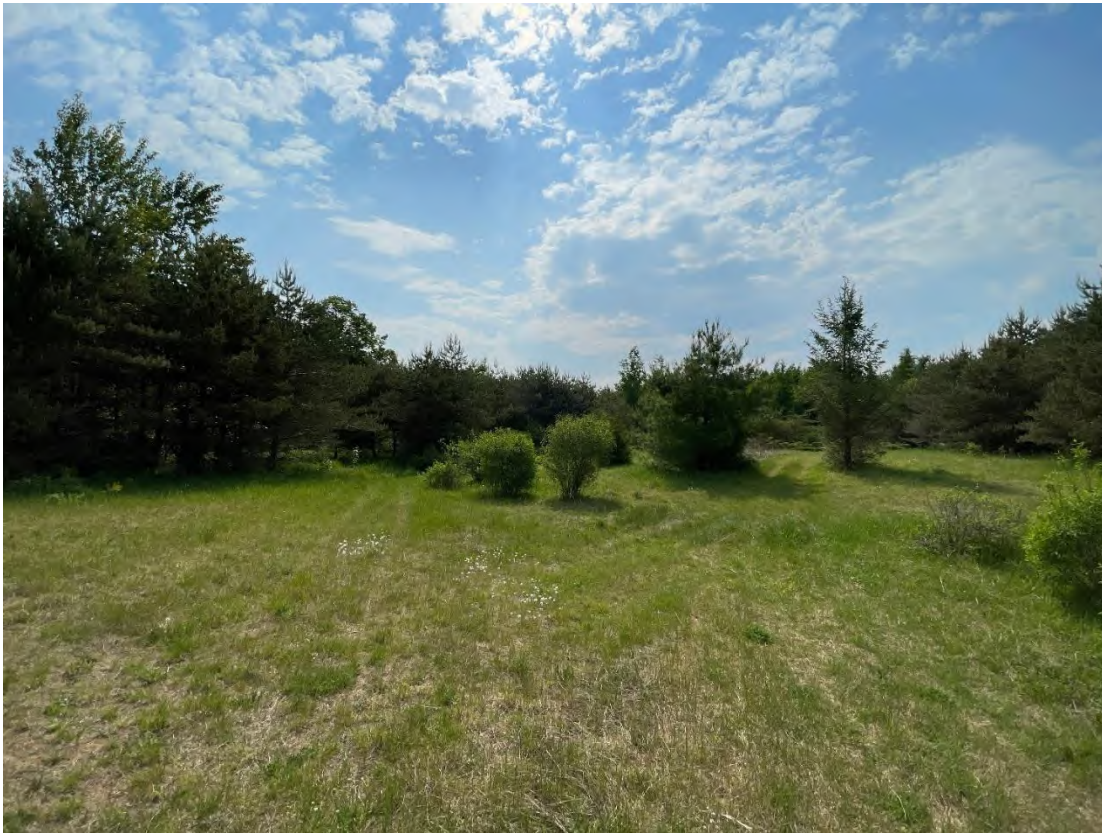
Figure 6. Dry – Moist Old Field Meadow Type (CUM1-1)

A Dry – Moist Old Field Meadow Type (CUM1-1; Figure 6) is located centrally on the Site. This area is characteristic of previous disturbance with scattered tree species including Large tooth Aspen (*Populus grandidentata*; ~5 cm DBH), Trembling Aspen (*Populus tremuloides*; 10-25 cm DBH), Eastern White Cedar (*Thuja occidentalis*; ~10 cm DBH), Scots Pine (*Pinus sylvestris*; 5-10 cm DBH), American Beech (*Fagus grandifolia*; ~10 cm DBH), Apple Spp. (*Malus*; 8-10 cm DBH), White Spruce (*Picea glauca*; 20-25 cm DBH), Larch/Tamarack (*Larix laricina*; ~5-10 cm DBH), Green Ash (*Fraxinus pennsylvanica*; <5 cm DBH). Dominant shrub and groundcover species included Common Juniper (*Juniperus communis*), Trembling Aspen (*Populus tremuloides*) saplings, Orchard Grass (*Dactylis glomerata*), Wild Strawberry (*Fragaria vesca*), Canada Goldenrod (*Solidago canadensis*), Poison Ivy (*Toxicodendron radicans*), Red Raspberry (*Rubus idaeus*), Alder Buckthorn (*Rhamnus frangula*), and Common Blackberry (*Rubus allegheniensis*).

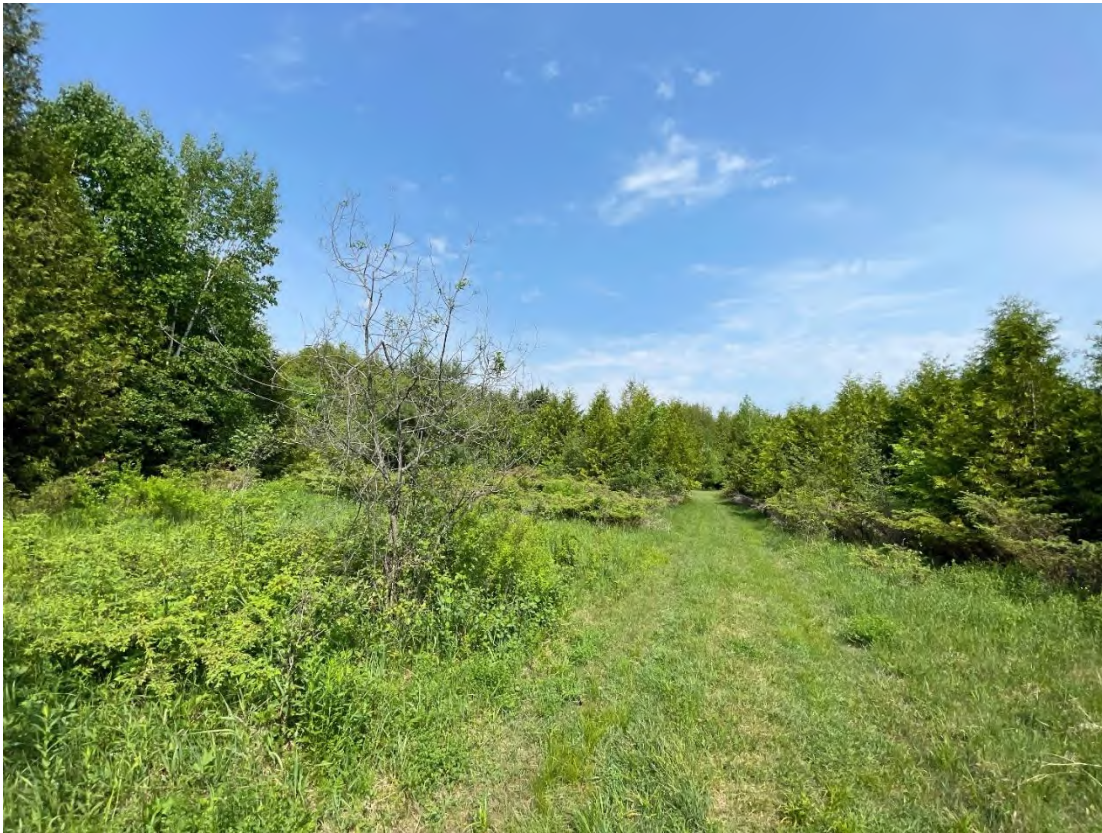
Figure 7. Dry – Fresh Mixed Meadow Ecosite (MEMM3)

A Dry – Fresh Mixed Meadow Ecosite (MEMM3) is located in the northwest corner of the Site (Figure 7). This area is mainly characterized by Eastern White Cedar (*Thuja occidentalis*), Scots Pine (*Pinus sylvestris*; ~10-20 DBH), Larch/Tamarack (*Larix laricina*; ~10 DBH), and scattered Butternut* (*Juglans cinerea*; ~10-20 DBH) trees. Dominant shrub and groundcover species included Common Juniper (*Juniperus communis*), Orchard grass (*Dactylis glomerata*), Wild strawberry (*Fragaria vesca*), Canada Goldenrod (*Solidago canadensis*), Alder Buckthorn (*Rhamnus frangula*), and Common Blackberry (*Rubus allegheniensis*).

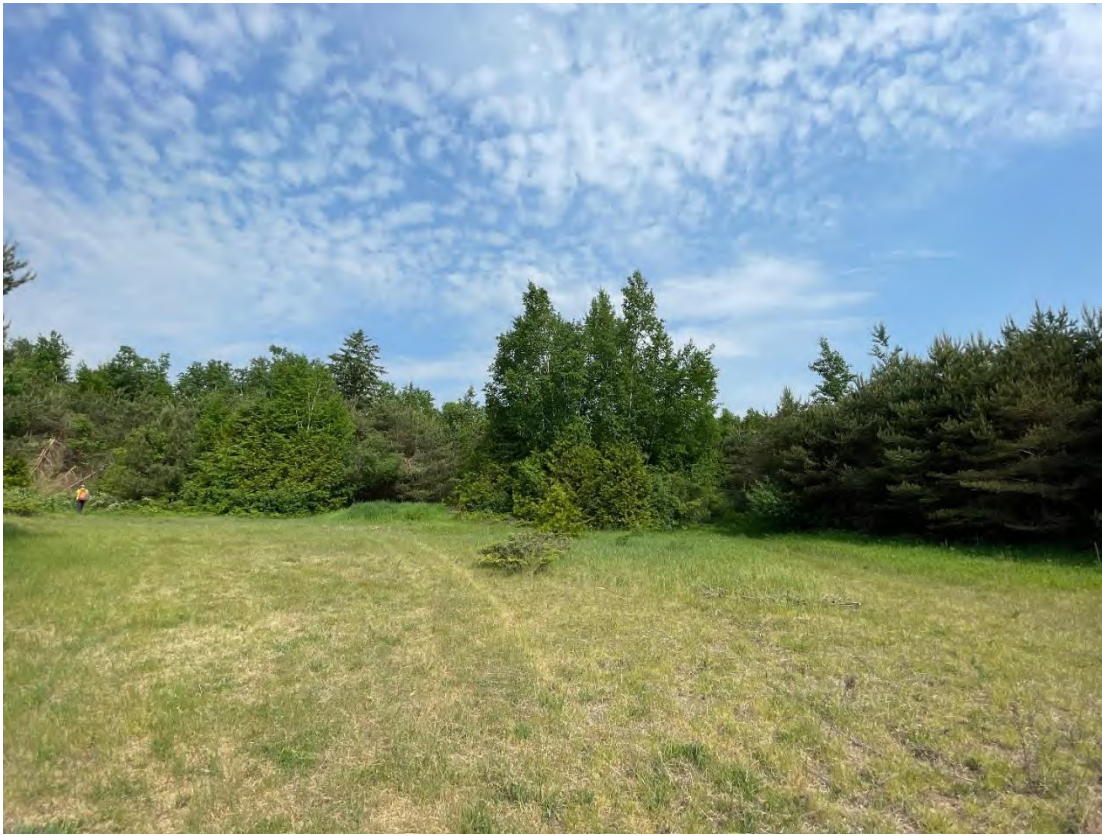
Figure 8. Dry – Fresh Scots Pine Naturalized Coniferous Plantation Type (FOCM6-3)

A Fresh Scots Pine Naturalized Coniferous Plantation Type (FOCM6-3) is located in the northwest corner of the Site (Figure 8). It is mainly dominated by Scots Pine (*Pinus sylvestris*; ~10-20 cm DBH), Jack Pine (*Pinus banksiana*; ~15 cm DBH), Eastern White Cedar (*Thuja occidentalis*), White Pine (*Pinus strobus*; ~20 cm DBH), White Birch (*Betula papyrifera*; 10-20 cm DBH), Butternut* (*Juglans cinerea*), American Beech (*Fagus grandifolia*), and Green Ash (*Fraxinus pennsylvanica*; 10-15 cm DBH).

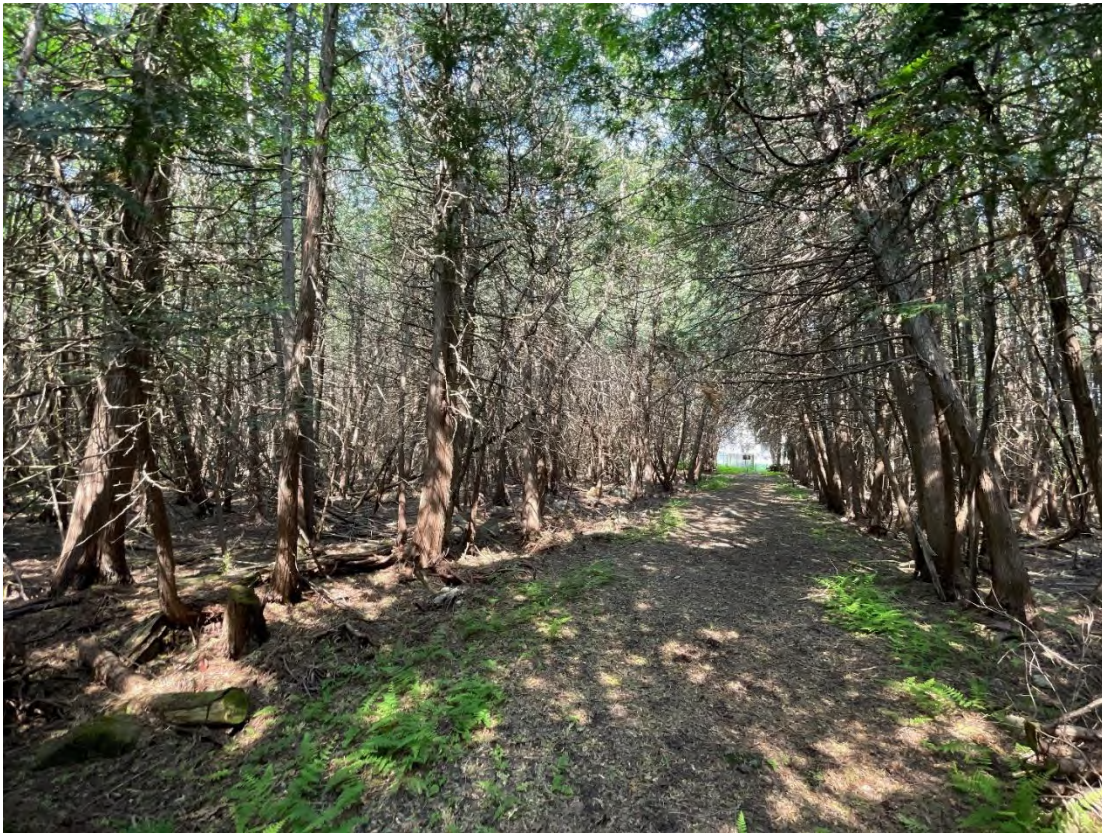
Figure 9. White Cedar Mineral Coniferous Swamp (SWCM1-1)

A White Cedar Mineral Coniferous Swamp (SWCM1-1) is located on Site (Figure 9). It is dominated by Eastern White Cedar (*Thuja occidentalis*) and has ground cover consisting of Bulblet Bladder Fern (*Cystopteris bulbifera*), Alder Buckthorn (*Rhamnus frangula*), Interrupted Fern (*Osmunda claytoniana*), Sensitive Fern (*Onoclea sensibilis*), and Poison Ivy (*Toxicodendron radicans*).

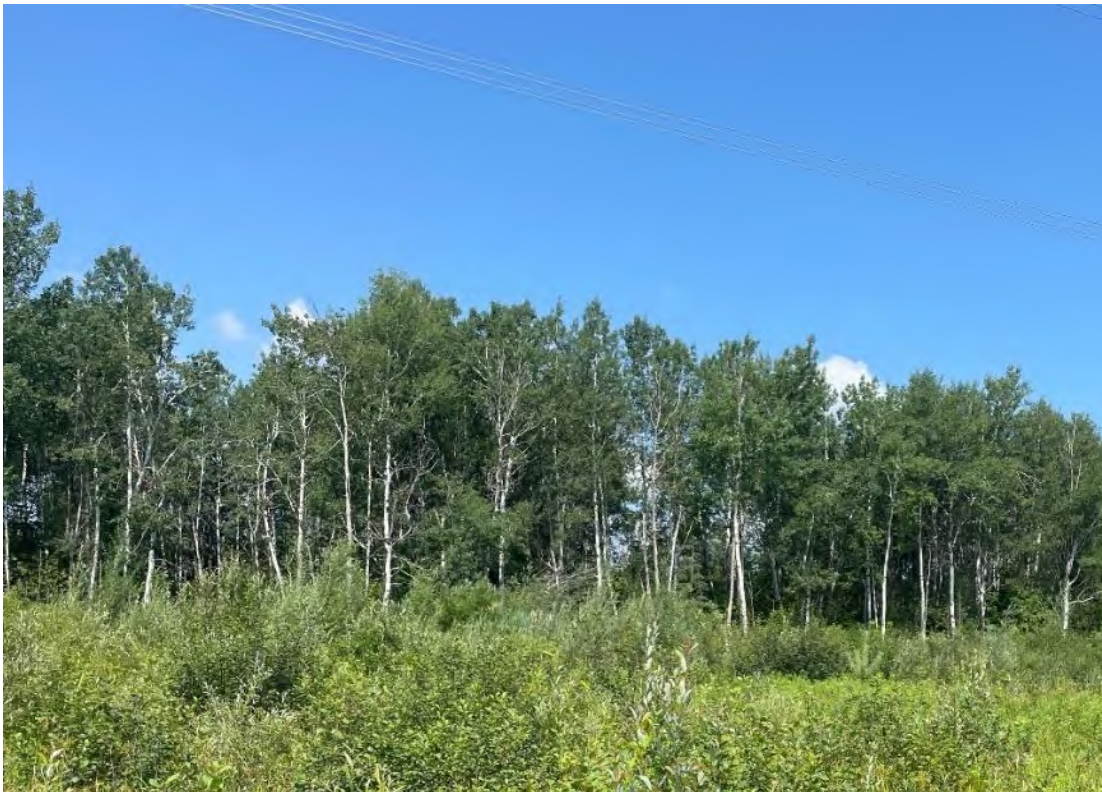
Figure 10. Fresh – Moist Lowland Deciduous Forest Ecosite (FODM7)

A Fresh-Moist Lowland Deciduous Forest Ecosite (FODM7) is located in the center of the Site (Figure 10). It is dominated by Trembling Aspen (*Populus tremuloides*), Eastern White Cedar (*Thuja occidentalis*), Butternut* (*Juglans cinerea*), Black Ash* (*Fraxinus nigra*), and Balsam Poplar (*Populus balsamifera*). Its ground cover consists of Common Buckthorn (*Rhamnus cathartica*), Poison Ivy (*Toxicodendron radicans*), White Panicle Aster (*Symphyotrichum lanceolatum*), Riverbank Grape (*Vitis riparia*), Common Ragweed (*Ambrosia artemisiifolia*), and Yellow Sweet Clover (*Melilotus officinalis*).

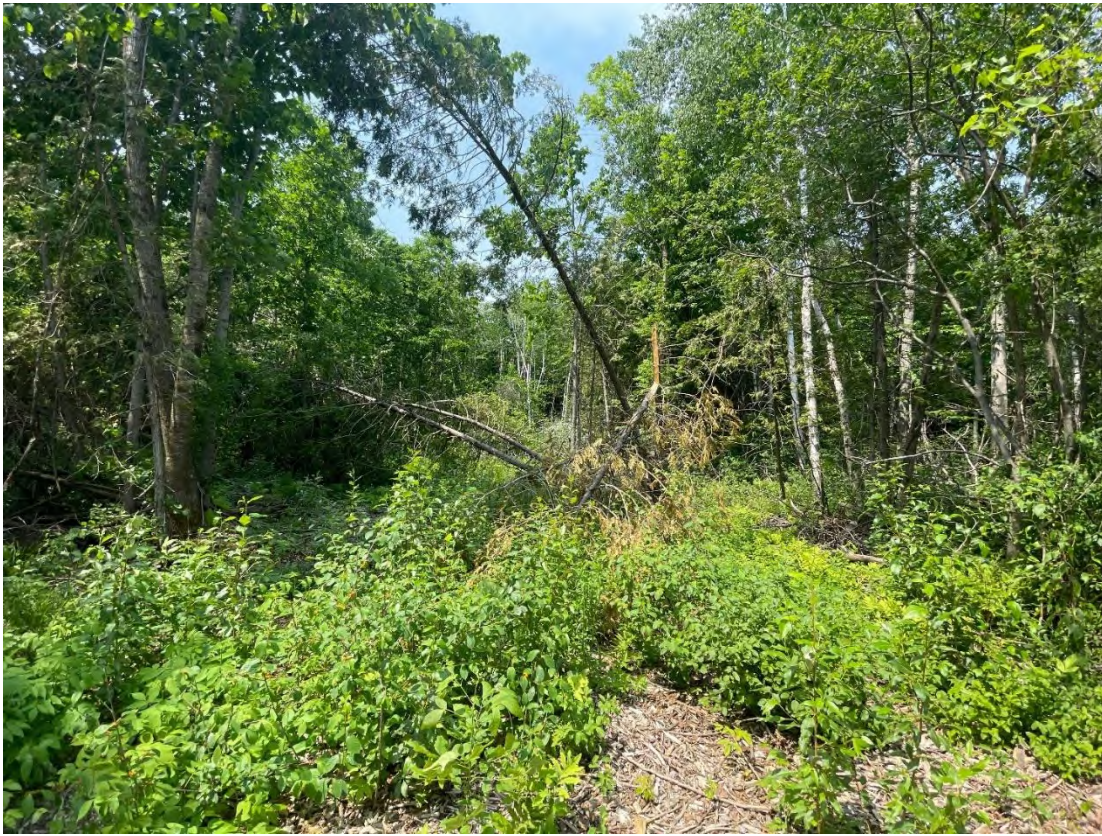
Figure 11. Fresh – Moist Poplar Deciduous Forest Type (FODM8-1)

A Fresh – Moist Poplar Deciduous Forest Type (FODM8-1; Figure 11) is located on Site and is dominated by Trembling Aspen (*Populus tremuloides*; 10-20 cm DBH), White Birch (*Betula papyrifera*; 10-20 cm DBH), Balsam Poplar (*Populus balsamifera*; 10-25 cm DBH), Butternut* (*Juglans cinerea*; 10-20 cm DBH), Eastern White Cedar (*Thuja occidentalis*; 10-20 cm DBH), Basswood (*Tilia americana*; ~30 cm DBH), Red Maple (*Acer rubrum*; ~27 cm DBH), American Elm (*Ulmus americana*; 10-20 cm DBH), and Black Ash* (*Fraxinus nigra*). Its dominant ground cover consists of Common Juniper (*Juniperus communis*), Trembling Aspen saplings (*Populus tremuloides*), Sensitive Fern (*Onoclea sensibilis*), Ostrich Fern (*Matteuccia struthiopteris*), Interrupted Fern (*Osmunda claytoniana*), Canada Goldenrod (*Solidago canadensis*), Poison Ivy (*Toxicodendron radicans*), Alder Buckthorn (*Rhamnus frangula*), Bloodroot (*Sanguinaria*), and Meadow Horsetail (*Equisetum pratense*).

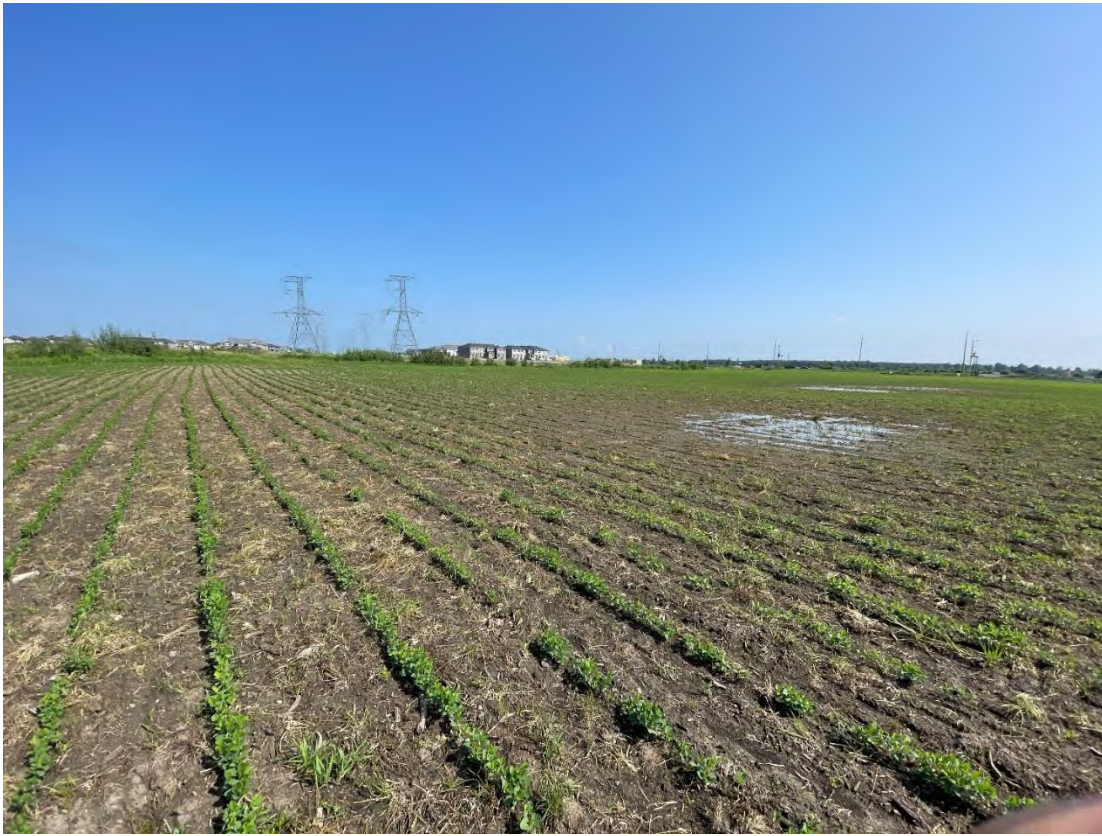
Figure 12. Medium Mineral Open Pasture Type (OAGM4)

A Medium Mineral Open Pasture Type (OAGM4) on Site (Figure 12) is dominated by planted crop cultivar and scattered shrub community species such as Canada Goldenrod (*Solidago canadensis*), Meadow Horsetail (*Equisetum pratense*), Purple Aster (*Symphyotrichum patens*), Common Mullein (*Verbascum thapsus*), Meadow Buttercup (*Ranunculus acris*), Wild Strawberry (*Fragaria vesca*), and Common Dandelion (*Taraxacum officinale*).

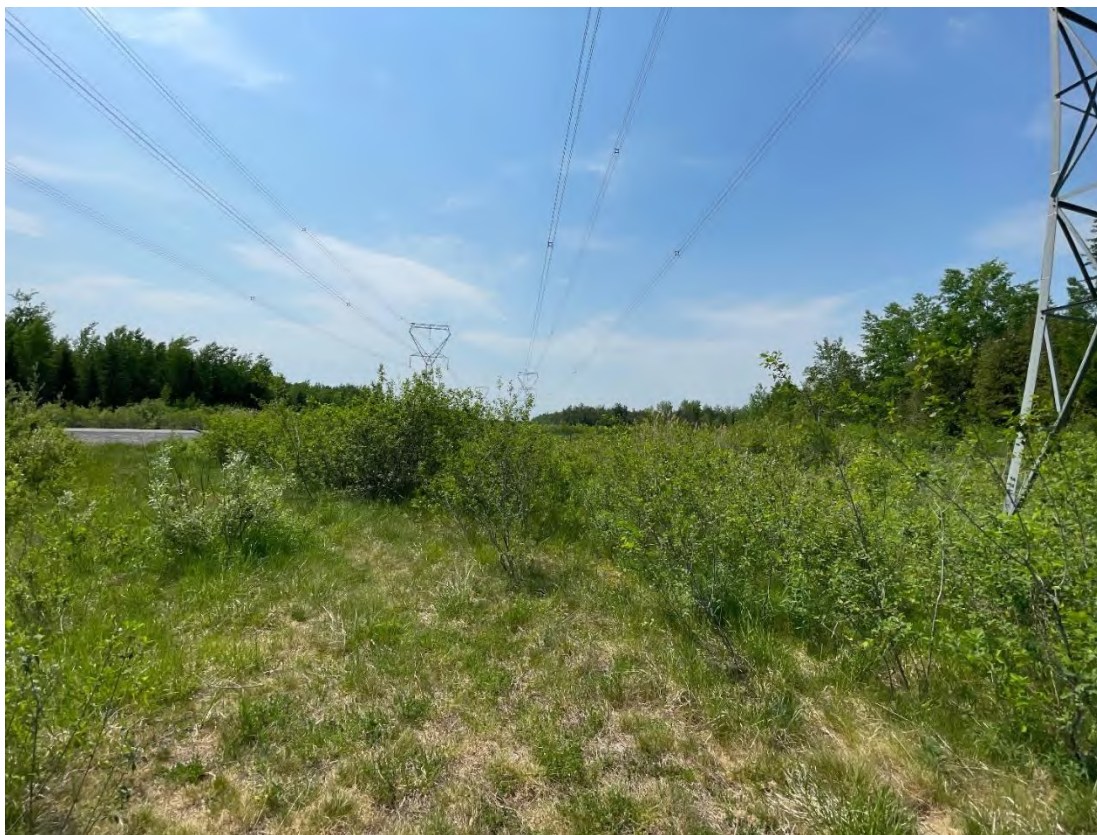
Figure 13. Cultural Thicket Ecosite (CUT1)

A Cultural Thicket Ecosite (CUT1; Figure 13) on Site is dominated by Bebb's Willow (*Salix bebbiana*), Alder Buckthorn (*Rhamnus frangula*), Trembling Aspen Saplings (*Populus tremuloides*), White Willow (*Salix alba*), White Meadowsweet (*Spiraea alba*), and Common Milkweed (*Asclepias syriaca*).

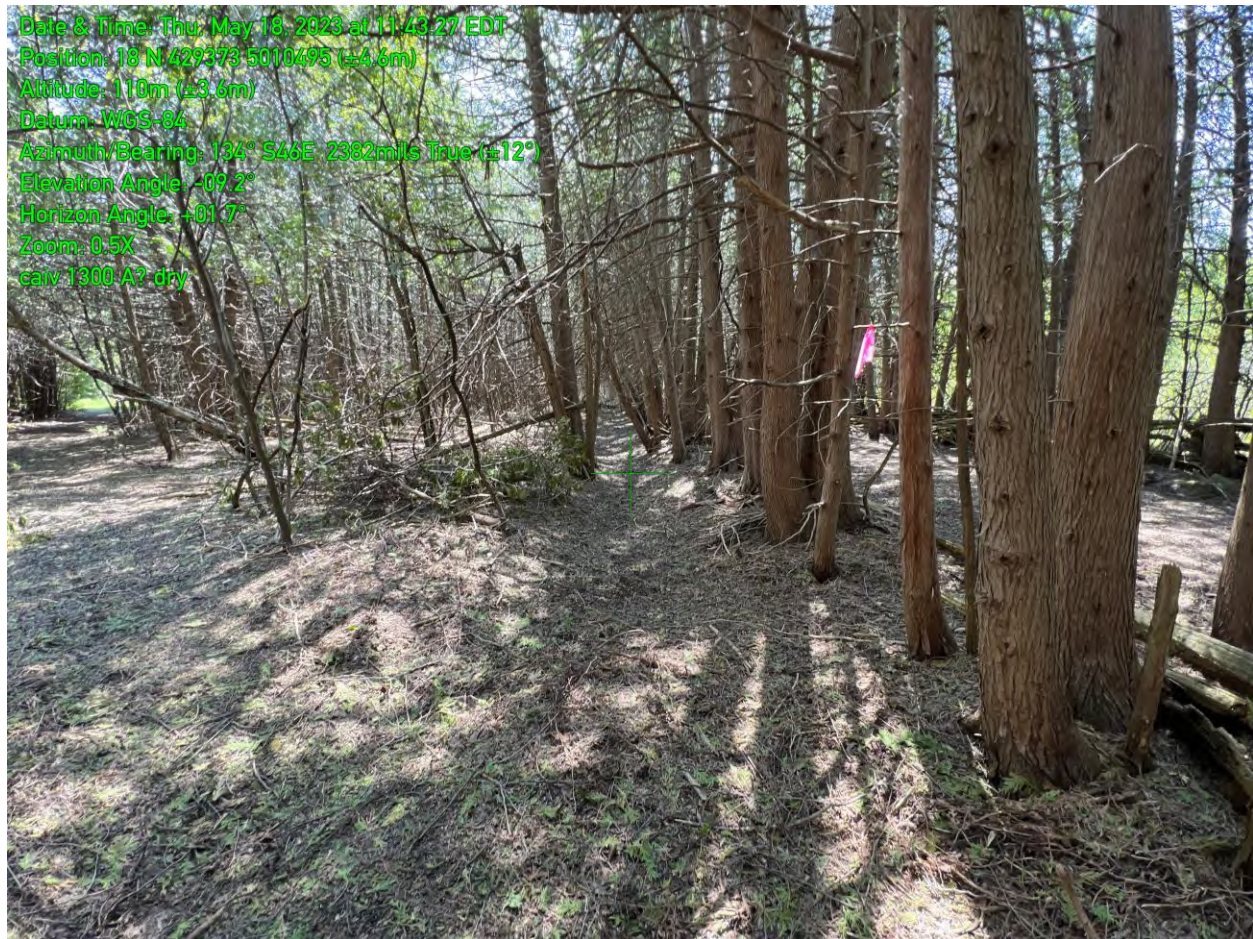
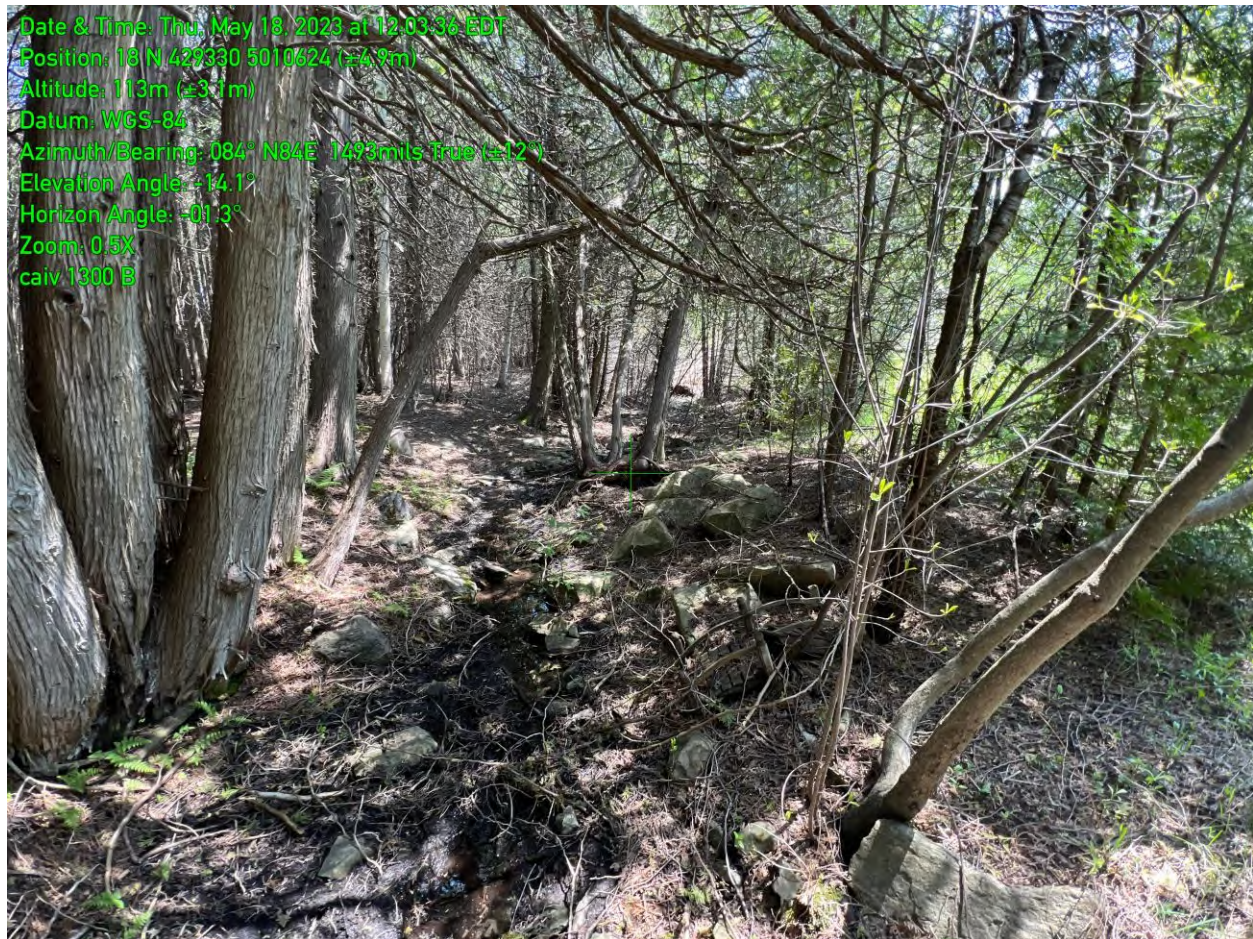
Figure 4 Tributary B

Tributary B originates within the SWCM1-1 community and flows southeast, eventually joining with Tributary E. It has a man-made standing water pool present with interstitial flow towards the Faulkner Drain. While areas of standing water can potentially function as amphibian breeding habitat, no amphibians were observed within this reach. The chain of classification descriptors leads to a management directive of Protection for this reach.

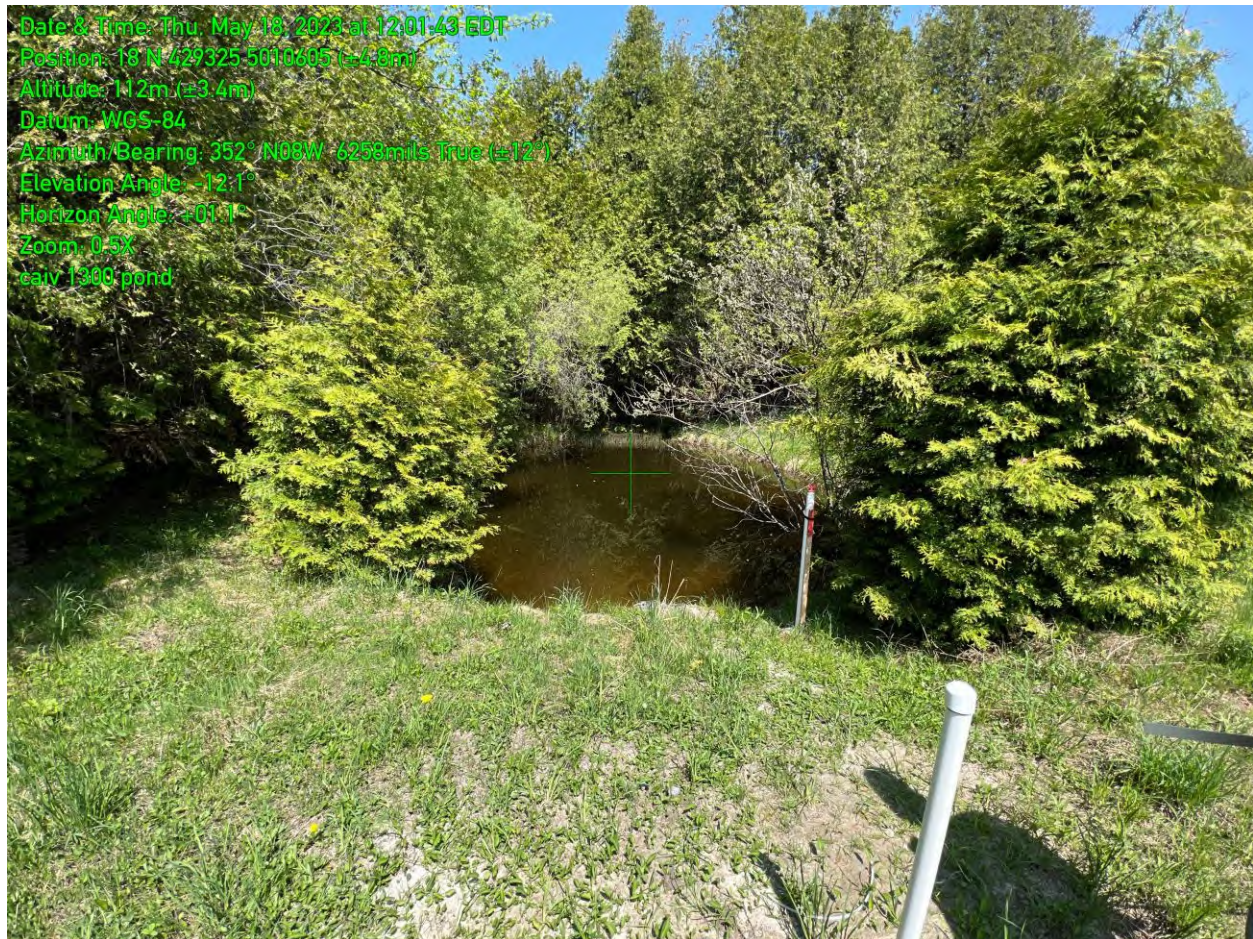
Figure 7 Tributary C

Tributary C is a roadside ditch feature that originates at the southwestern corner of the Site, at the terminus of Tributary D. It flows eastward, joining the Faulkner Drain. Tributary C is a permanent feature that has water present year-round. This feature was confirmed to function as amphibian breeding habitat and fish habitat. The chain of classification descriptors leads to a management directive of Protection for this reach. It is recommended that this feature be retained to maintain overland flow conditions on the Site and along Flewellyn Road.

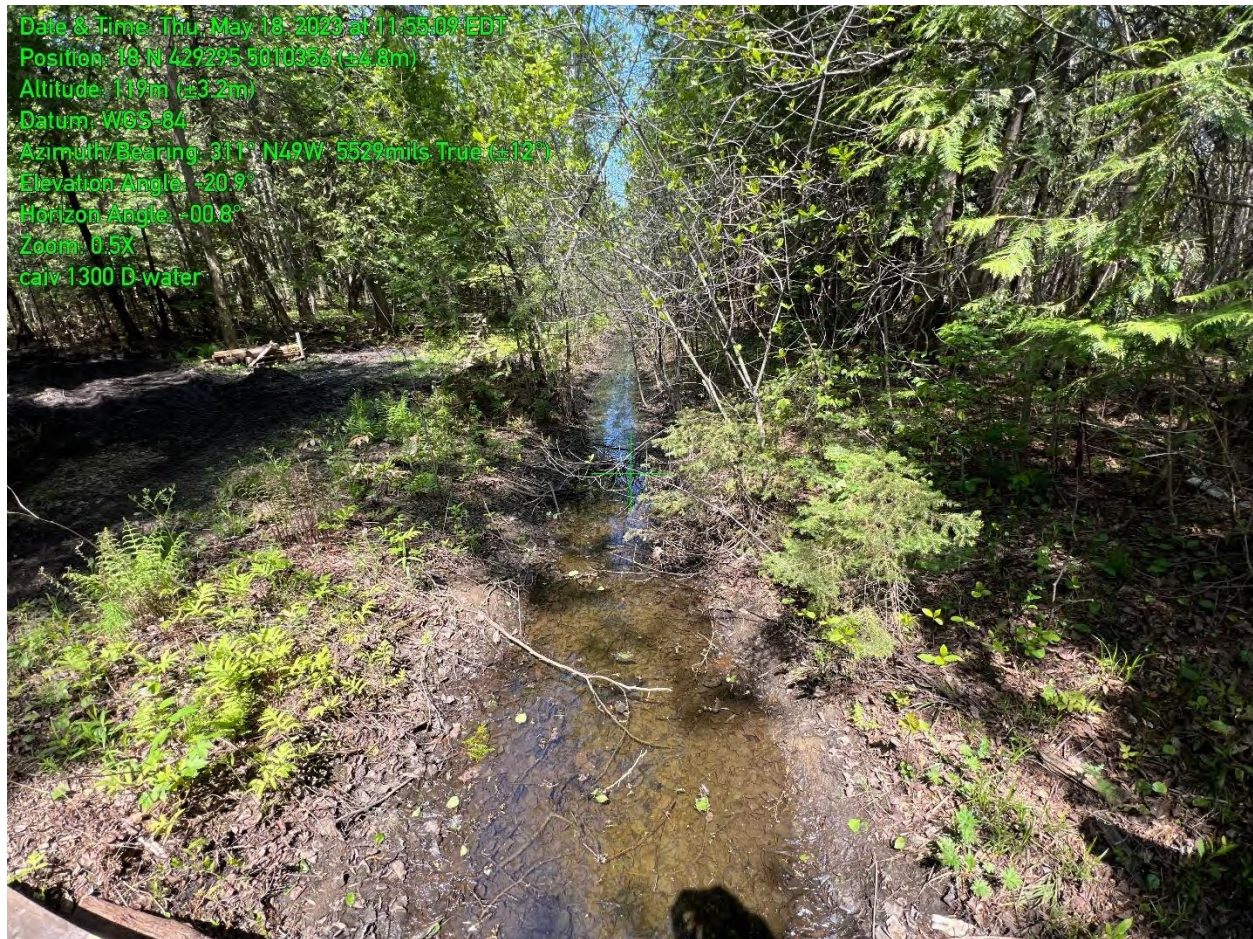
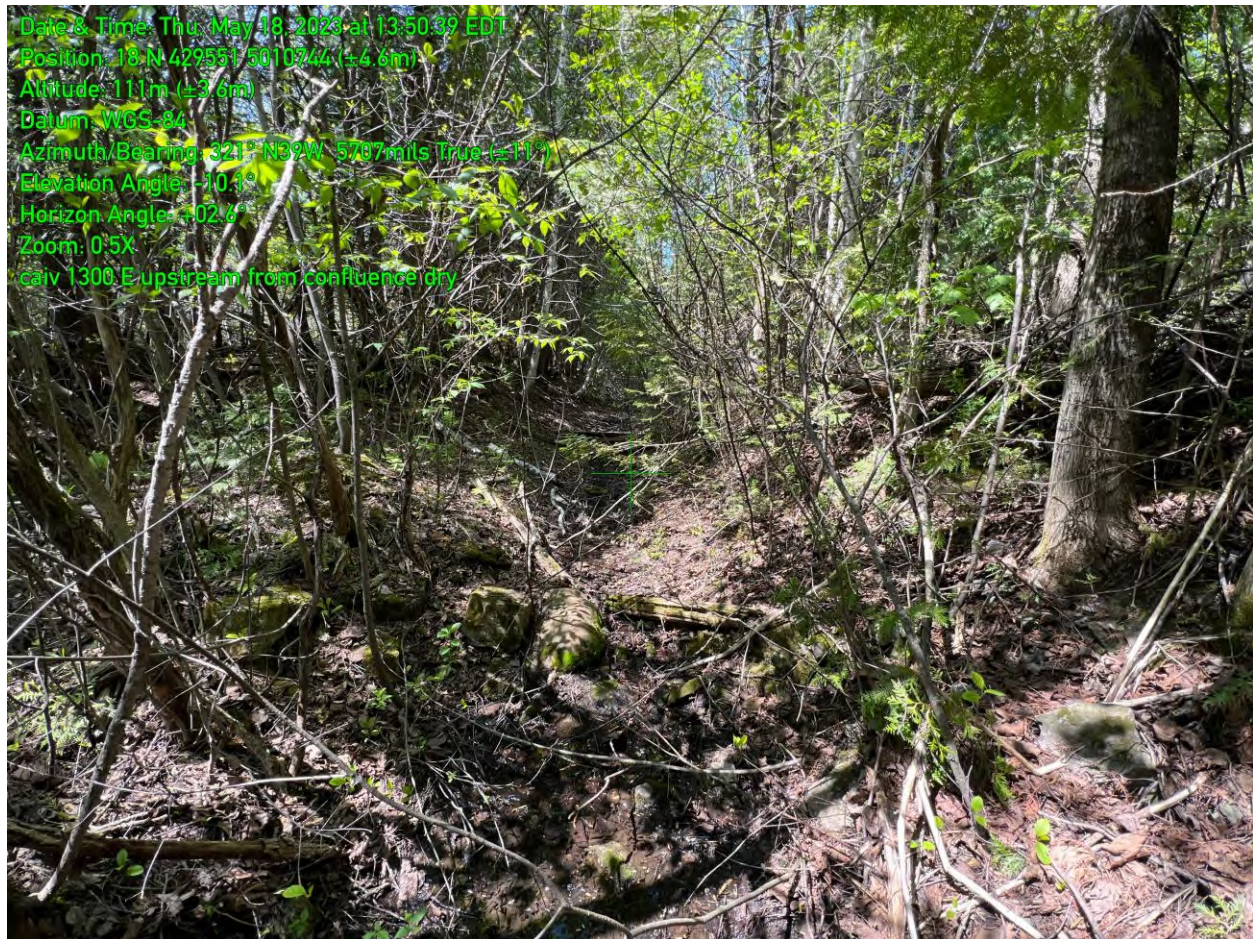
Figure 9 Tributary E

Tributary E is a constructed, linear channel feature that originates within the FOMM4-3 and MEMM3 vegetation communities and flows south eventually turning eastward joining the Faulkner Drain. It has intermittent standing water pools present with intermittent flow towards Faulkner Drain. Standing water contributes to groundwater recharge and can function as amphibian breeding habitat. Breeding amphibians were observed within this reach. The chain of classification descriptors leads to a management directive of Protection for this reach.

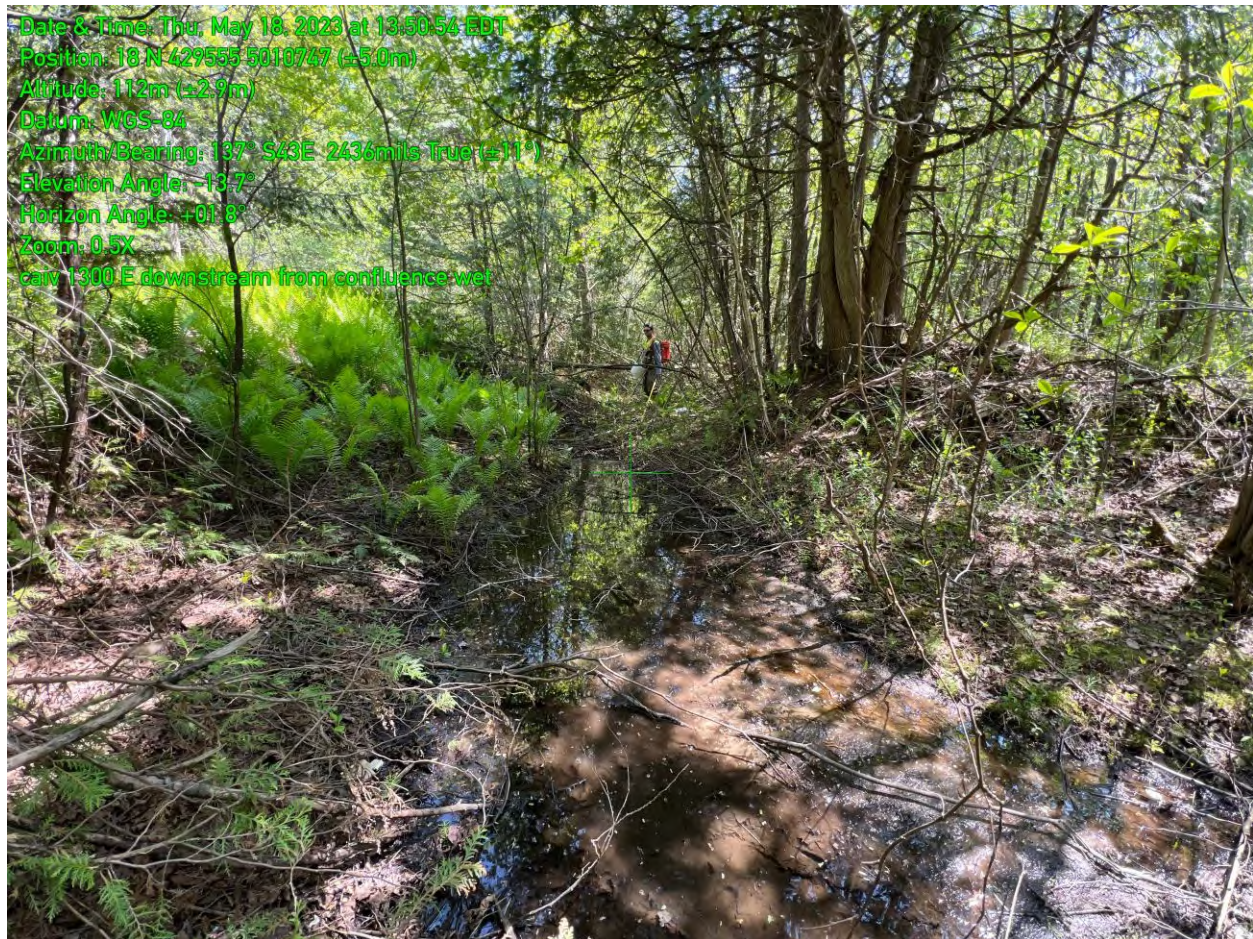
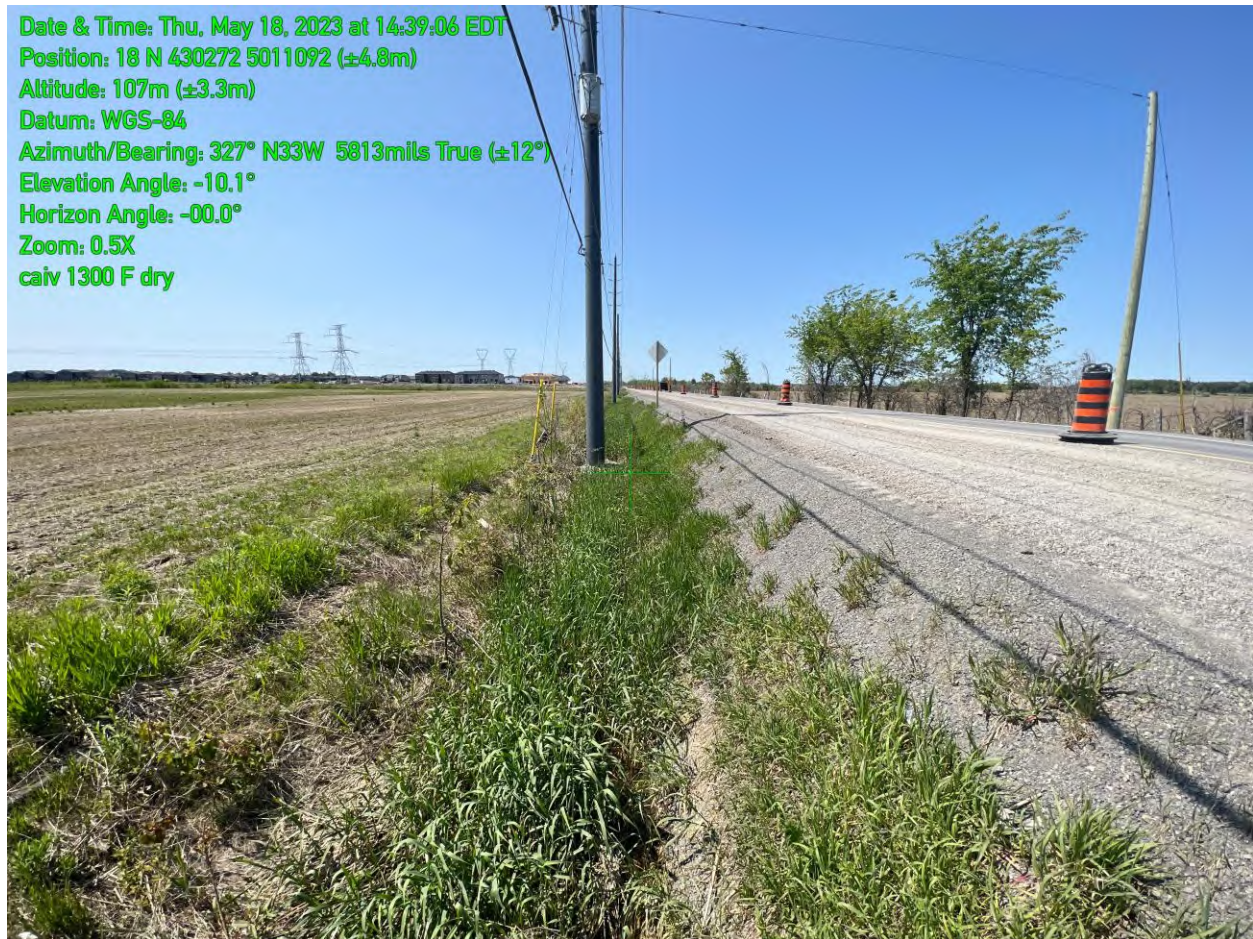
Figure 11 Tributary F

Tributary F is a roadside ditch feature located along Shea Road at the eastern Site boundary. It is located adjacent to an idle agricultural field and connects downstream to the Faulkner Drain at the intersection with Flewellyn Road. It primarily functions as a drainage feature supporting spring run-off and after heavy rainfall. Breeding amphibians were not observed within this reach. Significant groundworks have and continue to occur in the southern portion of this tributary, and a large portion of this tributary has been
