Stittsville South W4 Future Neighborhood Area: Environmental Impact Study

Updated Report

KILGOUR & ASSOCIATES LTD.
www.kilgourassociates.com

Project Number: CAIV 1300.4

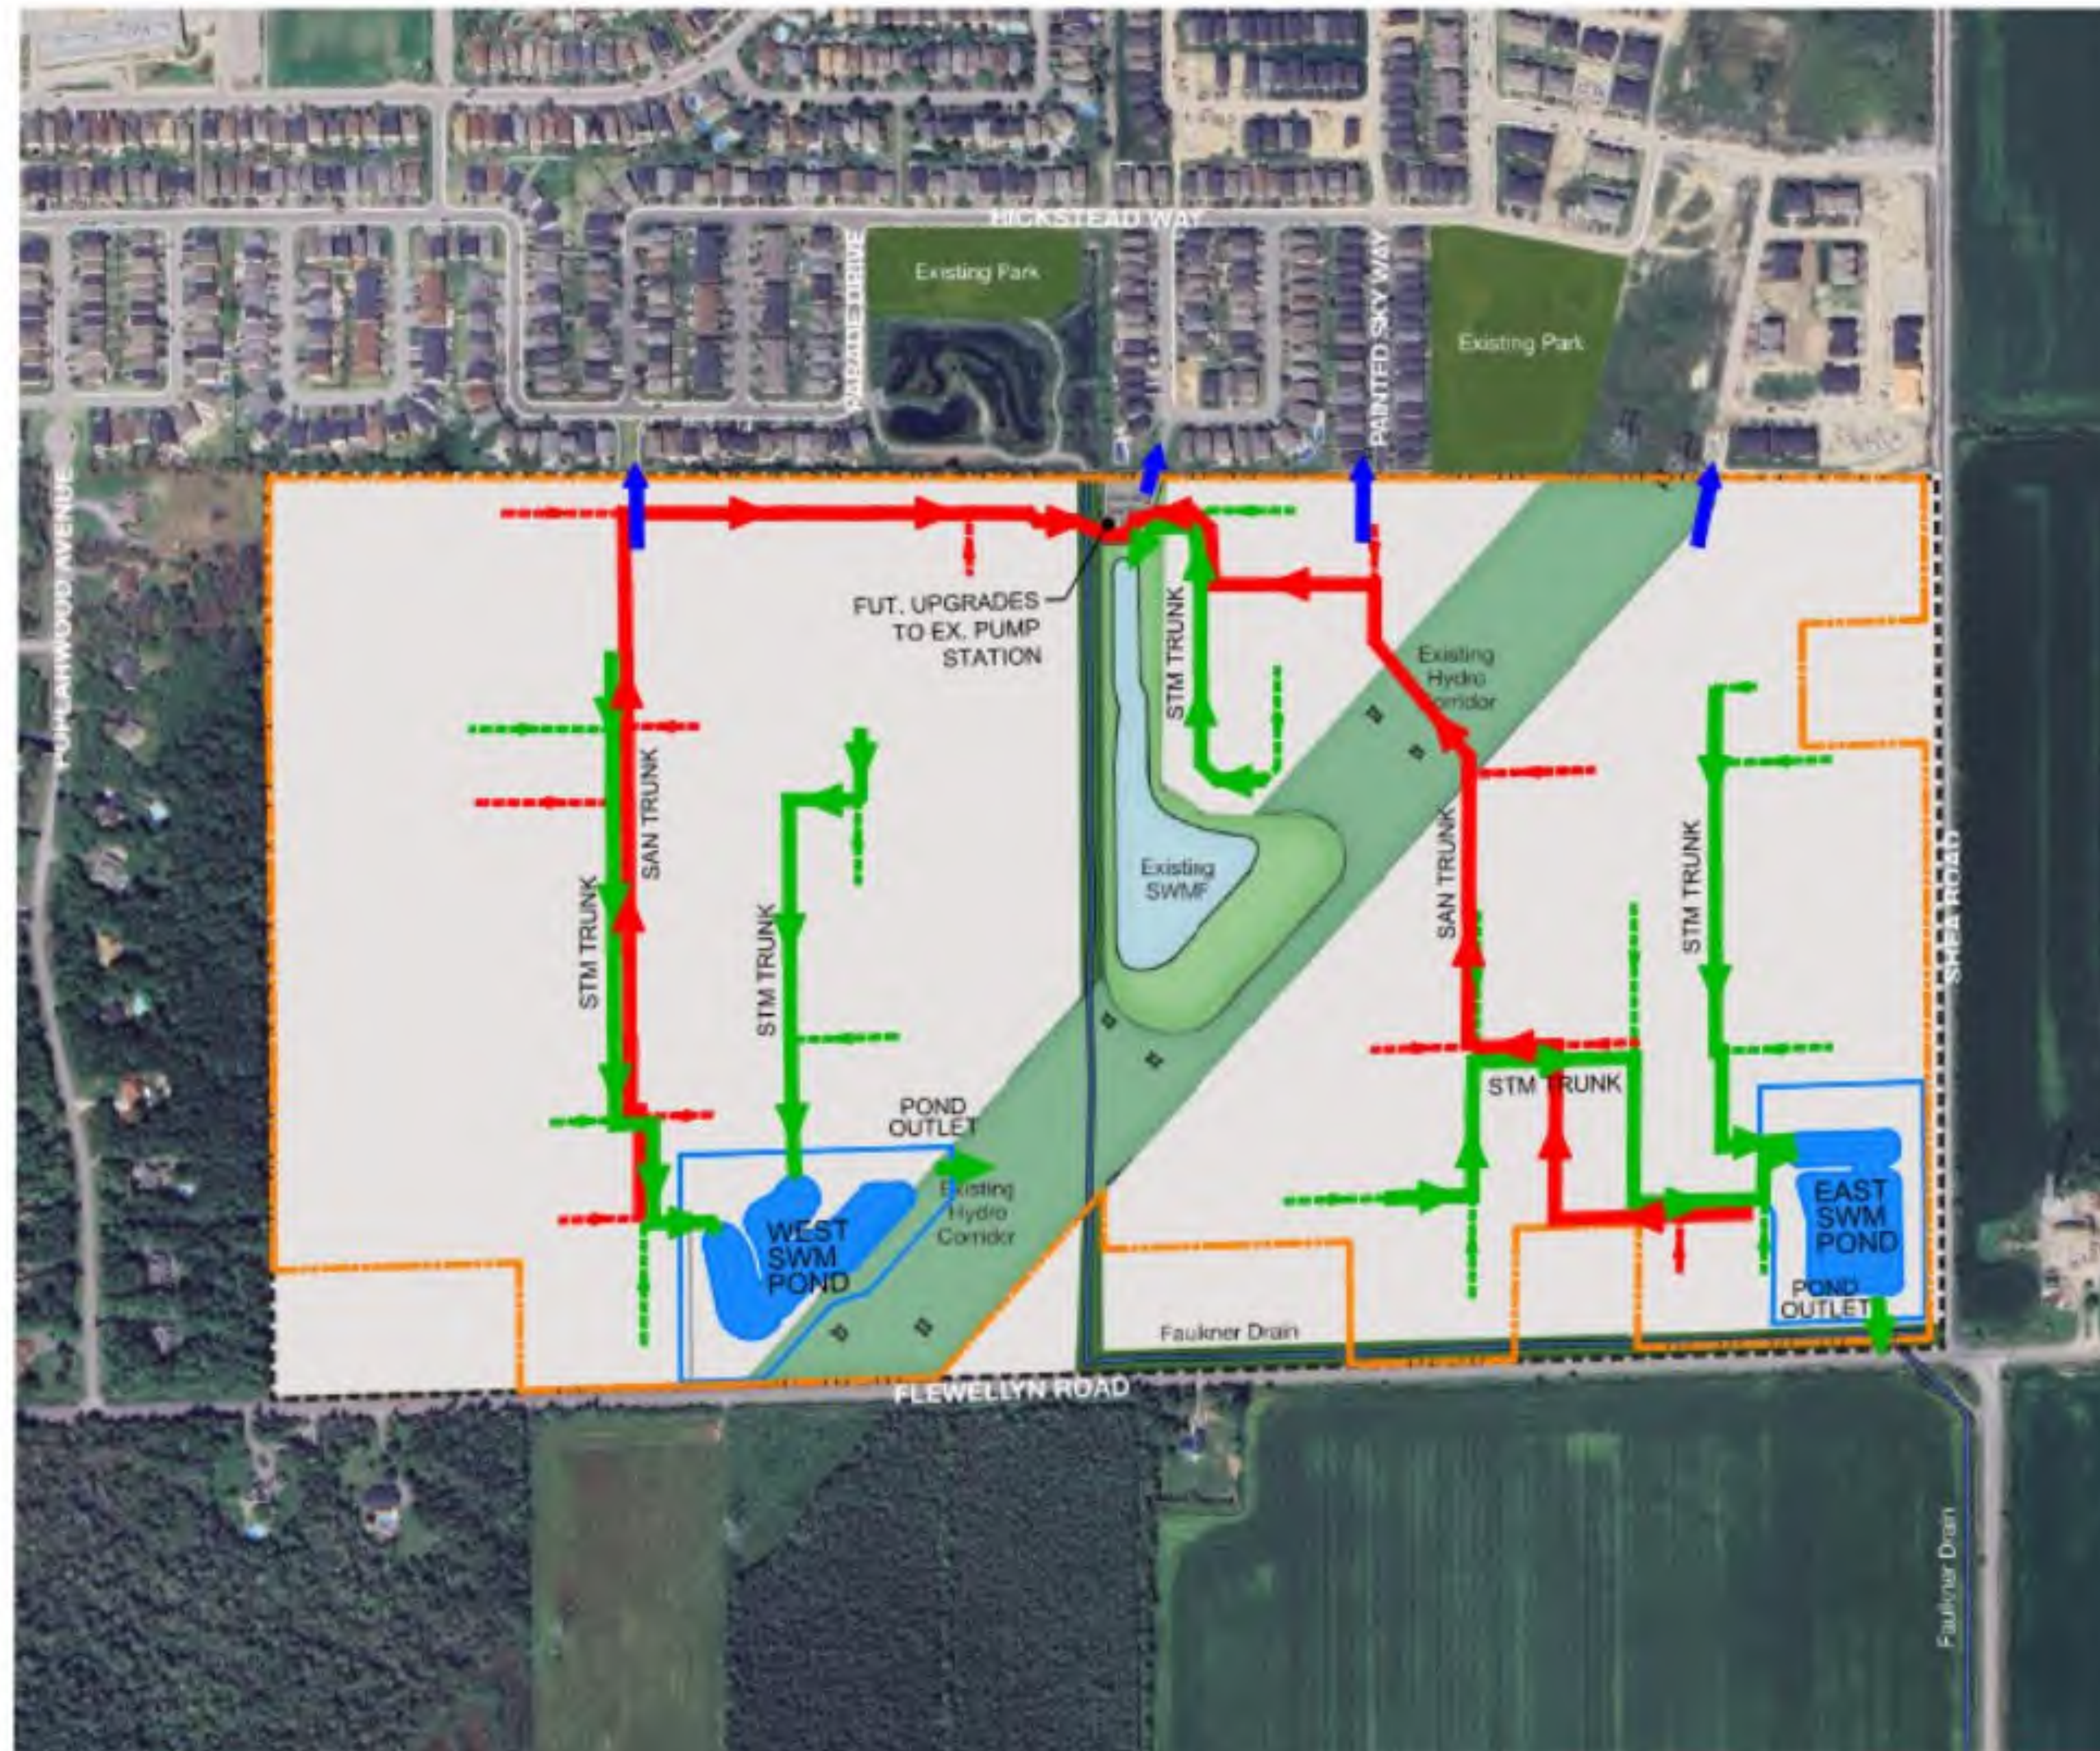
Stittsville South W-4 Conceptual Servicing Concept Plan - Option 1
