## Phase Two Environmental Site Assessment 116 Beech Street, Ottawa, Ontario

Phase Two Environmental Site Assessment

OTT-23005943-C0

2023-07-14

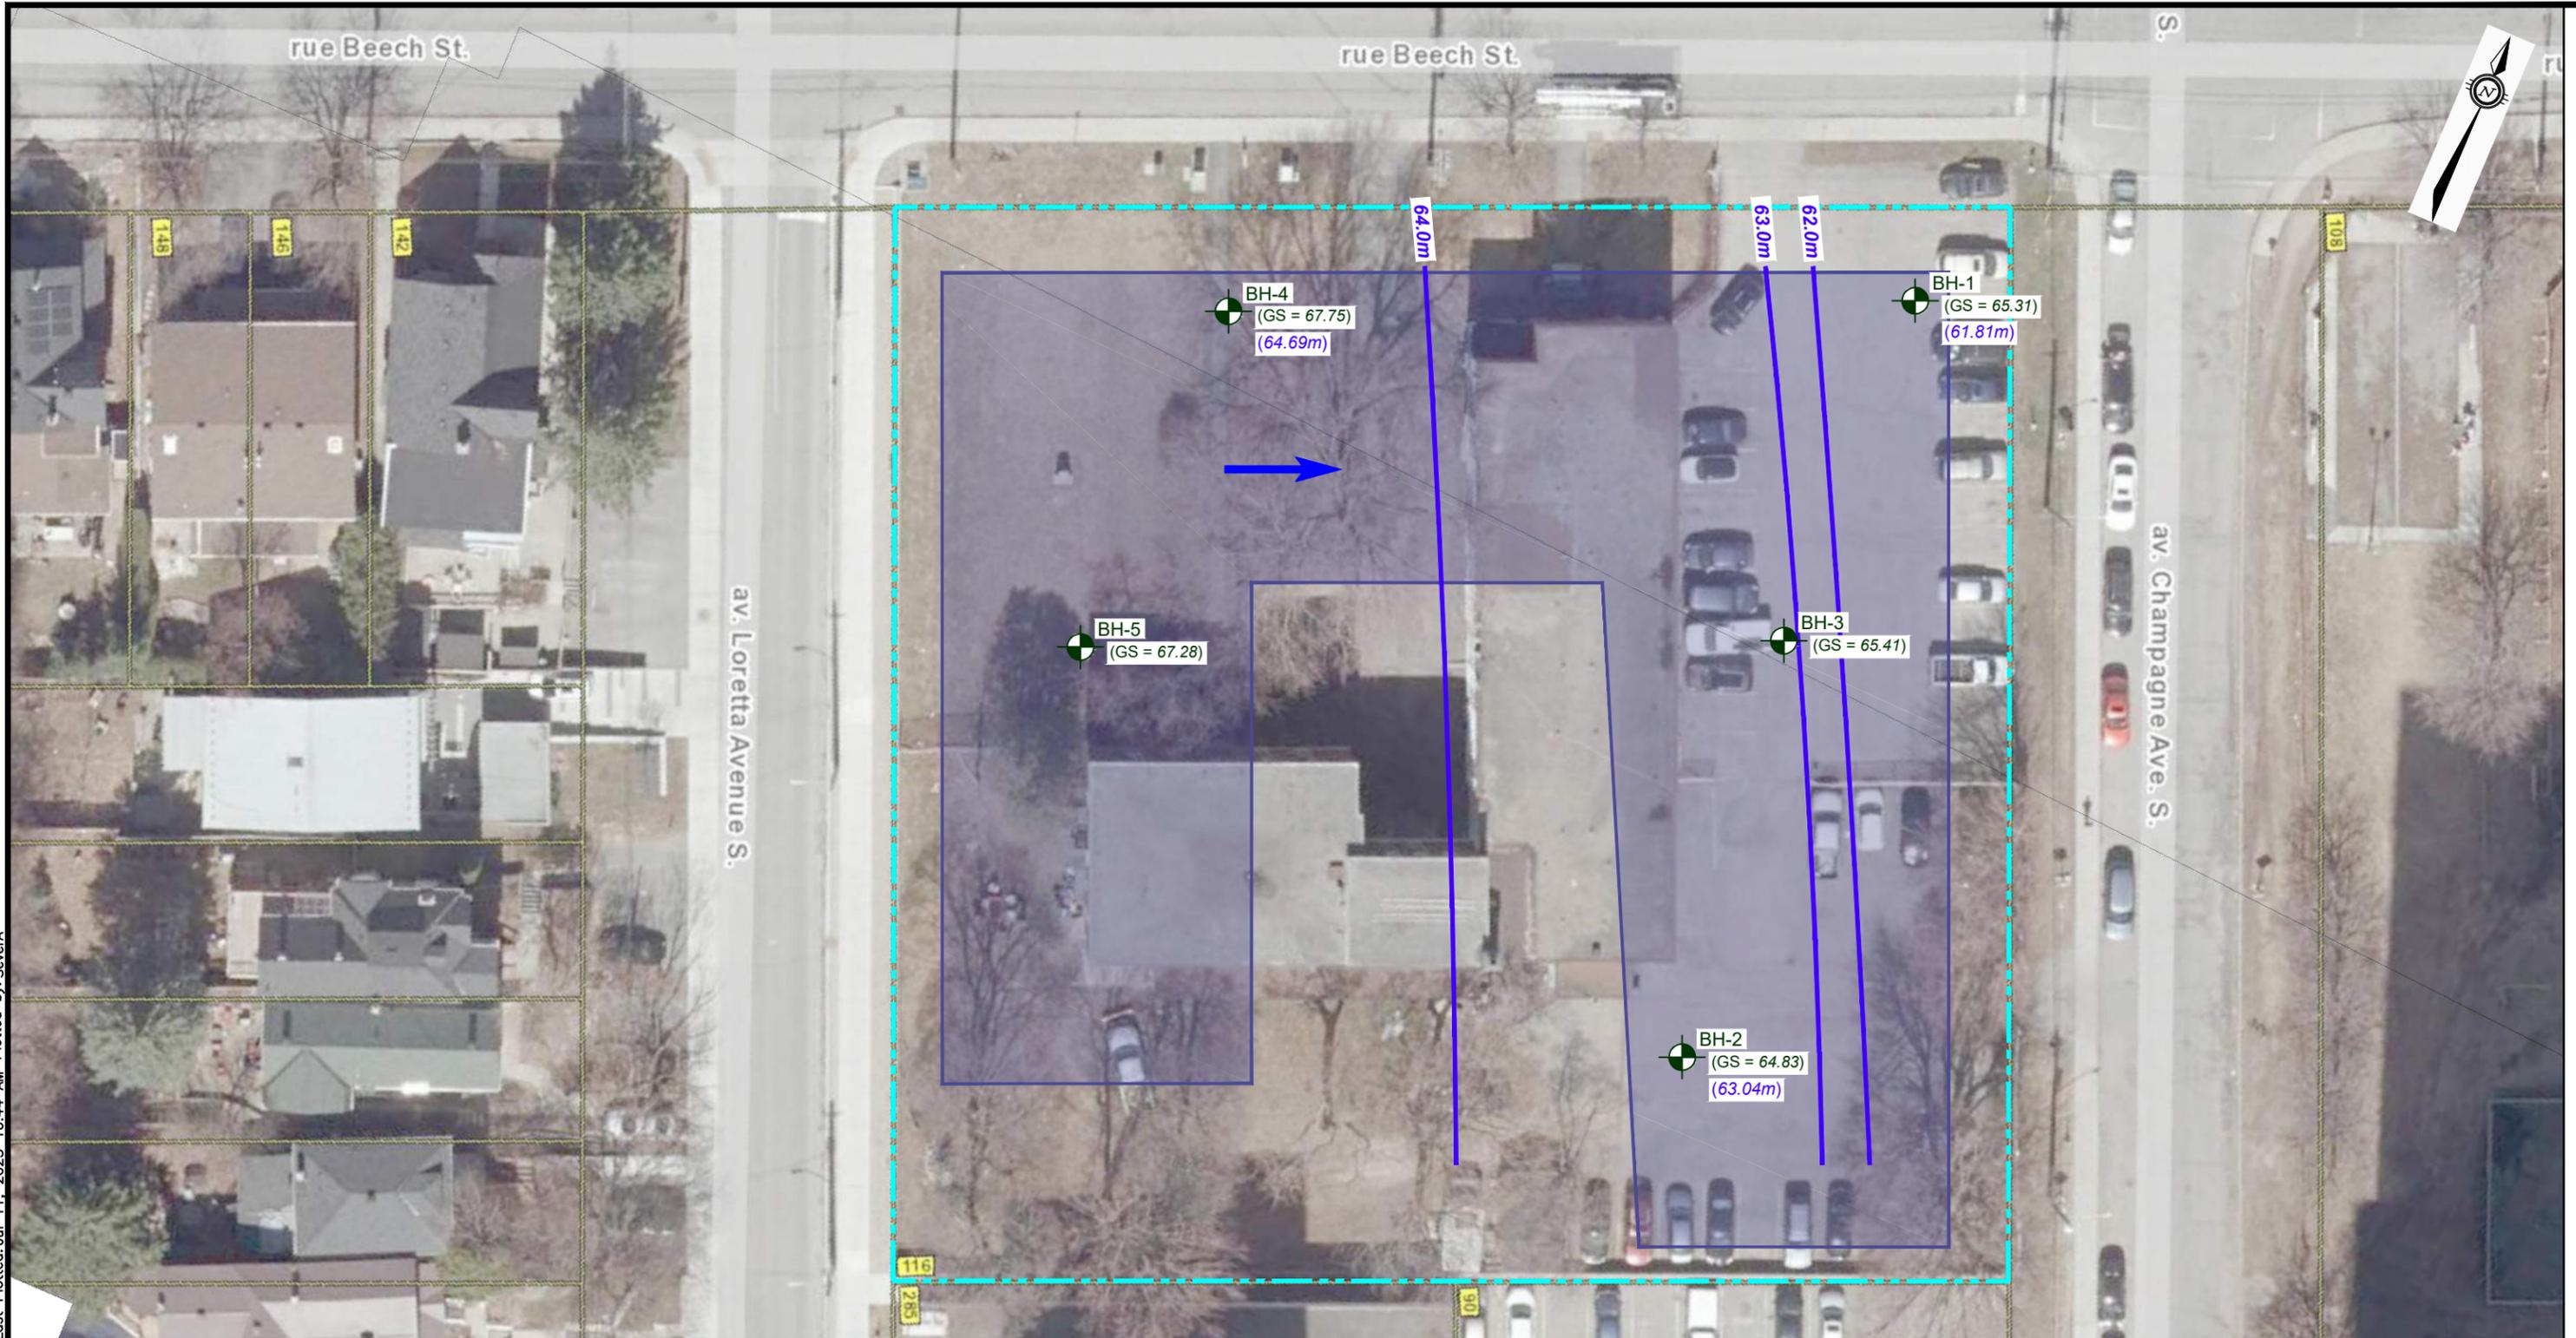
DATE	JULY 2023	<b>PROPOSED HIGH RISE DEVELOPMENT</b> 116 BEECH STREET, OTTAWA, ONTARIO <b>PHASE TWO ENVIRONMENTAL SITE ASSESSMENT</b> GROUNDWATER CONTOUR PLAN	project no.	OTT-23005943-C0
DESIGN	LW		scale	1:400
DRAWN BY	AS			FIG 4

PROPERTY BOUNDARIES
	PROPOSED HIGH RISE BUILDINGS FOOTPRINT
	BH-1 BOREHOLE NO. AND LOCATION (EXP, 2023)
	(GS = 65.31) GROUND SURFACE ELEVATION (m)
	ACCORDING TO FARLEY, SMITH & DENIS SURVEYING LTD. SURVEY (DATED: 16/09/2022)
	(61.81m) GROUNDWATER LEVEL (m)
	62.0m GROUNDWATER ELEVATION CONTOUR
	INFERRED GROUNDWATER FLOW DIRECTION

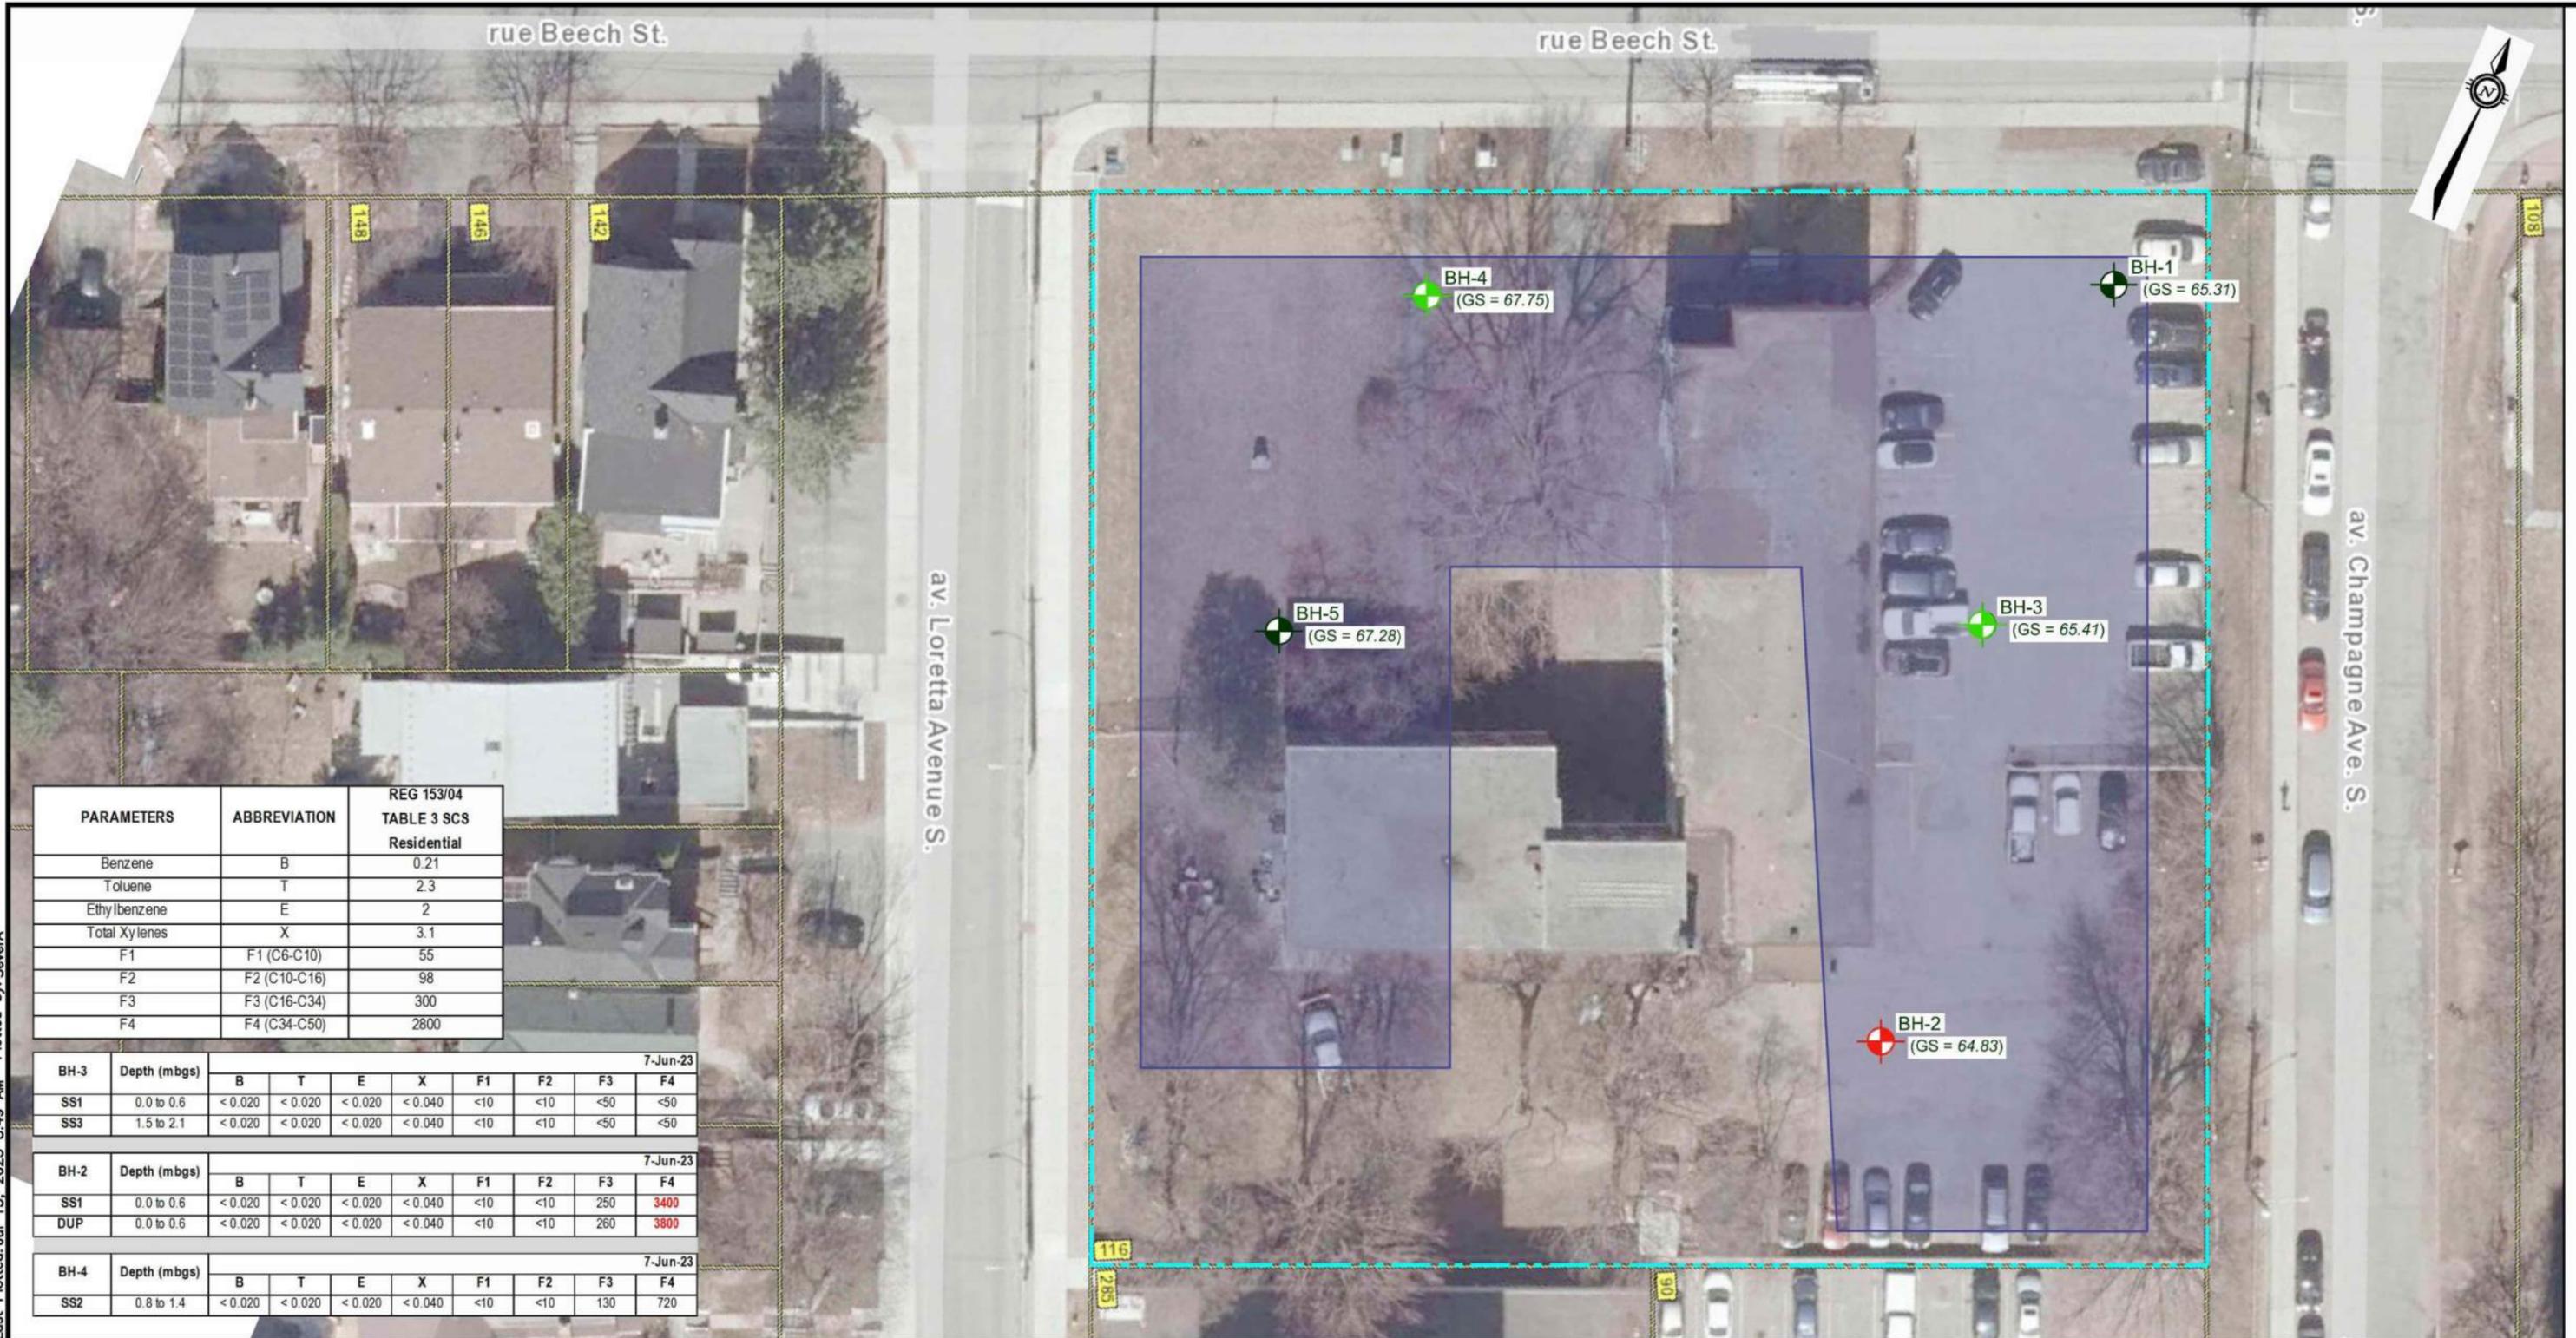
PARAMETERS	ABBREVIATION	REG 153/04 TABLE 3 SCS Residential
Benzene	B	0.21
Toluene	T	2.3
Ethylbenzene	E	2
Total Xylenes	X	3.1
F1	F1 (C6-C10)	55
F2	F2 (C10-C16)	98
F3	F3 (C16-C34)	300
F4	F4 (C34-C50)	2800

Borehole	Depth (mbgs)	7-Jun-23							
		B	T	E	X	F1	F2	F3	F4
BH-3	SS1 0.0 to 0.6	< 0.020	< 0.020	< 0.020	< 0.040	<10	<10	<50	<50
	SS3 1.5 to 2.1	< 0.020	< 0.020	< 0.020	< 0.040	<10	<10	<50	<50
BH-2	7-Jun-23								
	SS1 0.0 to 0.6	< 0.020	< 0.020	< 0.020	< 0.040	<10	<10	250	3400
	DUP 0.0 to 0.6	< 0.020	< 0.020	< 0.020	< 0.040	<10	<10	260	3800
BH-4	7-Jun-23								
	SS2 0.8 to 1.4	< 0.020	< 0.020	< 0.020	< 0.040	<10	<10	130	720

PHC and PAH impacted soil was identified in one fill sample (and duplicate) from BH-2 and is associated with poor fill quality, miscellaneous debris (likely small pieces of asphalt) was also observed in the fill material at this location. The depth of fill at this location was 0.1 to 0.6 m bgs.

Only a small part of the Phase Two property appears to be impacted and the contaminants do not appear to be migrating. It is recommended that the impacted soil be removed from the Phase Two property when the property is re-developed.

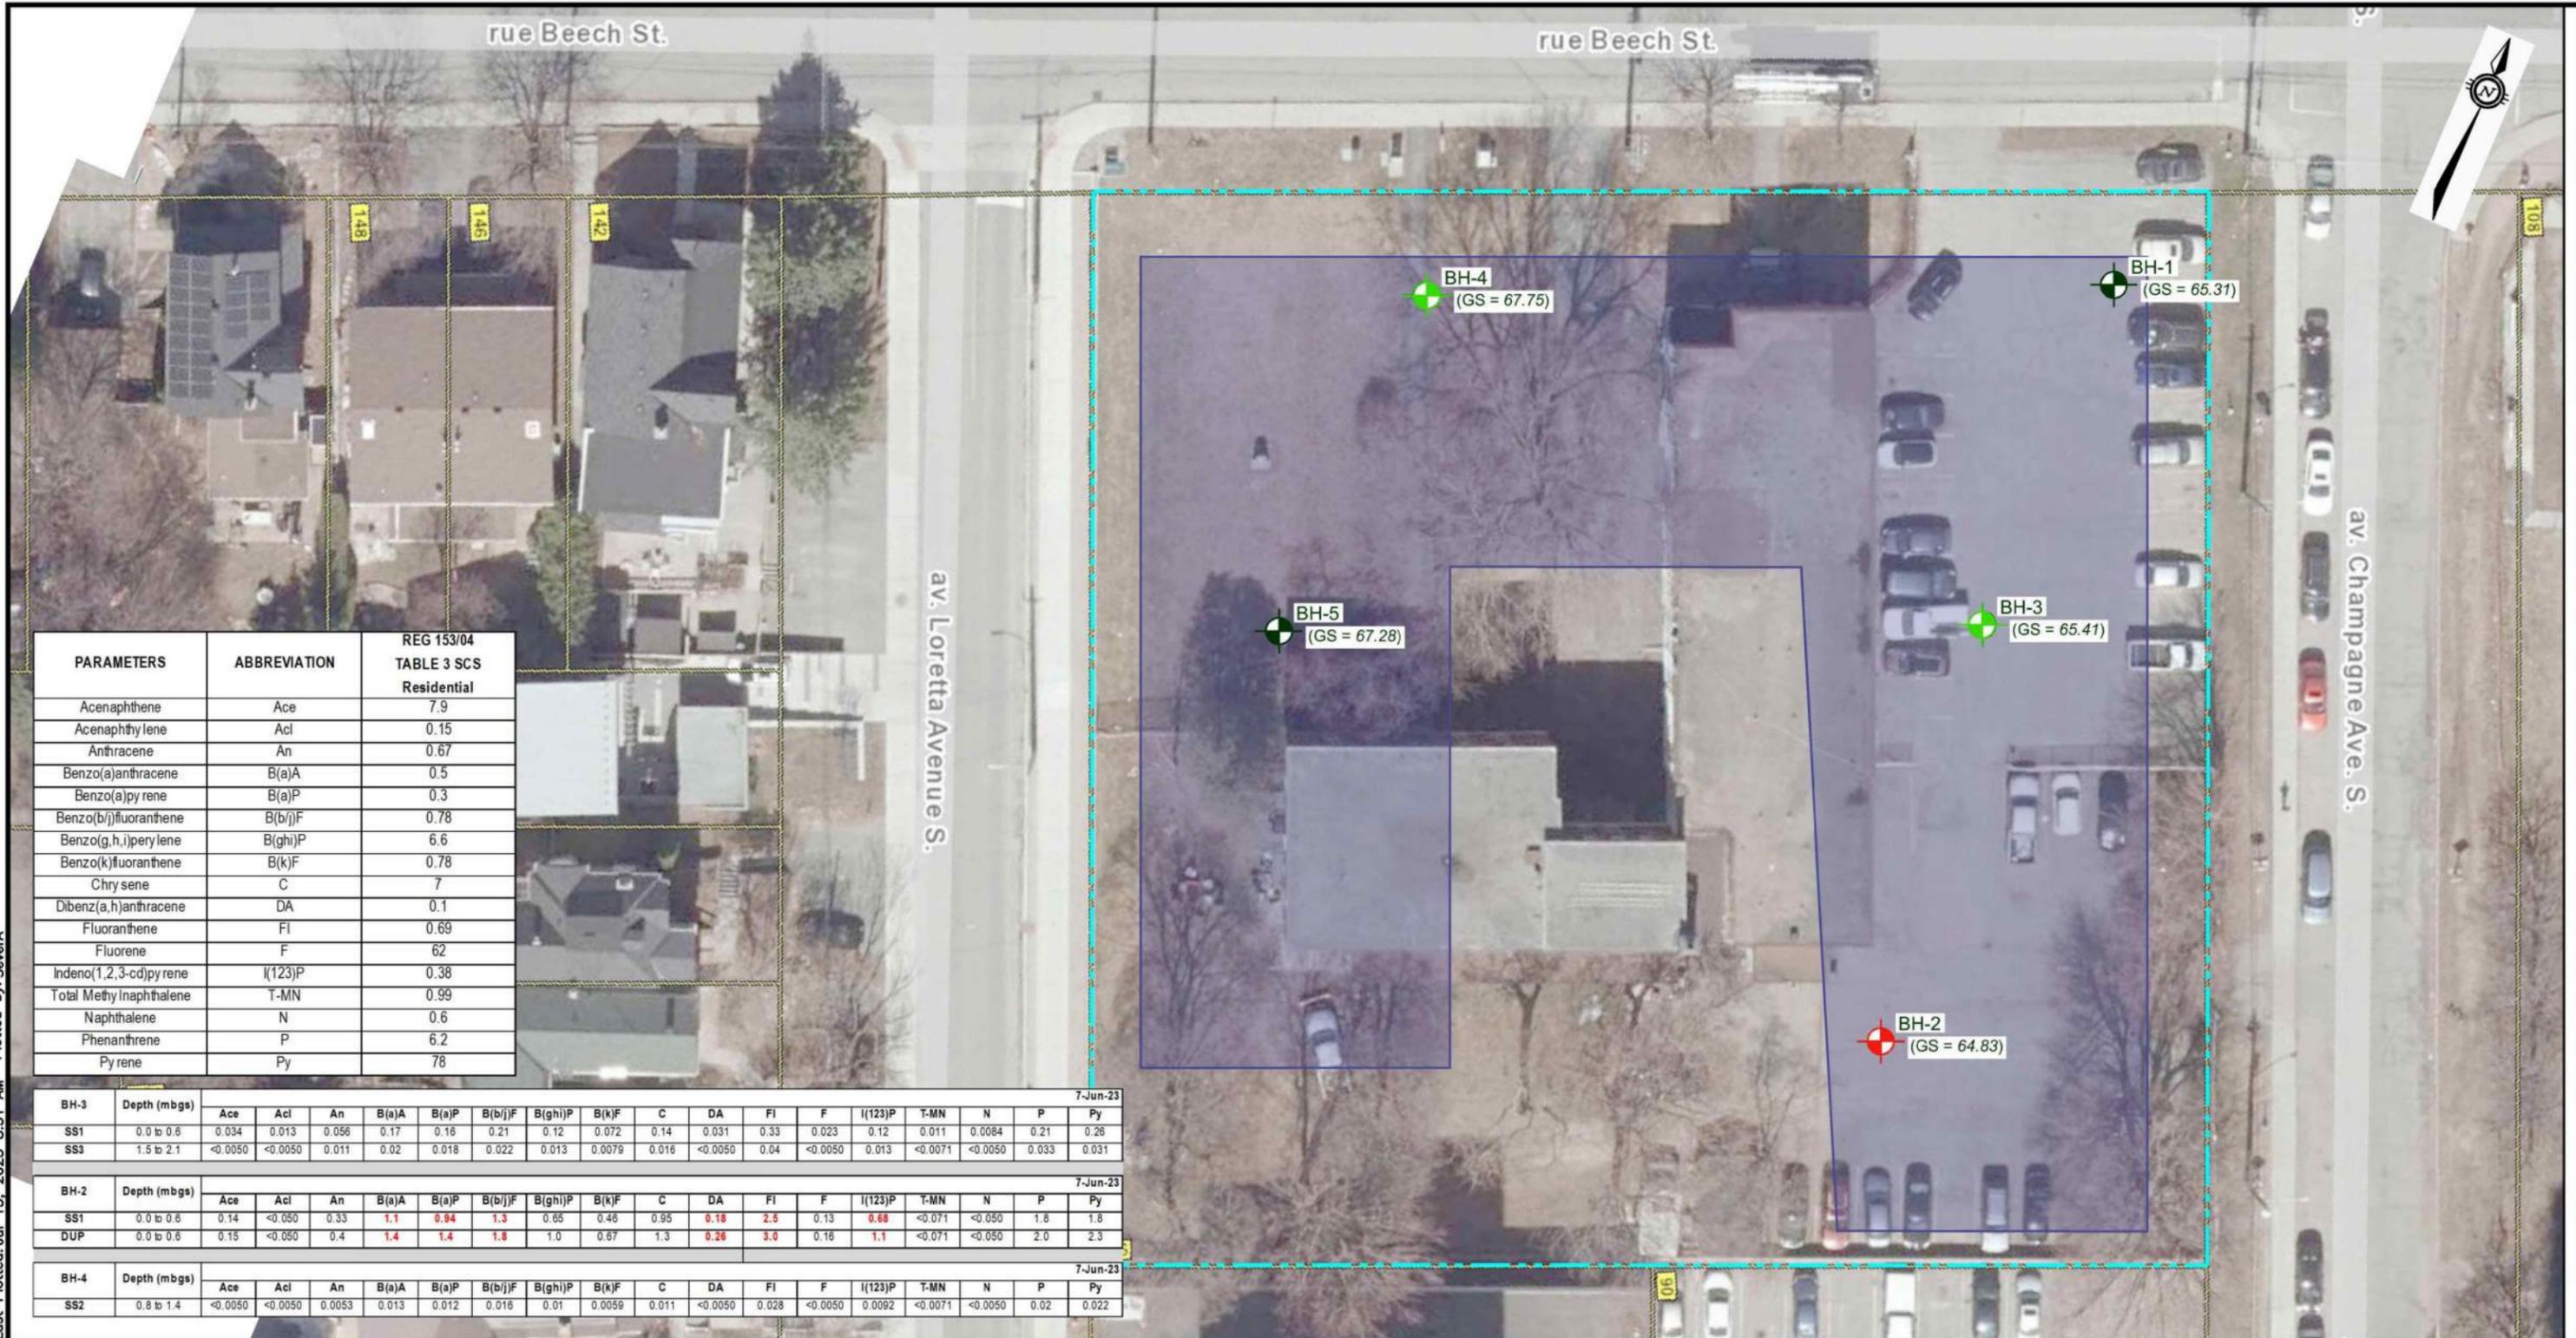
PARAMETERS	ABBREVIATION	REG 153/04 TABLE 3 SCS Residential
Acenaphthene	Ace	7.9
Acenaphthylene	Acl	0.15
Anthracene	An	0.67
Benzo(a)anthracene	B(a)A	0.5
Benzo(a)pyrene	B(a)P	0.3
Benzo(b)fluoranthene	B(b)F	0.78
Benzo(g,h,i)perylene	B(ghi)P	6.6
Benzo(k)fluoranthene	B(k)F	0.78
Chrysene	C	7
Dibenz(a,h)anthracene	DA	0.1
Fluoranthene	Fl	0.69
Fluorene	F	62
Indeno(1,2,3-cd)pyrene	I(123)P	0.38
Total Methyl naphthalene	T-MN	0.99
Naphthalene	N	0.6
Phenanthrene	P	6.2
Pyrene	Py	78

Borehole	Depth (mbgs)	7-Jun-23																	
		Ace	Acl	An	B(a)A	B(a)P	B(b)F	B(ghi)P	B(k)F	C	DA	Fl	F	I(123)P	T-MN	N	P	Py	
BH-3	SS1	0.0 to 0.6	0.034	0.013	0.058	0.17	0.16	0.21	0.12	0.072	0.14	0.031	0.33	0.023	0.12	0.011	0.0084	0.21	0.28
	SS3	1.5 to 2.1	<0.0050	<0.0050	0.011	0.02	0.018	0.022	0.013	0.0079	0.016	<0.0050	0.04	<0.0050	0.013	<0.0071	<0.0050	0.033	0.031
BH-2	Depth (mbgs)		Ace	Acl	An	B(a)A	B(a)P	B(b)F	B(ghi)P	B(k)F	C	DA	Fl	F	I(123)P	T-MN	N	P	Py
	SS1	0.0 to 0.6	0.14	<0.050	0.33	1.1	0.94	1.3	0.65	0.46	0.95	0.18	2.5	0.13	0.68	<0.071	<0.050	1.8	1.8
	DUP	0.0 to 0.6	0.15	<0.050	0.4	1.4	1.4	1.8	1.0	0.67	1.3	0.26	3.0	0.16	1.1	<0.071	<0.050	2.0	2.3
BH-4	Depth (mbgs)		Ace	Acl	An	B(a)A	B(a)P	B(b)F	B(ghi)P	B(k)F	C	DA	Fl	F	I(123)P	T-MN	N	P	Py
	SS2	0.8 to 1.4	<0.0050	<0.0050	0.0053	0.013	0.012	0.016	0.01	0.0059	0.011	<0.0050	0.028	<0.0050	0.0092	<0.0071	<0.0050	0.02	0.022

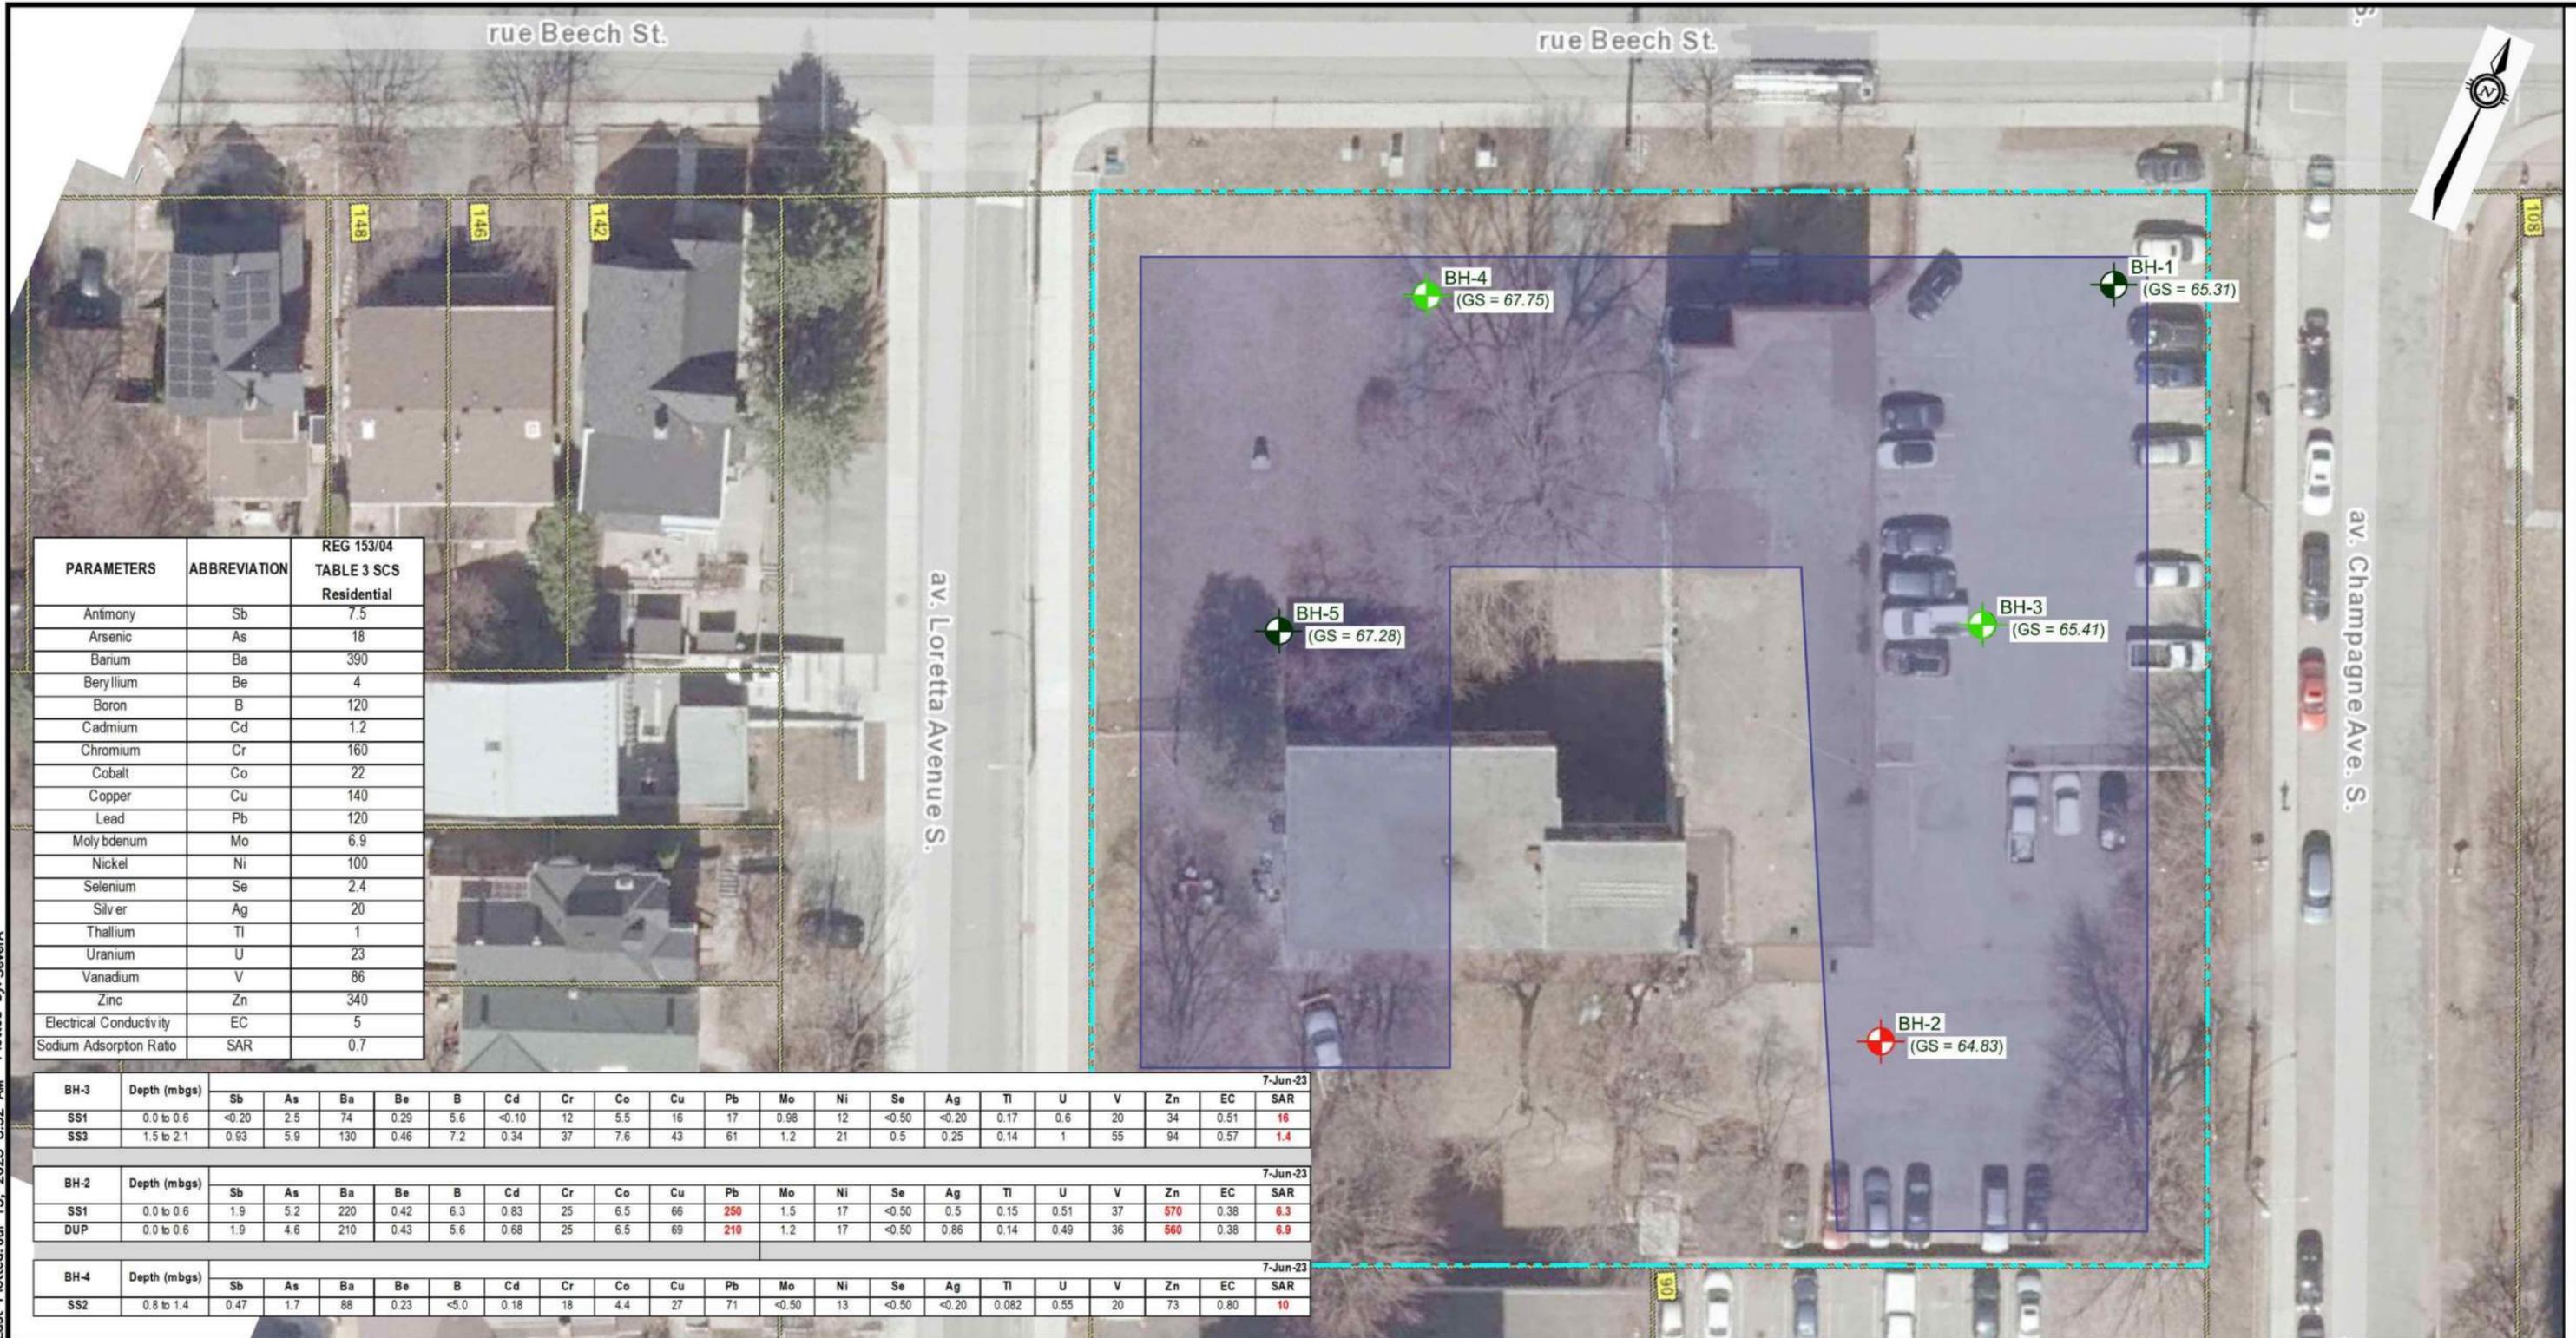
DATE	JULY 2023		<b>PROPOSED HIGH RISE DEVELOPMENT</b> 116 BEECH STREET, OTTAWA, ONTARIO	project no.	OTT-23005943-CO
DESIGN	LW	CHECKED		MM	scale
DRAWN BY	AS		<b>PHASE TWO ENVIRONMENTAL SITE ASSESSMENT</b> <b>SOIL ANALYTICAL RESULTS – INORGANICS</b>	<b>FIG 9</b>

PARAMETERS	ABBREVIATION	REG 153/04 TABLE 3 SCS Residential
Antimony	Sb	7.5
Arsenic	As	18
Barium	Ba	390
Beryllium	Be	4
Boron	B	120
Cadmium	Cd	1.2
Chromium	Cr	160
Cobalt	Co	22
Copper	Cu	140
Lead	Pb	120
Molybdenum	Mo	6.9
Nickel	Ni	100
Selenium	Se	2.4
Silver	Ag	20
Thallium	Tl	1
Uranium	U	23
Vanadium	V	86
Zinc	Zn	340
Electrical Conductivity	EC	5
Sodium Adsorption Ratio	SAR	0.7

Borehole	Depth (mbgs)	7-Jun-23																			
		Sb	As	Ba	Be	B	Cd	Cr	Co	Cu	Pb	Mo	Ni	Se	Ag	Tl	U	V	Zn	EC	SAR
BH-3	SS1 0.0 to 0.6	<0.20	2.5	74	0.29	5.6	<0.10	12	5.5	16	17	0.98	12	<0.50	<0.20	0.17	0.6	20	34	0.51	1.6
	SS3 1.5 to 2.1	0.93	5.9	130	0.46	7.2	0.34	37	7.6	43	61	1.2	21	0.5	0.25	0.14	1	55	94	0.57	1.4
BH-2	7-Jun-23																				
	SS1 0.0 to 0.6	1.9	5.2	220	0.42	6.3	0.83	25	6.5	66	250	1.5	17	<0.50	0.5	0.15	0.51	37	570	0.38	6.3
	DUP 0.0 to 0.6	1.9	4.6	210	0.43	5.6	0.68	25	6.5	69	210	1.2	17	<0.50	0.86	0.14	0.49	36	560	0.38	6.9
BH-4	7-Jun-23																				
	SS2 0.8 to 1.4	0.47	1.7	88	0.23	<5.0	0.18	18	4.4	27	71	<0.50	13	<0.50	<0.20	0.082	0.55	20	73	0.80	1.0

The remaining samples met the Table 3 SCS for all parameters analysed with the exception of sodium adsorption ratio, which exceeded the Table 3 SCS in all of the soil samples analysed. However, as all of the soil samples were collected from boreholes drilled in the parking lot in accordance with Section 49.1 of O.Reg. 153/04 if, in the opinion of the Qualified Person, the applicable SCS at the Phase Two property are exceeded solely due to the application of a substance to surfaces for the safety of vehicular or pedestrian traffic under conditions of snow or ice or both, the applicable SCS is deemed not to be exceeded. Road salt is considered to have been applied to the driving and parking surfaces on the Phase Two property. Therefore, for the purpose of this investigation, the elevated SAR in the soil samples collected from the site are deemed not to exceed the Table 3 SCS.

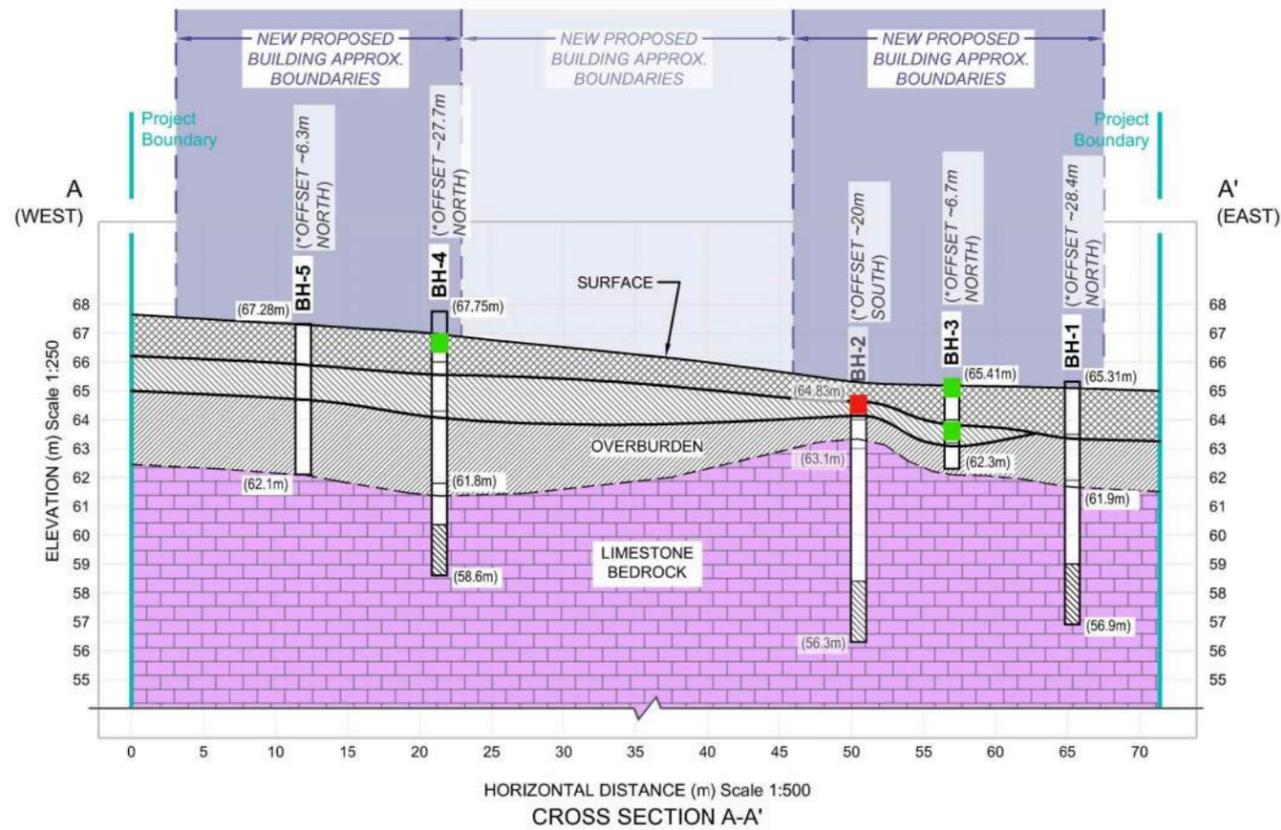
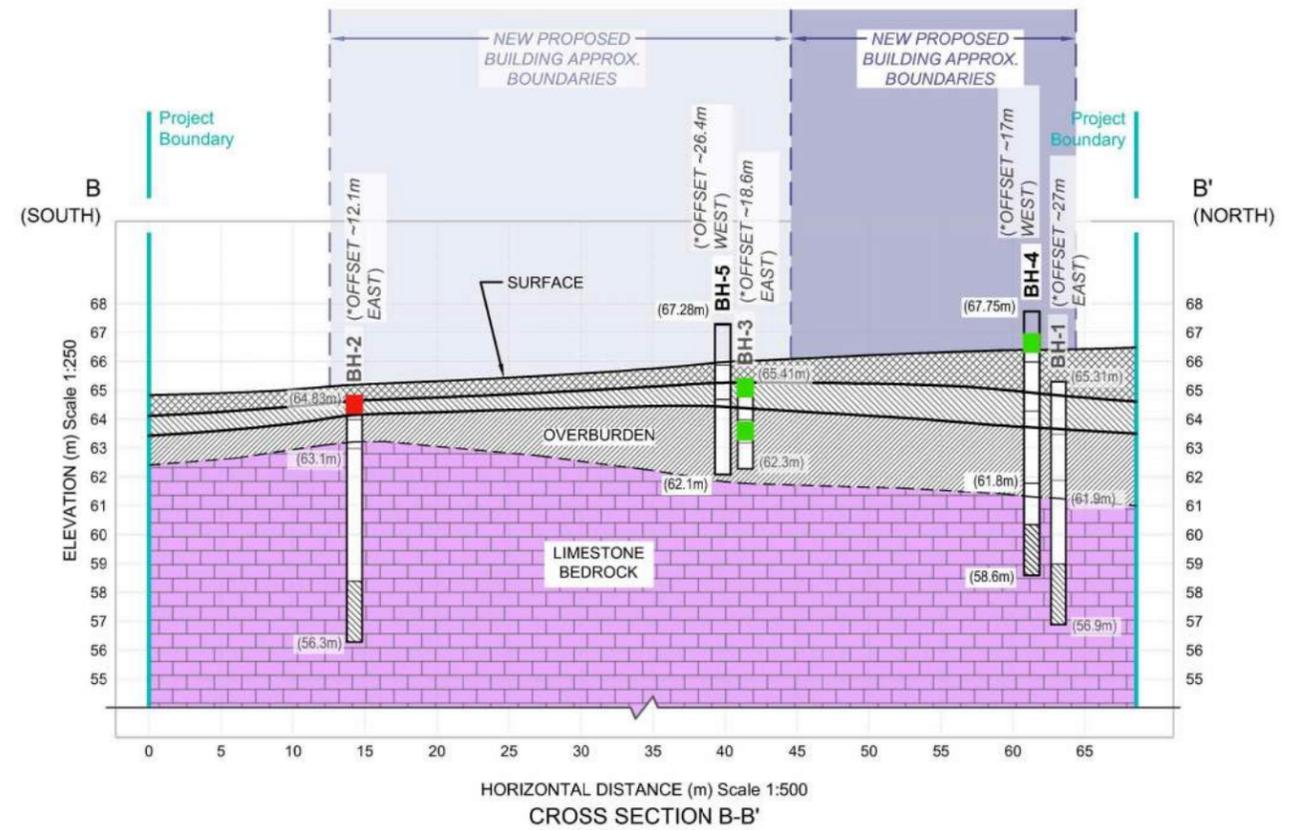
DATE JULY 2023	<b>PROPOSED HIGH RISE DEVELOPMENT</b> 116 BEECH STREET, OTTAWA, ONTARIO	project no. OTT-23005943-C0
DESIGN LW		scale 1:500 / 1:250
DRAWN BY AS		<b>PHASE TWO ENVIRONMENTAL SITE ASSESSMENT</b> SOIL CROSS SECTIONS A-A' & B-B' – PHC & VOC
		<b>FIG 10</b>

PARAMETERS	ABBREVIATION	REG 153/04 TABLE 3 SCS Residential
Benzene	B	0.21
Toluene	T	2.3
Ethylbenzene	E	2
Total Xylenes	X	3.1
F1	F1 (C6-C10)	55
F2	F2 (C10-C16)	98
F3	F3 (C16-C34)	300
F4	F4 (C34-C50)	2800

Borehole	Depth (mbgs)	7-Jun-23								
		B	T	E	X	F1	F2	F3	F4	
BH-3	SS1	0.0 to 0.6	< 0.020	< 0.020	< 0.020	< 0.040	<10	<10	<50	<50
	SS3	1.5 to 2.1	< 0.020	< 0.020	< 0.020	< 0.040	<10	<10	<50	<50
	DUP	0.0 to 0.6	< 0.020	< 0.020	< 0.020	< 0.040	<10	<10	260	3800
BH-2	SS1	0.0 to 0.6	< 0.020	< 0.020	< 0.020	< 0.040	<10	<10	250	3400
	DUP	0.0 to 0.6	< 0.020	< 0.020	< 0.020	< 0.040	<10	<10	260	3800
	DUP	0.0 to 0.6	< 0.020	< 0.020	< 0.020	< 0.040	<10	<10	260	3800
BH-4	SS2	0.8 to 1.4	< 0.020	< 0.020	< 0.020	< 0.040	<10	<10	130	720
	DUP	0.8 to 1.4	< 0.020	< 0.020	< 0.020	< 0.040	<10	<10	130	720
	DUP	0.8 to 1.4	< 0.020	< 0.020	< 0.020	< 0.040	<10	<10	130	720

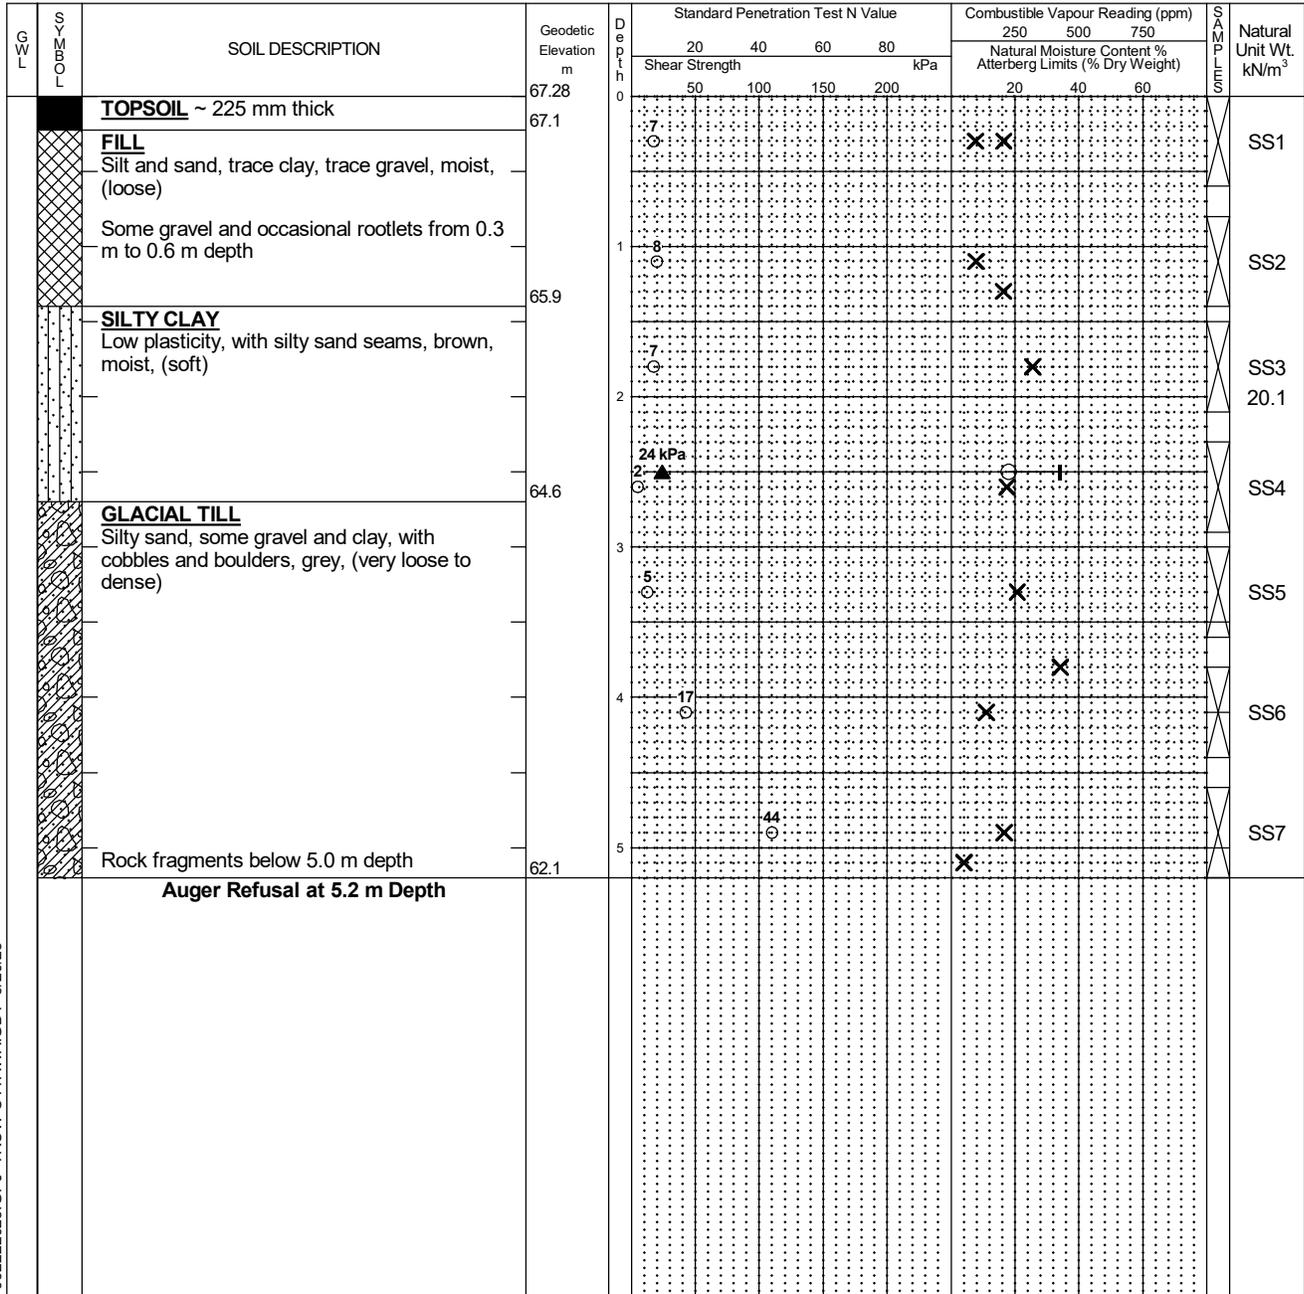
LOG OF BOREHOLE GINT LOGS 062222023.GPJ TROW OTTAWA.GDT 6/26/23

- NOTES:
- Borehole data requires interpretation by EXP before use by others
  - Borehole was backfilled upon completion
  - Field work supervised by an exp representative.
  - See Notes on Sample Descriptions
  - Log to be read with EXP Report OTT-23005943-A0
