PHASE ONE ENVIRONMENTAL SITE ASSESSMENT

441-443 ECHO DRIVE,
OTTAWA, ON K1S 1N6

JB Holdings

Project No.: 2512064

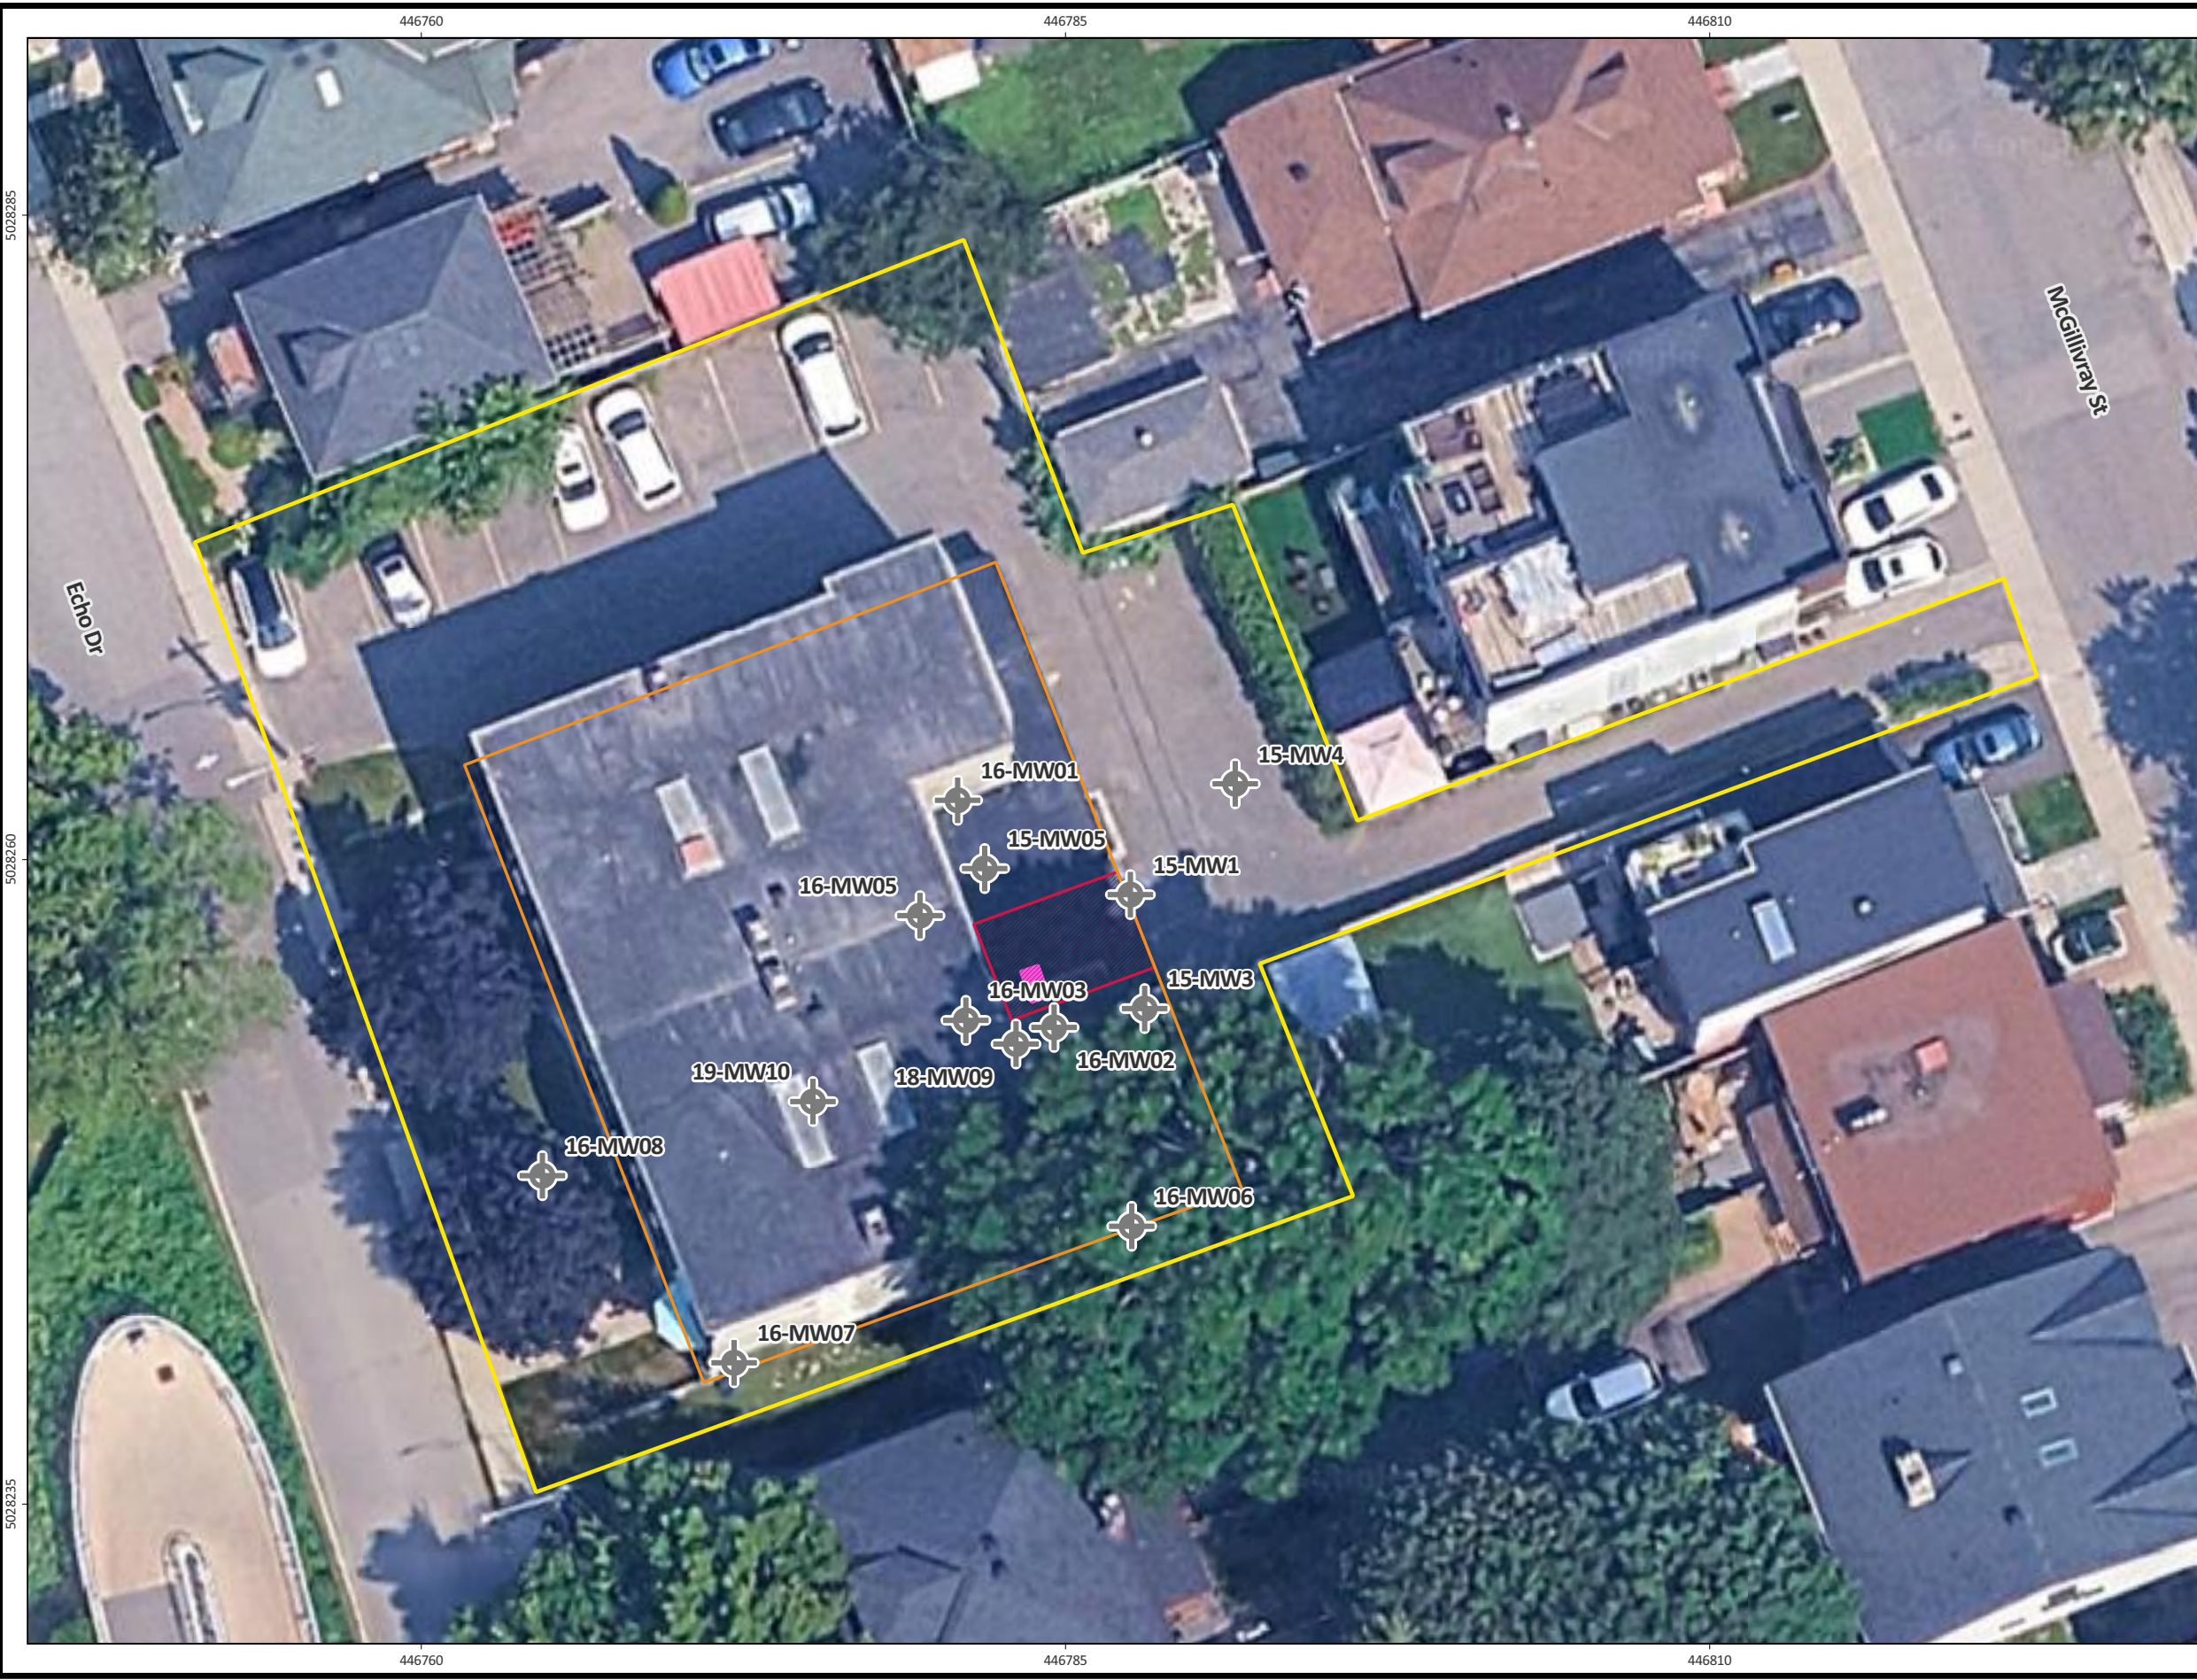
| Figure: | | FIG-03 |

from the Site during the 2018 groundwater quality assessment, with the exception of 16-MW02, reportedly met the applicable Table 3 Site Condition Standard (SCS). The locations of all historical monitoring wells installed at the Site are illustrated in FIG-05 of Appendix A, with the exception of monitoring well 15-MW02, as it was removed as a result of the remedial excavation.

- Property Boundary
- Building 1: 441-443 Echo Drive
- Location of Former Underground Storage Tank
- Apprximate Extent of Historical Remedial Excavation
- + Approximate Location of Historical Monitoring Wells (Concentric Geoscience)

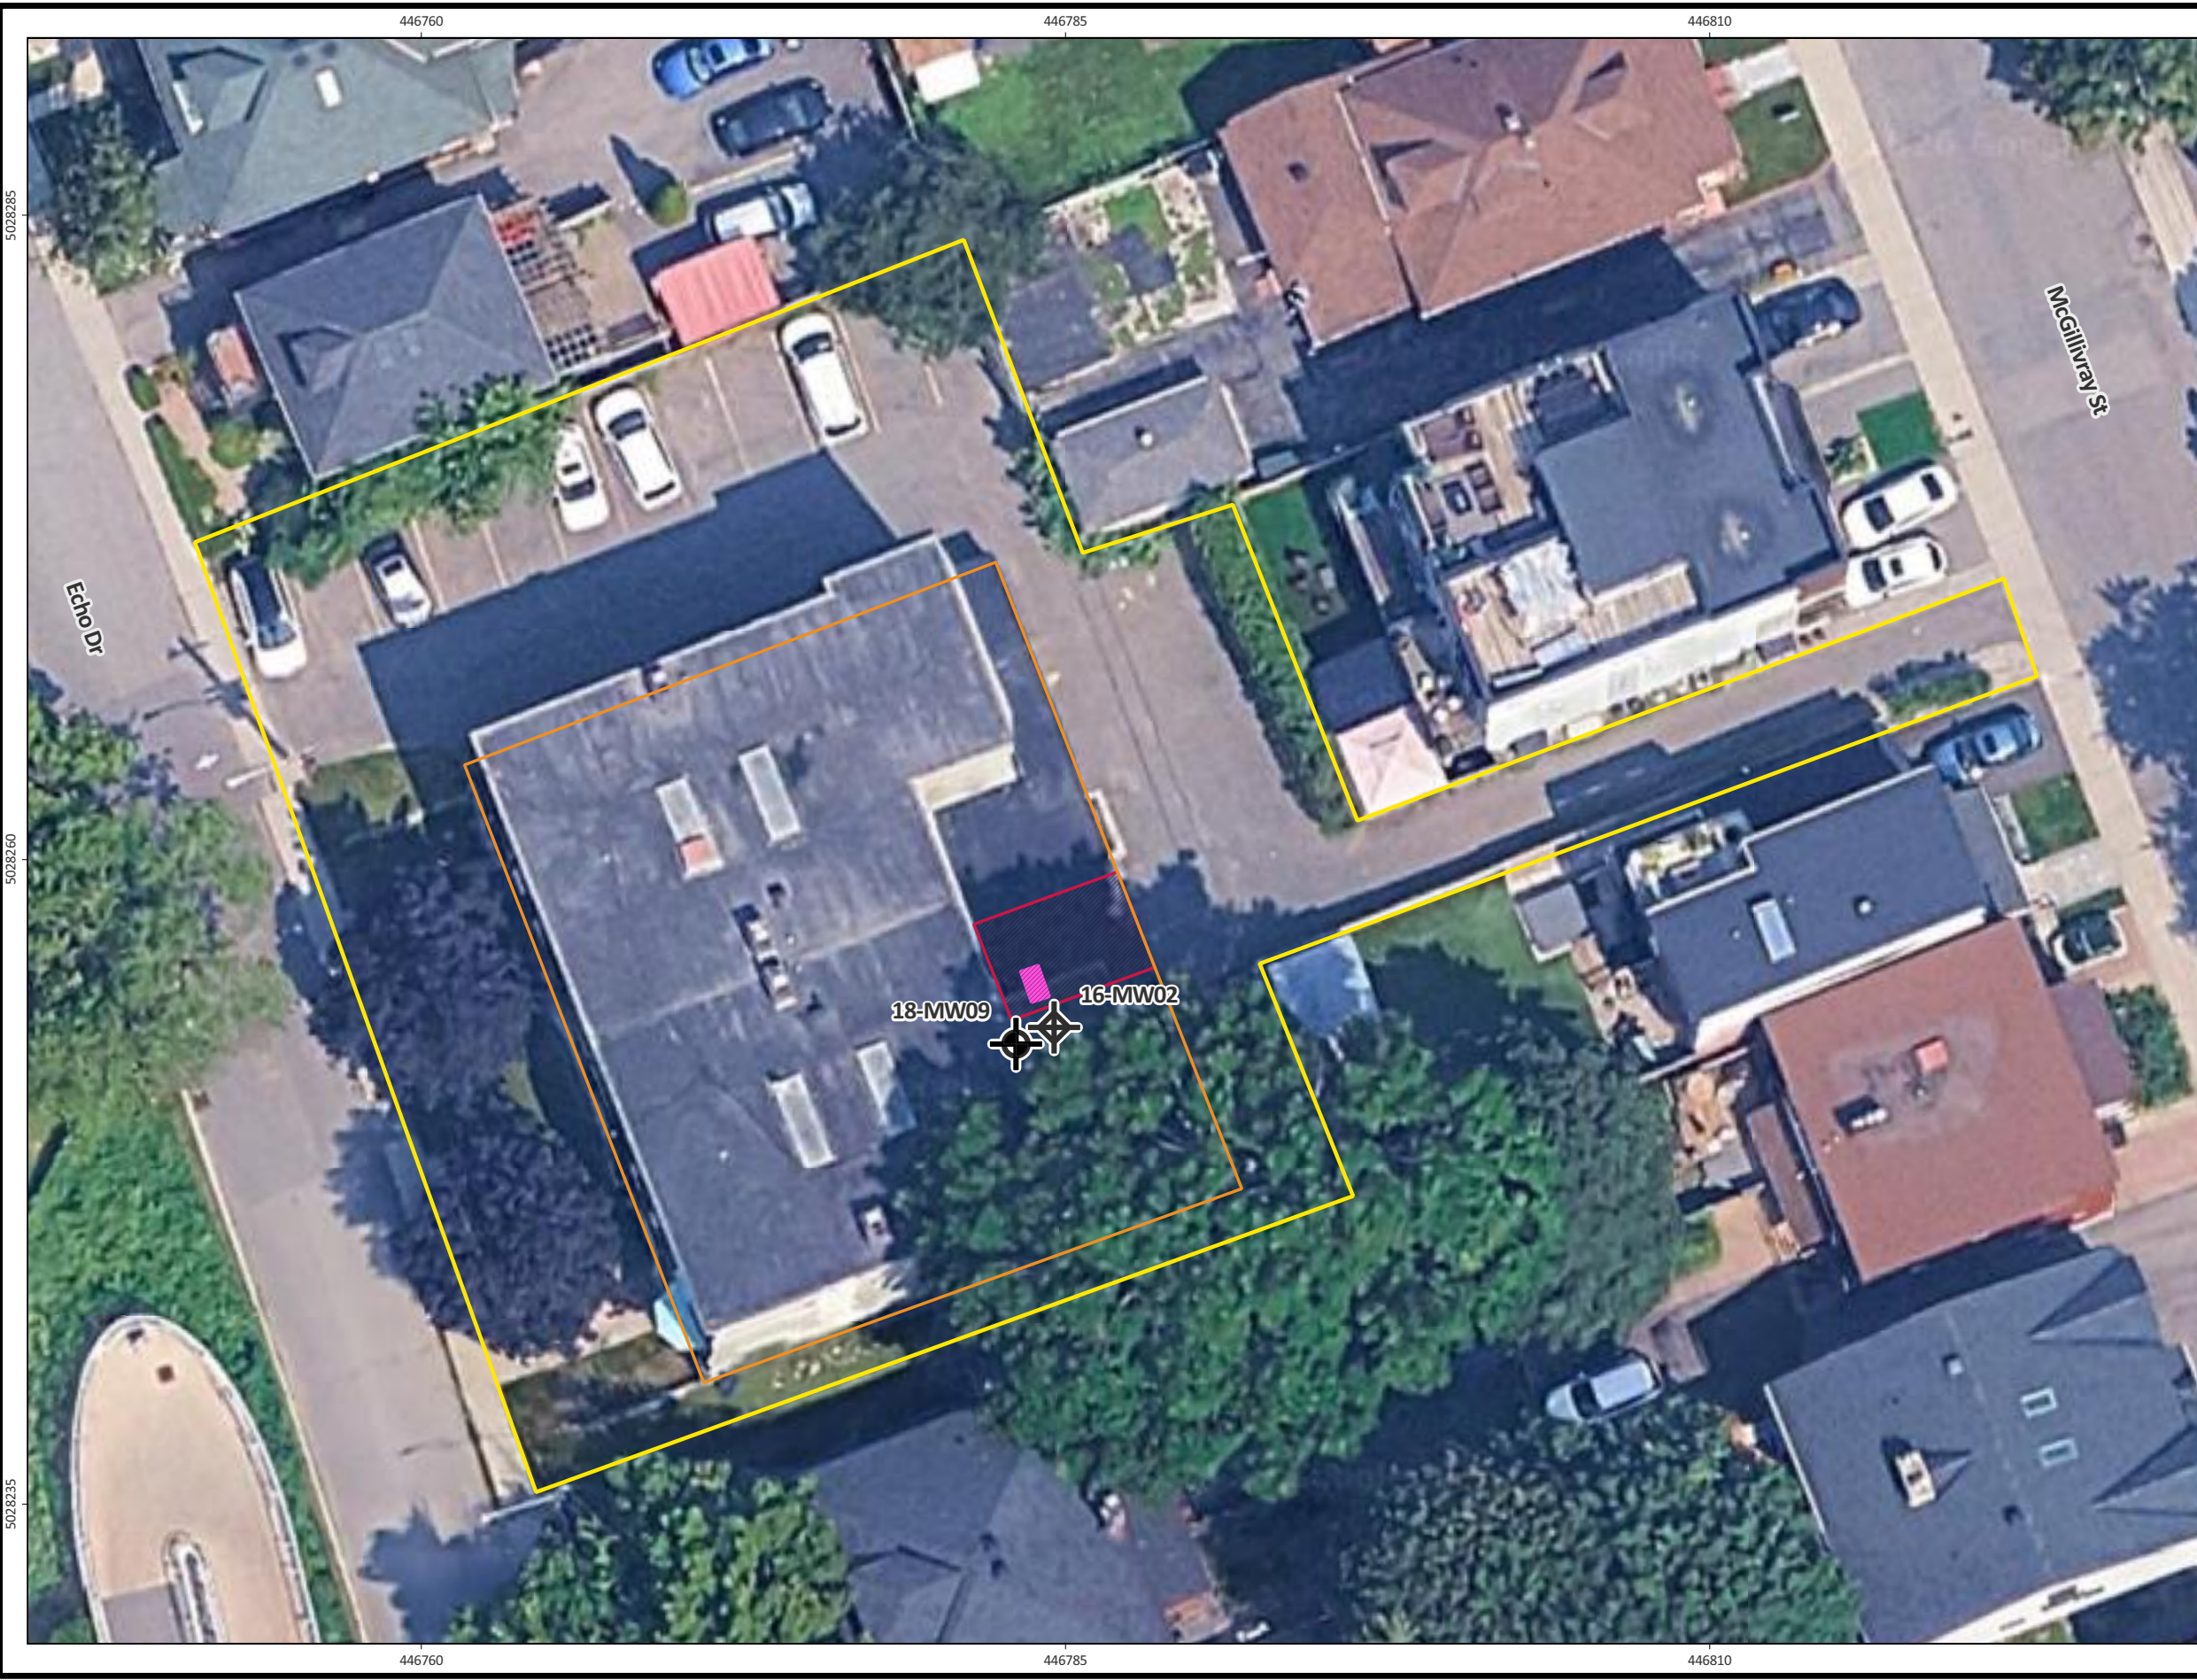
As the groundwater samples collected from monitoring well 18-MW09 met the applicable Table 3 SCS for the previous four (4) consecutive quarterly monitoring events, CGI concluded that the groundwater remediation program met the conditions for site closure, and that no further groundwater monitoring or sampling is required in relation to the historical UST leak.

- Property Boundary
- Building 1: 441-443 Echo Drive
- Location of Former Underground Storage Tank
- Approximate Extent of Historical Remedial Excavation
- +
+
+
+
 Approximate Location of Previously Impacted Monitoring Well Used For Remedial Injection Program (Concentric Geoscience, 2018-2020)
- +
+
+
+
 Approximate Location of Down-Gradient Monitoring Well Used For Confirmatory Groundwater Sampling (Concentric Geoscience, 2021)

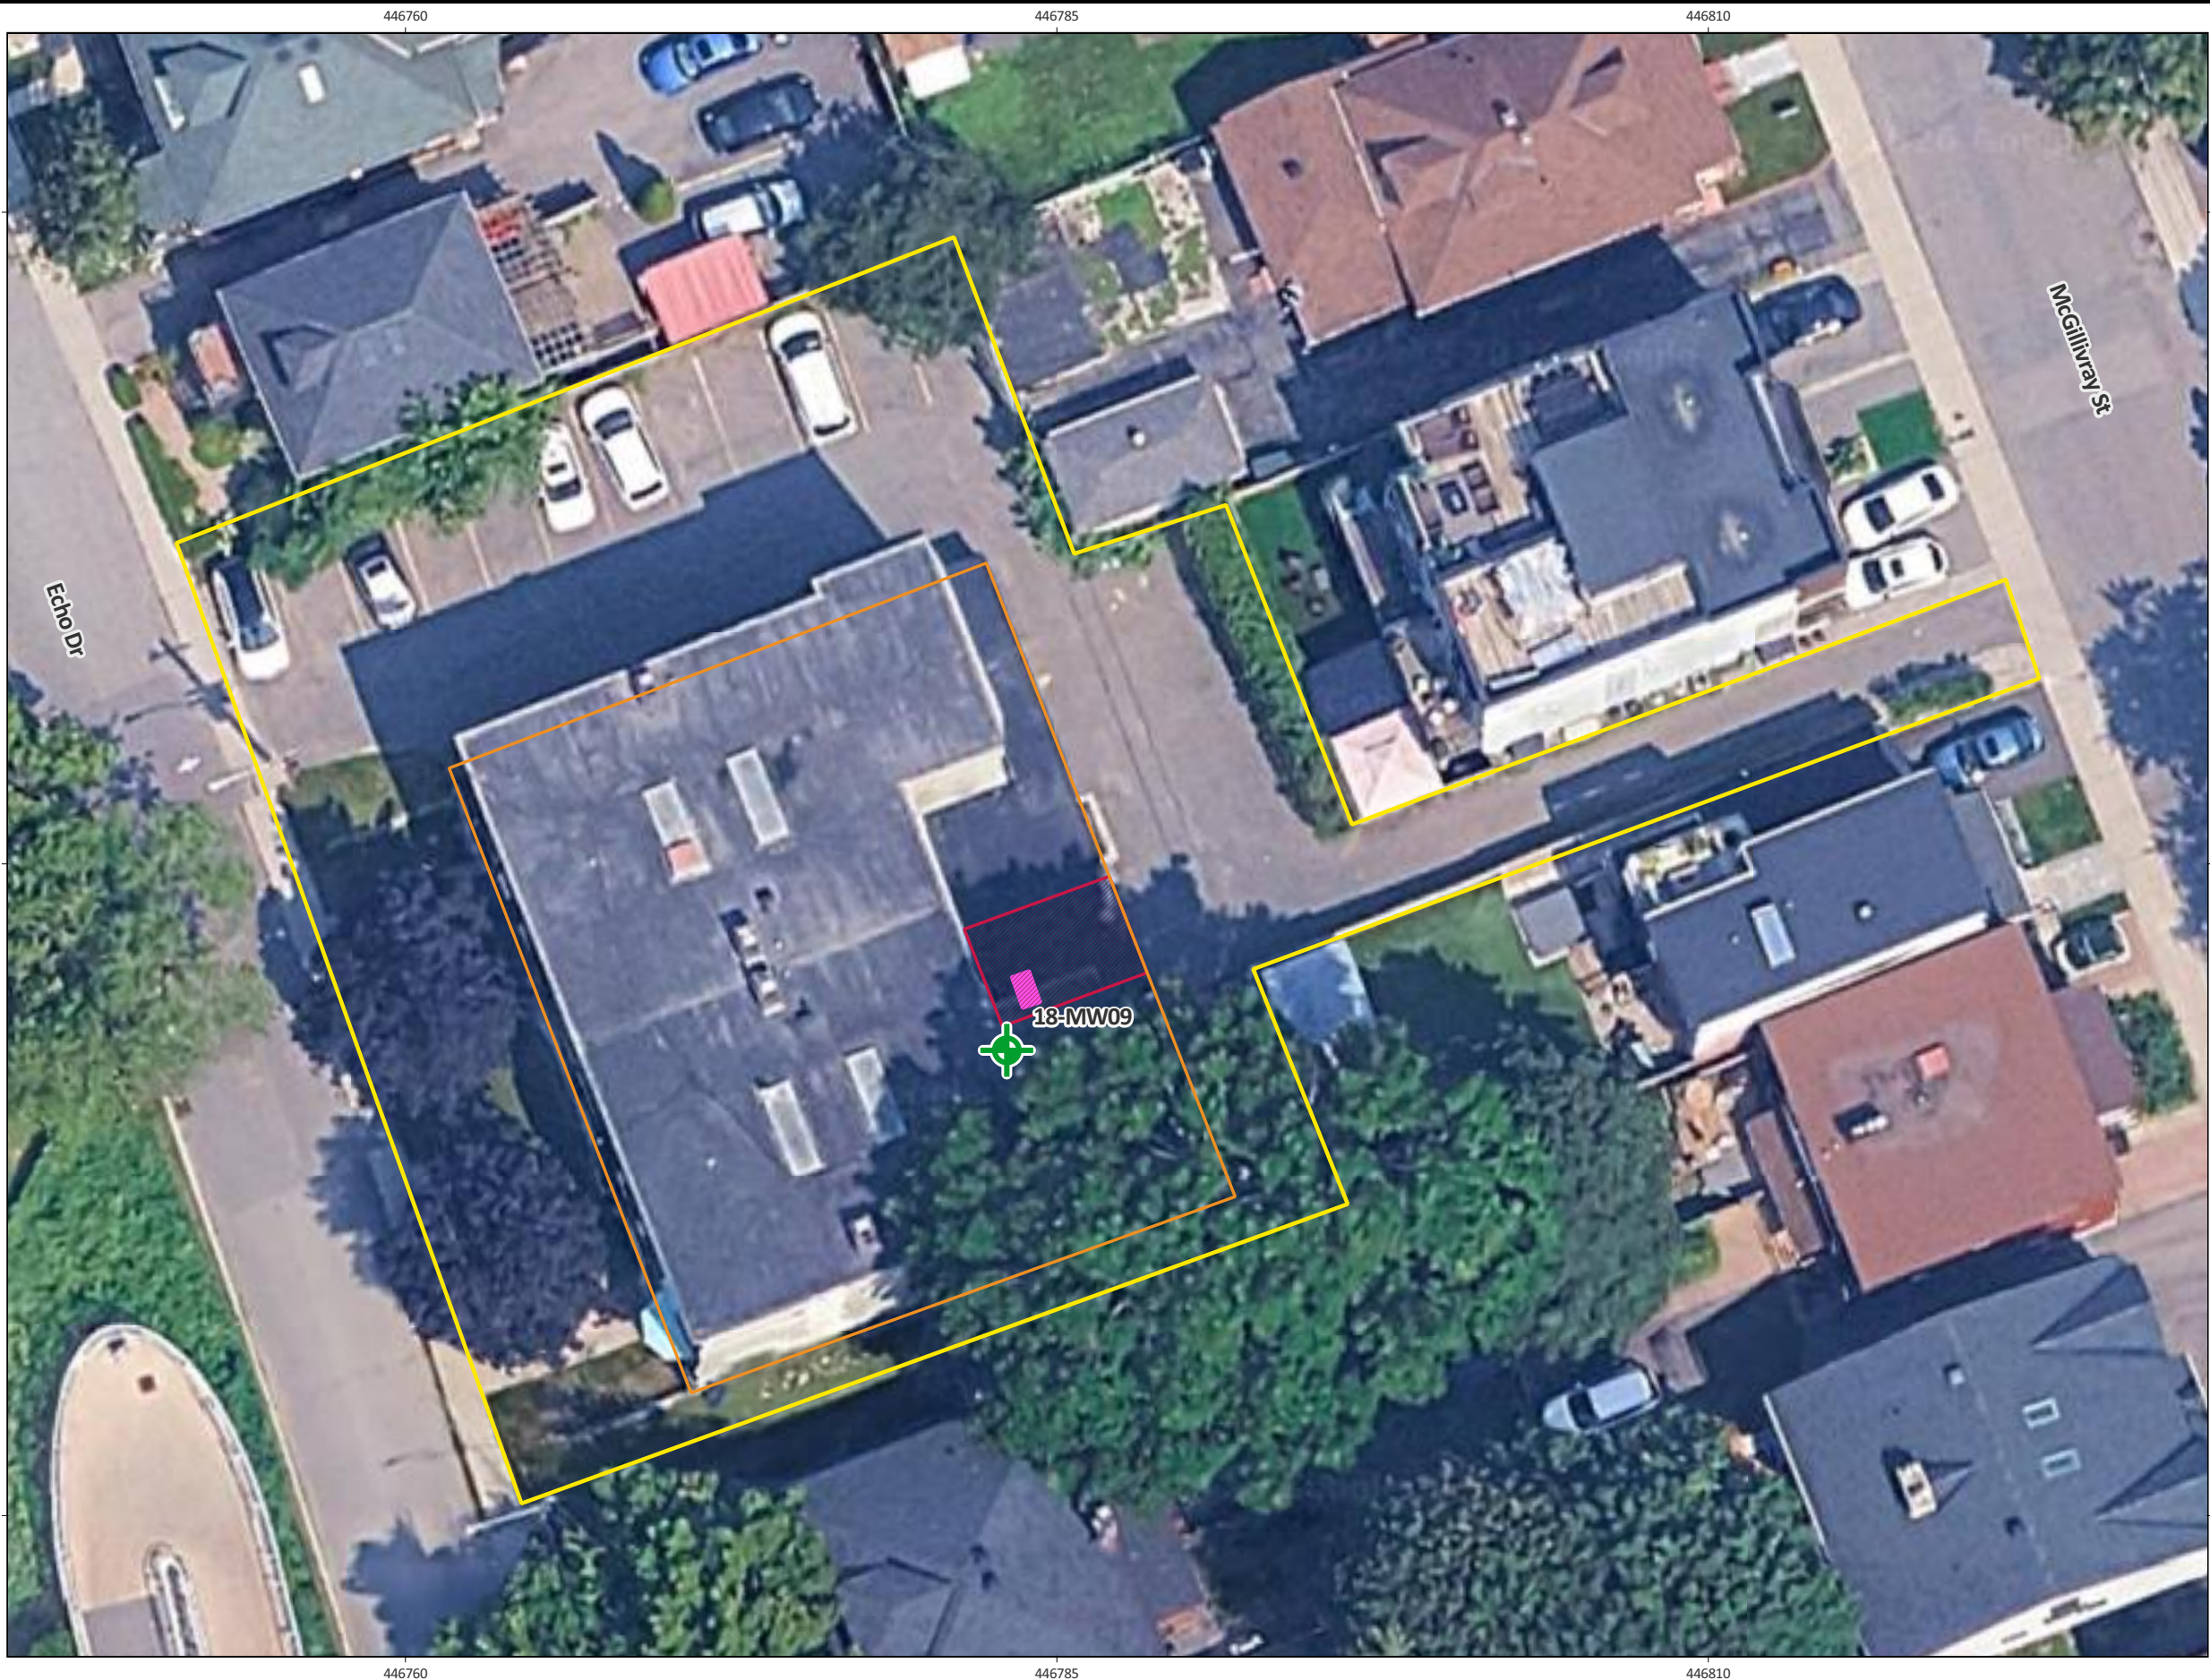
In response to the groundwater impact identified during their groundwater quality assessment, CGI initiated ISCO treatment of monitoring well 16-MW02 with hydrogen peroxide in October 2018, which continued from October 2018 to November 2019. It should be noted that prior to the ISCO treatment, CGI installed an identically constructed monitoring well immediately down gradient of 16-MW02 (identified as 18-MW09) to function as the sampling point to monitor the effectiveness of the ISCO treatment/groundwater remediation.

- Property Boundary
- Building 1: 441-443 Echo Drive
- Location of Former Underground Storage Tank
- Approximate Extent of Historical Remedial Excavation
- + Groundwater Meets Applicable Table 3 Site Condition Standards (Concentric Geoscience, 2021)
- + Groundwater Exceeds Applicable Table 3 Site Condition Standards
- + Approximate Location of Previously Impacted Monitoring Well Used For Remedial Injection Program (Concentric Geoscience, 2018-2020)

In December 2020, CGI injected a 10% potassium nitrate solution into monitoring well 16-MW02 in order to stimulate biodegradation of PHCs sorbed to the PetroFix, and in March 2021, a groundwater sample collected from 18-MW09 indicated that the concentrations of PHCs had decreased to a concentration that met the applicable Table 3 SCS. As such, monthly confirmatory groundwater sampling of monitoring well 18-MW09 was initiated.

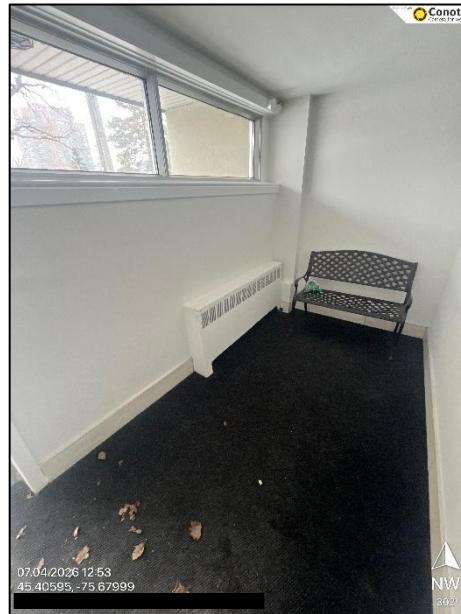
Photograph 5

Example of the heating units observed throughout the on-site residential building

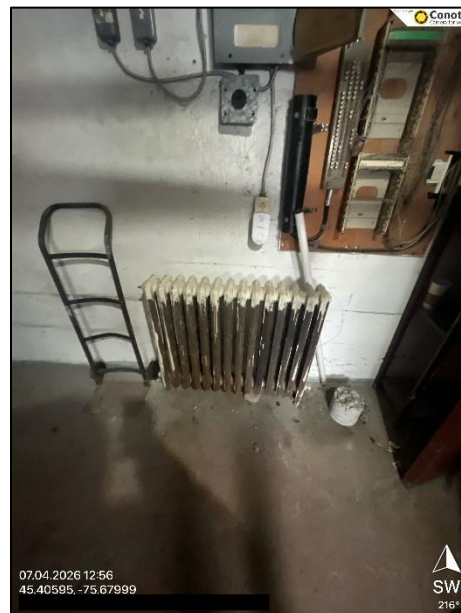
Photograph 6

Example of the heating units observed throughout the on-site residential building

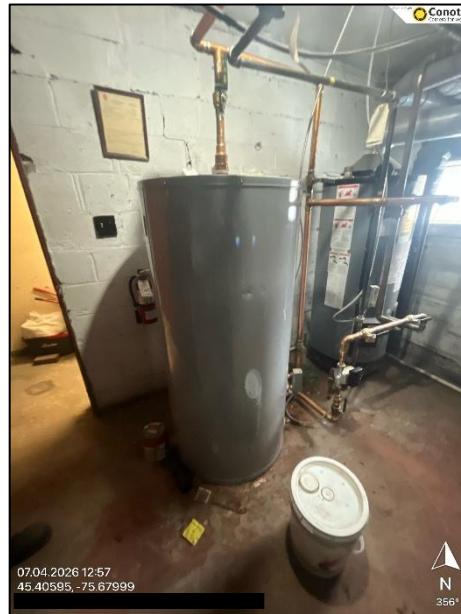
Photograph 7

| ELEMENT | OBSERVED ON-SITE | | DETAILS |
|--|---|---|--|
| Heating/Cooling Systems | <input checked="" type="checkbox"/> | <input type="checkbox"/> | Multiple electric hot water tanks, and one (1) gas powered boiler was observed in the mechanical room in the western portion of the building, and as per Mark Mandica, the residential units are heated via water radiators units. |

Water heater observed in the mechanical room in the western portion of the on-site residential building

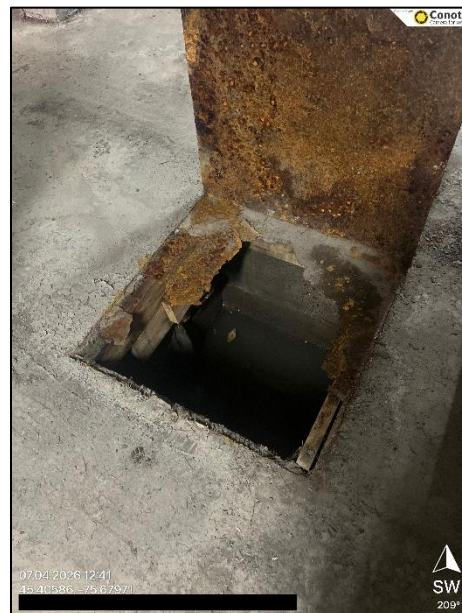
Photograph 8

| ELEMENT | OBSERVED ON-SITE | | DETAILS |
|---|---|---|--|
| Sumps | <input checked="" type="checkbox"/> | <input type="checkbox"/> | One (1) sump was observed within the garage, and it is inferred that the sump drains to the municipal sewer system. |

Sump observed in the mechanical room in the western portion of the on-site residential building
