# **Phase I Environmental Site Assessment**

466 Tremblay Road and 1440 St. Laurent Boulevard  
Ottawa, Ontario

Prepared for Rohit Homes

**Report: PE7622-1  
August 4, 2026**

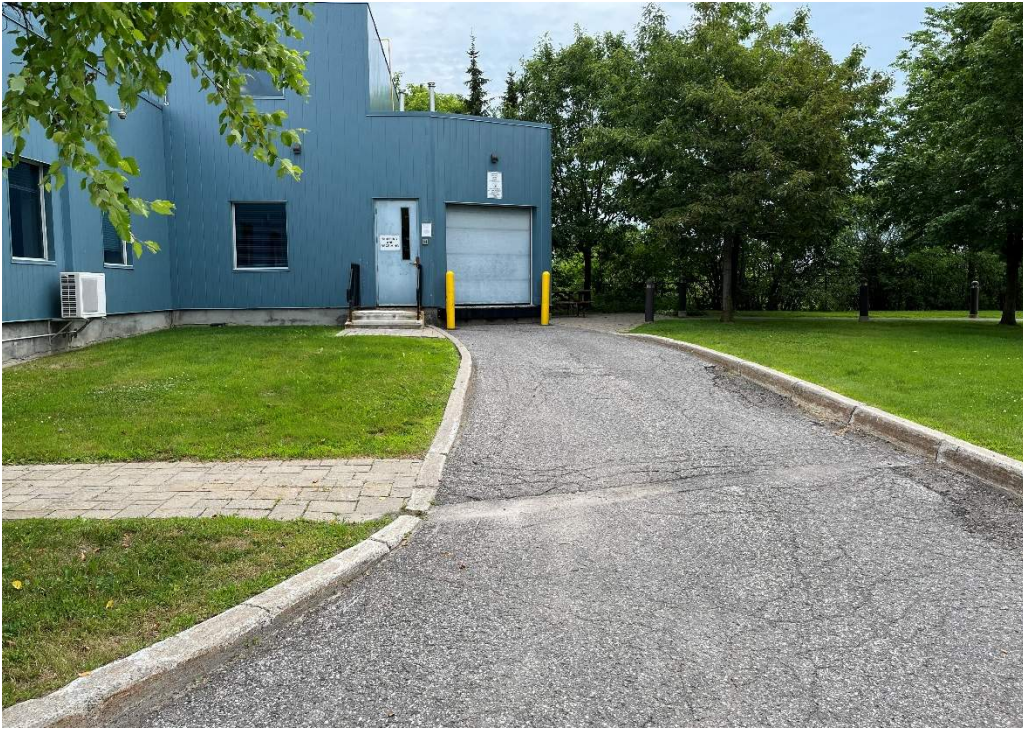
Photograph 1: Rear addition of the subject building, looking at the shipping and receiving dock.

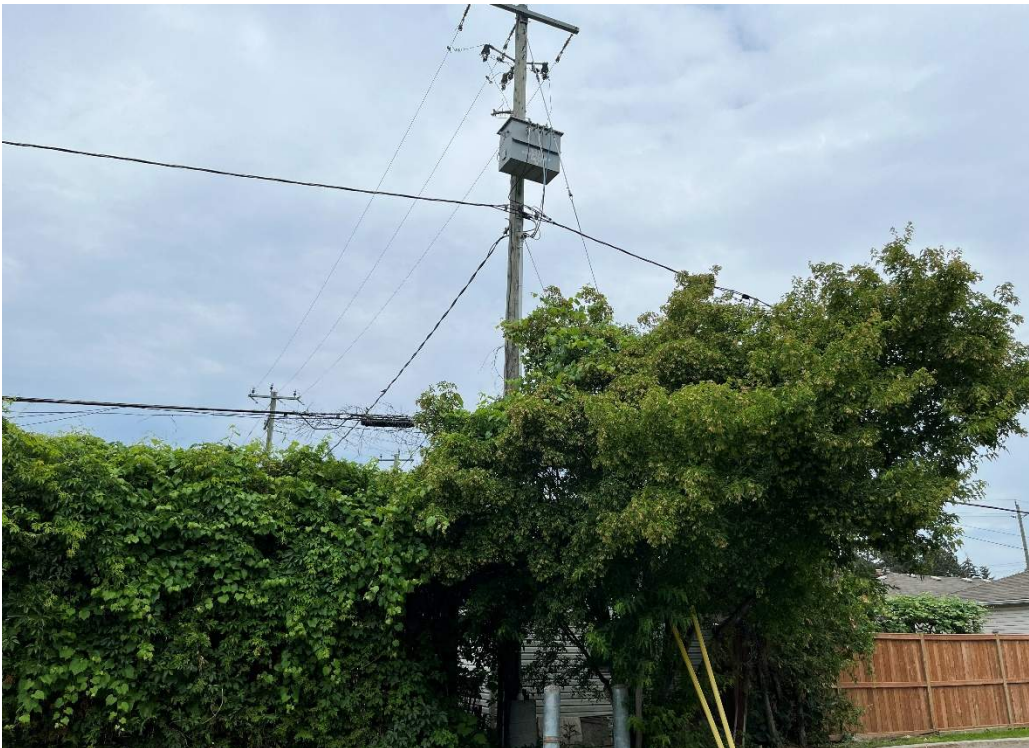
Photograph 4: Pole-mounted transformer along western property limits.

One pole-mounted transformer was observed along the western property limits south of the subject building. No signs of surficial staining, abnormal odours, stressed vegetation, or any other indications of subsurface contamination were present at the time of the site inspection. Based on the age of this transformer, PCBs are not considered to be present within this equipment.

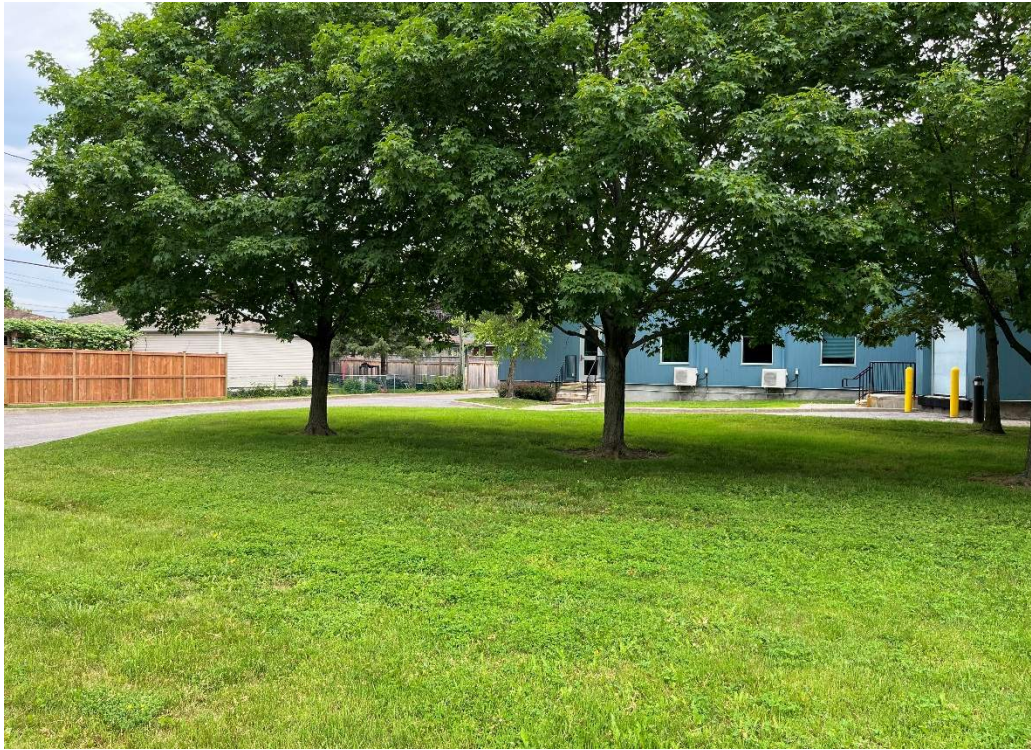
Photograph 5: Location of former pole-mounted transformers.
