# A CONSERVATION PLAN

CITY REGISTRY OFFICE 70 NICHOLAS STREET  
OTTAWA, ONTARIO

APRIL 26, 2022 FINAL

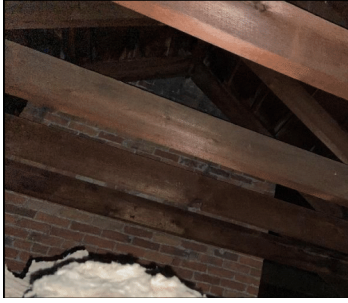
<p><b>CONSERVATION APPROACH</b> - Rehabilitation. The wood roof trusses span north south and bear on the north and south exterior walls. The sawn lumber roof rafters, collar ties and decking will be replaced by a new non-combustible roof structure complying with current OBC Standards.</p> <p><i>Figure 3: Interior truss system to be replaced with east façade of chimney in the background.</i></p>

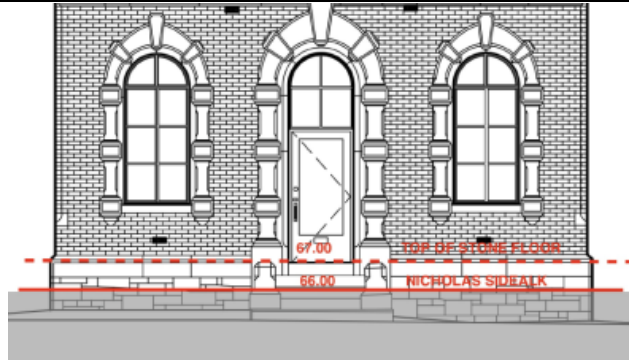
Figure 4: The red markers indicate the relationship of the building to Nicholas Street with a reduced grade difference. The shading at the base of the drawing indicates the new ground level.

<p>Due to soft lime-based mortar, localized removals of bricks can be completed effectively with minimal damage and a high rate of salvageability. Reintegration will require local repair and repointing masonry. Required masonry repairs should be performed, as directed by the masonry specialist including replacing damaged and cracked units. Both interior and exterior face brick should receive a light cleaning.</p>
<p>Stone Foundation</p>	<p><b>CONSERVATION APPROACH - Rehabilitation</b>                  The stone masonry foundation walls at the exterior perimeter are ±40" thick with rough cut rubble coursed face stone and limestone rubble back-up. Within the building footprint the reclaimed stone units from the exposed east-west and south foundation walls will be reconstructed in their original positions. Stonework showing evidence of failure or potentially damaged in the dismantling procedure will be repaired or replaced with matching stone units. The details will be adjusted to accommodate between the revised and original finished floor level. The finished floor level of the relocated CRO at EL 67.00 will match the ground floor of the main building and a portion of the visible exterior stone foundation will be obscured.</p>

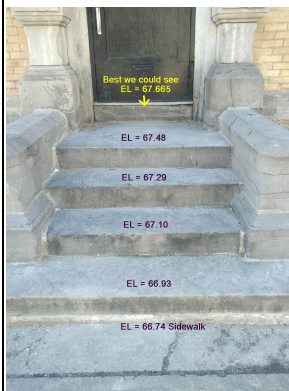
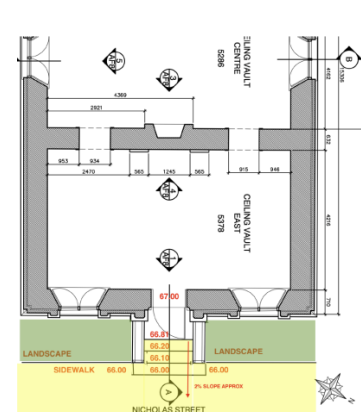
Figure 5 and 6: view and plan showing the existing steps with elevations noted and a plan view showing the planned rehabilitation of the steps being used as pavers.

<p>Entry Steps</p>	<p><b>CONSERVATION APPROACH - Rehabilitation.</b>                  Cut stone entrance stairs will be removed, labeled, restored, and stored for future reinstallation with height adjusted. The details will be adjusted to accommodate the revised layout between the new finished floor level (67.00) and the final grade at the foot of the stairs (66.60) eliminating 5 risers to 2 risers to match the Nicholas Street sidewalk at the bottom of the steps. Re-setting the lowest three steps level with the Nicholas Street sidewalk as a stone "entrance apron."</p>
--------------------	---

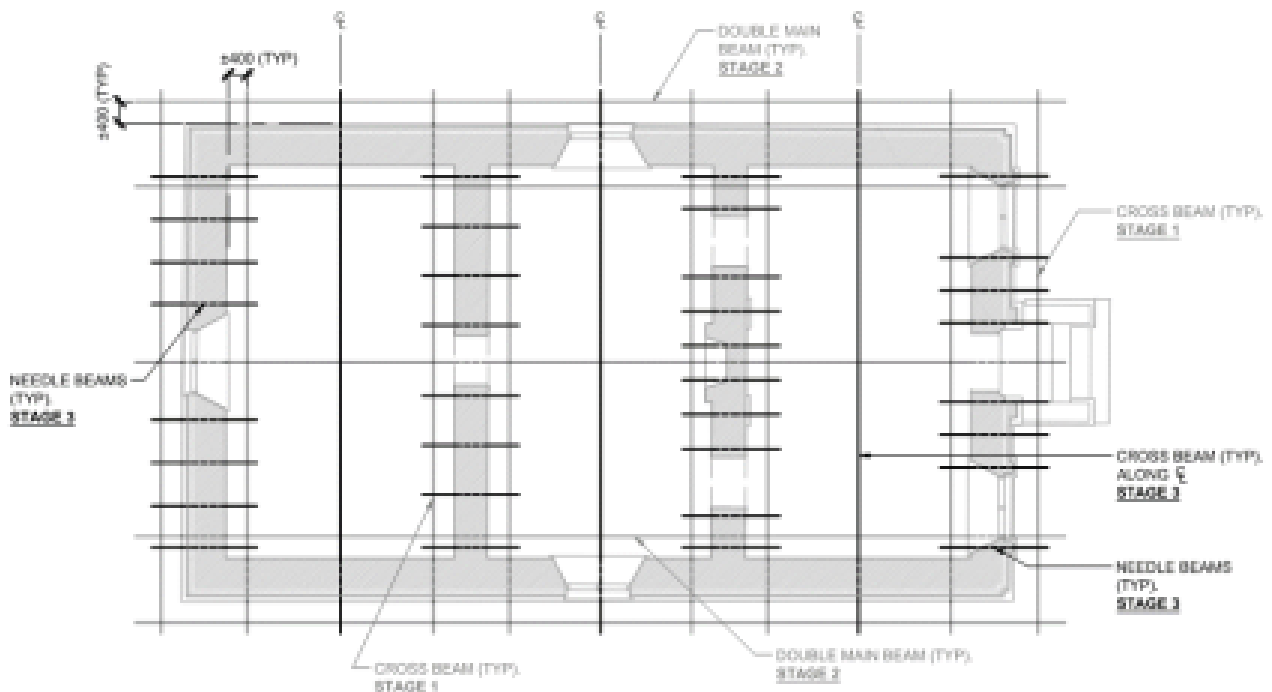
Figure 15: A plan view of the CRO with the Stage 1, 2, & Stage 3 Beam system

Moving operation, including a description of equipment has been developed CDS Building Movers and include four stages: - Stage 1: Install Cross Beams, Stage 2: Install Main Beams, Stage 3: Install Needle Beams, Stage 4: Lifting and Travel. These are described in detail as Appendix D.

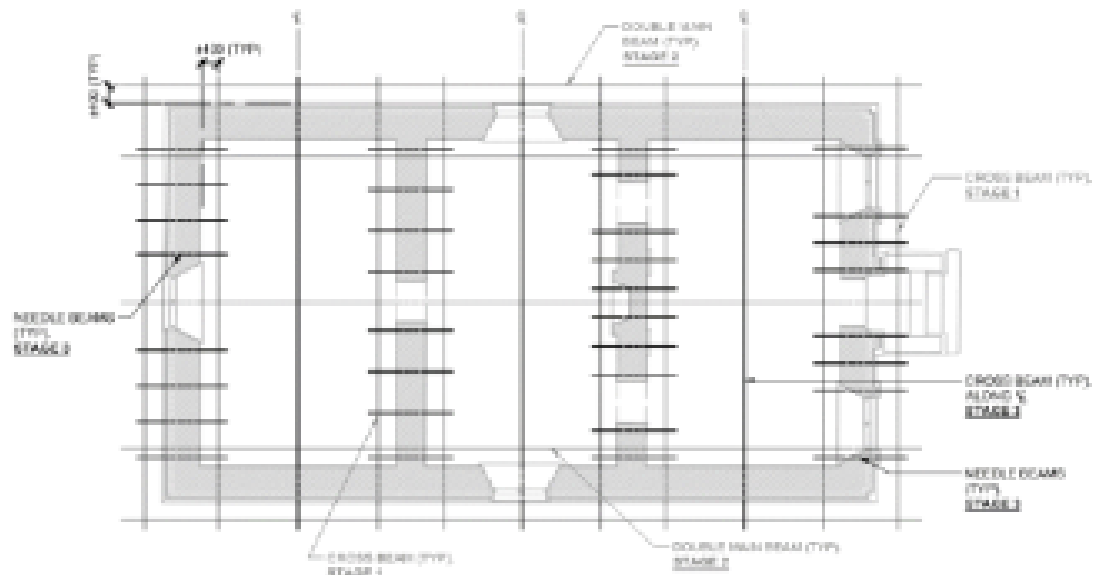
**Stage 3: Needle Beam Installation**

**Stage 3: Install Needle Beams** – At this stage the needle beams under the north-south walls will be installed in the same manner as the previous beams. These are the beams that interact directly with the north-south masonry wall and transfer load to the cross beams.
