**RE: TREE INFORMATION REPORT (FULL) FOR 275 HILLCREST ROAD, ROCKCLIFFE**

This Tree Information Report (TIR) was prepared by Integrated Forestree Services Inc. (IFS) in support of a building permit application for 275 Hillcrest Road in Rockcliffe. The need for this report is related to trees protected under the City of Ottawa’s Tree Protection By-law (By-law No. 2020-340). The work proposed for this residential lot includes the demolition of an existing dwelling and construction of new larger dwelling (see plan on page 4 of this report).

DRAWING: Tree Information Plan

PROJECT: 275 HILLCREST ROAD  
CITY OF OTTAWA

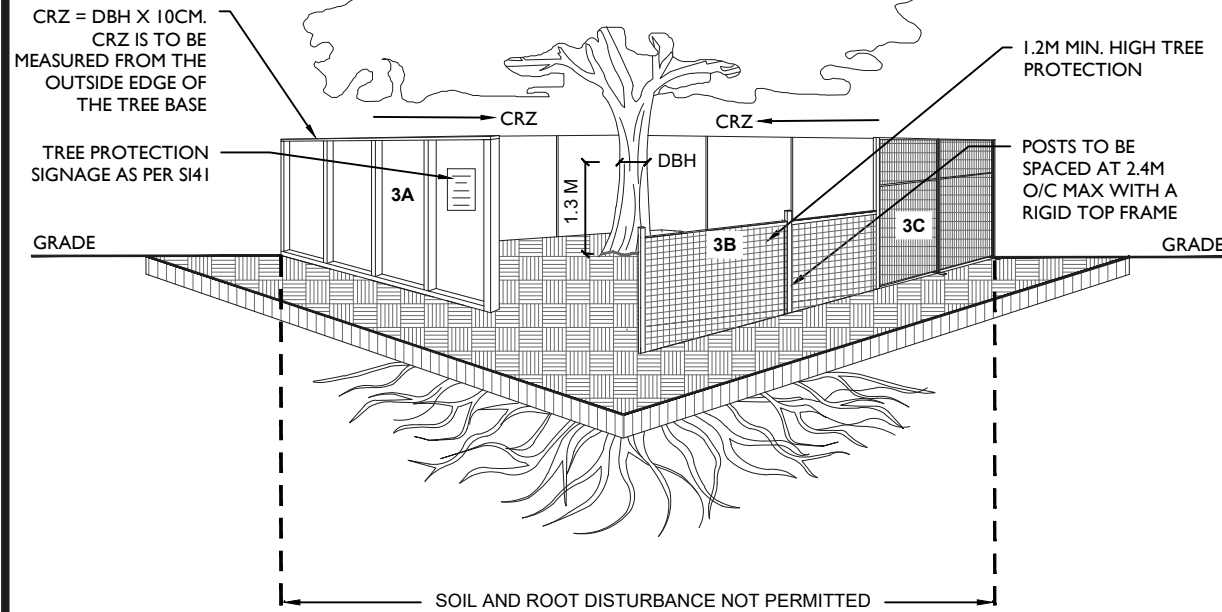
Tree Protection

TREE PROTECTION FENCING  
TREE TRUNK

PLAN VIEW

3. TREE PROTECTION FENCING MUST BE AT LEAST 1.2M IN HEIGHT AND BE CONSTRUCTED OF RIGID OR FRAMED MATERIALS SUCH AS:
    - A. PLYWOOD HOARDING
    - B. SNOW FENCE

1. Erect a fence as close as possible to the critical root zone (CRZ) of trees (City of Ottawa tree protection barrier detail included on page 7).
2. Do not place any material or equipment within the CRZ of the tree.
3. Do not attach any signs, notices or posters to any tree.
4. Do not raise or lower the existing grade within the CRZ without approval.
5. Tunnel or bore when digging within the CRZ of a tree.
6. Do not damage the root system, trunk or branches of any tree.
7. Ensure that exhaust fumes from all equipment are NOT directed towards any tree's crown.

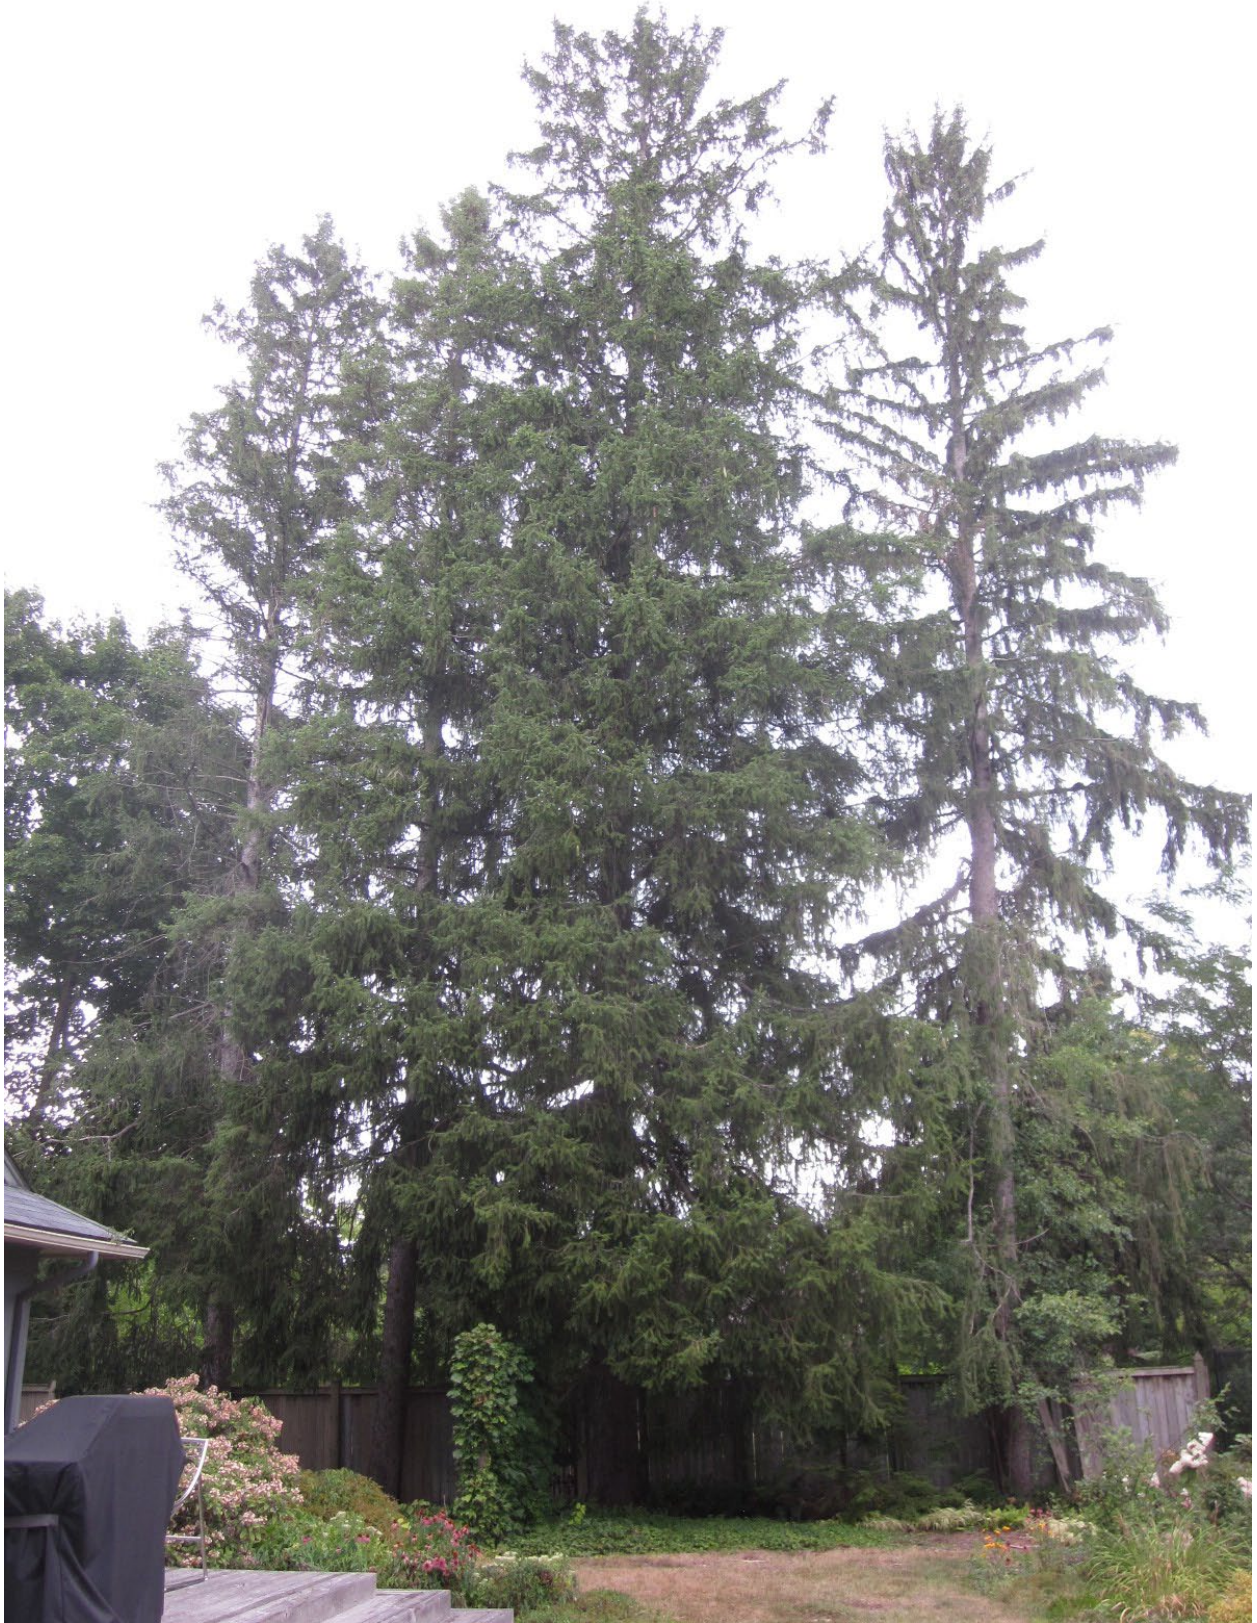
| Tree No. | Tree species /Tolerance to Construction <sup>1</sup> | Owner ship <sup>2</sup> | DBH <sup>3</sup> (cm) | CRZ <sup>4</sup> (m) | Distance to excavation (m) <sup>5</sup> | Tree Condition; Age Class; Condition Notes; Species Origin and <b>Status (to be removed or preserved and protected)</b> | Reason for removal | Forester's Opinion re. Removal |
|---|---|---|---|---|---|---|---|---|
| 1 | Norway spruce ( <i>Picea abies</i> ) / Moderate - Good | Private | 48.2 | 4.8 | >10 | Fair; mature; central dominant stem and leader; lower crown thin due to influence of previous tree towards west; fair crown density, annual increment and needle colour; introduced species; <b>to be preserved and protected</b> | Not applicable – to be preserved | NA |
| 2 | Norway spruce ( <i>Picea abies</i> ) / Moderate - Good | Private | 49.6 | 5 | >10 | Fair; mature; central dominant stem and leader; fair crown density, annual increment and needle colour; introduced species; <b>to be preserved and protected</b> | Not applicable – to be preserved | NA |
| 3 | Norway spruce ( <i>Picea abies</i> ) / Moderate - Good | Private | 71.7 | 7.2 | >10 | Good; mature; central dominant stem and leader; good crown density, annual increment and needle colour; good root collar; introduced species; <b>to be preserved and protected</b> | Not applicable – to be preserved | NA |
| 4 | Norway spruce ( <i>Picea abies</i> ) / Moderate - Good | Private | 54.2 | 5.4 | >10 | Fair; mature; central dominant stem and leader; crown asymmetric due to influence of previous tree towards east; fair crown density, annual increment and needle colour; girdling root on south; introduced species; <b>to be preserved and protected</b> | Not applicable – to be preserved | NA |

Picture 1. Trees #1-4 (left to right) at 275 Hillcrest Road – private spruce trees (to be retained)

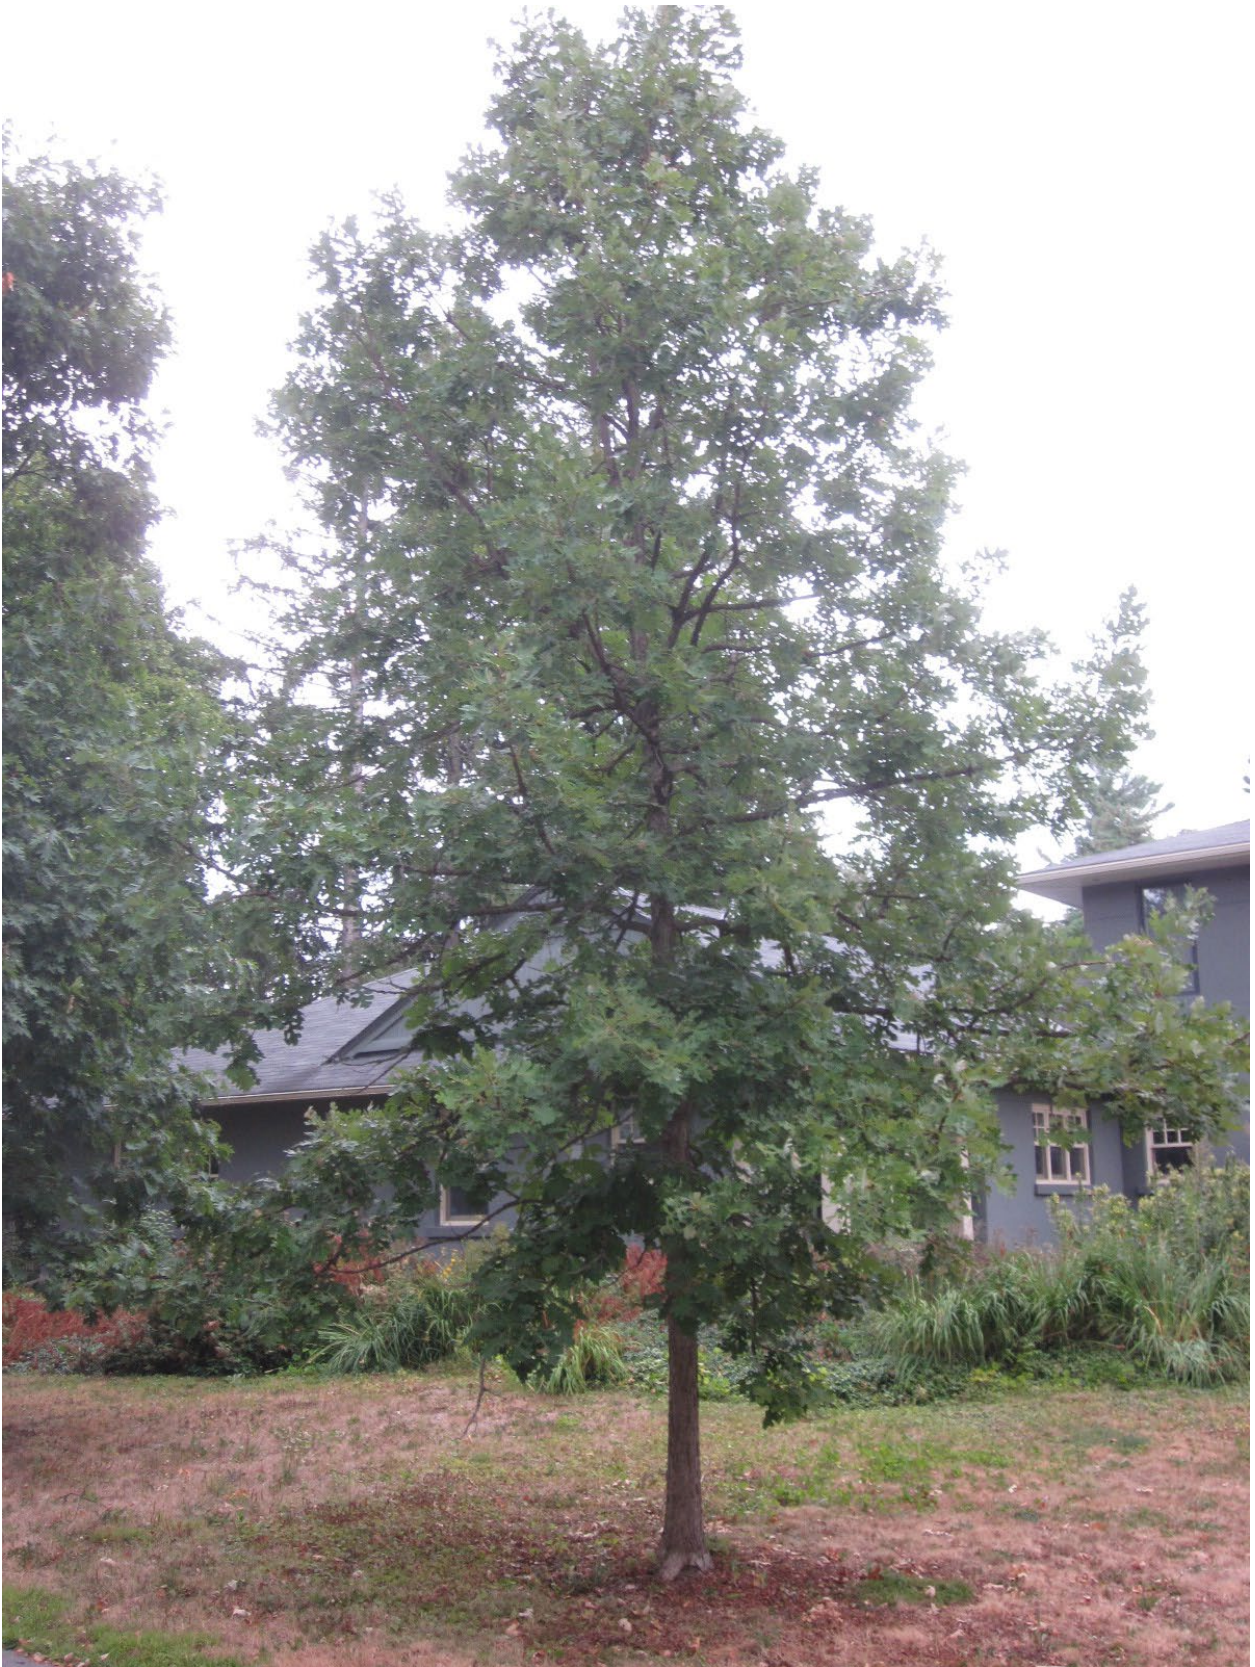
| Tree No. | Tree species /Tolerance to Construction <sup>1</sup> | Owner ship <sup>2</sup> | DBH <sup>3</sup> (cm) | CRZ <sup>4</sup> (m) | Distance to excavation (m) <sup>5</sup> | Tree Condition; Age Class; Condition Notes; Species Origin and <b>Status (to be removed or preserved and protected)</b> | Reason for removal | Forester's Opinion re. Removal |
|---|--|---|---|---|---|--|---|---|
| 8 | Bur oak ( <i>Quercus macrocarpa</i> ) / Moderate - Good | City | 14.4 | 1.4 | >5 | Good; immature; central dominant stem with competing laterals starting at 1.75m; competing leaders near apex; native species; <b>to be preserved and protected</b> | Not applicable – to be preserved | NA |

Picture 2. Tree #8 at 275 Hillcrest Road – bur oak on city property (to be retained)

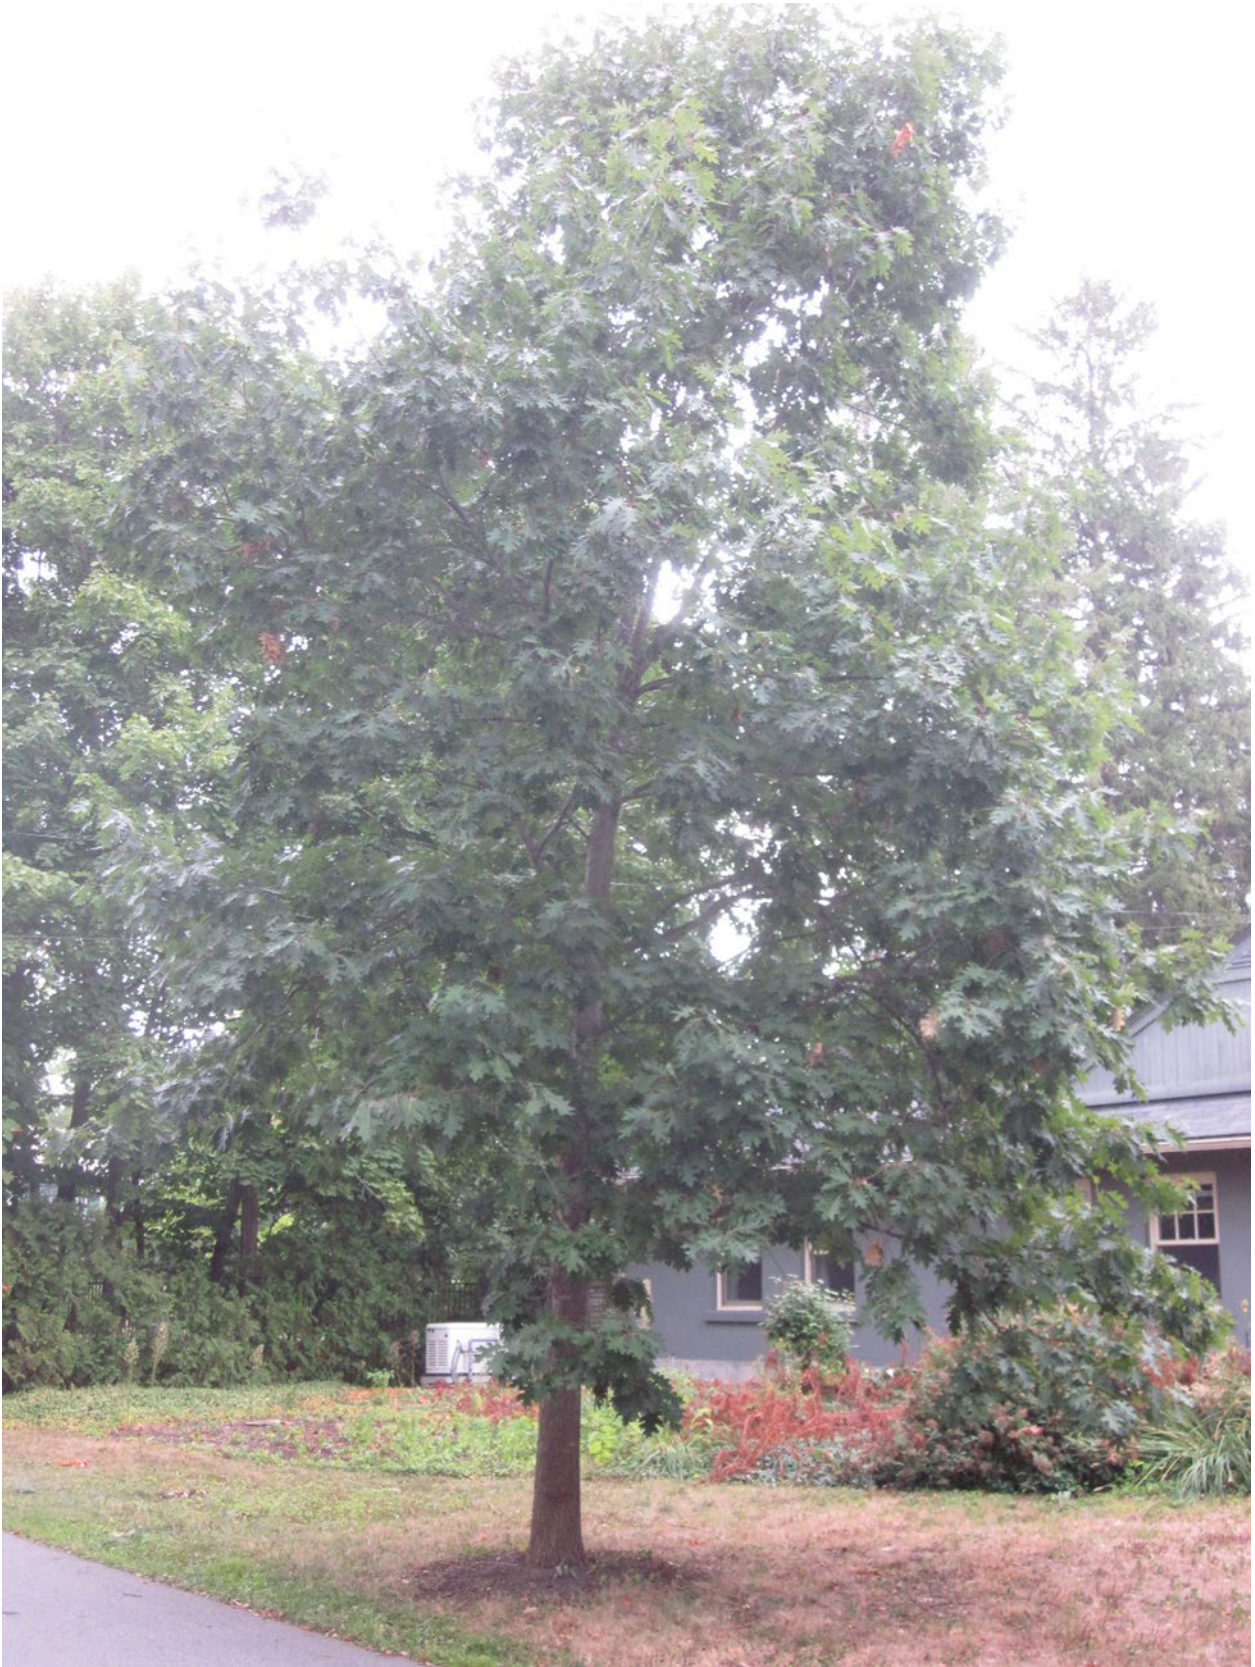
| Tree No. | Tree species /Tolerance to Construction <sup>1</sup> | Owner ship <sup>2</sup> | DBH <sup>3</sup> (cm) | CRZ <sup>4</sup> (m) | Distance to excavation (m) <sup>5</sup> | Tree Condition; Age Class; Condition Notes; Species Origin and <b>Status (to be removed or preserved and protected)</b> | Reason for removal | Forester's Opinion re. Removal |
|---|--|---|---|---|---|--|---|---|
| 9 | Red oak ( <i>Quercus rubra</i> ) / Moderate - Good | City | 24.0 | - | - | Good; maturing; central dominant stem with competing leaders at 5m; suppressed laterals starting at 2.25m; native species; <b>to be removed</b> | Conflicts with proposed driveway | Tree and stump be removed |

Picture 3. Tree #9 at 275 Hillcrest Road – red oak on city property (to be removed)

A total of two replacement trees are proposed in compensation for the loss of tree #9. As noted on the plan on page 4, suggested planting locations of two large trees are shown.

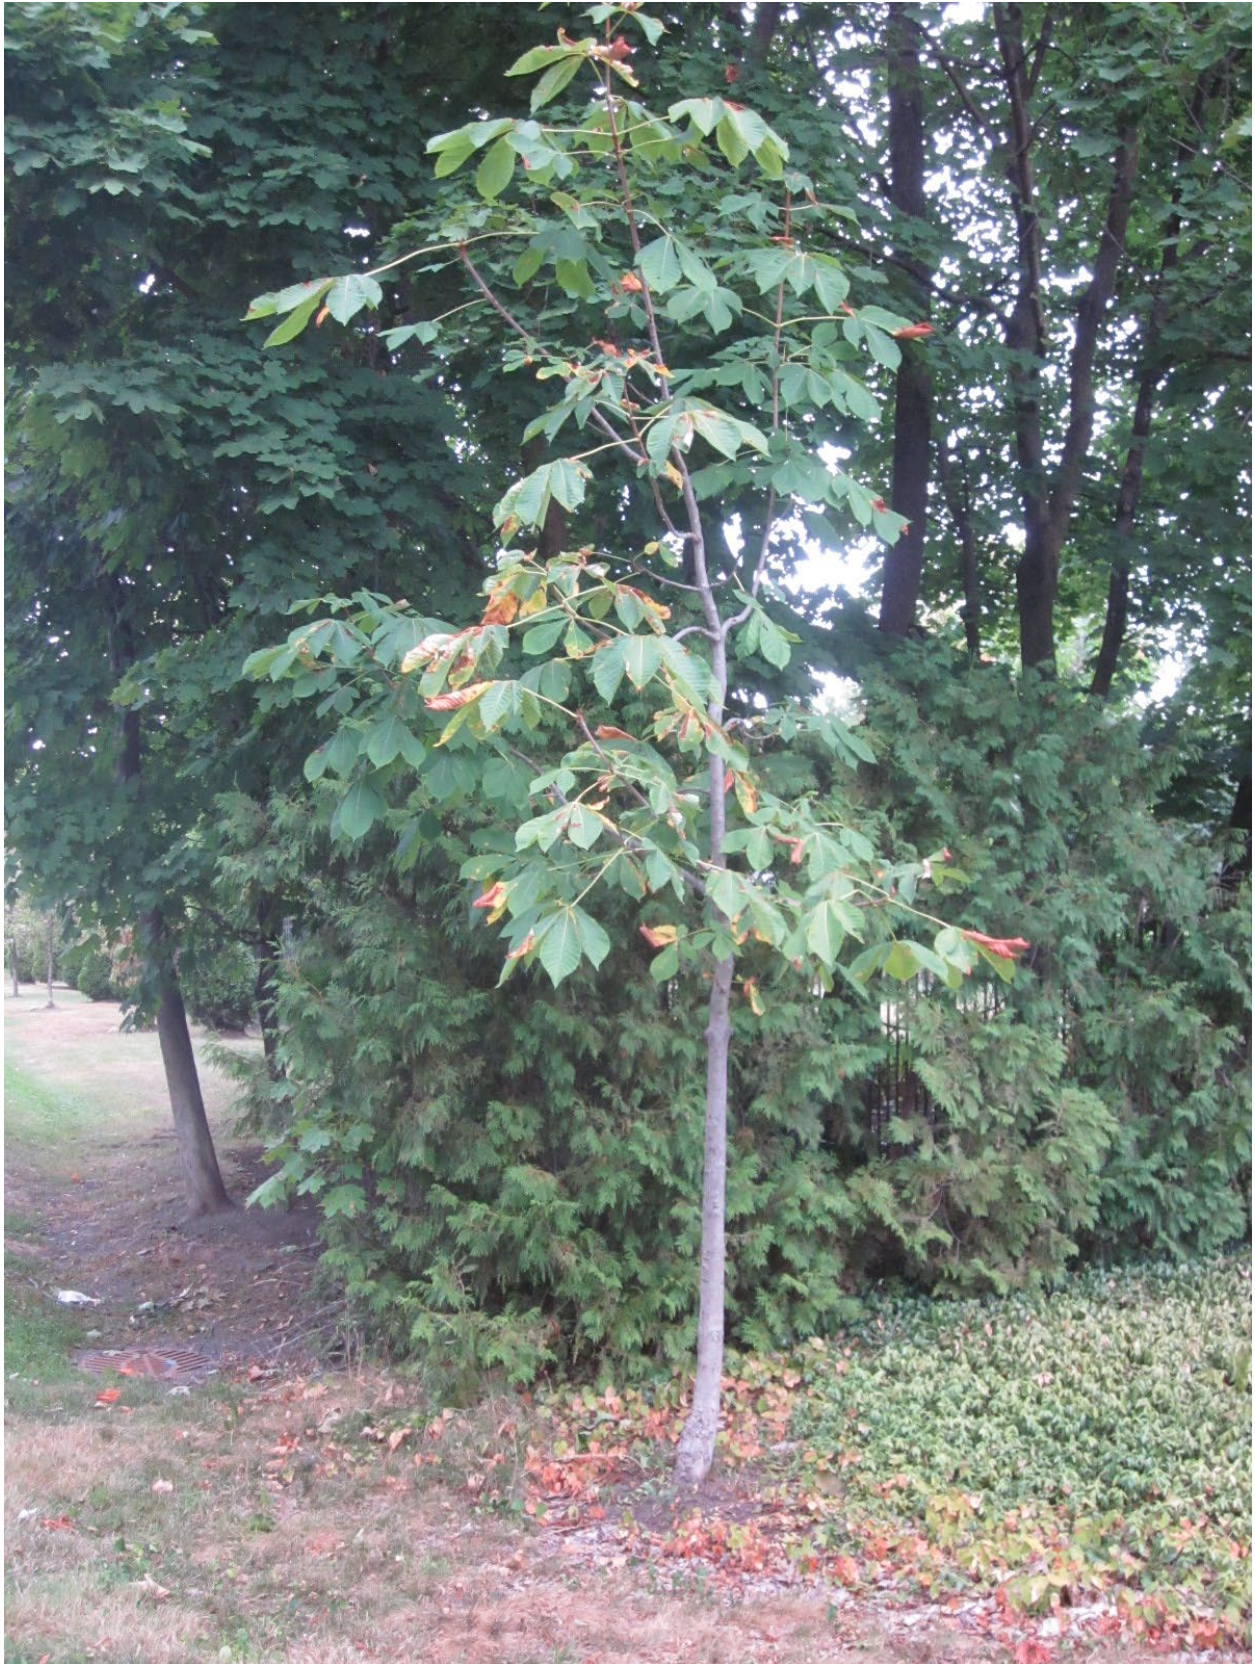
| Tree No. | Tree species /Tolerance to Construction <sup>1</sup> | Owner ship <sup>2</sup> | DBH <sup>3</sup> (cm) | CRZ <sup>4</sup> (m) | Distance to excavation (m) <sup>5</sup> | Tree Condition; Age Class; Condition Notes; Species Origin and <b>Status (to be removed or preserved and protected)</b> | Reason for removal | Forester's Opinion re. Removal |
|---|--|---|---|---|---|--|---|---|
| 10 | Ohio buckeye ( <i>Aesculus glabra</i> ) / Poor | City | 6 | 0.6 | >5 | Good; immature; planted within the last 5 years; growth form divergent towards west due to influence of two neighbouring Norway maples ( <i>Acer platanoides</i> ) – both of which are <30cm DBH; introduced species; <b>to be preserved and protected</b> | Not applicable – to be preserved | NA |

Picture 4. Tree #10 at 275 Hillcrest Road – Ohio buckeye on city property (to be retained)
