Hydrogeological Study

8520 McArton Road, Ottawa, Ontario

Project Number: 19-213-1

April 30, 2020

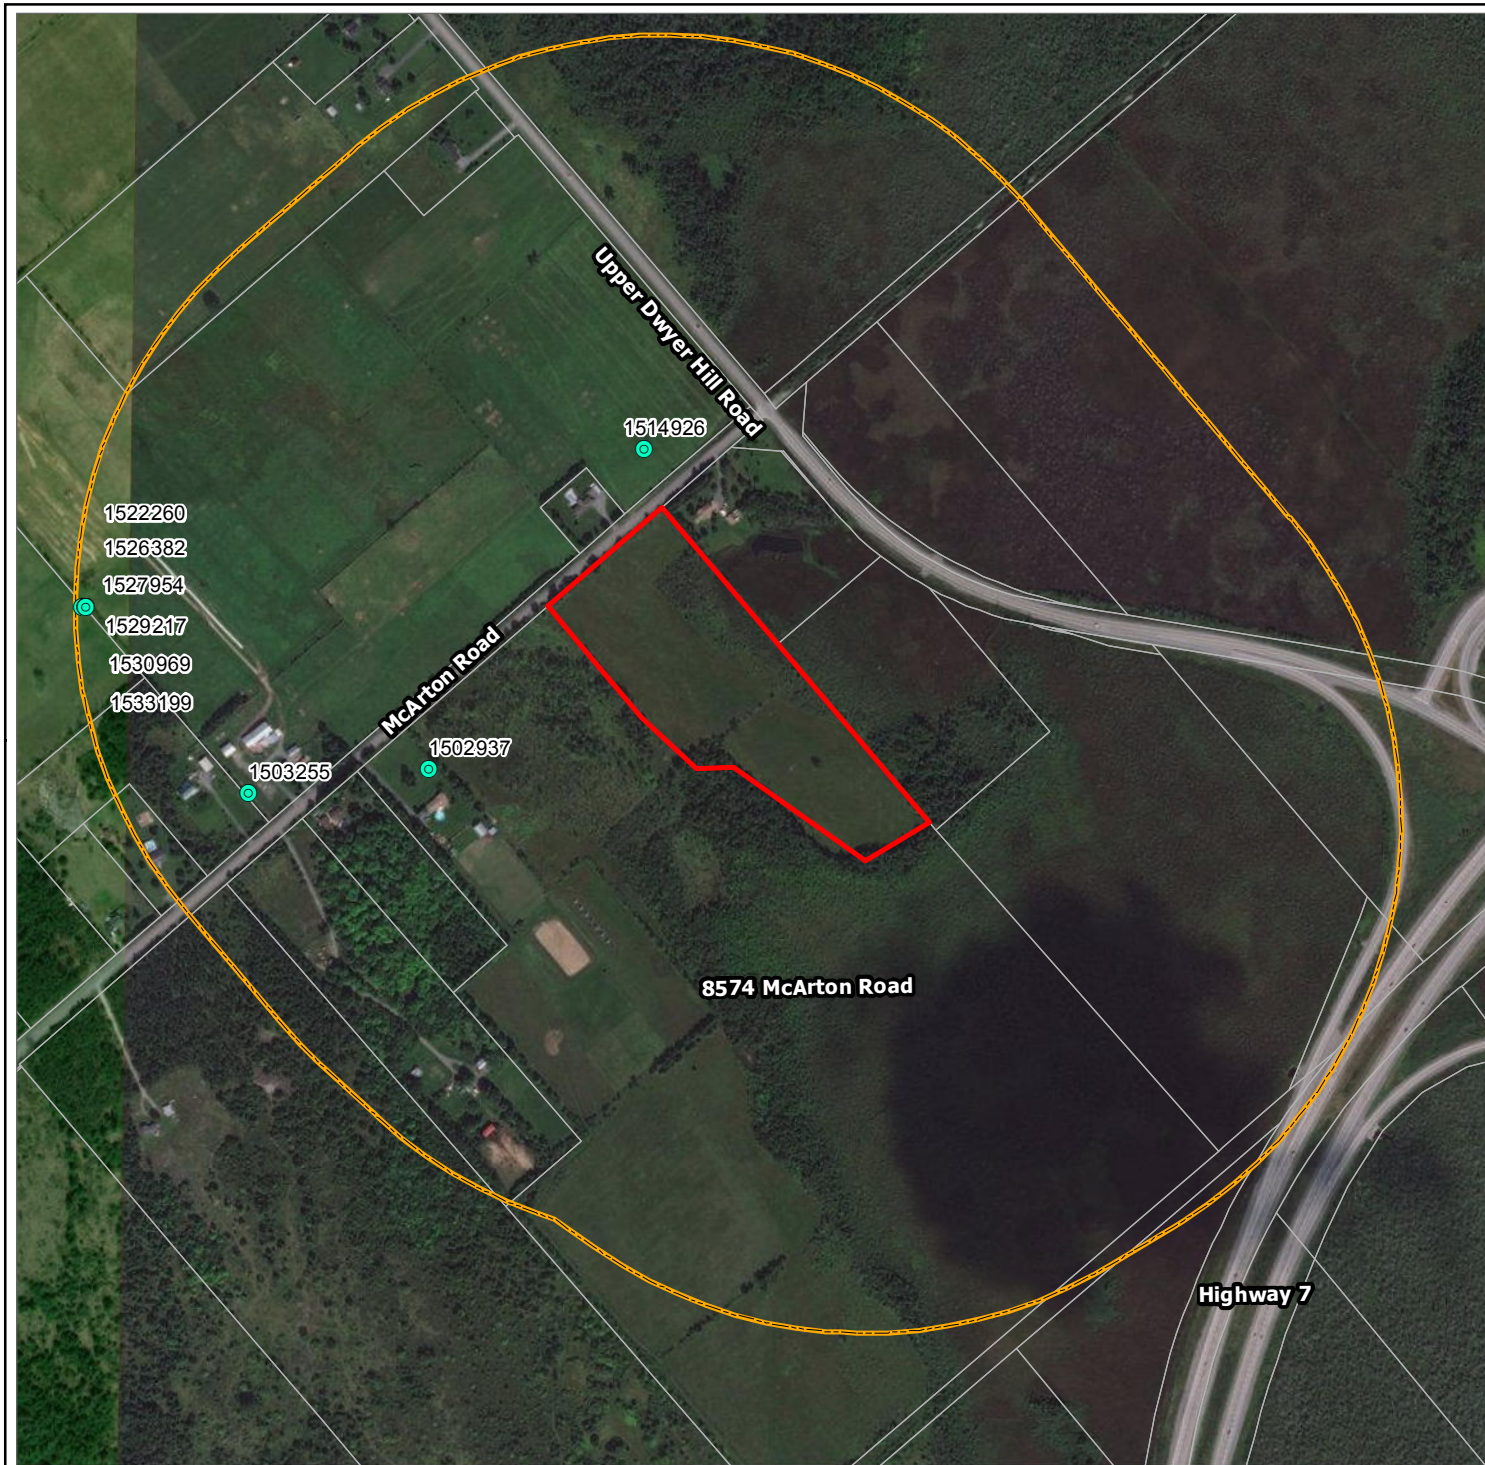
All MECP water wells within 500 m, as summarized in Table 1, are completed within the bedrock. The average depth to bedrock is approximately 1 m BGS; however, some of the records reported depth to bedrock of zero and describe the upper unit as broken rock. Average well depth is 39.3 m and varies from 21.3 to 68.6 m.

- 8520 McArton Road
- 500m Buffer Area from Property Line
- City of Ottawa Property Lines
- MOECC Water Wells

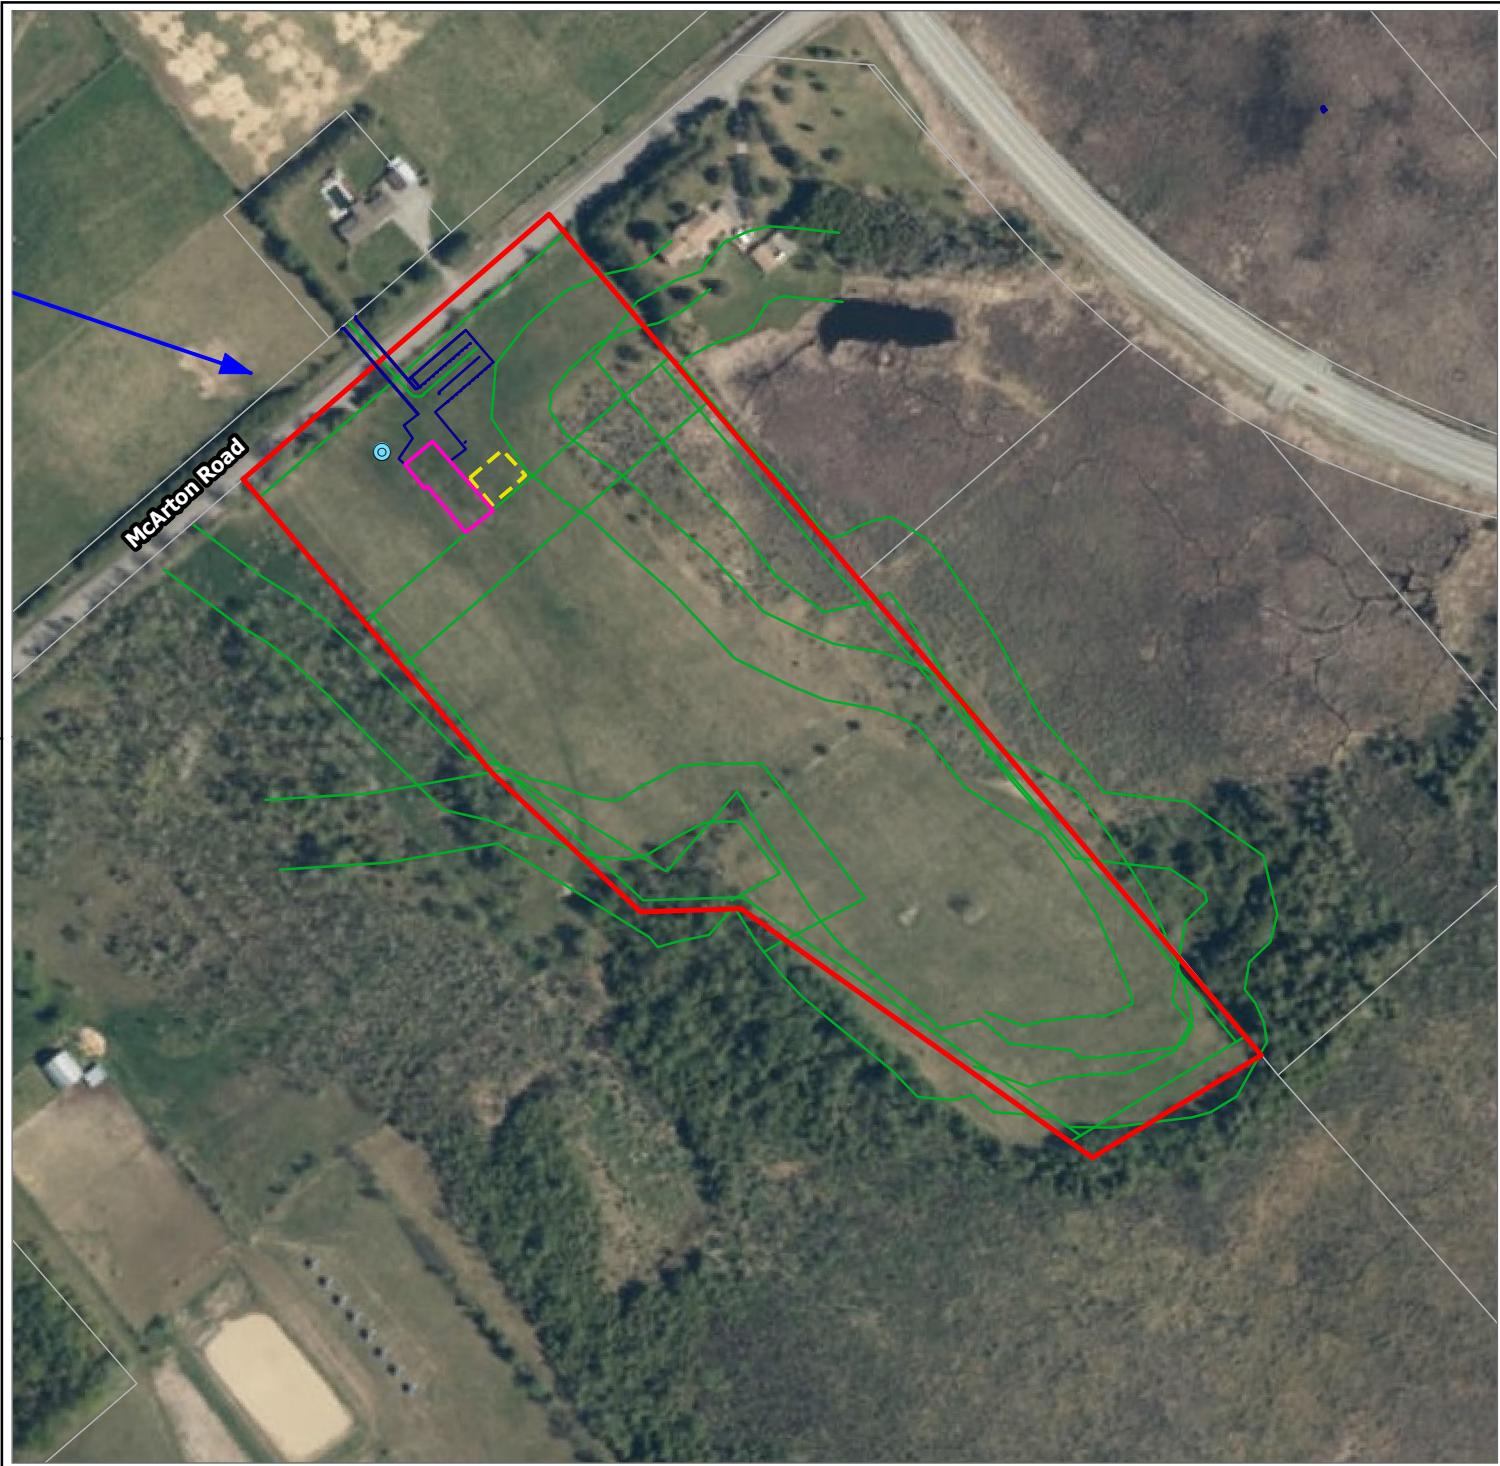
Figure A.6, Appendix A, provides a generalized lot development plan, showing the placement of the well and recommended location of the septic system. Note that installation of the well and septic shall, at a minimum, be constructed in accordance with O.Reg. 903 and the Ontario Building Code (Part 8), respectively. Appendix H provides a copy of the draft proposed Site Plan.

- The septic bed should be sited in an area of thicker soil cover, if possible, and may require import of additional suitable fill material;
- Due to the soil conditions a clay seal may be required below the septic leaching bed to ensure additional isolation from the underlying soil and bedrock; and,
- Ensure the septic bed is located downgradient from the well head (i.e. southeast of the well).
