**PHASE I - ENVIRONMENTAL SITE ASSESSMENT
VACANT PROPERTY
BANK STREET AT PARKWAY ROAD
CITY OF OTTAWA (GREELY), ONTARIO**

Sunset Lakes Development Corporation

December 17, 2003

Report No. E2834-1

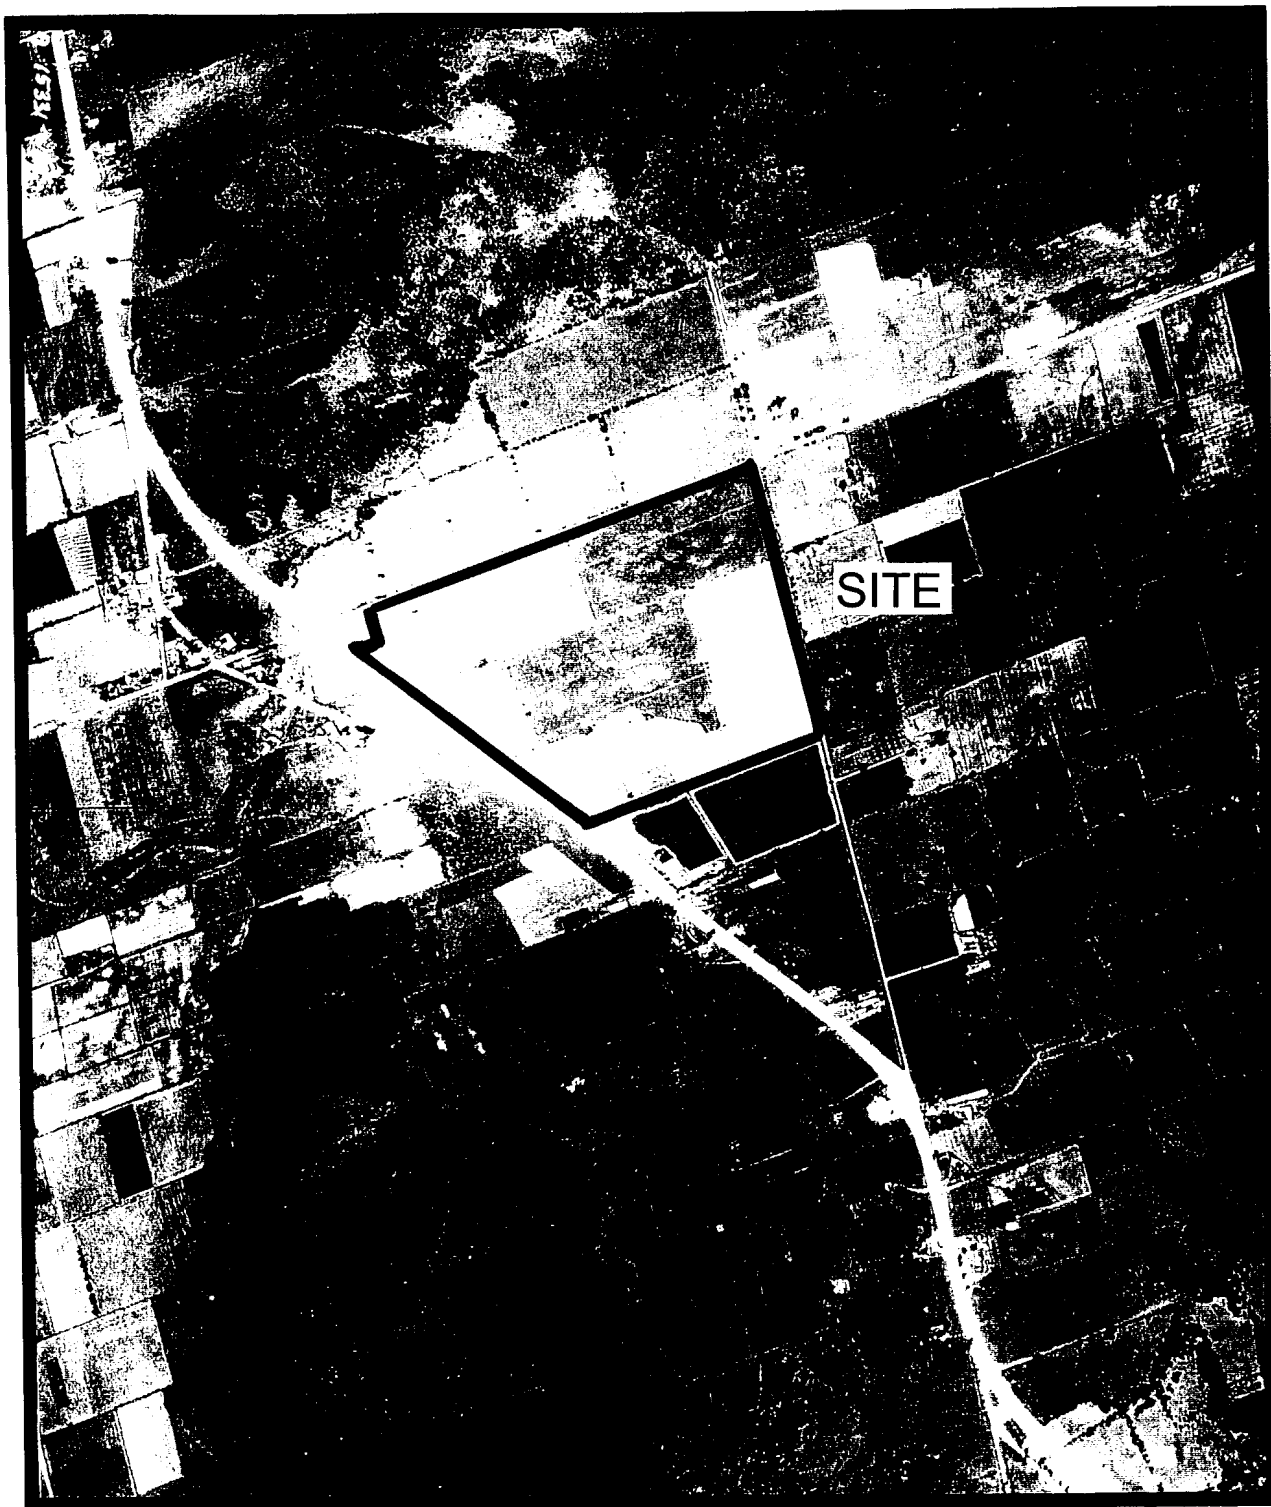
AERIAL PHOTOGRAPH
1956

| 1956 | No major changes were made to the subject property or neighbouring sites. Bank Street was constructed along the west property line of the subject site. |

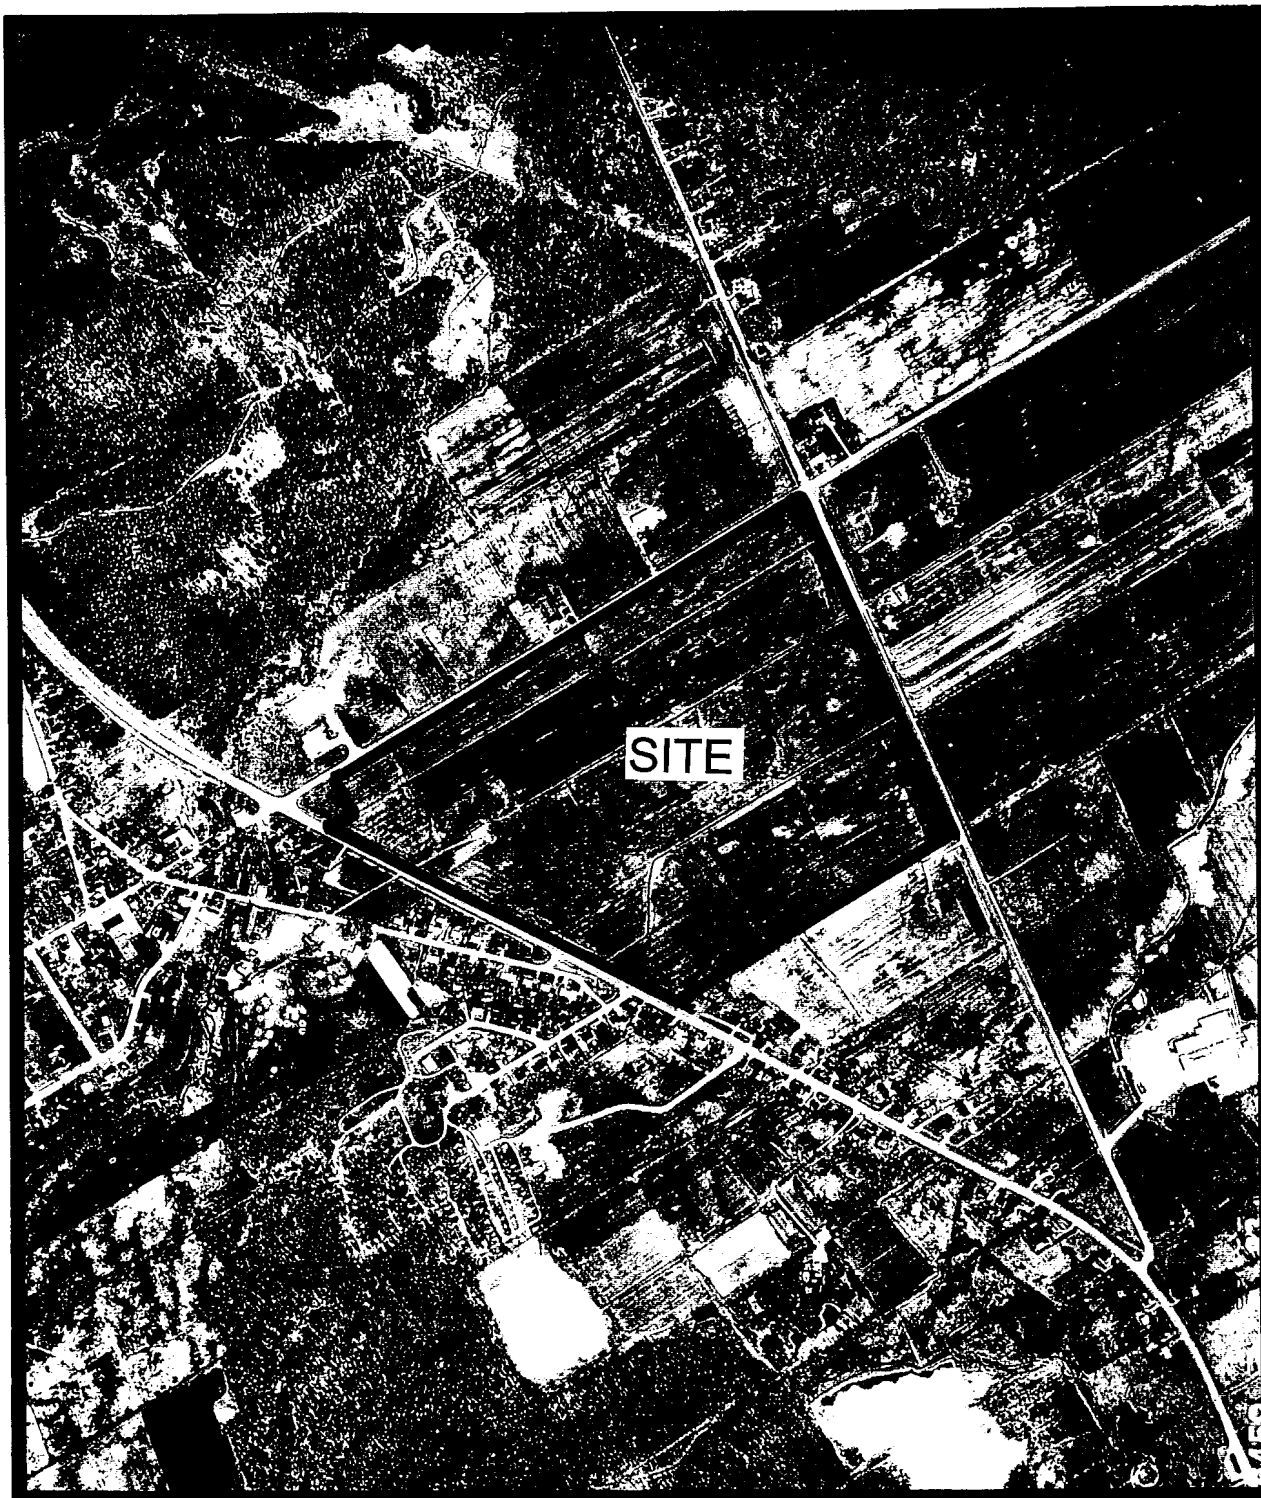
AERIAL PHOTOGRAPH
1984

| 1984 | No significant changes were made to the subject property with the exception of a barn constructed in the northwestern portion of the site. A road maintenance facility, a church and residential dwellings were constructed on the north side of Parkway Road. |

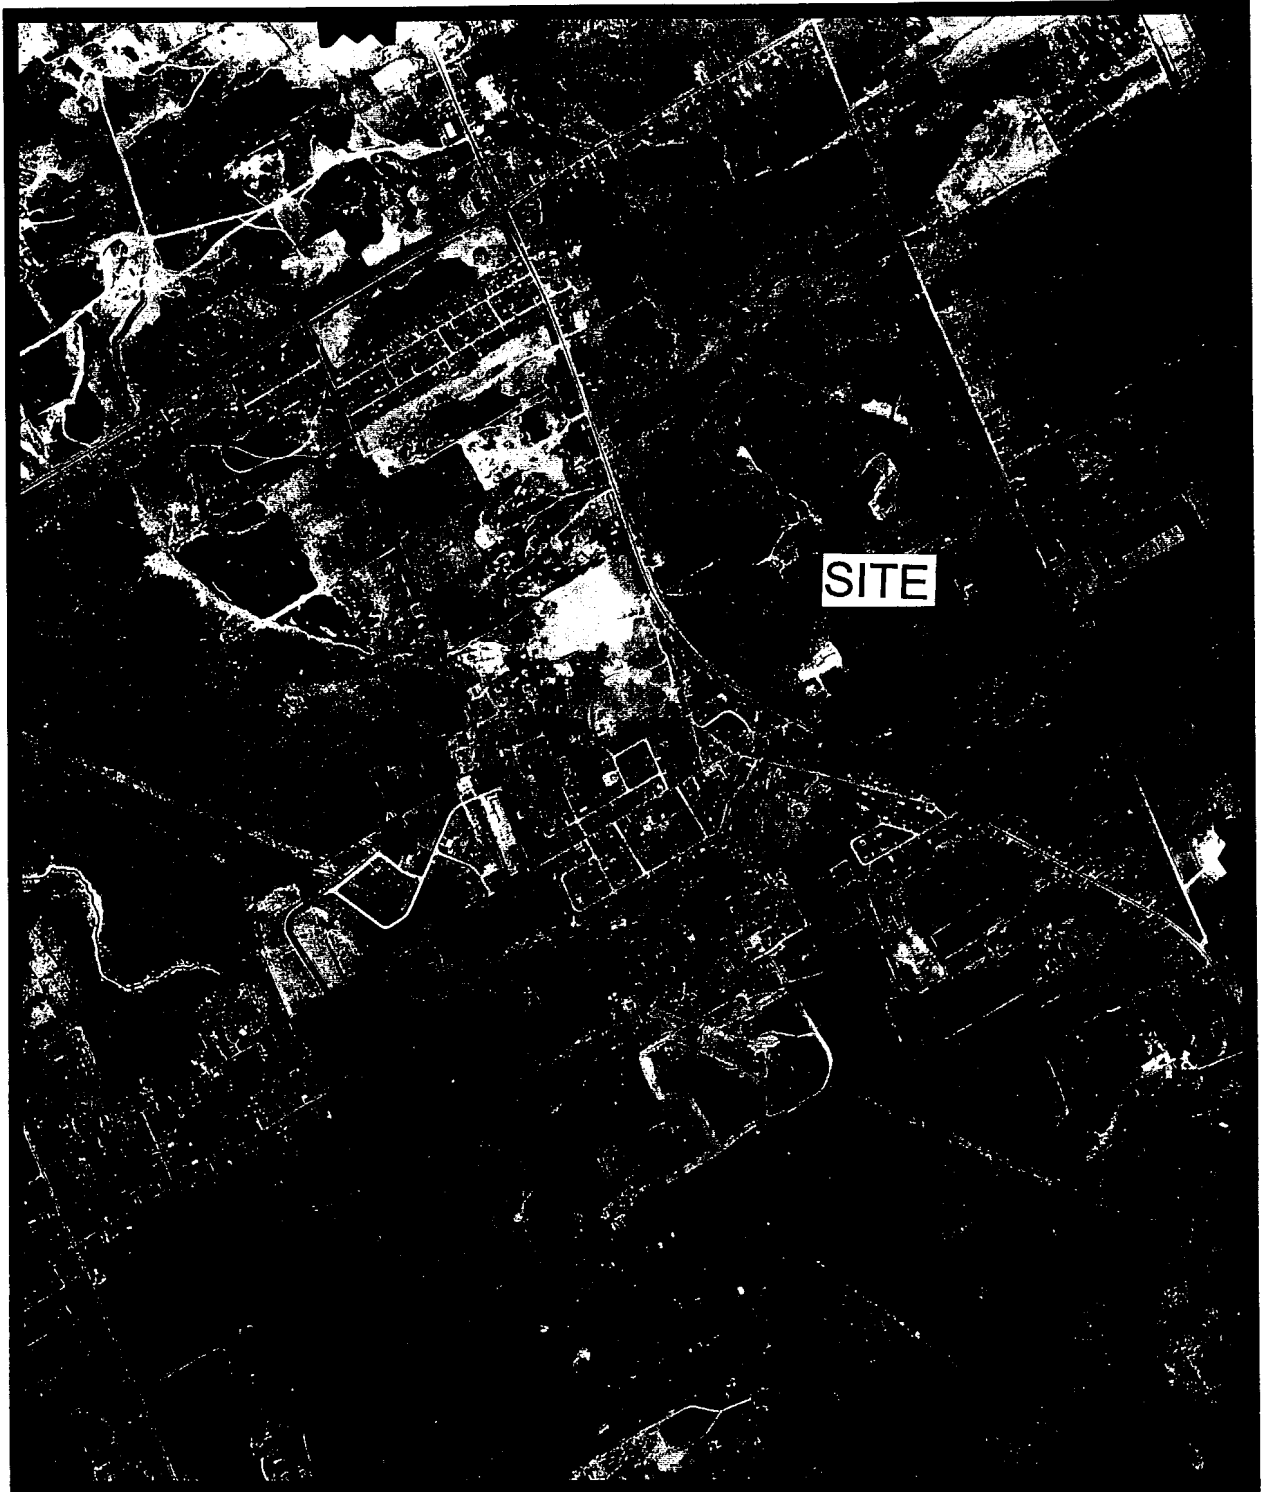
AERIAL PHOTOGRAPH
1989

| 1989 | No significant changes have been made to the subject site with the exception of an additional barn constructed near the previously mentioned structure. No significant changes were made to the neighbouring properties. The road maintenance yard appears like it does today. |

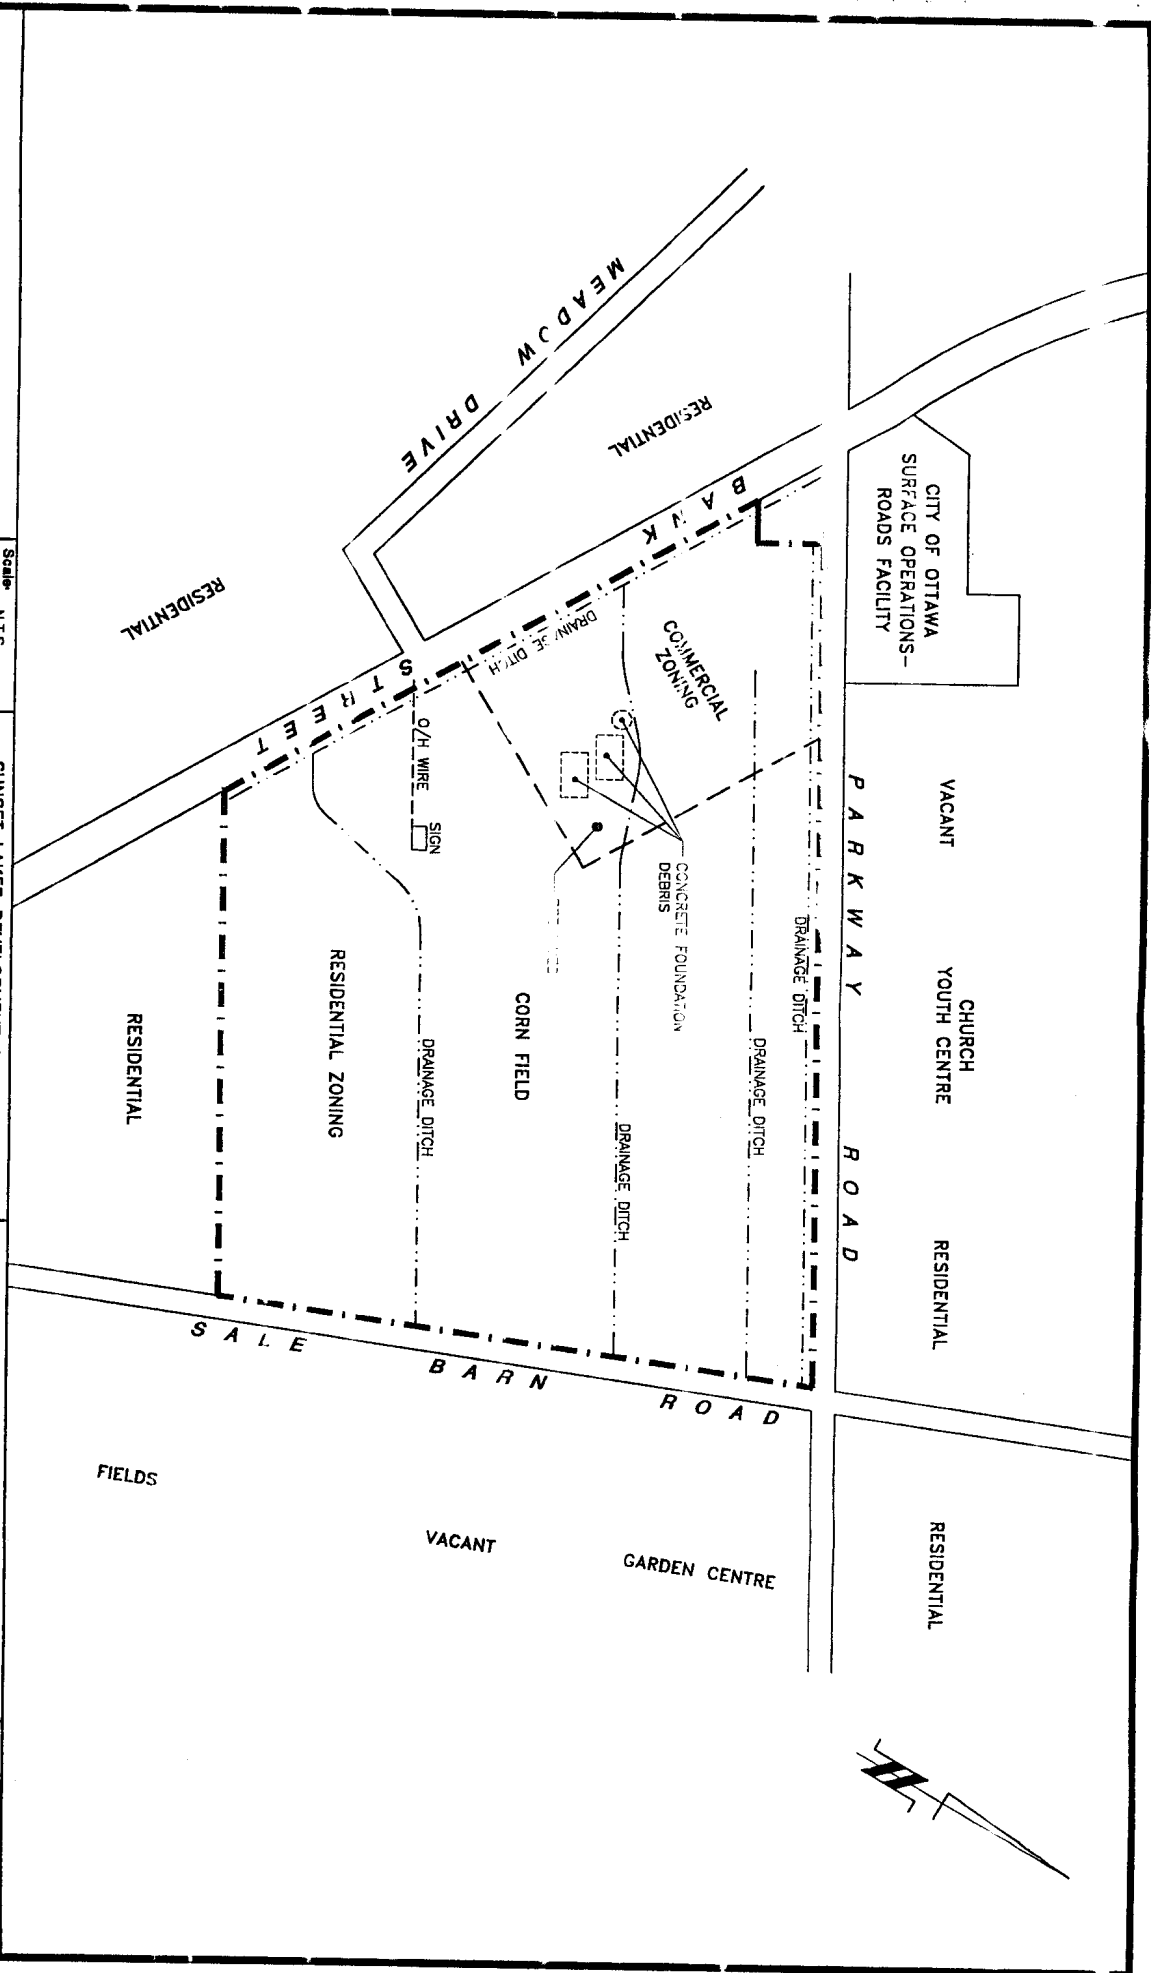
Dwg. No. **E2834-1**
 Report No. E2834-01
 Date: 12/2003

- ☐ North - *Parkway Road, commercial (City yard), church and residential;*
- ☐ South - *Residential;*
- ☐ East - *Sale Barn Road followed by commercial farm and vacant fields;*
- ☐ West - *Bank Street followed by residential.*

The environmental impact of the neighbouring properties upon the subject site was considered to be low with the possible exception of the road maintenance facility located across Parkway Road. Based on interviews with MTO personnel, it was determined that the storage and handling of salt on has impacted the shallow groundwater aquifer beneath the former MTO site, although no information was available for the deeper groundwater aquifer. The potential for impacted groundwater, in the shallow aquifer to have migrated onto the subject property is difficult to assess, since the nature and depth of the overburden materials, the bedrock formation and the groundwater flow direction are not well known. However, it is our opinion that the potential for the deeper aquifer to have been significantly impacted is low. Furthermore, road salt impacted groundwater can be readily treated and it is not considered to represent a significant liability to the subject land.

Land use adjacent to the subject site is illustrated on Drawing No. E2834-1 - Site Plan in Appendix 2 of this report.

It is our understanding that a hydrogeological study will be required prior to the development of the site. As part of this study, it is recommended that one of the test well be installed in relatively close proximity to the road maintenance facility in order to assess the groundwater quality in the bedrock aquifer.
