**Phase I - Environmental Site Assessment**

144 Renfrew Avenue  
Ottawa, Ontario

TC United Group

Report: PE4003-1

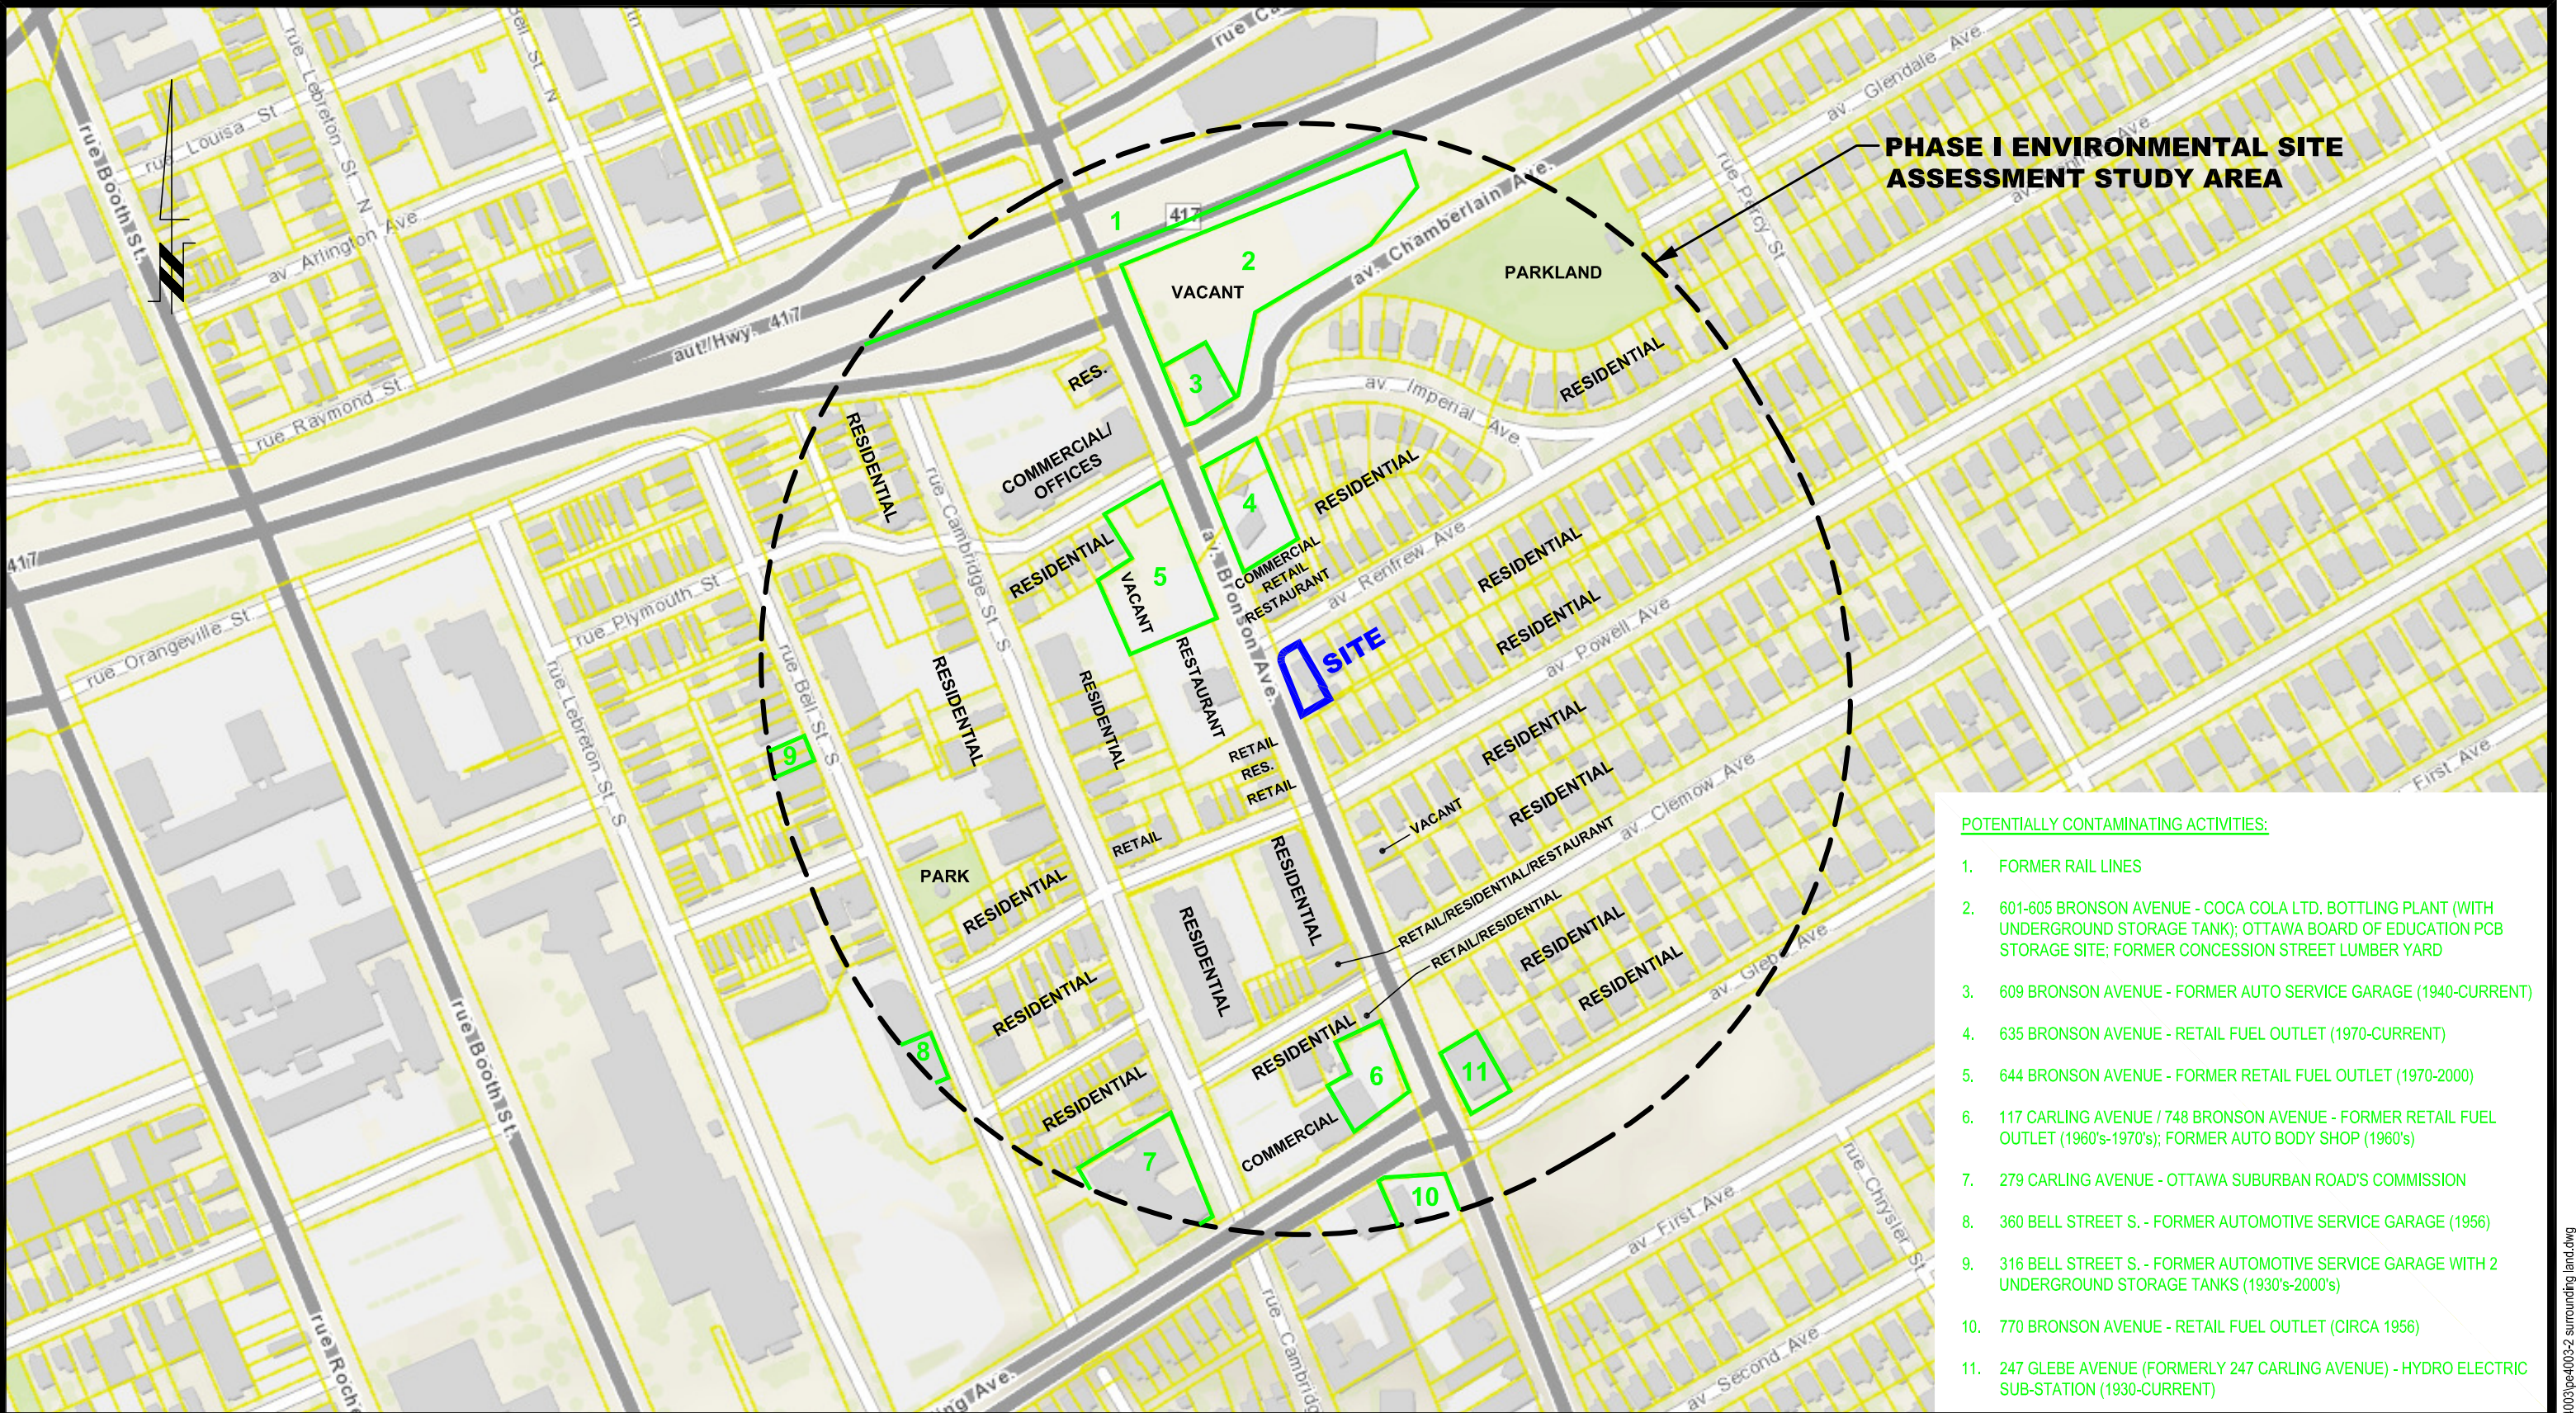
**DRAWING PE4003-2 – SURROUNDING LAND USE PLAN**

**PHASE I ENVIRONMENTAL SITE ASSESSMENT STUDY AREA**

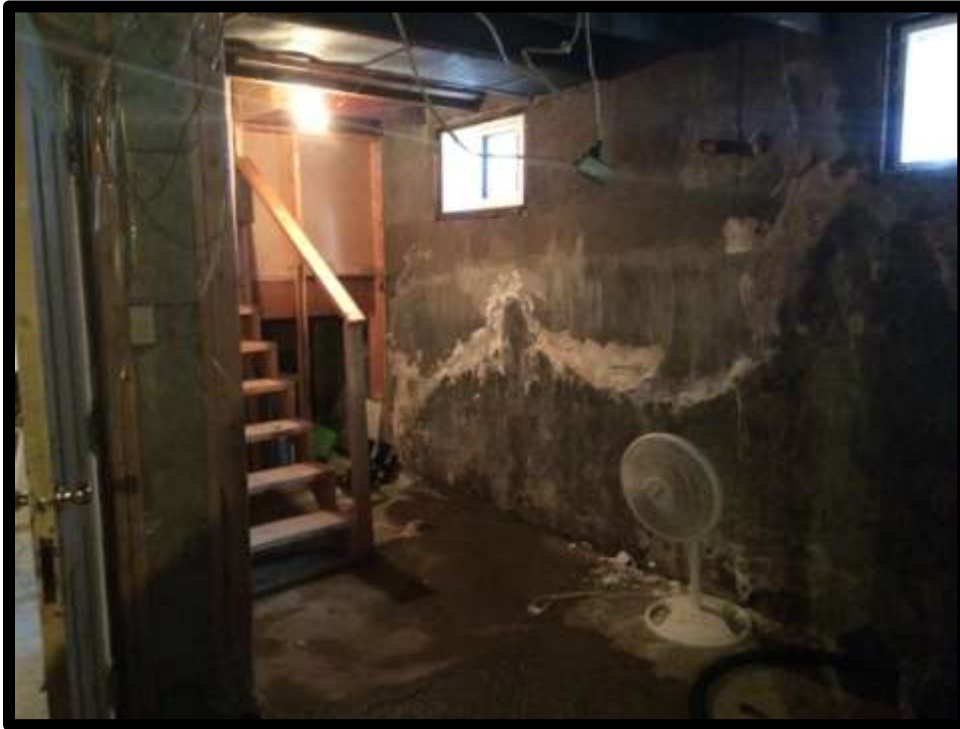
No tanks remain at the subject site, however, holes for vent/fill pipes in the foundation wall and the fuel lines in the floor slab remain as evidence of the former fuel oil heating system at the subject site. No visual or olfactory indications of spills or leaks of the former tank were noted in the basement. The previous use of fuel oil at the subject site is not considered to represent a concern for the subject site. Chemical storage in the building was limited to a few cans of paint and household cleaning supplies. No concerns were identified with respect to fuel and chemical storage at the subject property.

Photograph 1: View of former aboveground storage tank area in unfinished portion of the basement. Moisture on walls and floor are from weeping foundation. No oil staining or odour was observed.

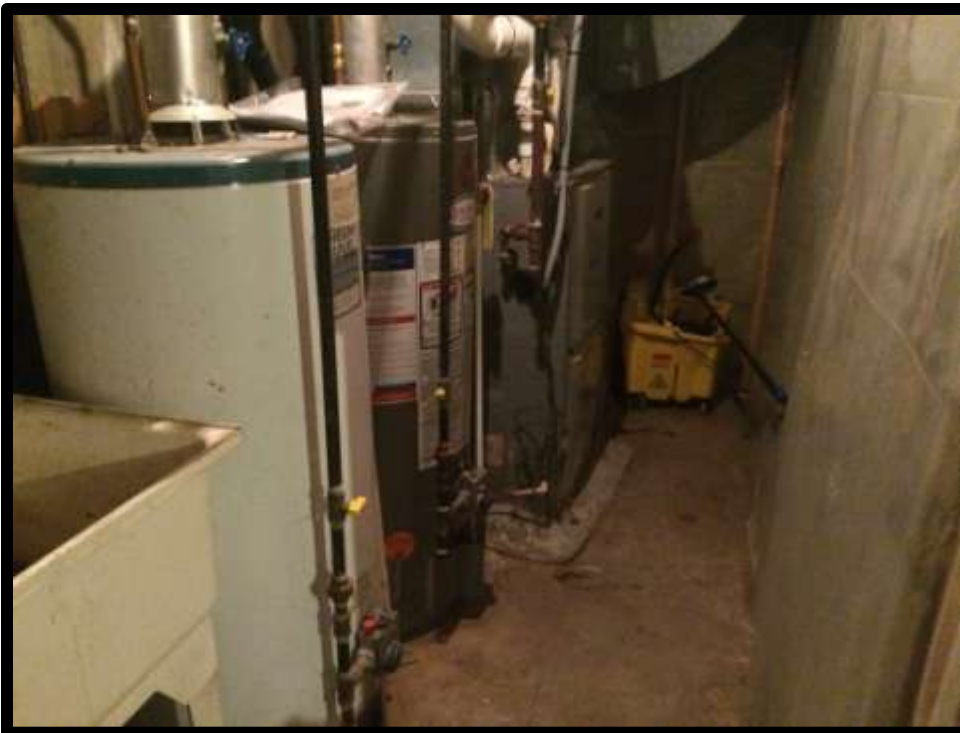
Photograph 2: View of furnace, water heaters and remnant fuel line from historical oil system.

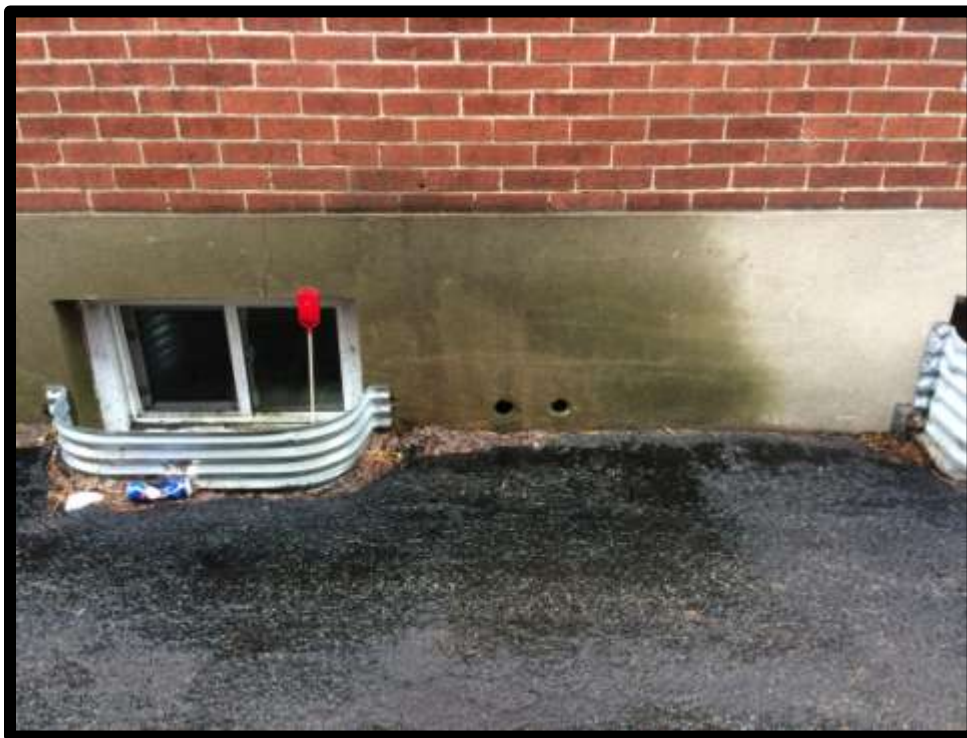
Photograph 3: View of former vent/fill pipe holes in foundation. Moisture from meltwater and rain dripping from the roof. No sheen was observed or petroleum odours were identified in the vicinity of the holes.
