Environmental Impact Statement &
Tree Conservation Report (Revised)
1026 to 1054 Hunt Club Road, Ottawa, ON

August 2017
Prepared for Claridge Homes Inc.

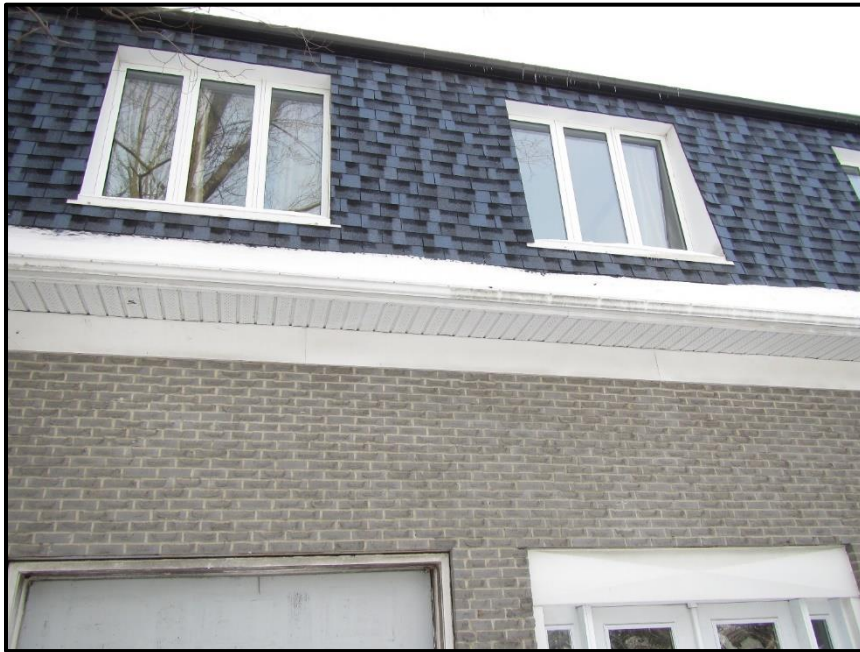
Photograph 1: Residential home at 1054 Hunt Club Road. Note vinyl plastic siding and painted metal overhang (February 6th, 2017).

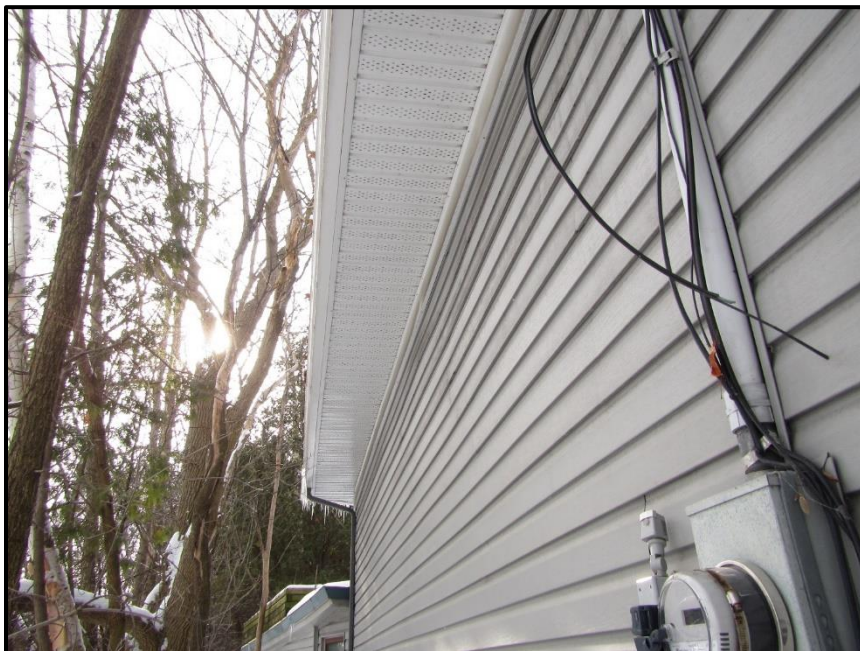
Photograph 2: Residential home at 1054 Hunt Club Road. Note vinyl plastic siding and painted metal overhang (February 6th, 2017).

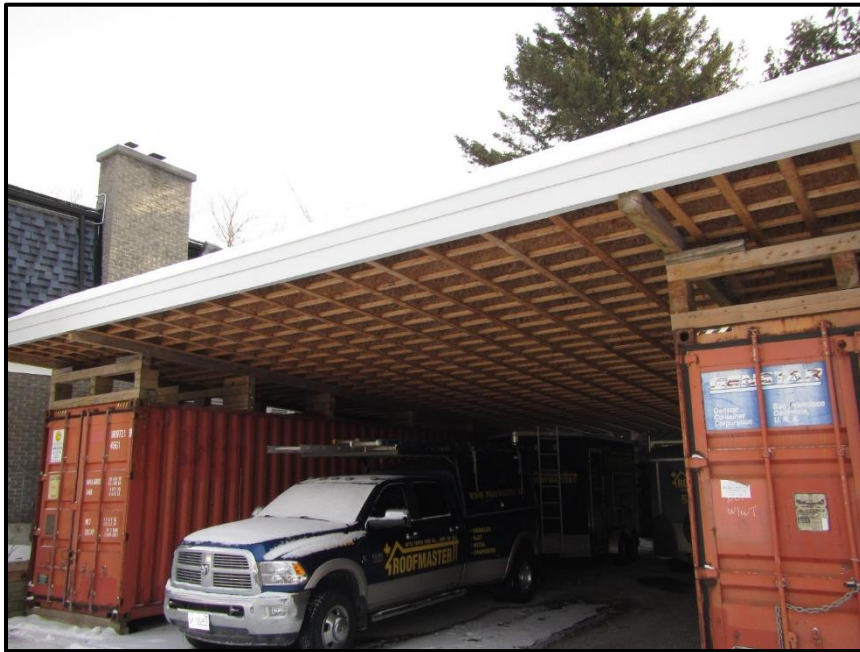
Photograph 3: Temporary covered work area at 1054 Hunt Club Road. Note wooden lattice roof on shipping containers (February 6th, 2017).

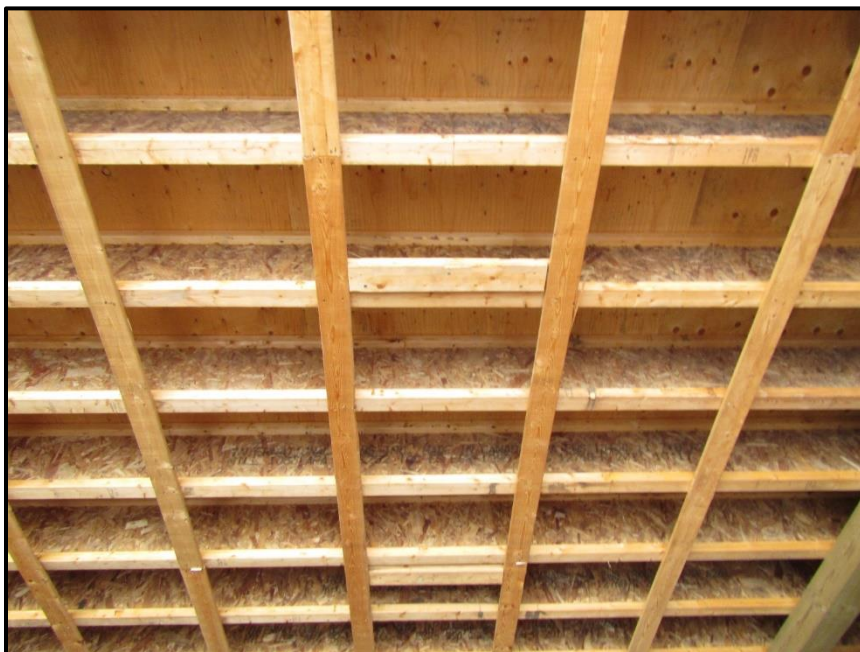
Photograph 4: Roof of temporary covered work area at 1054 Hunt Club Road. Note wooden lattice roof on shipping containers (May 15th, 2017).

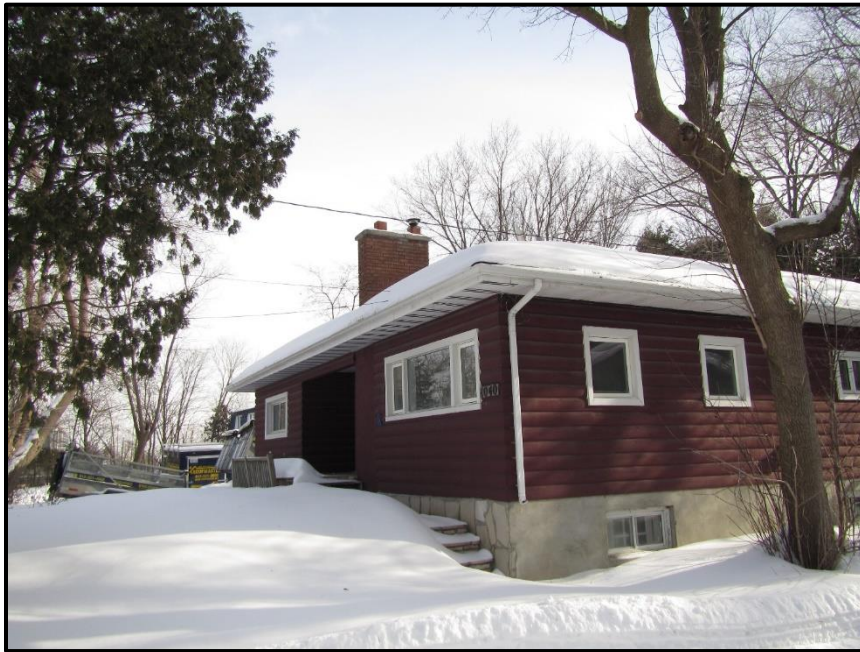
Photograph 5: Residential home at 1040 Hunt Club Road. Note vinyl plastic siding and painted metal overhang (February 6th, 2017).

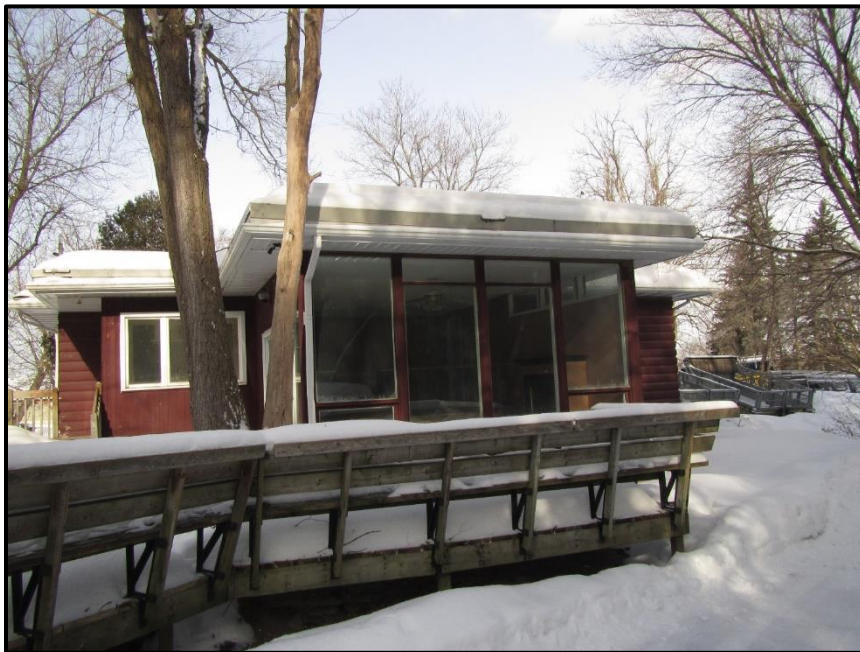
Photograph 6: Residential home at 1040 Hunt Club Road. Note vinyl plastic siding and painted metal overhang (February 6th, 2017).

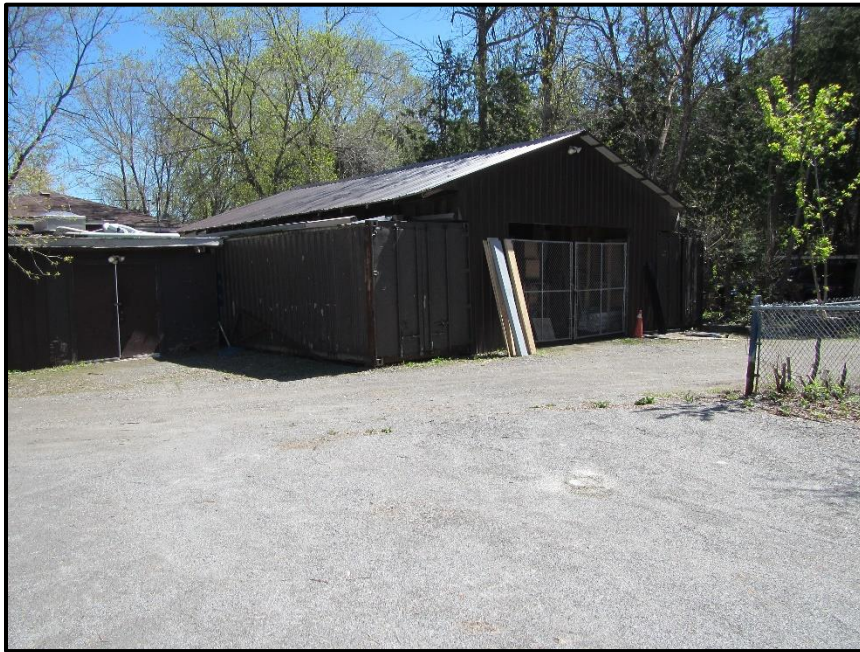
Photograph 7: Storage shed at 1038 Hunt Club Road. Note painted metal siding on wooden frame (May 15th, 2017).

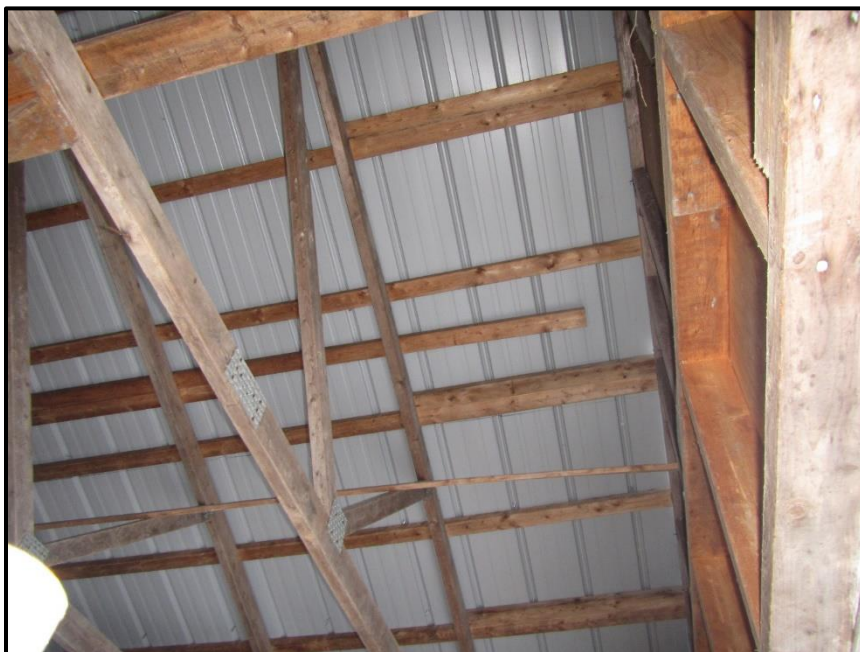
Photograph 8: Interior of storage shed at 1038 Hunt Club Road. Note painted metal siding on wooden frame (May 15th, 2017).

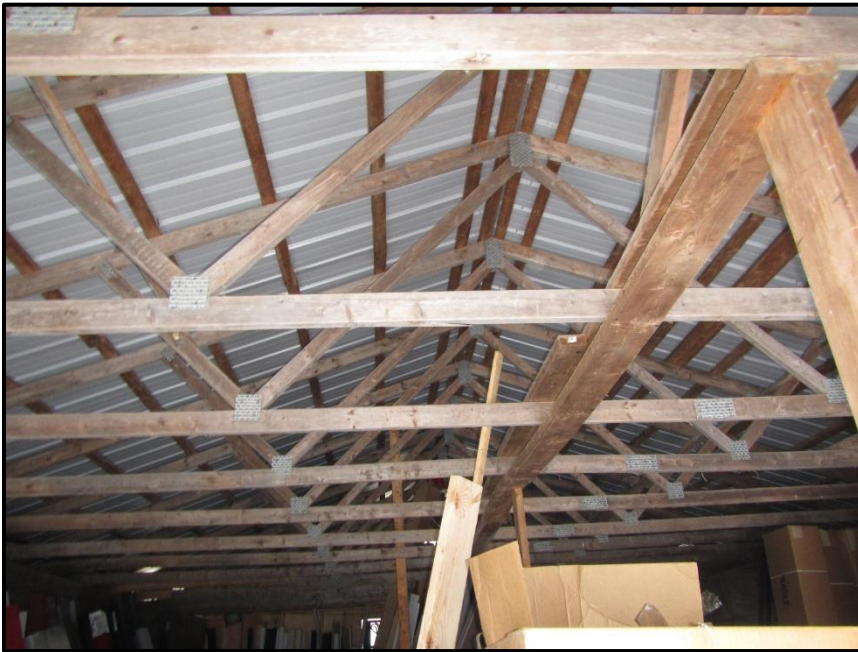
Photograph 9: Interior of storage shed at 1038 Hunt Club Road. Note painted metal siding on wooden frame (May 15th, 2017).

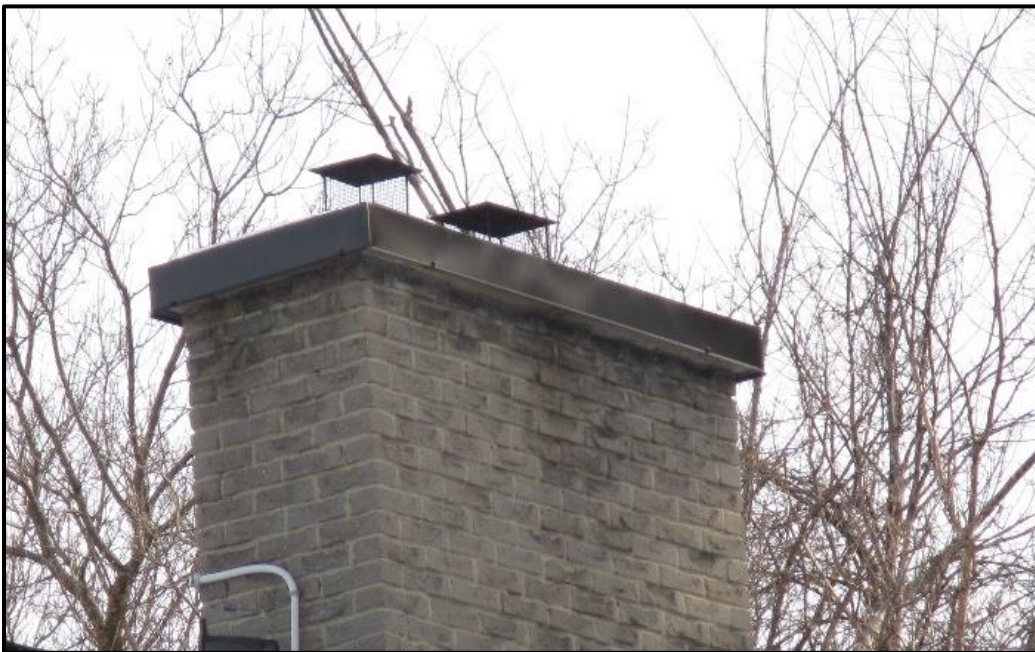
Photograph 10: Chimney at 1054 Hunt Club Road. Note wire mesh cap on chimney (February 6th, 2017).

- **Chimney Swift:** Chimney Swifts may be found nesting in uncapped stone chimneys (SARO 2017). As shown in Photograph 10, the residential home at 1054 Hunt Club Road includes a chimney with a wire mesh cap that would prevent Chimney Swifts from nesting. As shown in Photograph 11, the residential home at 1040 Hunt Club Road includes a chimney with a ceramic liner and a metal cap that would prevent Chimney Swifts from nesting. Neither structure includes uncapped chimneys that could be suitable for Chimney Swift nesting. The temporary covered work area and storage shed found within the Site do not have any chimneys. Due to the absence of potentially suitable chimneys, Chimney Swifts are not likely to be a significant concern for the proposed development. Due to the absence of potentially suitable chimneys, a follow-up survey for Chimney Swifts is not required.

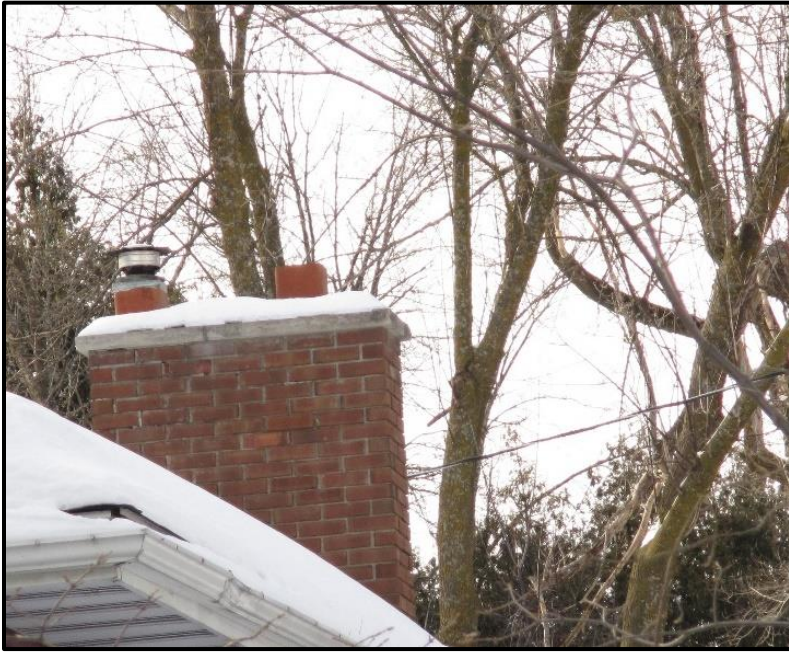
Photograph 11: Chimney at 1040 Hunt Club Road. Note metal cap and ceramic liner (February 6th, 2017).

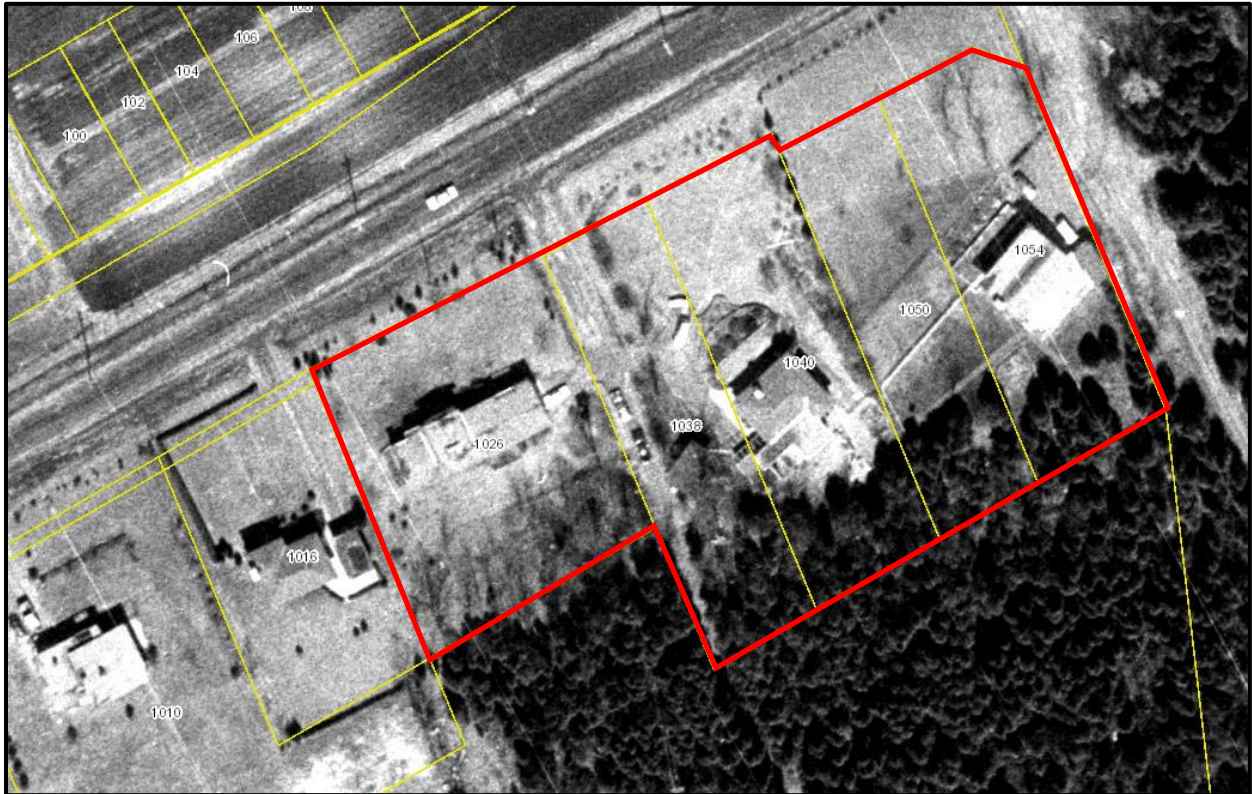
Photograph 1: Historic Air Photo from 1965. Property boundary shown in red. Note majority of Site is developed with residential homes. Few mature trees are present in the front yards. White Cedar trees are present in the backyards. The adjacent White Cedar Coniferous Forest (south) is present in 1965 (Photos from City of Ottawa 2017).

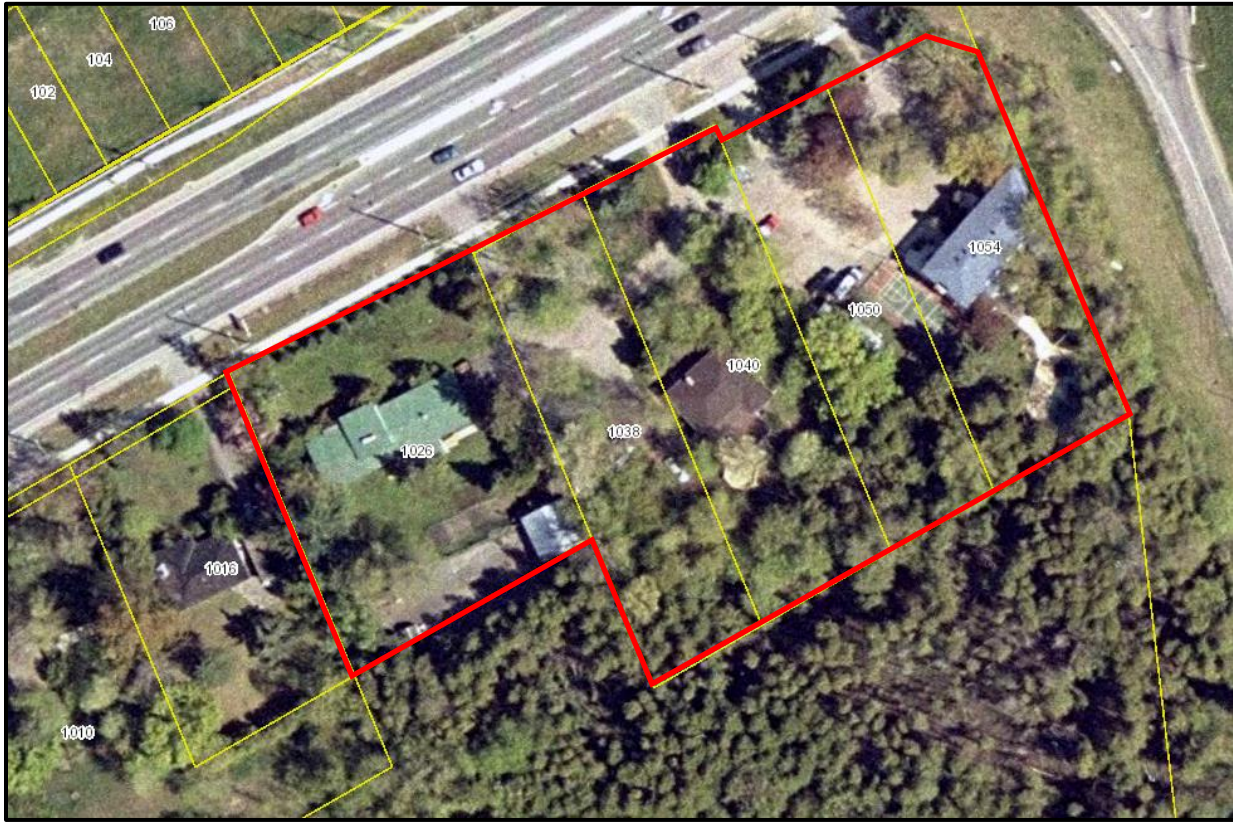
Photograph 2: Historic Air Photo from 2002. Property boundary shown in red. Note majority of Site is developed with residential homes surrounded by numerous mature trees. White Cedar trees are present in the backyards. The adjacent White Cedar Coniferous Forest (south) remains present (Photos from City of Ottawa 2017).

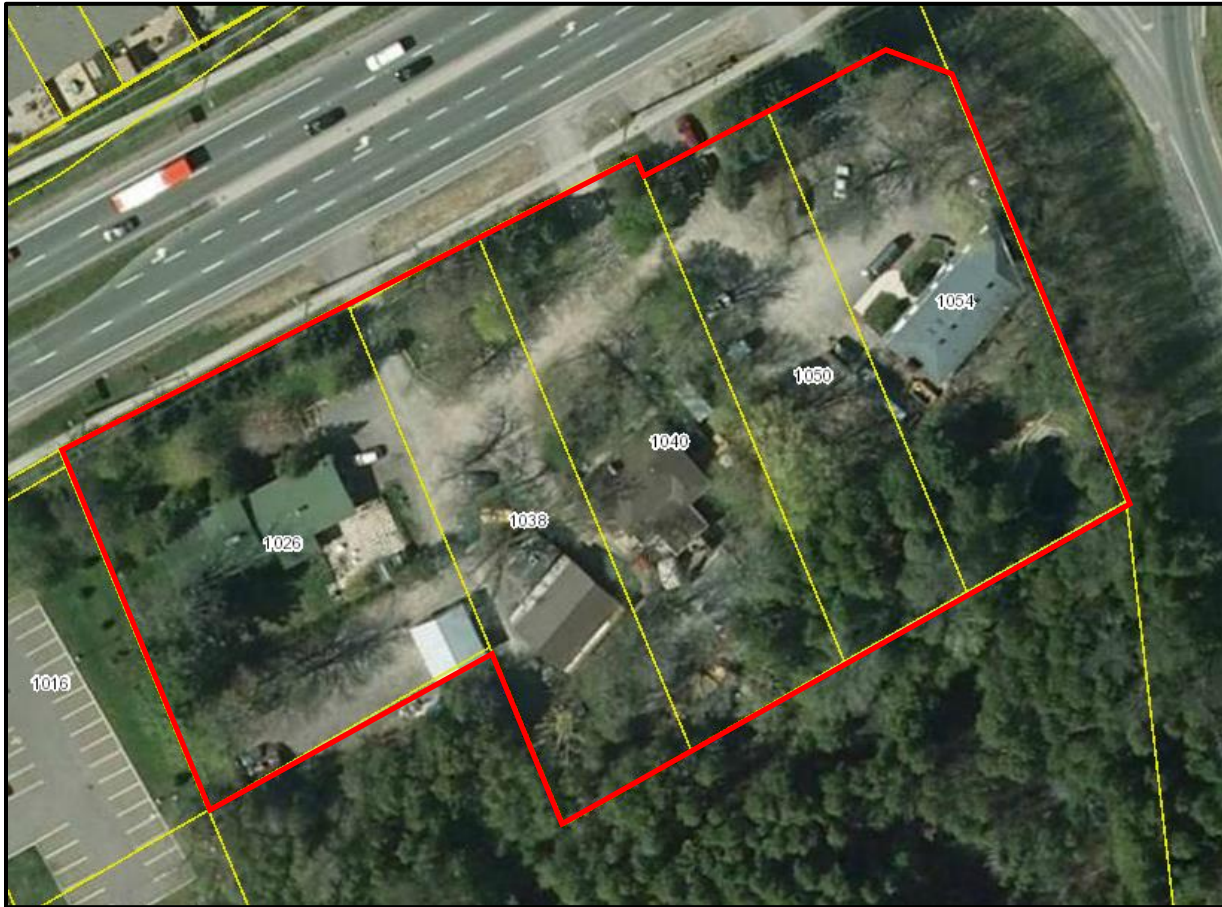
Photograph 3: Historic Air Photo from 2011. Property boundary shown in red. Note majority of Site is developed with residential homes surrounded by numerous mature trees. White Cedar trees are present in the backyards. The extent of mature trees within the yards is reduced compared to 2002. The adjacent White Cedar Coniferous Forest (south) remains present (Photos from City of Ottawa 2017).

Air photos from 2002 and 2011 show that the Site was occupied by residential homes as recently as 2011, and that mature trees were growing in much of the surrounding yards. However, by 2011 much of the front yards were paved or covered with compacted gravel to make parking areas/driveways, reducing the number of trees and extent of permeable surfaces. The storage shed located at 1038 Hunt Club Road was also constructed between 2002 and 2011, further reducing the extent of mature trees. Stands of mature trees remained in the backyards and in the adjacent White Cedar Coniferous Forest south of the Site in 2011.

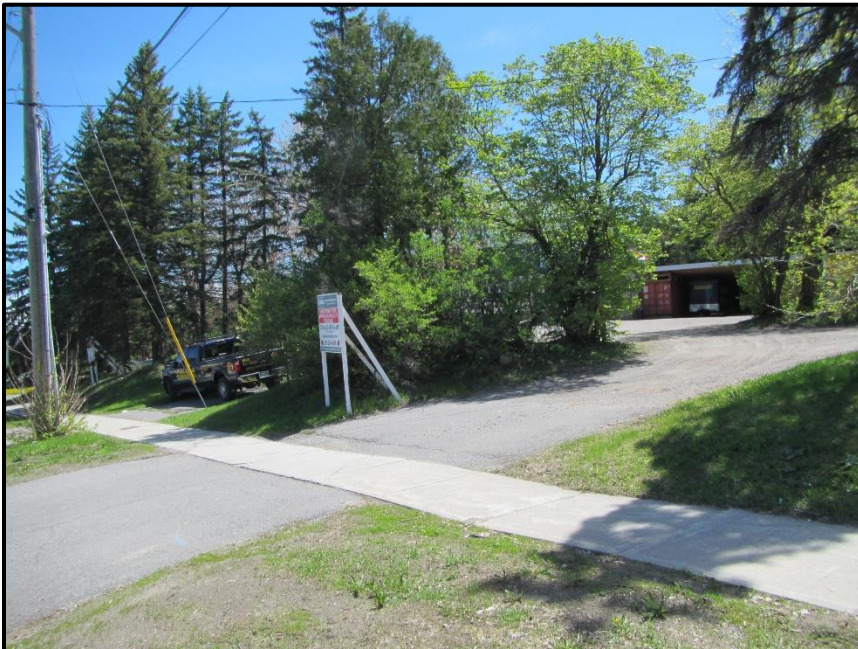
Photograph 5: Looking east at planted Norwegian Spruce in Coniferous Hedgerow. Hunt Club Road on left (May 15th, 2017).

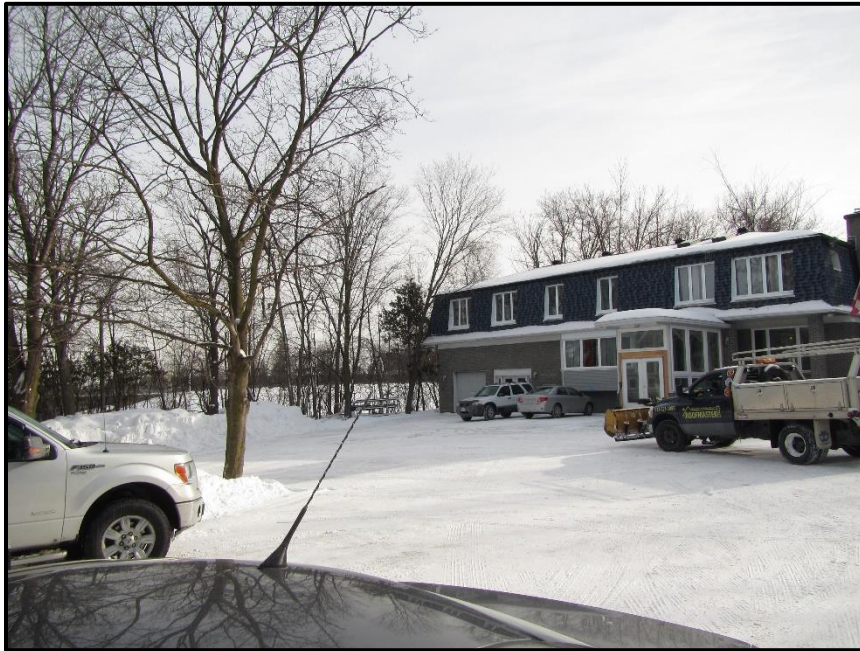
Photograph 6: Looking southeast at 1054 Hunt Club Road with Deciduous Hedgerow in background (February 6th, 2017).

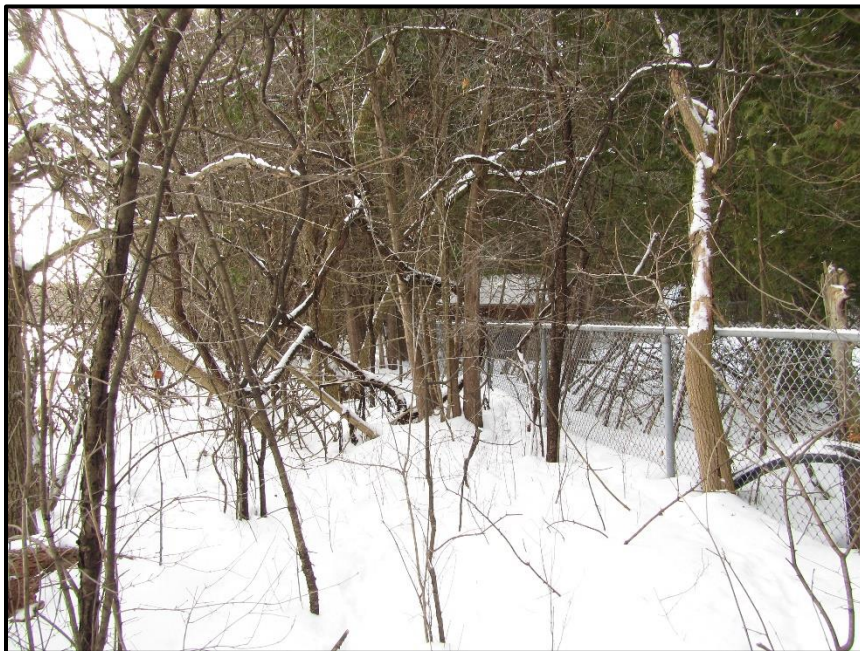
Photograph 7: Looking south along Deciduous Hedgerow. Fence at eastern property line on right, Airport Parkway on left (February 6th, 2017).

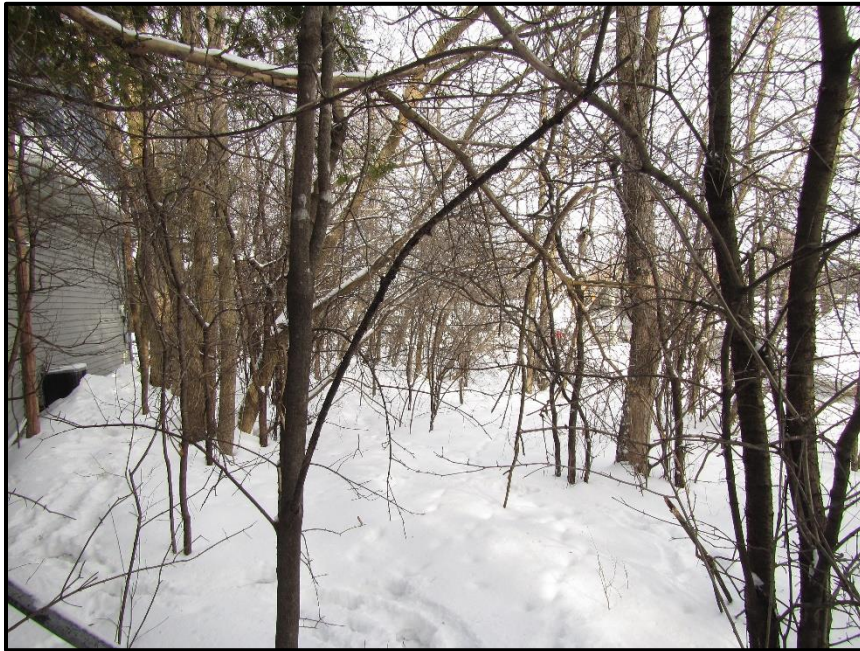
Photograph 8: Looking north along Deciduous Hedgerow. 1056 Hunt Club Road on left, Airport Parkway on right (February 6th, 2017).

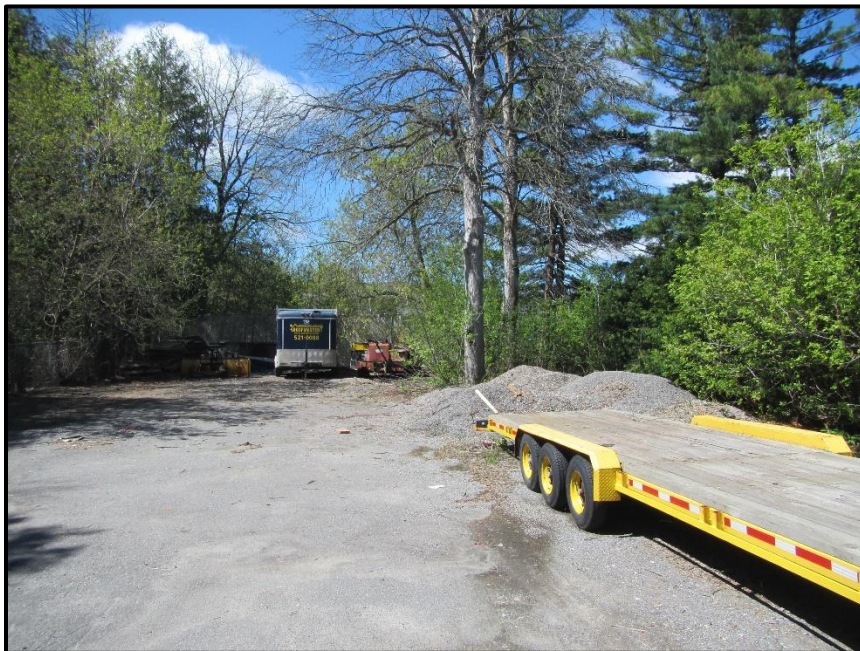
Photograph 9: White Cedar hedge in western part of 1026 Hunt Club Road (on right), looking west. Large White Pines and large dead White Ash in western part of 1026 Hunt Club Road shown (May 15th, 2017).

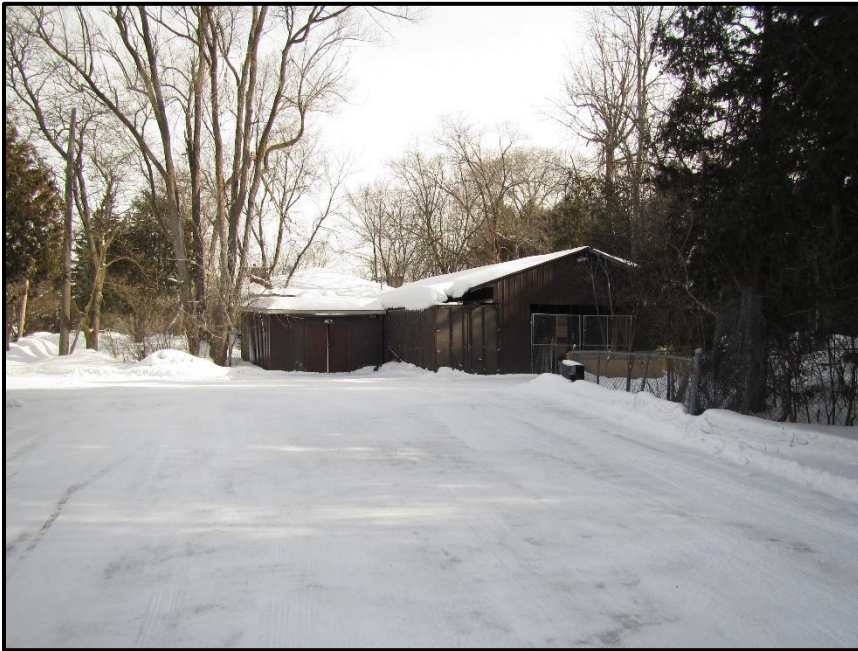
Photograph 10: Looking east at storage shed in 1038 Hunt Club Road. Large stressed American Elm at left of storage shed. Chain-link fence marks property edge on right (White Cedars are beyond property line) (February 6th, 2017).

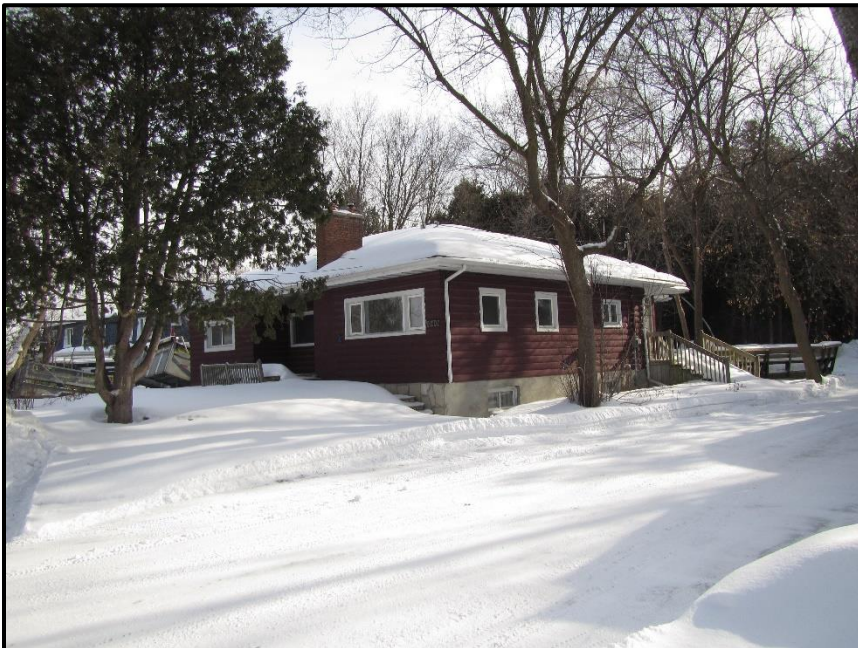
Photograph 11: Looking south at house at 1040 Hunt Club Road. Front yard trees in foreground, backyard White Cedars in background (February 6th, 2017).

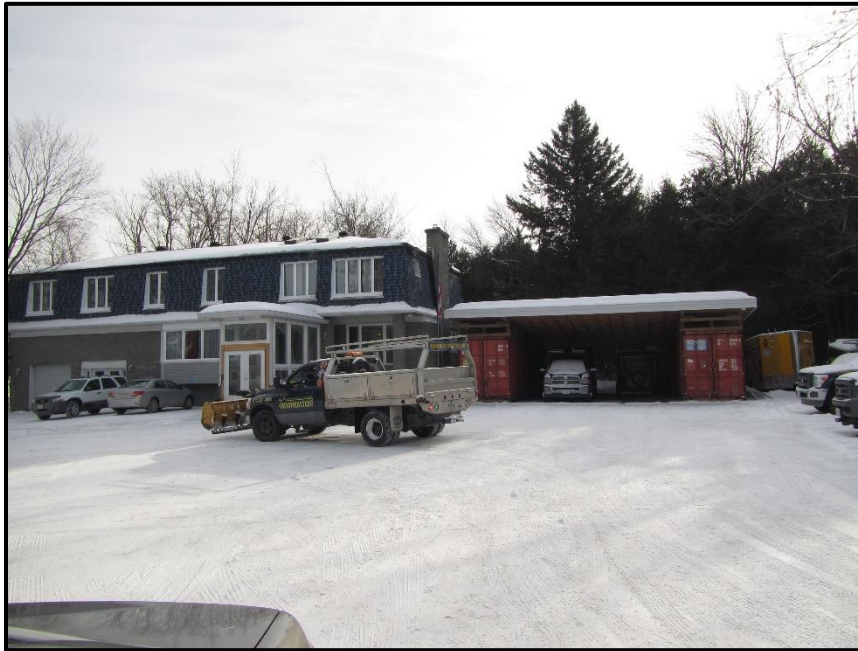
Photograph 12: Looking south at residence (left) and covered work area (right) within 1056 Hunt Club Road. Residence is used as a contractor office. Backyard White Cedars in background (February 6th, 2017).

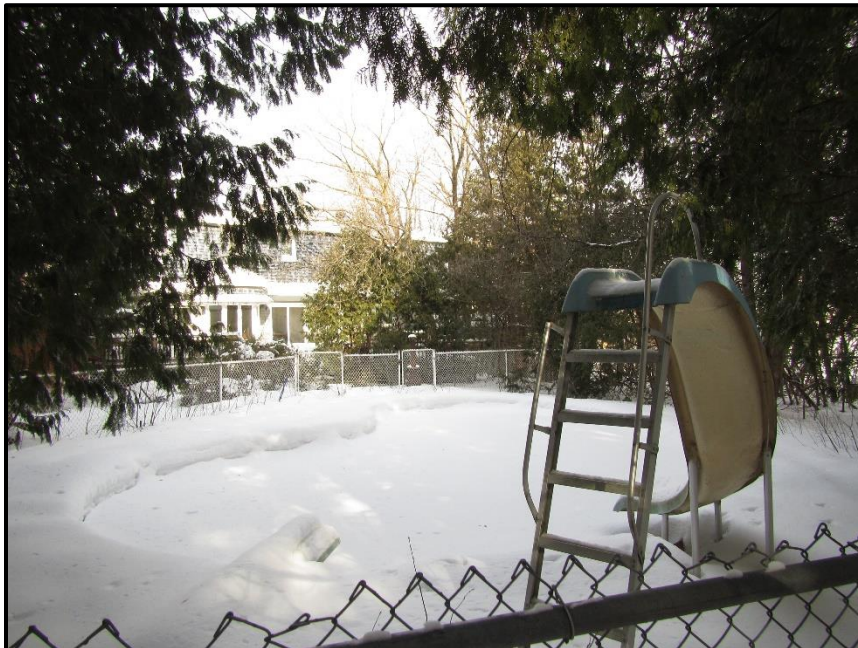
Photograph 13: Looking north from southern property line, behind 1056 Hunt Club Road. Note backyard swimming pool. 1056 Hunt Club Road residence is shown in background (February 6th, 2017).

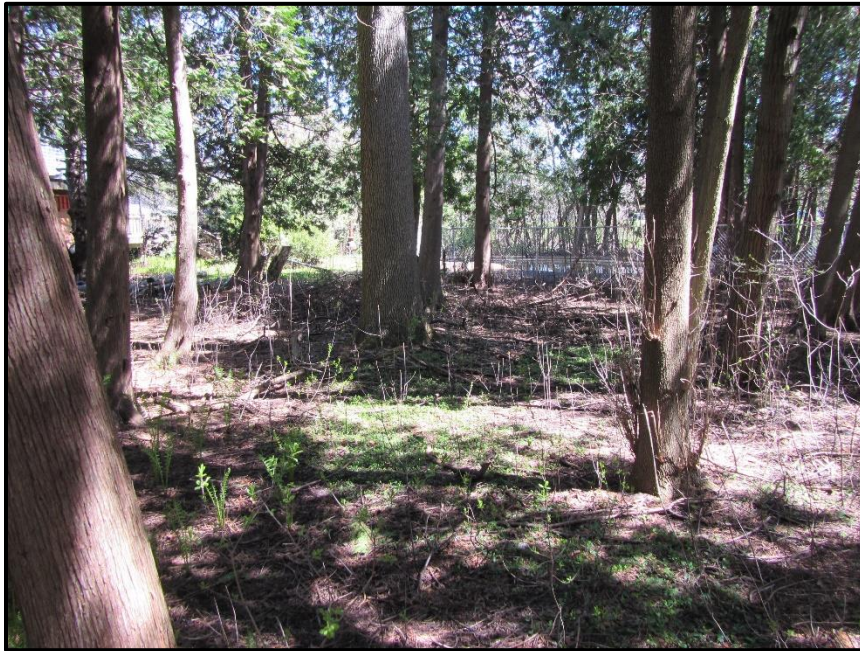
Photograph 14: Looking east from southern property line, behind 1050 Hunt Club Road. Note White Cedars growing in low density in backyard (May 15th, 2017).

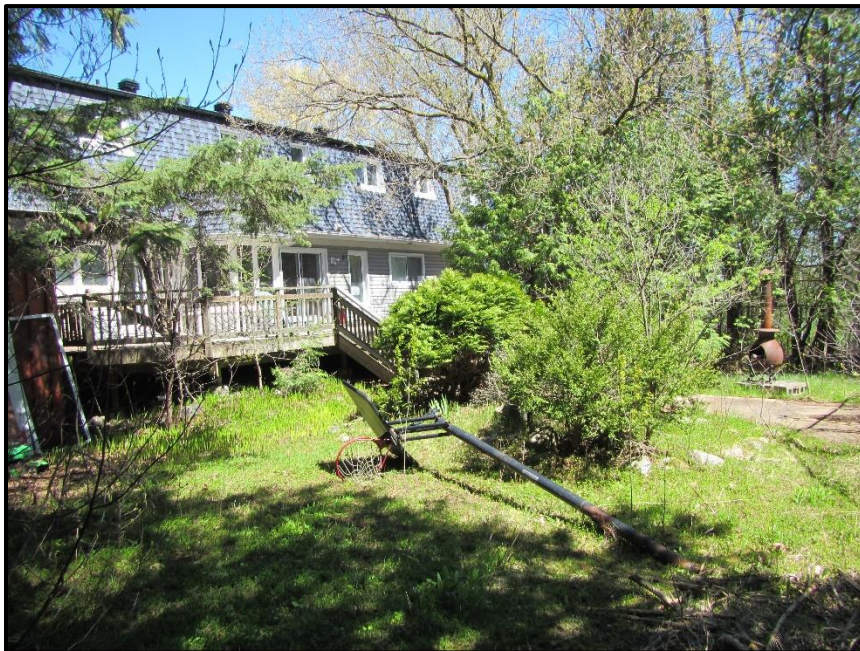
Photograph 15: Looking north from southern property line, behind 1056 Hunt Club Road (May 15th, 2017).

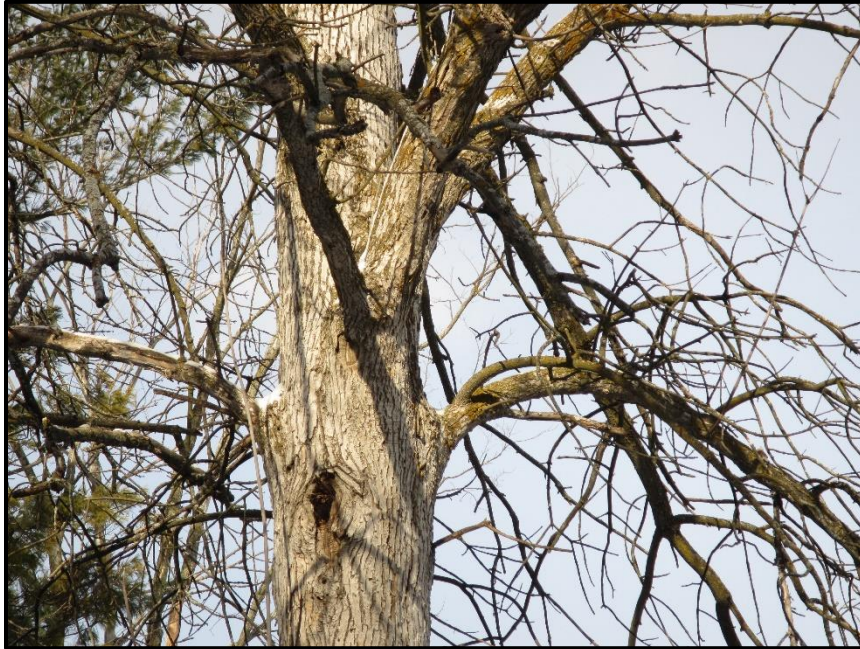
Photograph 16: Close-up of large dead White Ash in 1026 Hunt Club Road, showing extensive damage from Emerald Ash Borer (February 6th, 2017).
