Phase I Environmental Site Assessment

Surface Parking Lot
East Part of 851 Richmond Road
Ottawa, Ontario

July 31, 2017

Report: PE4053-1

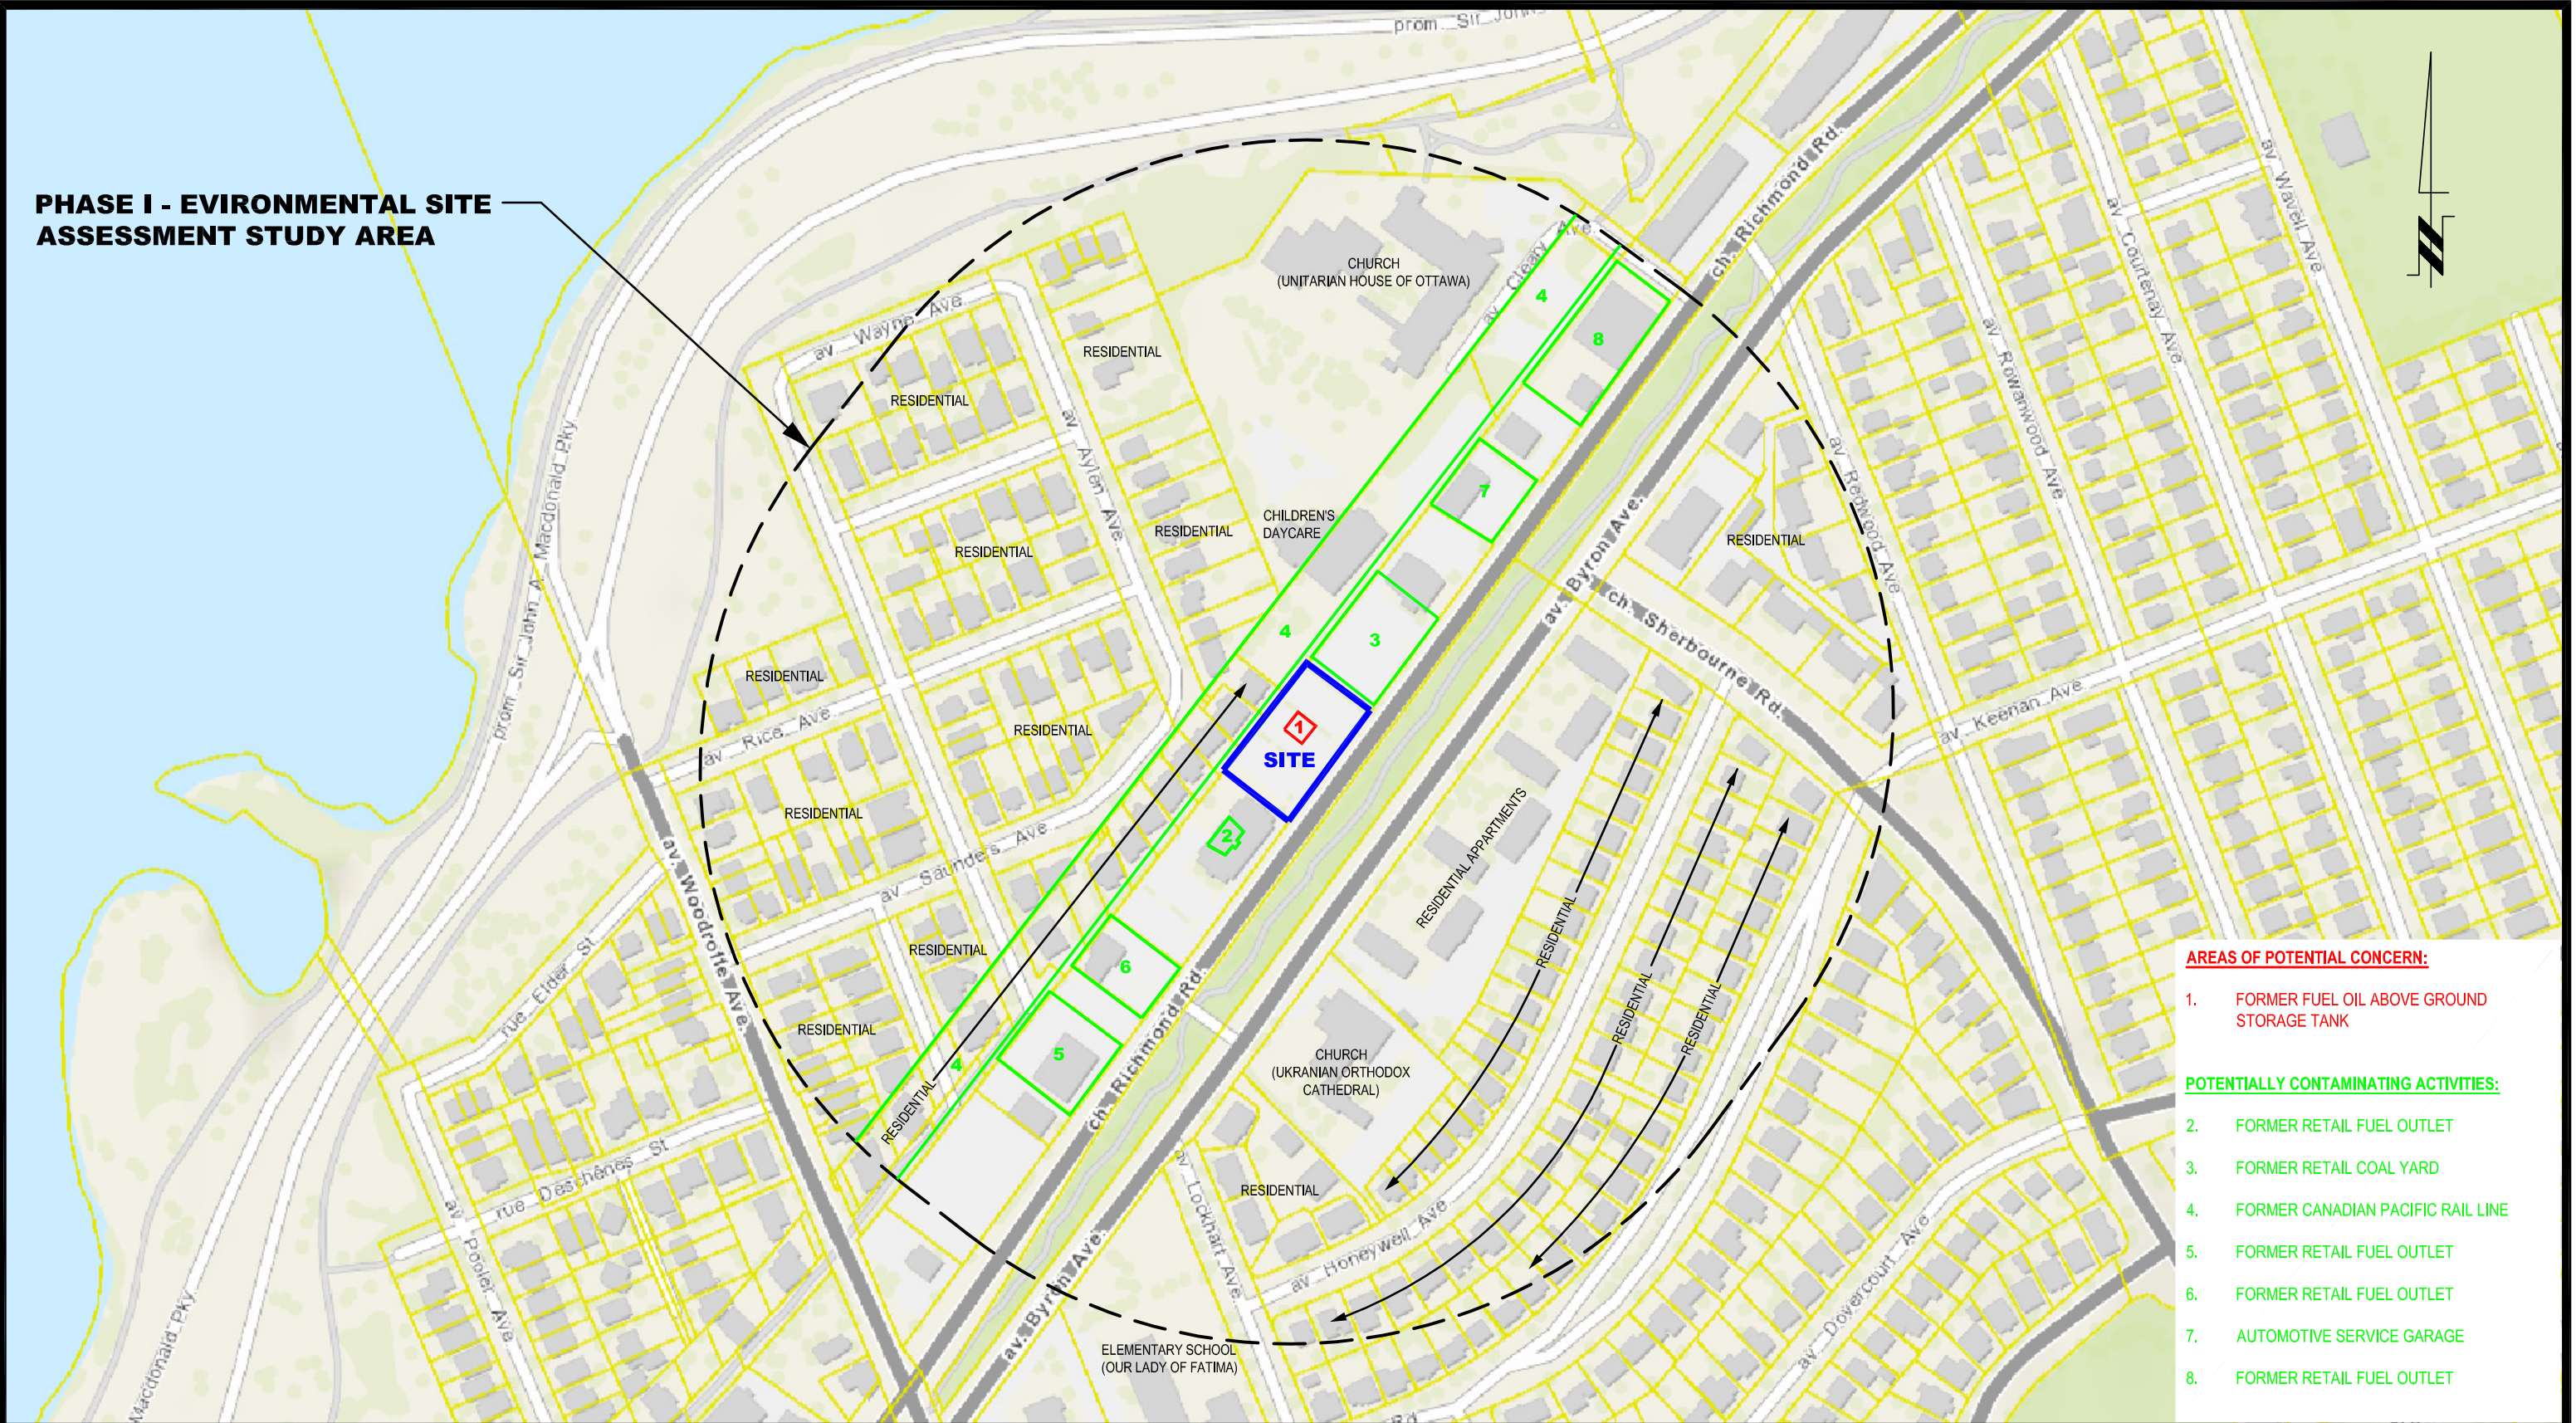
AREAS OF POTENTIAL CONCERN:

- 1. FORMER FUEL OIL ABOVE GROUND STORAGE TANK

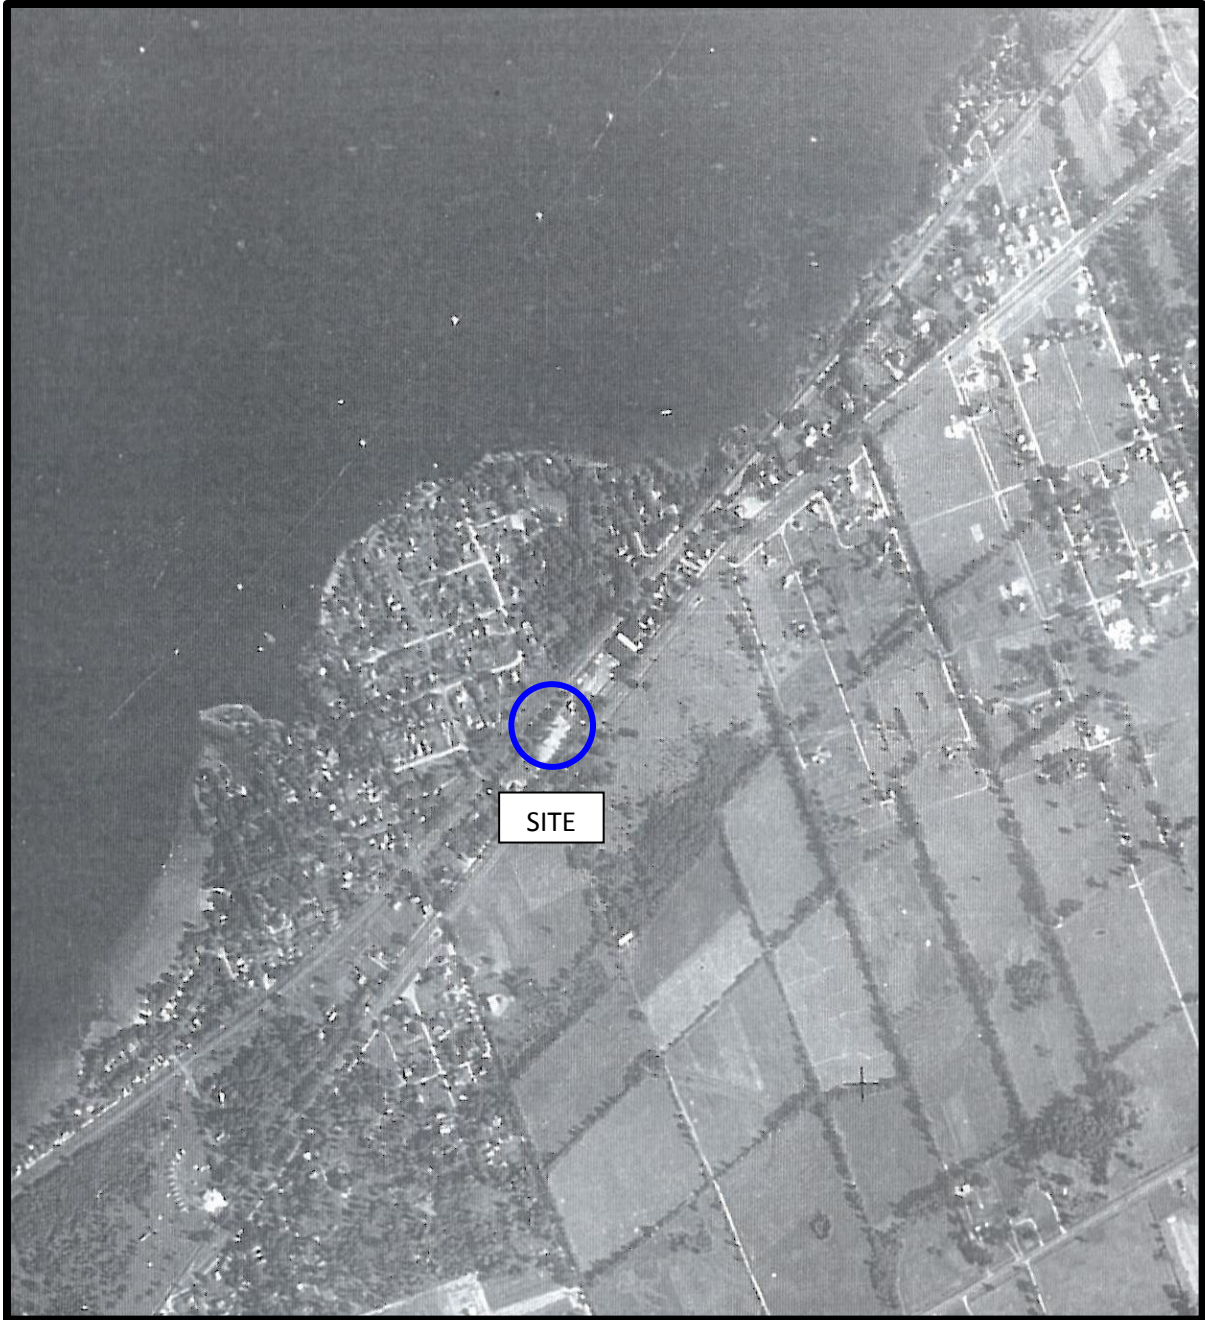
AERIAL PHOTOGRAPH
1946

| 1946 | The subject property appears to be occupied by a structure, but due to the resolution of the photo, it is not possible to distinguish the nature of the building. Part of the property also appears vacant. The property to the east is occupied by a large building. Vacant fields are present to the south. A rail line is present to the north, and residential dwellings can be seen beyond the rail line. |

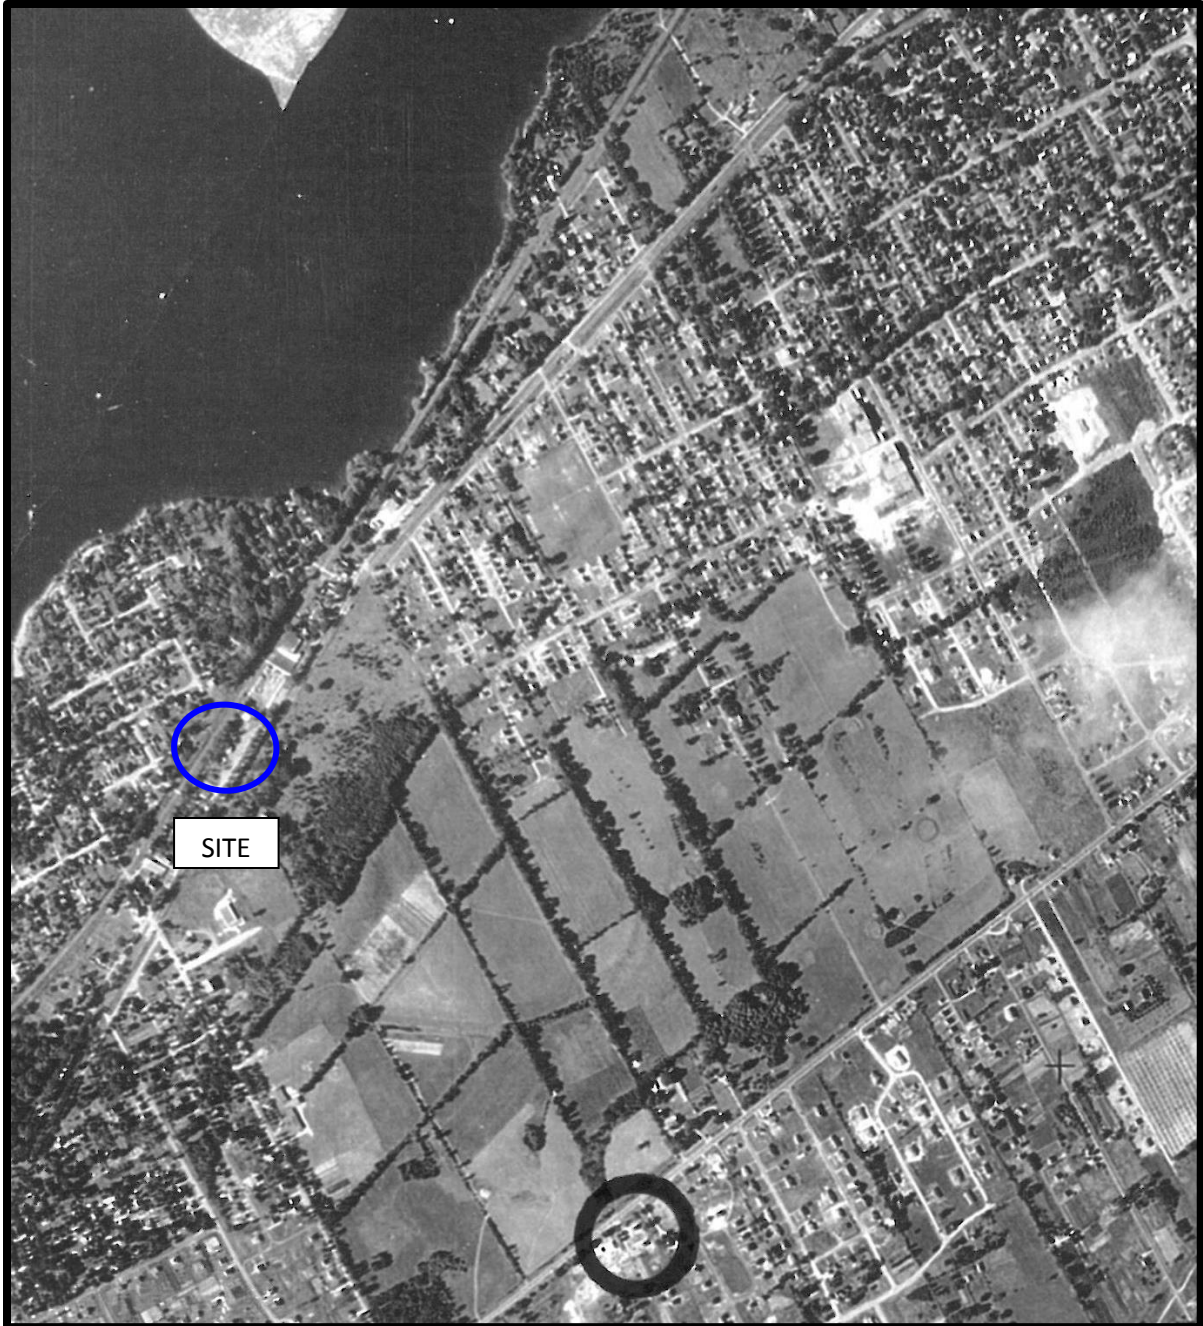
AERIAL PHOTOGRAPH
1952

| 1952 | No significant changes appear to have been made to the subject site or neighbouring properties. |

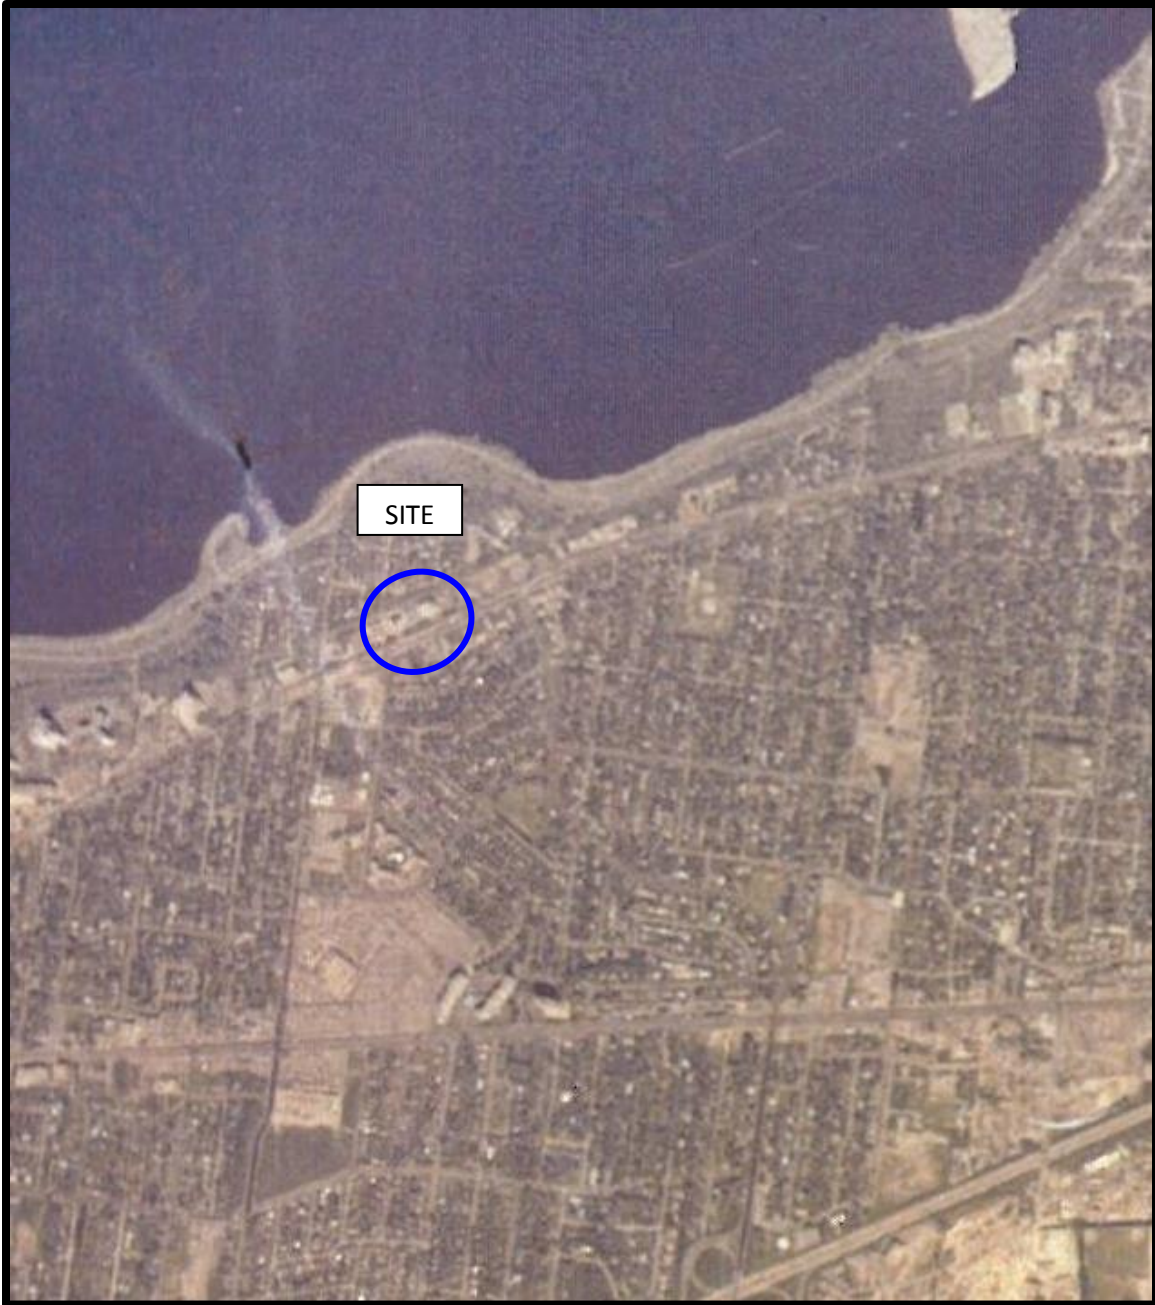
AERIAL PHOTOGRAPH
1976

| 1976 | The subject property appears to be vacant (parking area) for the newly constructed apartment building. Residential development has occurred to the south of the property. |

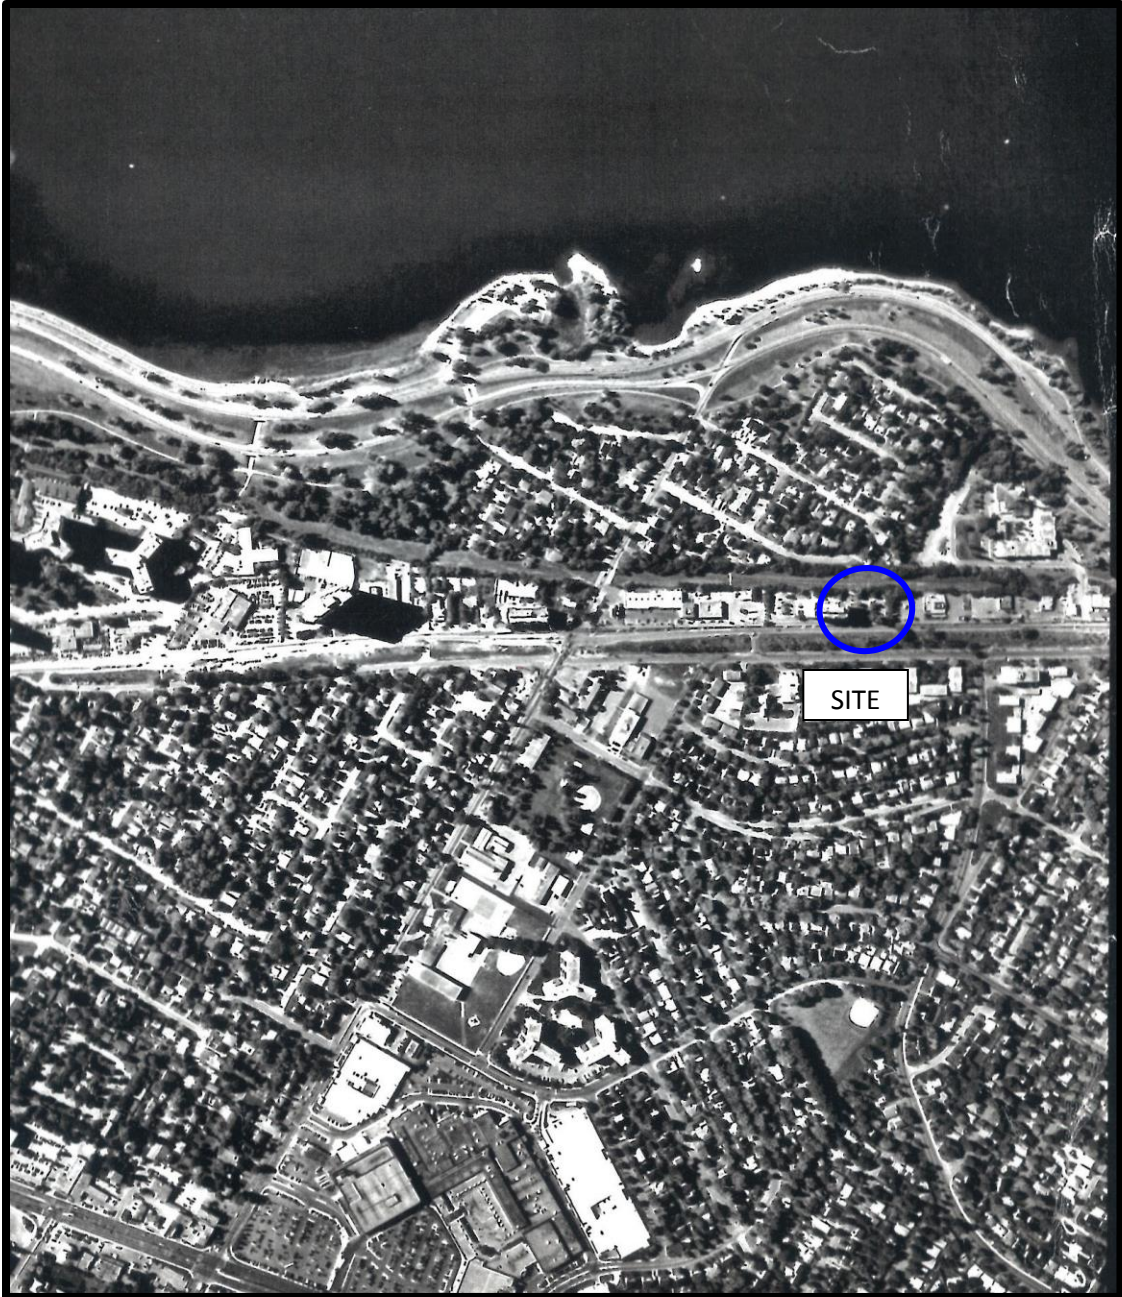
AERIAL PHOTOGRAPH
1986

| 1986 | No significant changes have been made to the subject site or adjacent properties. |

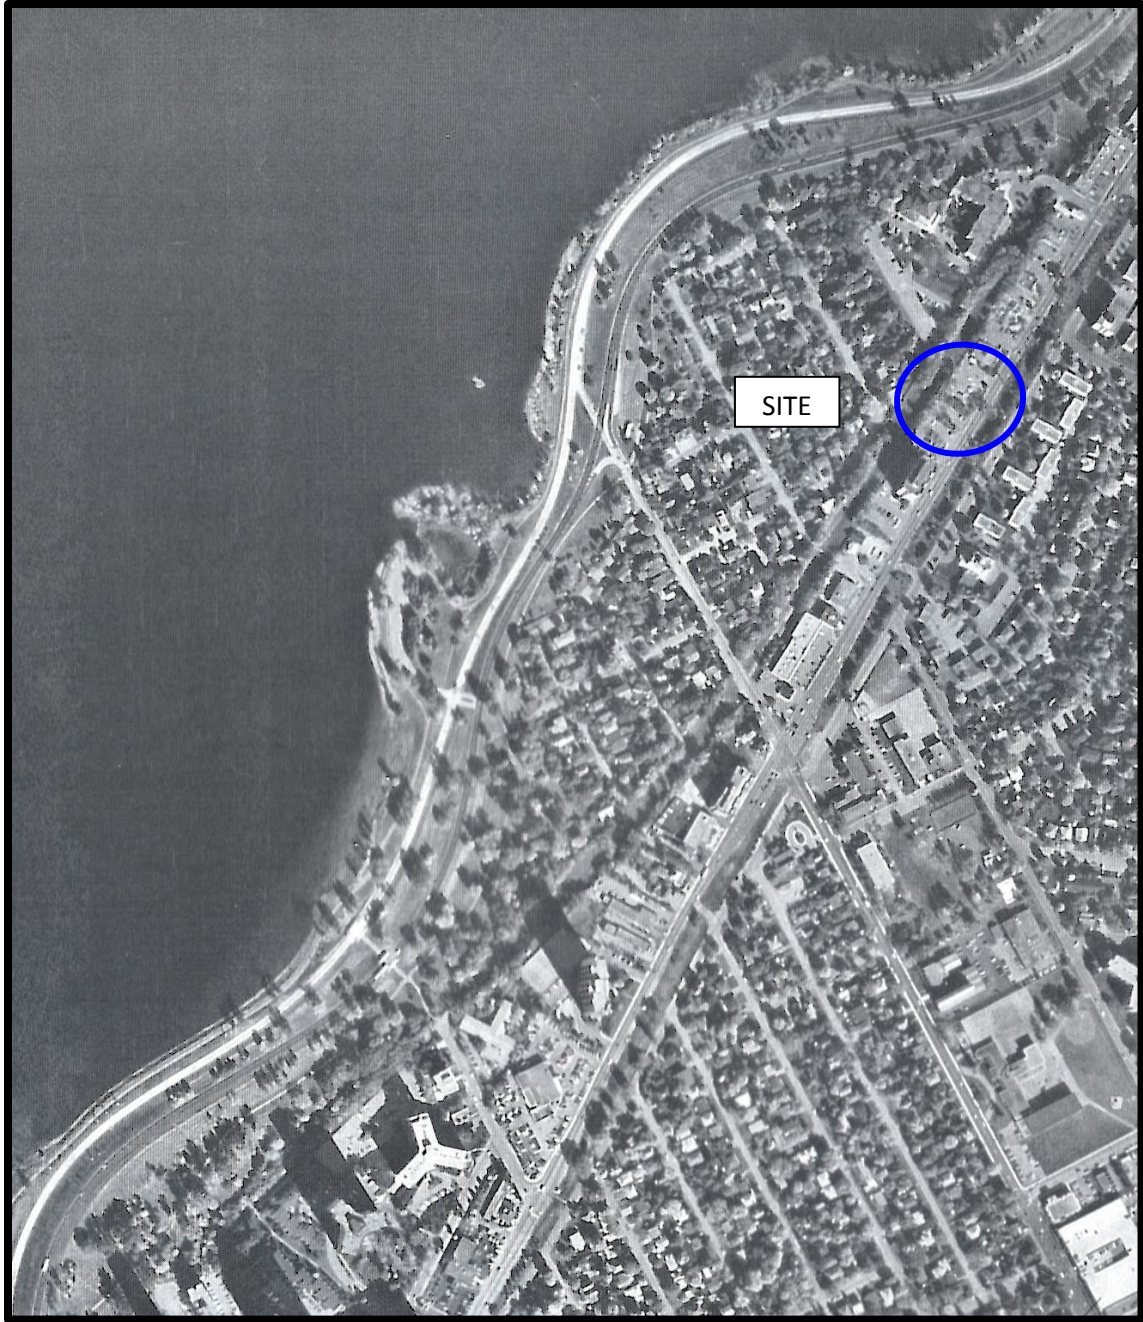
AERIAL PHOTOGRAPH
1992

| 1992 | No significant changes have been made to the subject site or adjacent properties. |
