## **Phase I - Environmental Site Assessment**

Vacant Property  
1034 McGarry Terrace and 1117 Longfields Drive  
Ottawa, Ontario

November 3, 2017

Report: PE2830-2

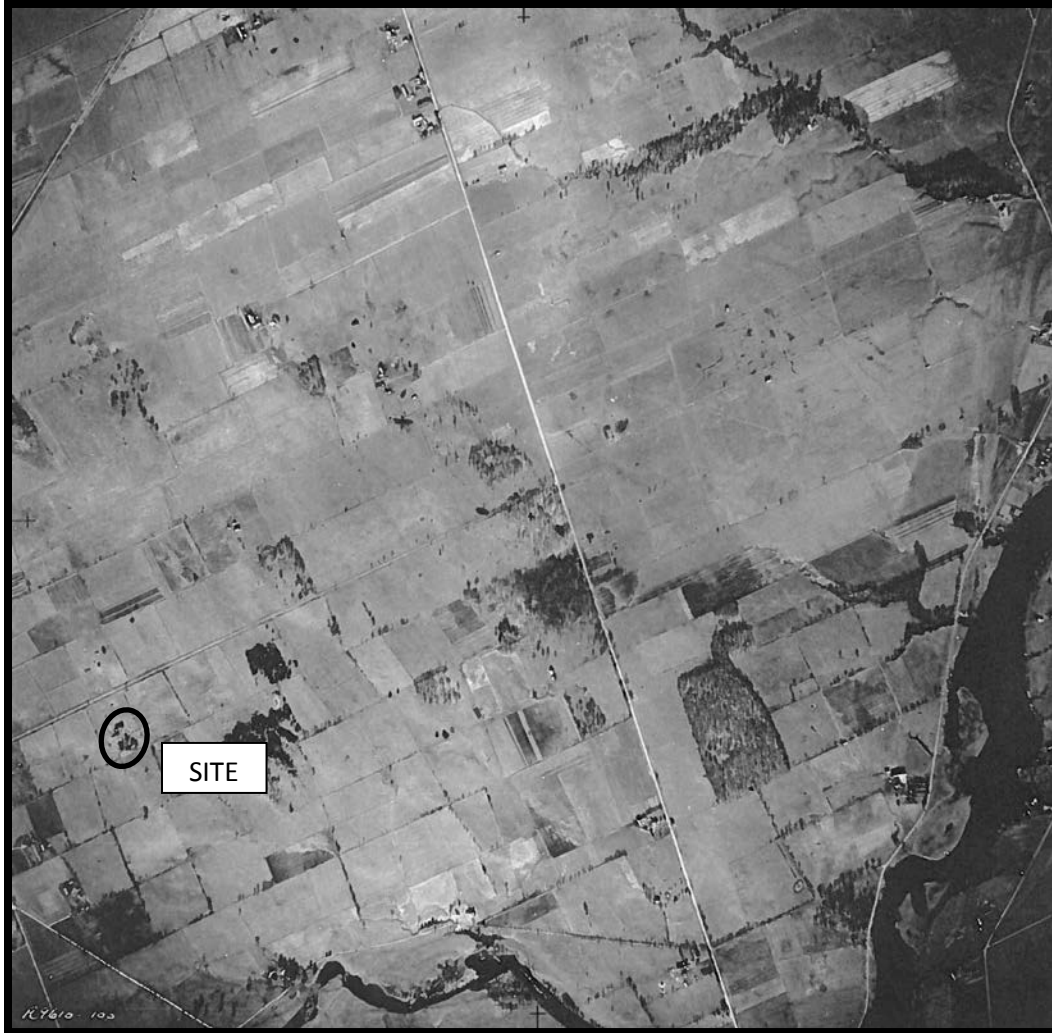
AERIAL PHOTOGRAPH  
1945

1945	It appears as though the subject site is occupied by buildings, however, due to the poor scale of the photograph, it is difficult to distinguish. Adjacent properties to the north, south, east and west appear to be vacant, and used as agricultural lands. A road is located north of the site, and travels in an east-west direction (presumably Strandherd Drive).
1954	No significant changes appear to have been made to the subject property. In this photograph, more than one building is clearly defined on the subject site. Adjacent properties appear to be vacant agricultural lands, however, there may be a structure (or structures) present on the property to the north of the site (across the roadway).
1960	No significant changes appear to have been made to the subject property, or neighbouring properties.
1973	At least one of the garage structures appears to have been constructed on the subject property. Neighbouring properties appear to be used for agriculture.

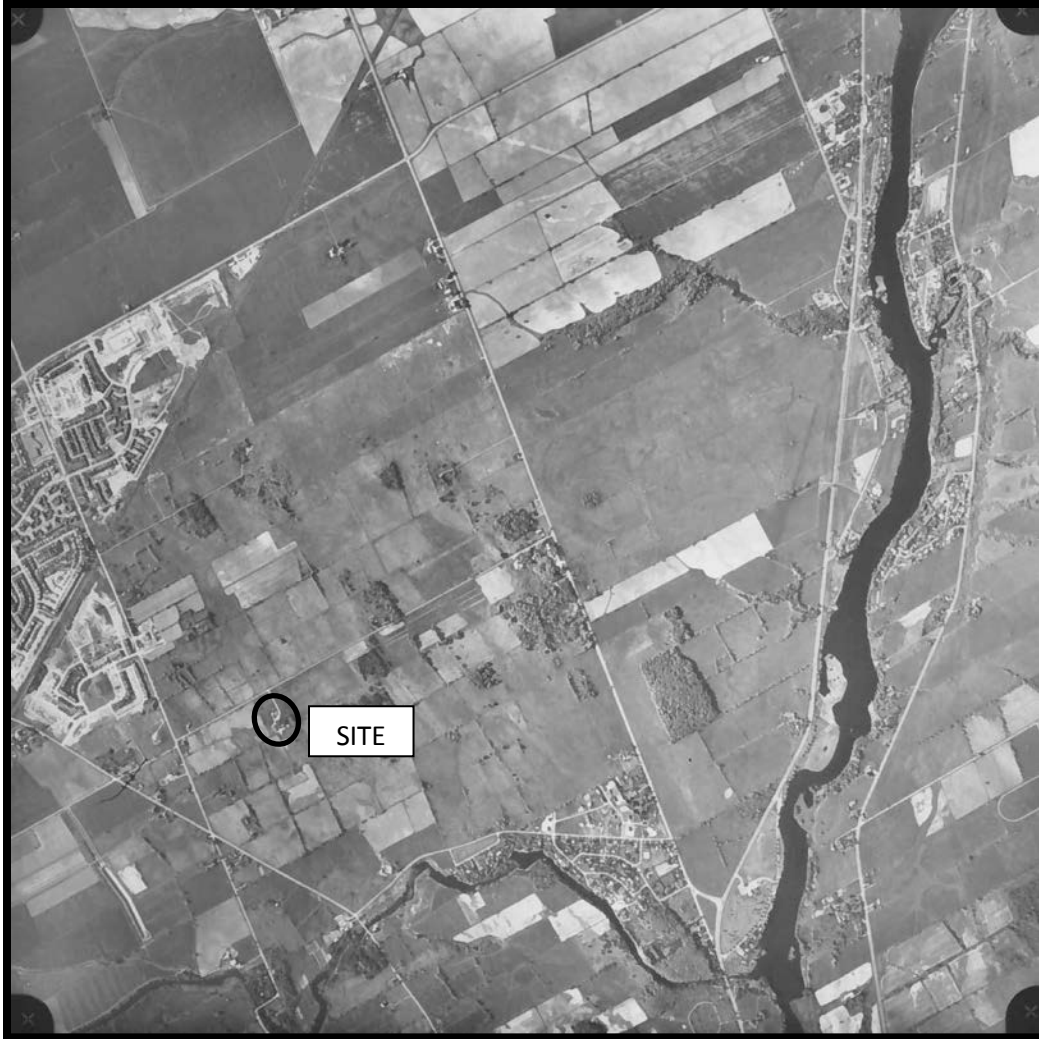
AERIAL PHOTOGRAPH  
1979

1979	No changes appear to have been made to the subject site or neighbouring properties.
1987	No changes appear to have been made to the subject site or neighbouring properties.

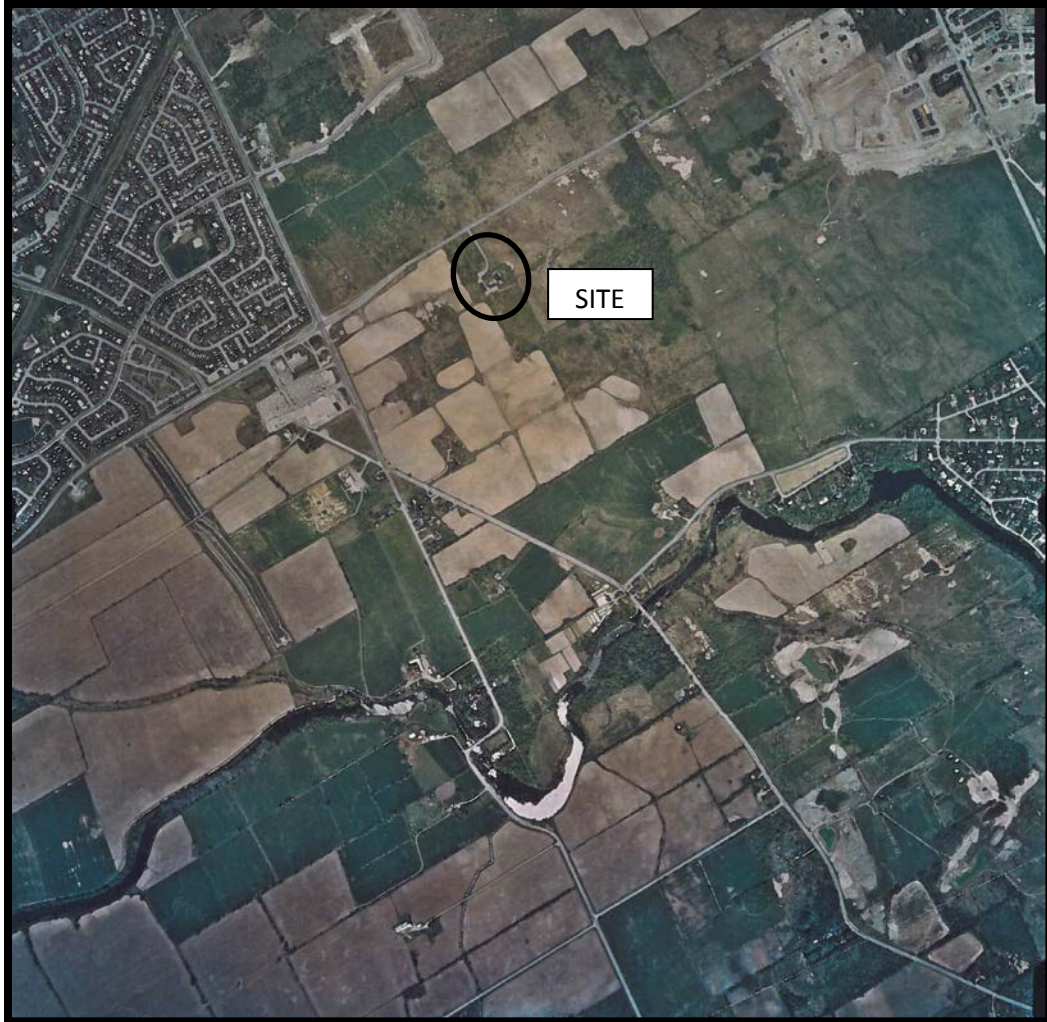
AERIAL PHOTOGRAPH  
1999

- 1999 No changes appear to have been made to the subject site or neighbouring properties. In this photograph, three (3) buildings are clearly present on the subject site. They appear to be consistent with those currently present on site.

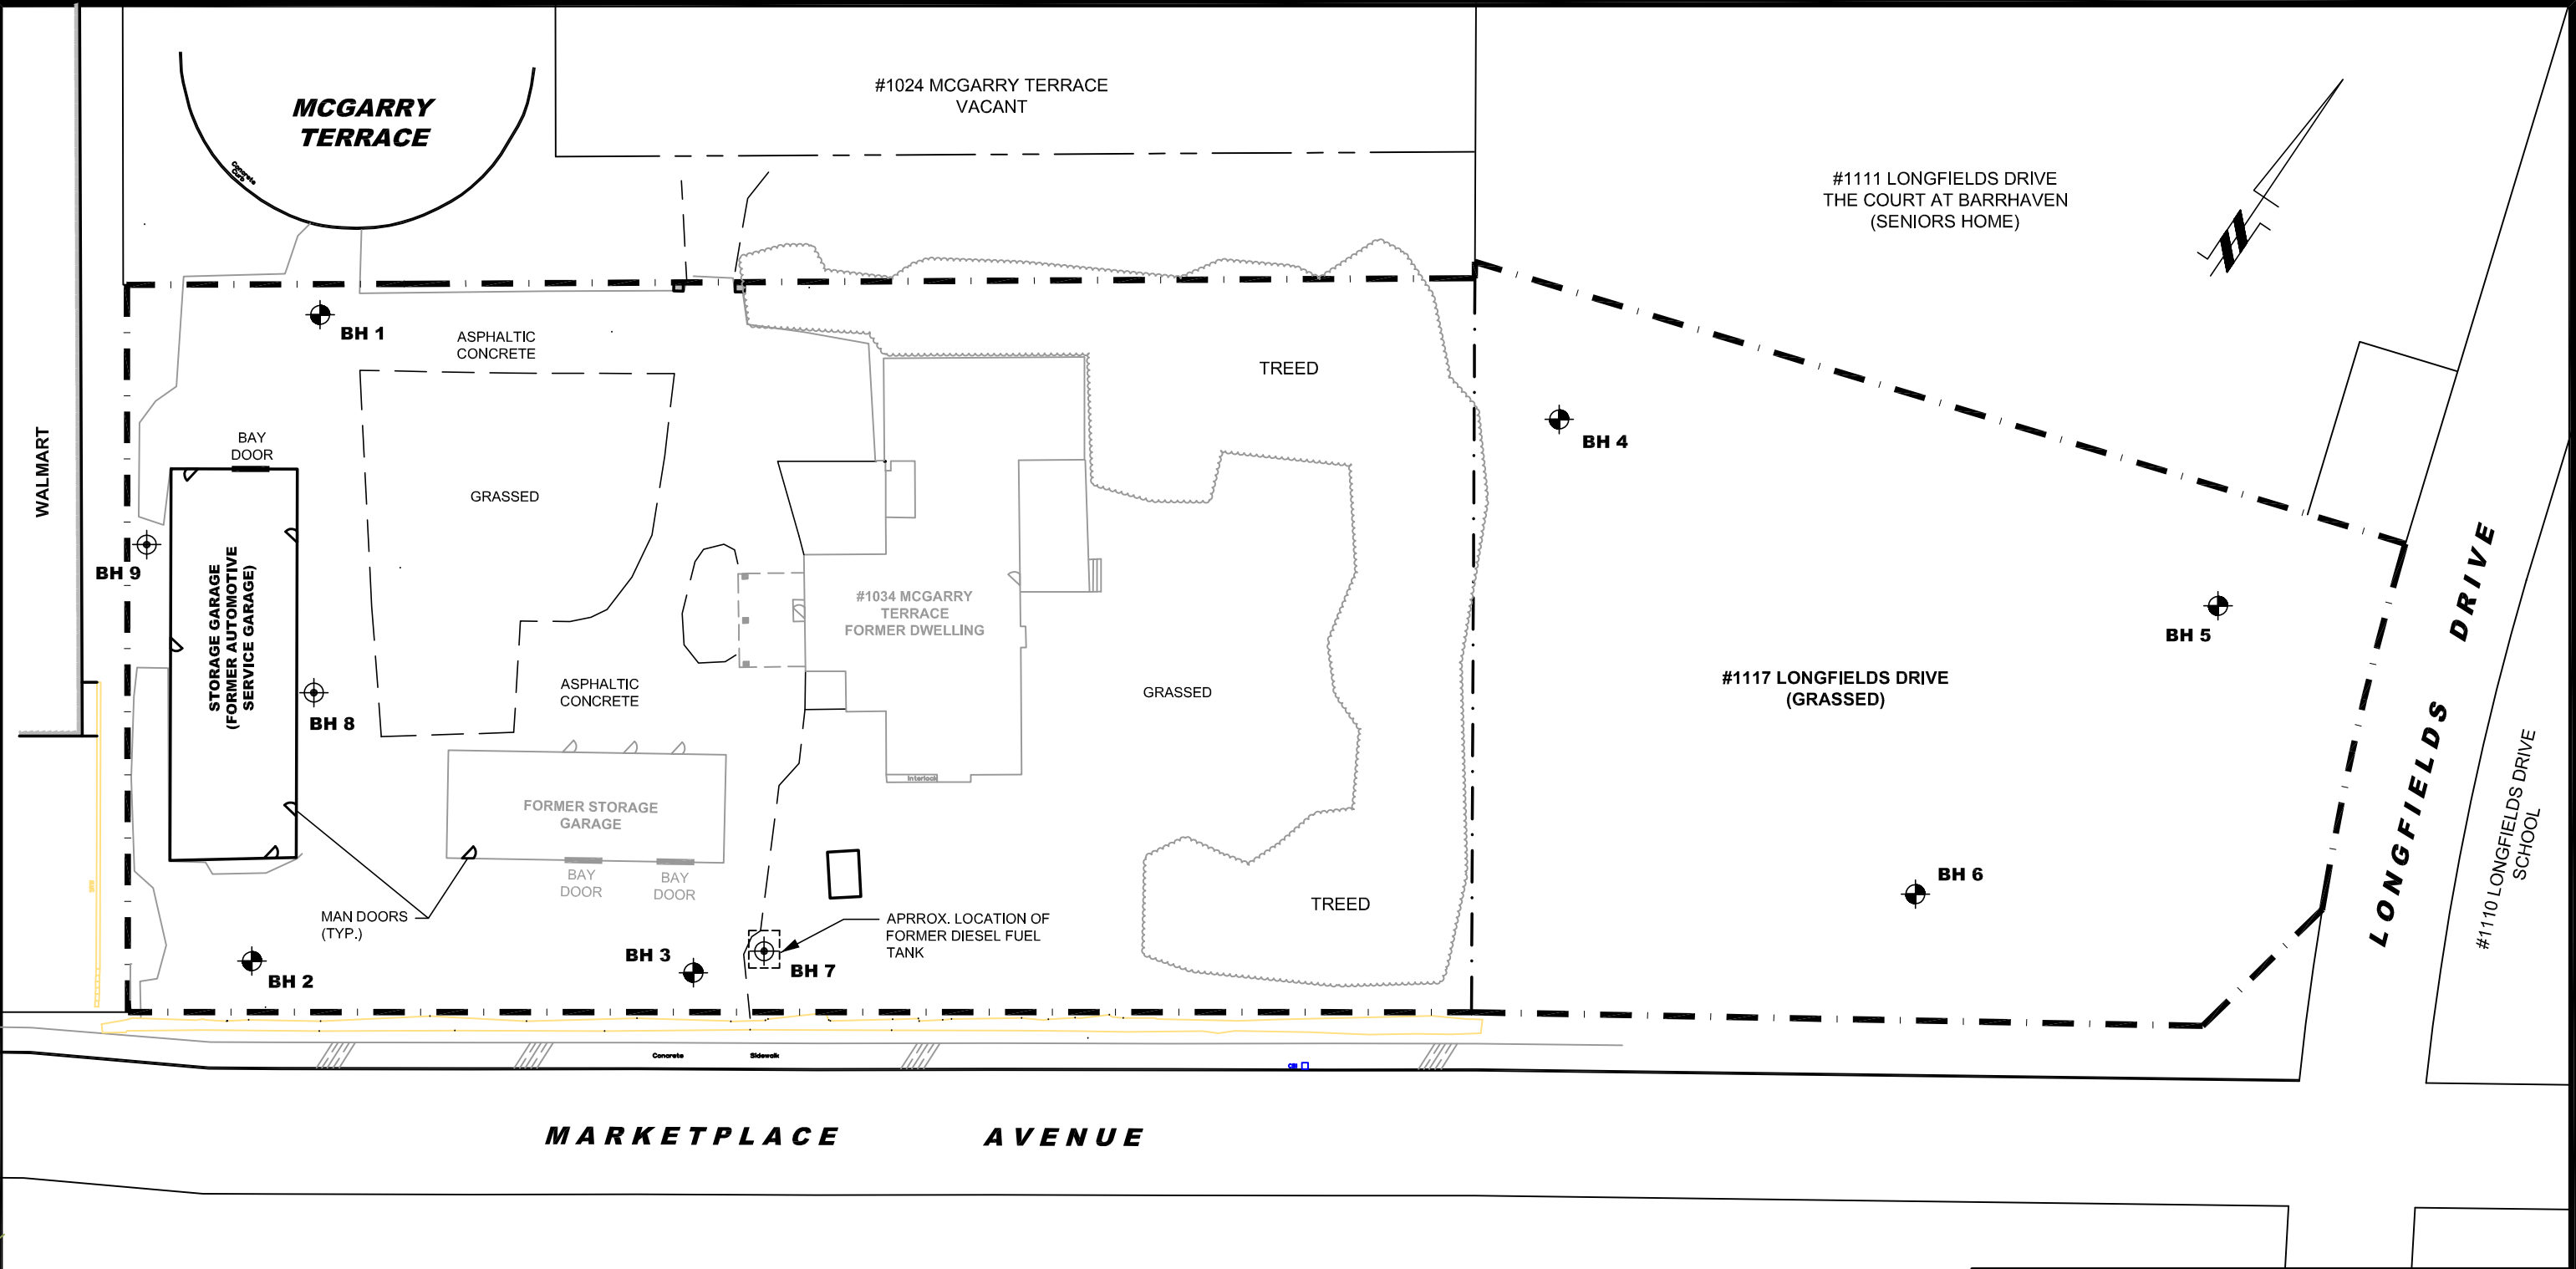
Dwg. No.	<b>PE2830-2</b>
Report No.:	PE2830-2
Date:	09/2013

Paterson has also recently conducted a geotechnical investigation on the subject property, whose boreholes are presented on drawing PE2830-3-Site Plan. No signs of impacted soil material were encountered during this investigation.

**CONCEPTUAL SITE MODEL:**  
**SITE PLAN**

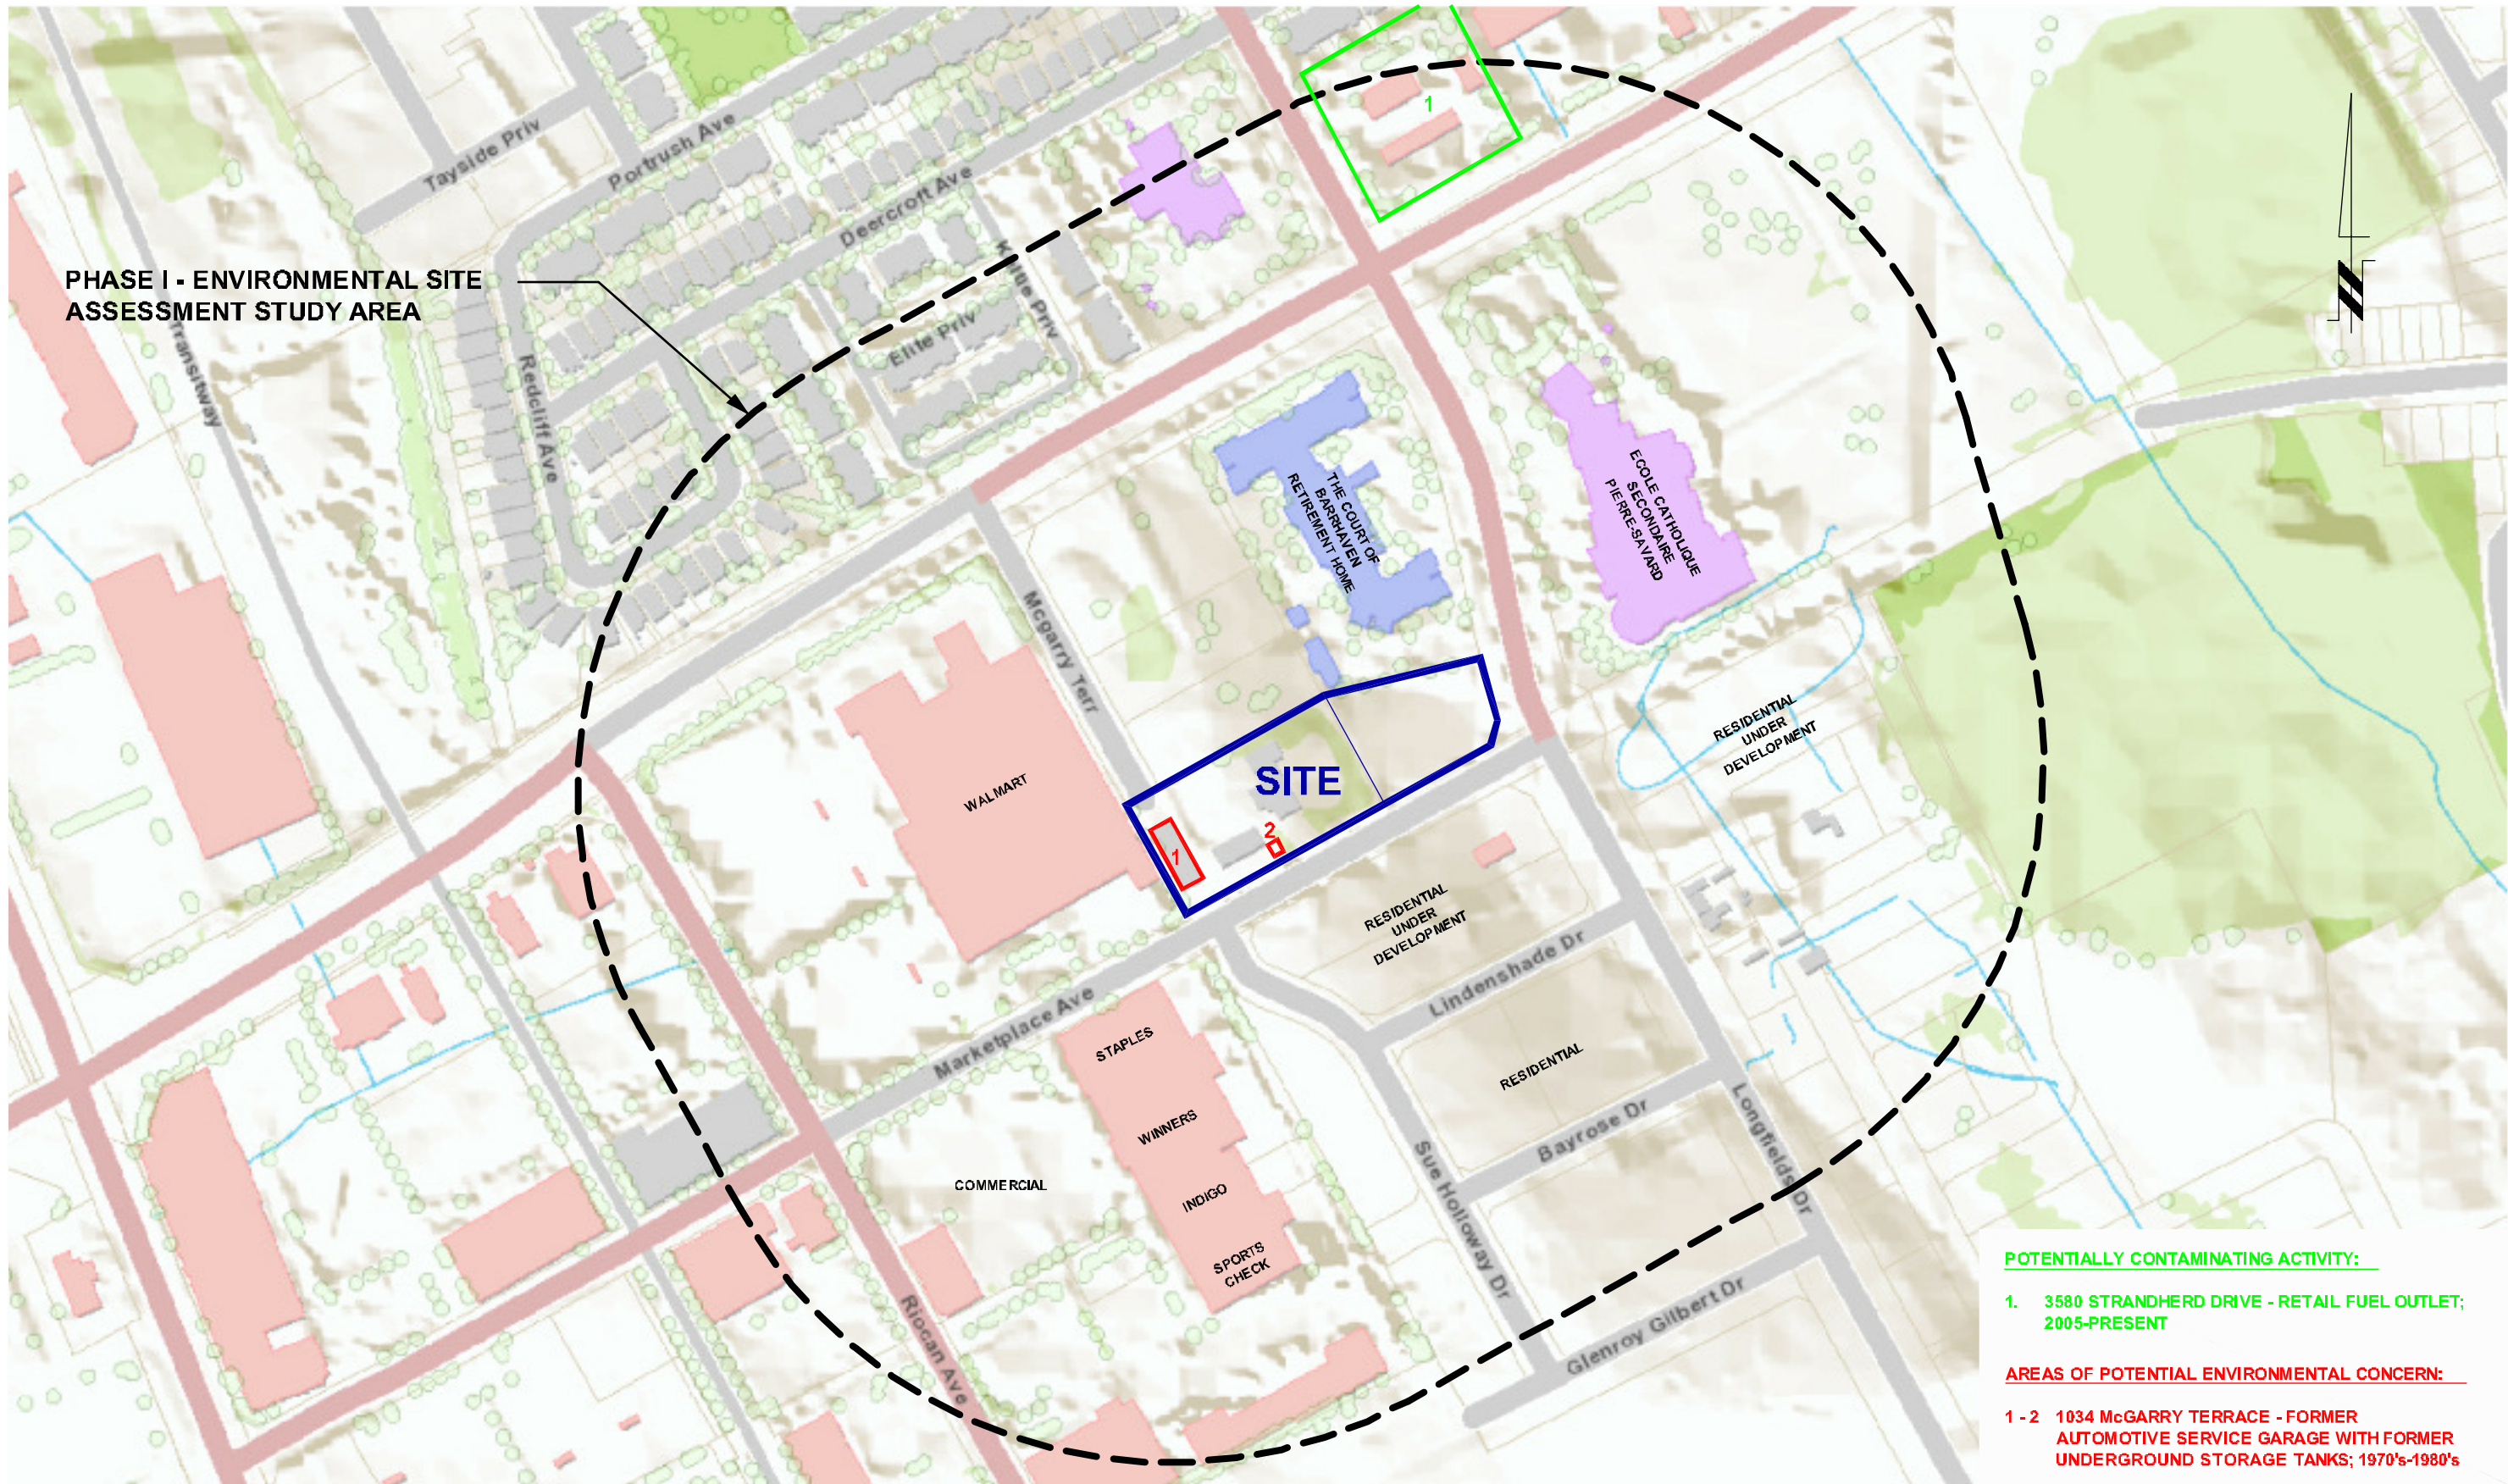
PHASE I - ENVIRONMENTAL SITE ASSESSMENT STUDY AREA

- POTENTIALLY CONTAMINATING ACTIVITY:**
- 3580 STRANDHERD DRIVE - RETAIL FUEL OUTLET; 2005-PRESENT
- AREAS OF POTENTIAL ENVIRONMENTAL CONCERN:**
- 1 - 2 1034 MCGARRY TERRACE - FORMER AUTOMOTIVE SERVICE GARAGE WITH FORMER UNDERGROUND STORAGE TANKS; 1970's-1980's
