Phase I Environmental Site Assessment

Vacant Property
603 Cummings Avenue
Ottawa, Ontario

September 13, 2017

Report: PE4084-1

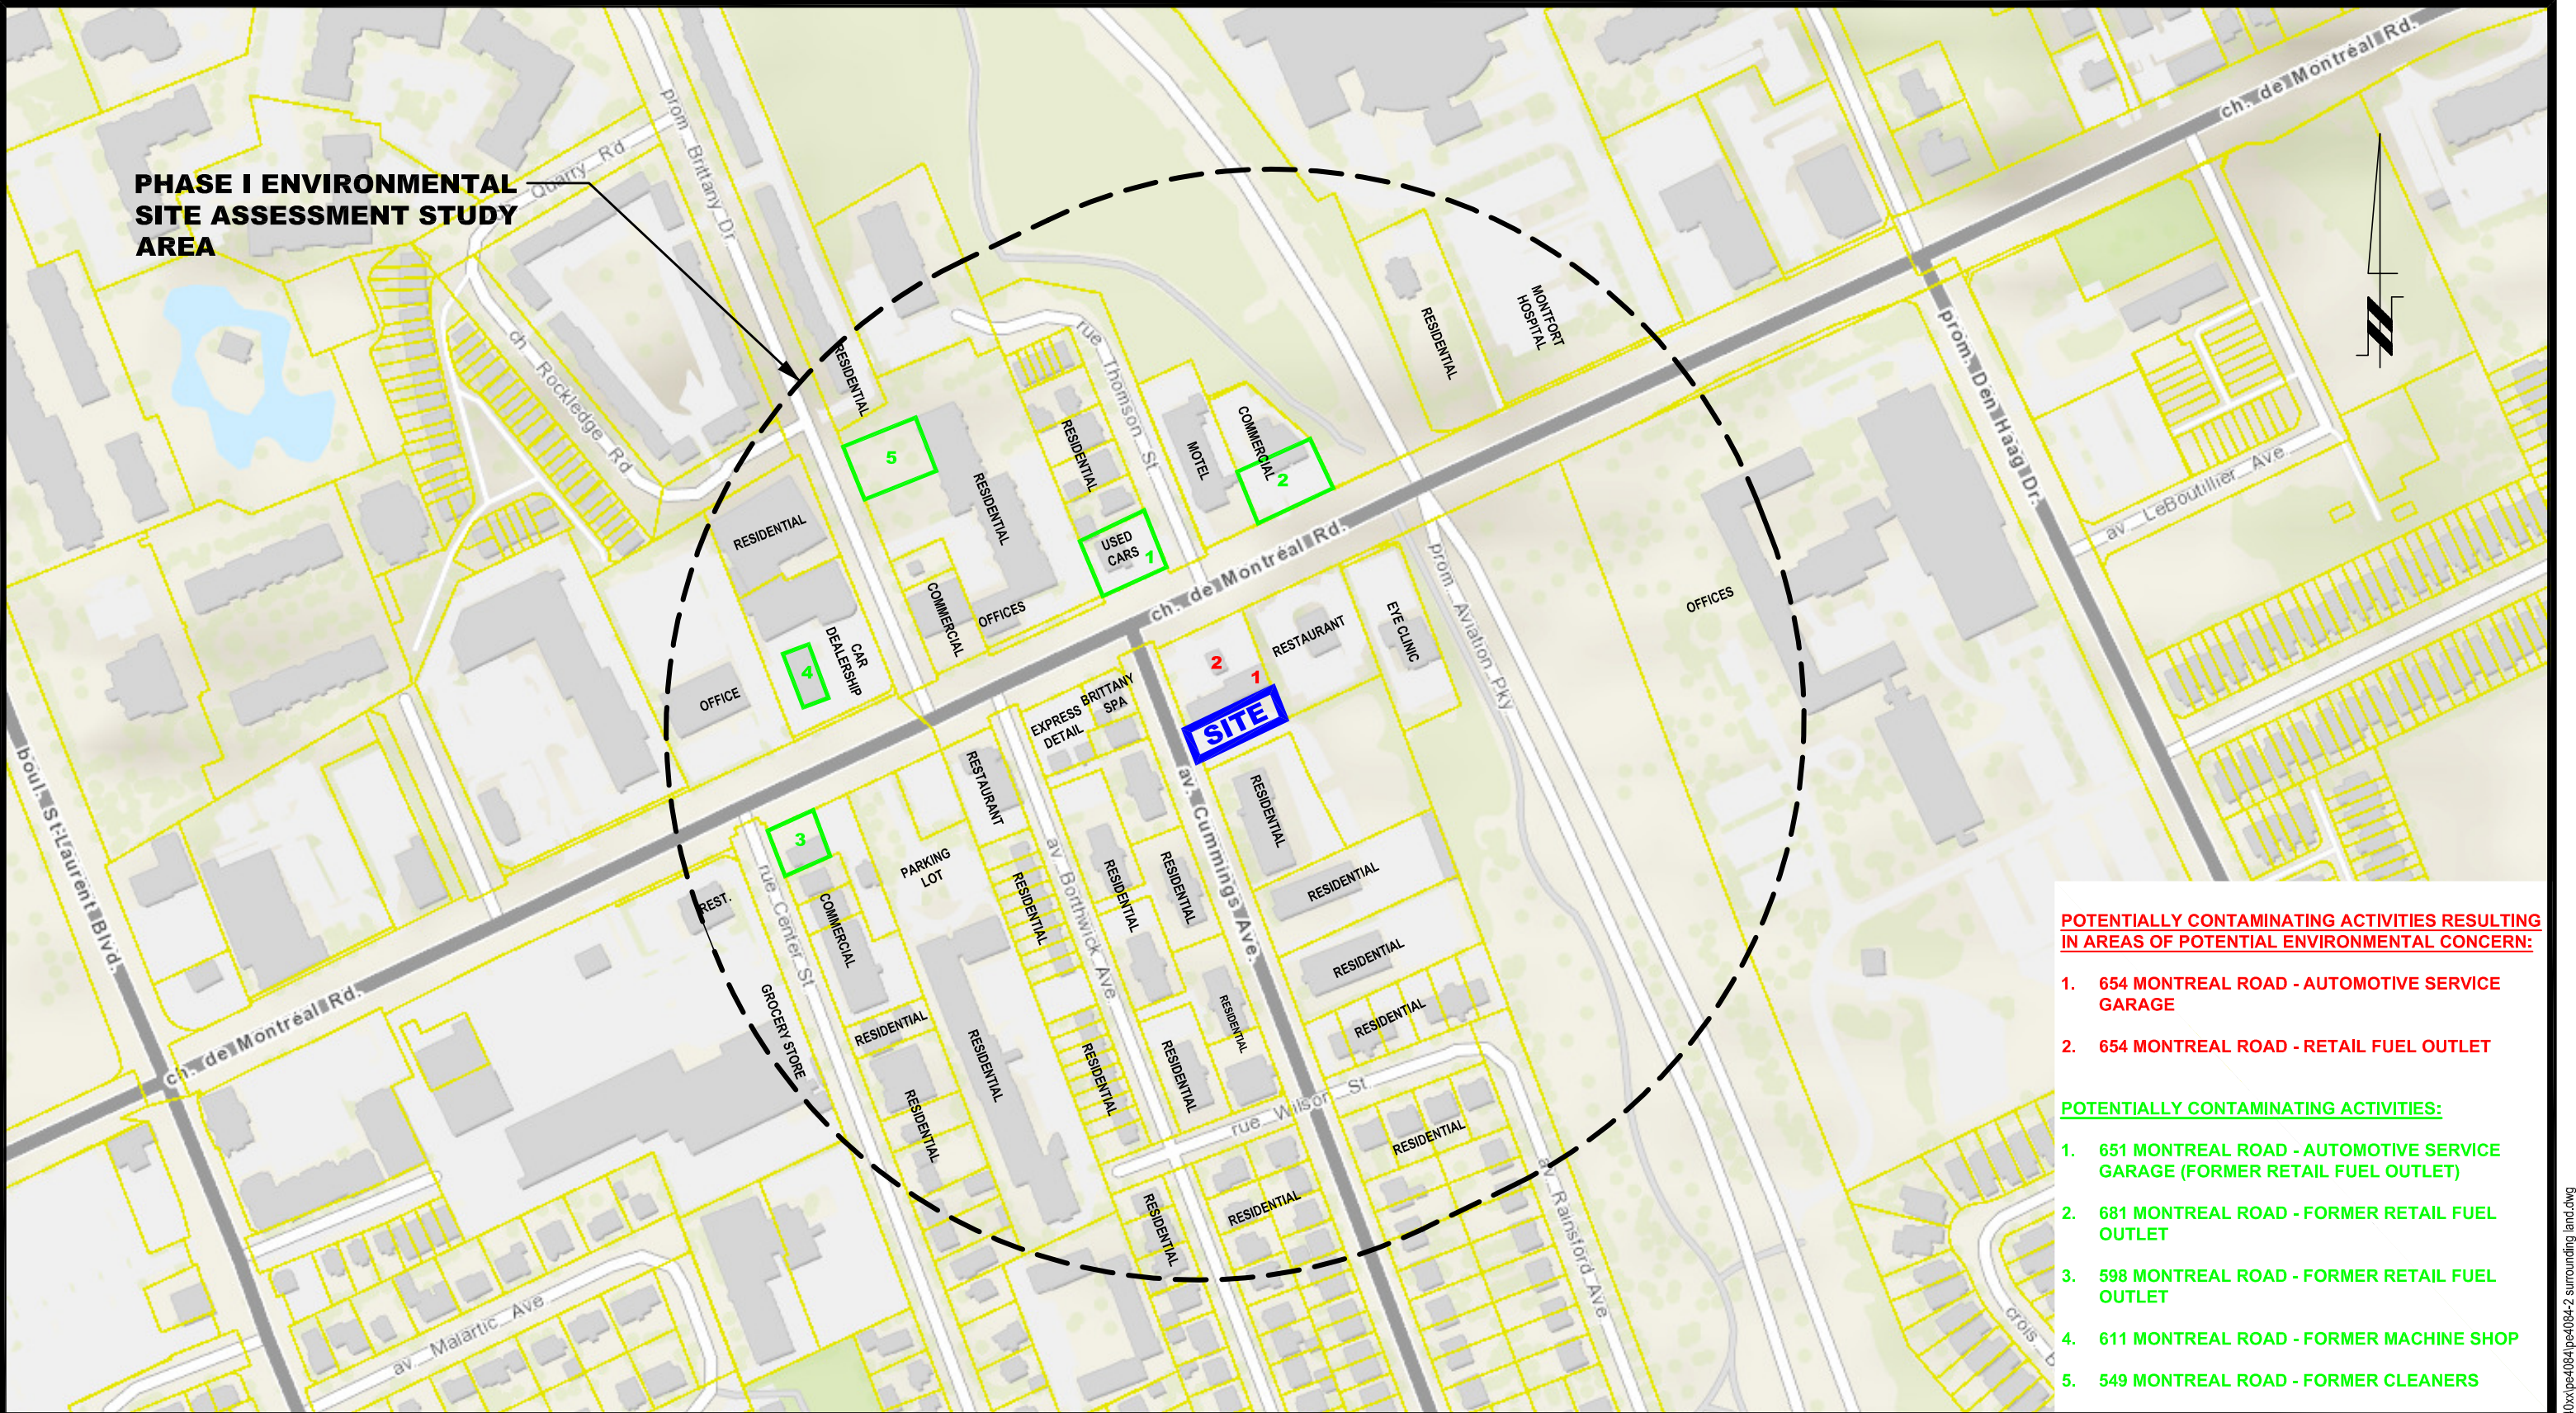
POTENTIALLY CONTAMINATING ACTIVITIES RESULTING IN AREAS OF POTENTIAL ENVIRONMENTAL CONCERN:

1. 654 MONTREAL ROAD - AUTOMOTIVE SERVICE GARAGE
2. 654 MONTREAL ROAD - RETAIL FUEL OUTLET

Potentially contaminating activities were noted in the historical searches and site visits conducted as part of this Phase I-ESA. Two of these are considered to have created areas of potential environmental concern; the retail fuel outlet and the automotive service garage both located on the adjacent property to the north.

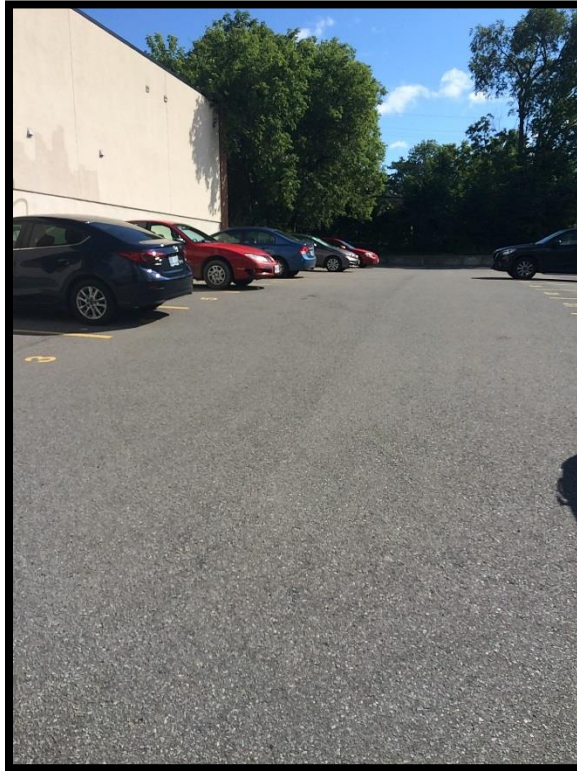
Photograph 1: View of the subject site, looking east.

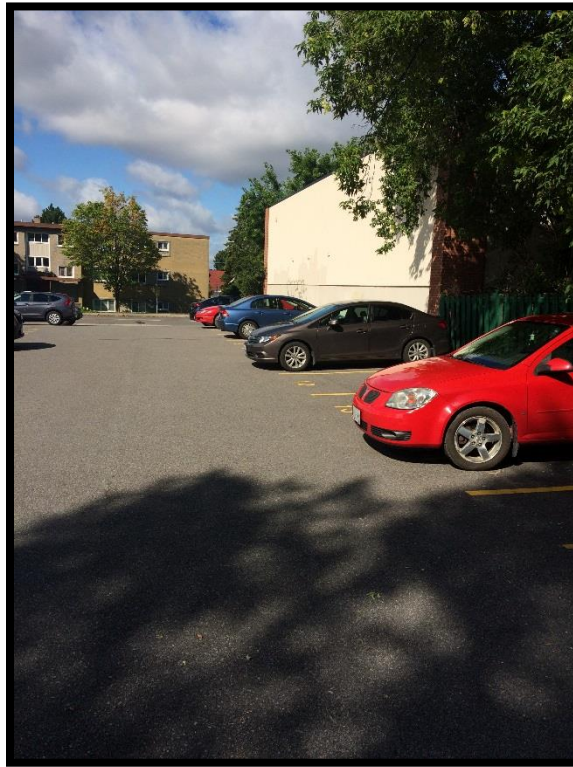
Photograph 3: View of the subject site, looking west, towards Cummings Avenue.

The subject property is a vacant paved lot, used for vehicular parking. The site slopes to the west, towards Cummings Avenue. No significant or unusual staining was observed on the property. The property is located at an elevation lower than the adjacent property to the north, but higher than the property to the south.

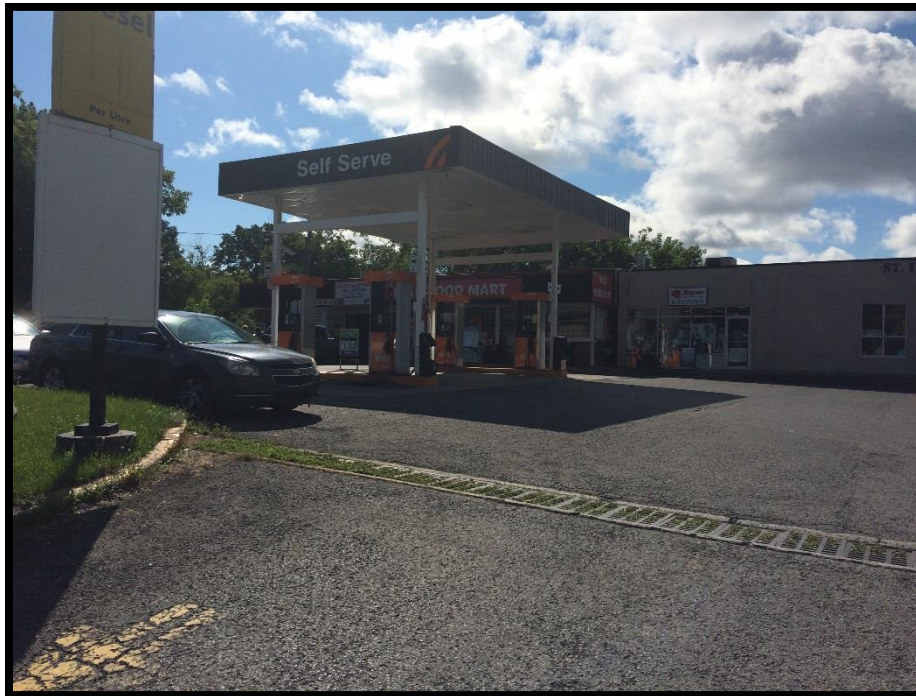
Photograph 4: Photograph of the property adjacent to the north of the subject site, the pump island of the retail fuel outlet can be seen in the foreground. The automotive service garage can be seen in the background of the photo.

Based on the results of this Phase I – ESA **a Phase II Environmental Site Assessment is required for the property.**
