Phase I Environmental Site Assessment

Vacant Property
Tanger Outlet Mall – 8555 Campeau Drive
Ottawa, Ontario

January 30, 2018

Report: PE4225-1

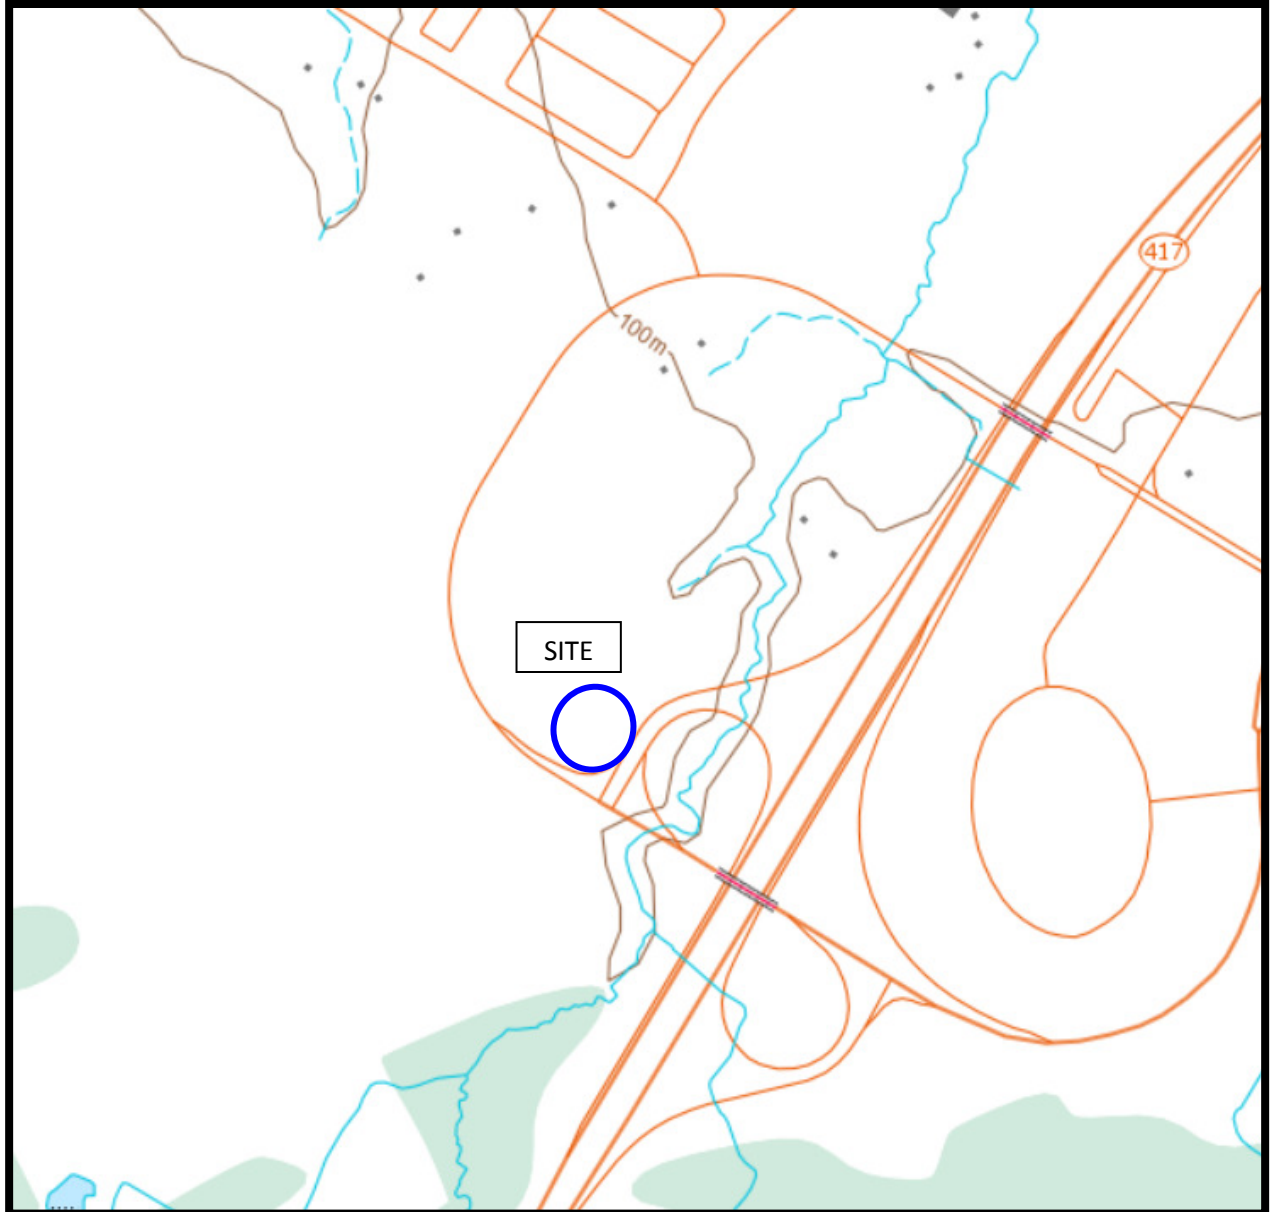
FIGURE 2
TOPOGRAPHIC MAP

Topographic information was obtained from Natural Resources Canada – The Atlas of Canada website. The topographic maps indicate that the elevation of the subject site is approximately 105 m above sea level. The regional topography in the general area of the site slopes downward to the north and east. An illustration of the referenced topographic map is presented on Figure 2 – Topographic Map, appended to this report.

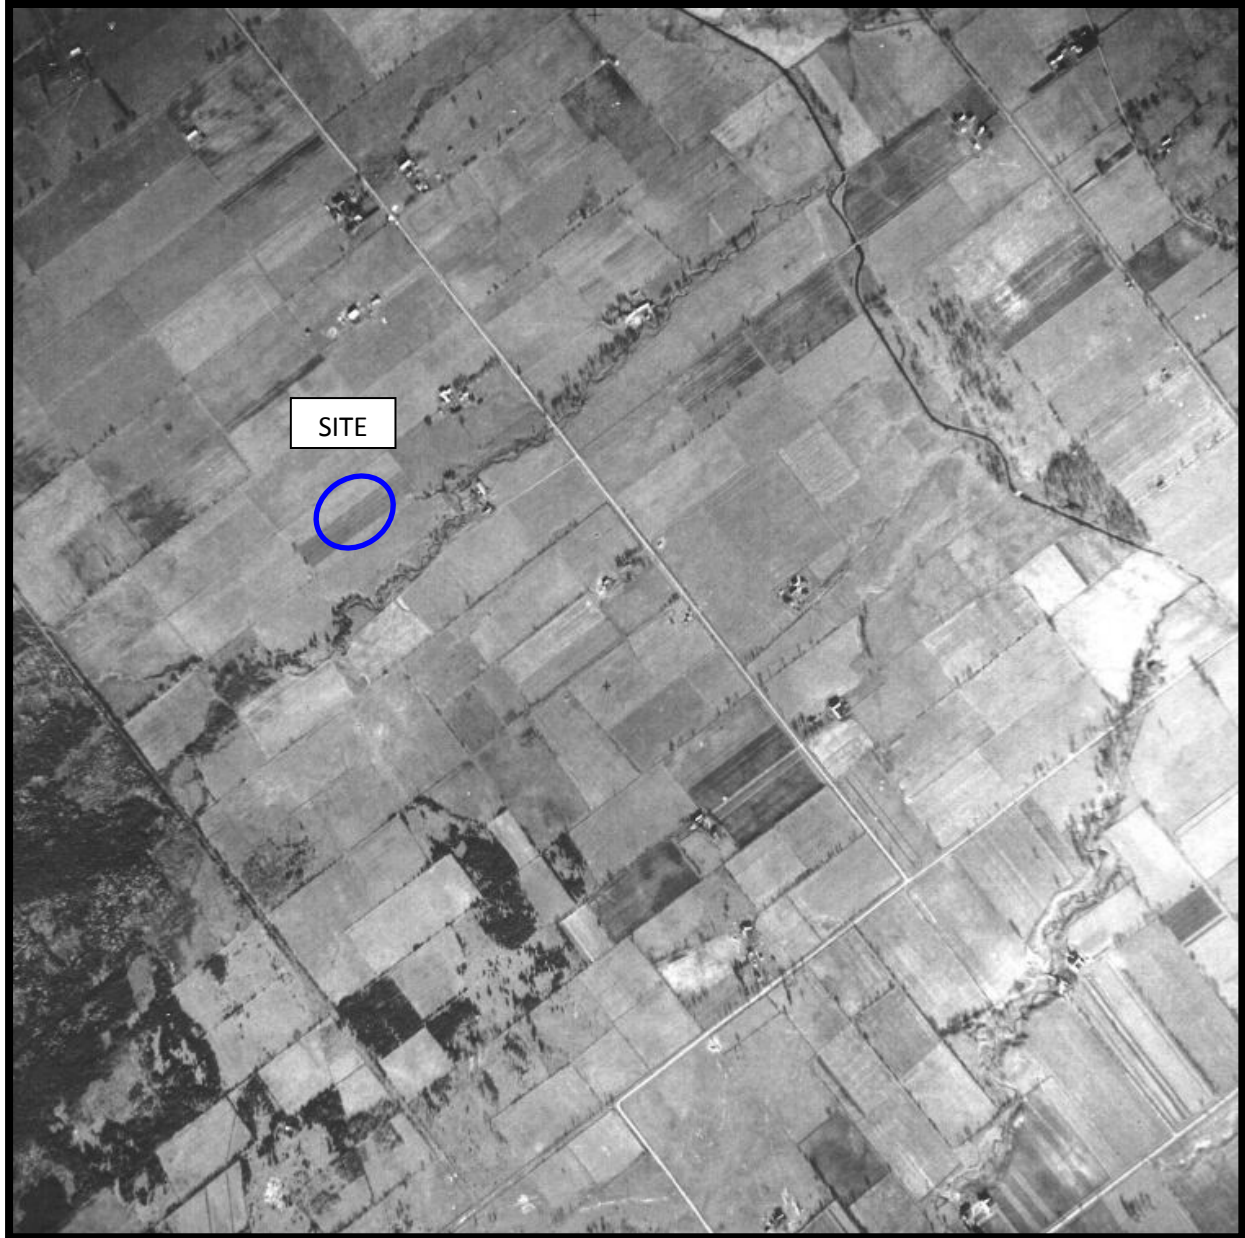
AERIAL PHOTOGRAPH
1945

| 1945 | The subject site is a vacant agricultural field. Surrounding properties are also agricultural fields. No apparent roads are present in the Phase I study area. |

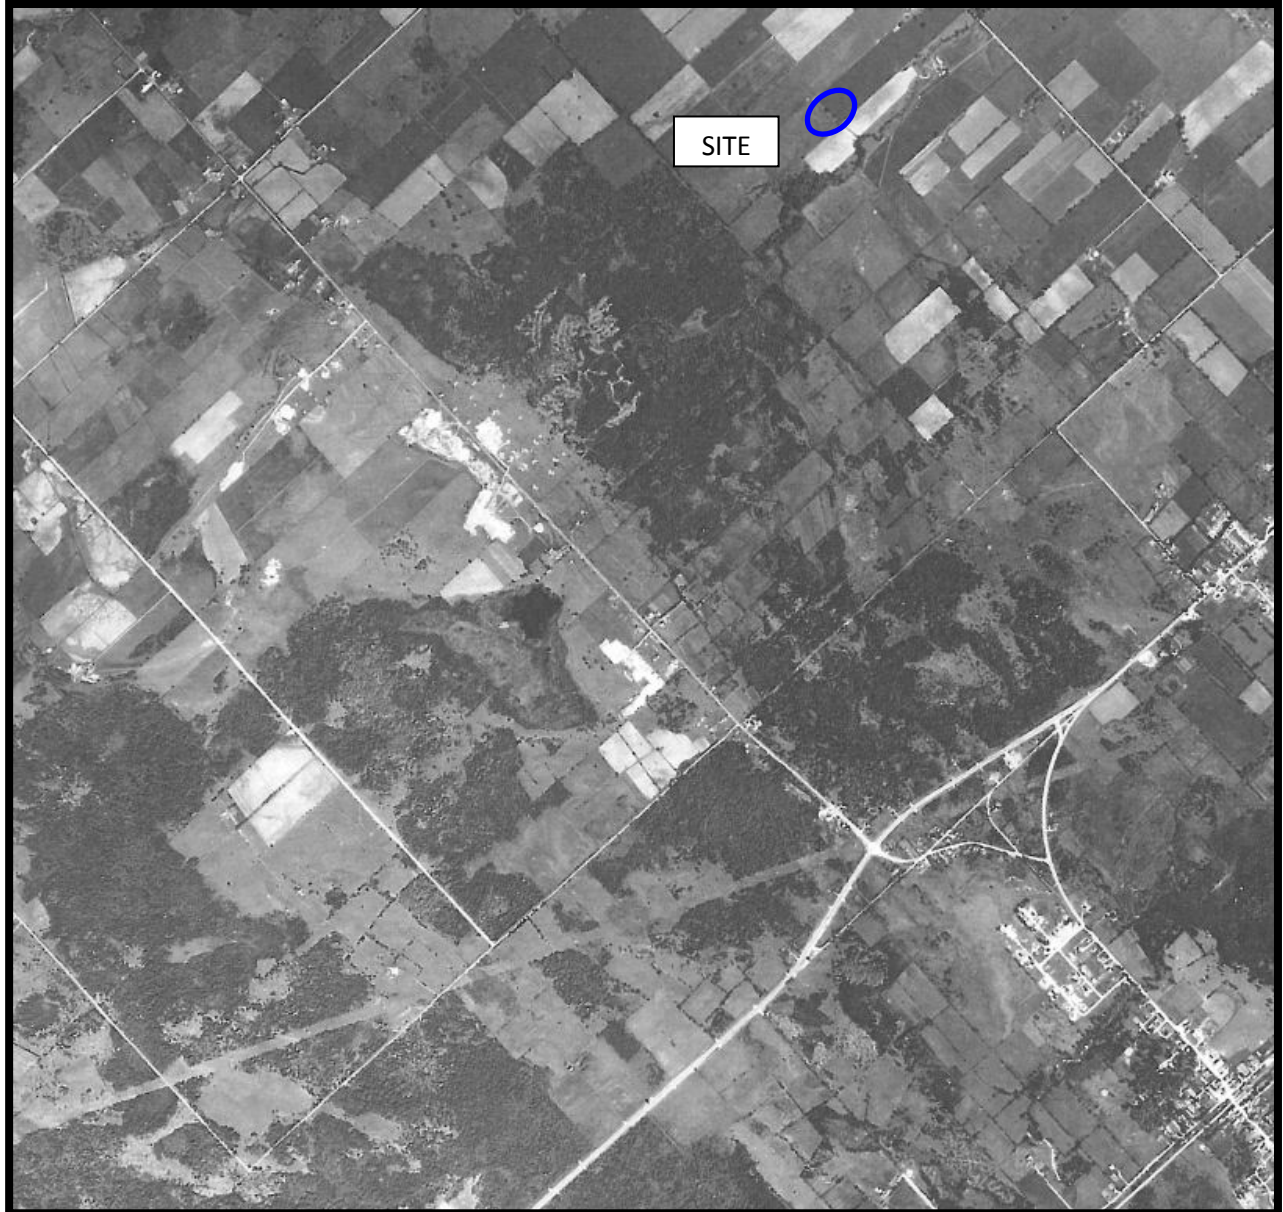
AERIAL PHOTOGRAPH
1959

| 1959 | No changes have been made to the subject site or surrounding properties. |

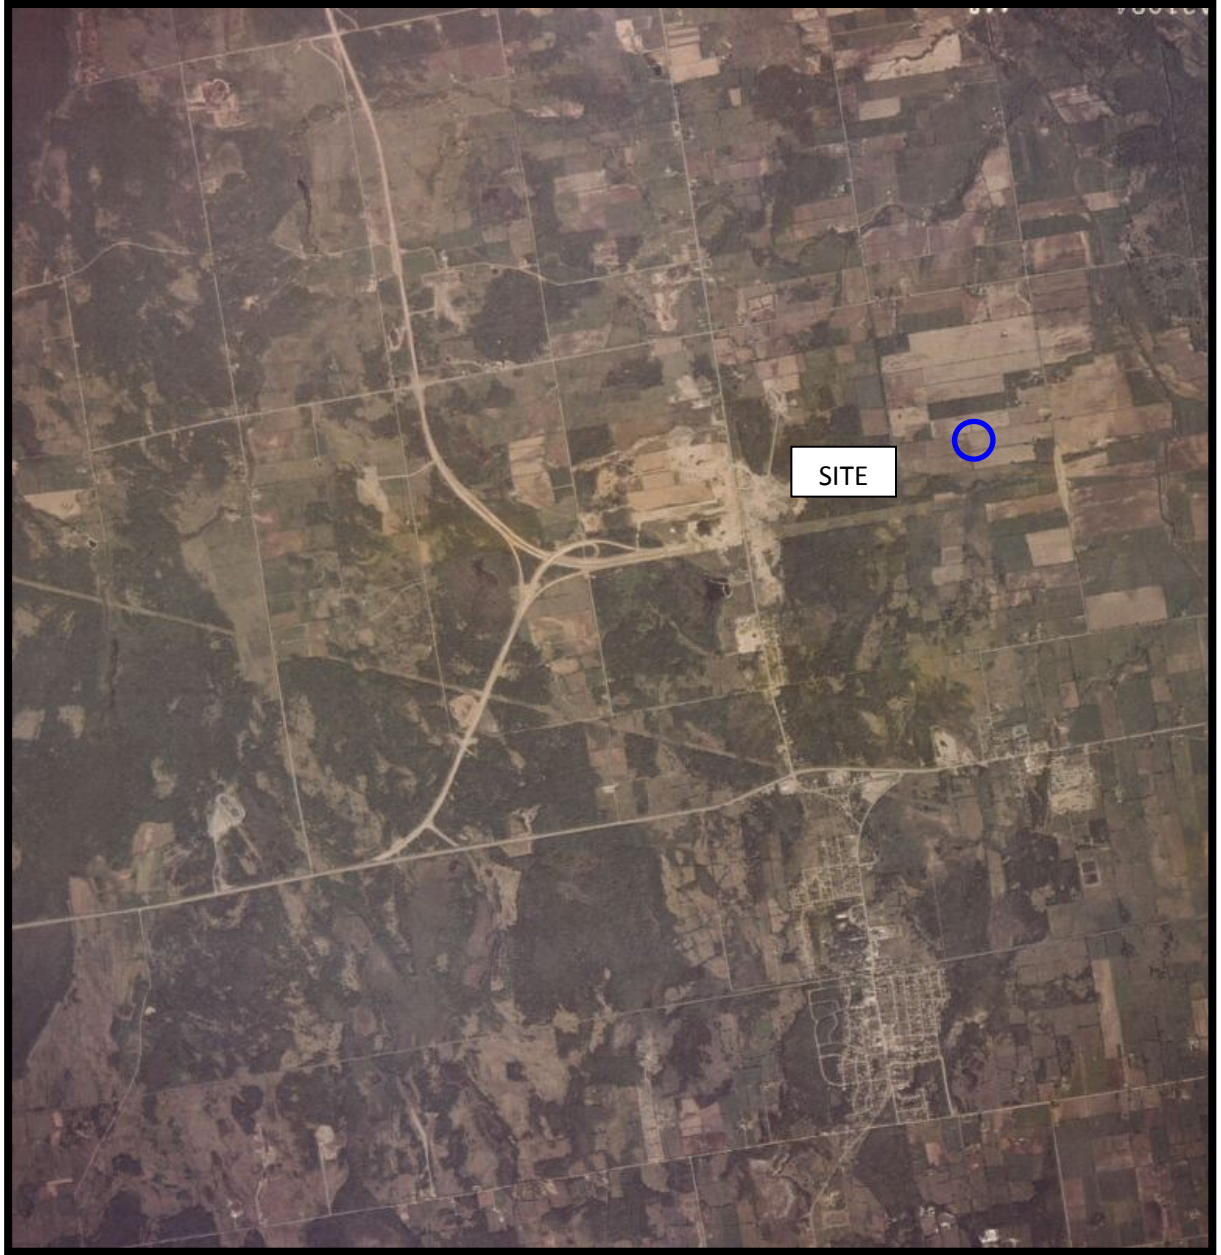
AERIAL PHOTOGRAPH
1976

| 1976 | No changes have been made to the subject site or surrounding properties. |

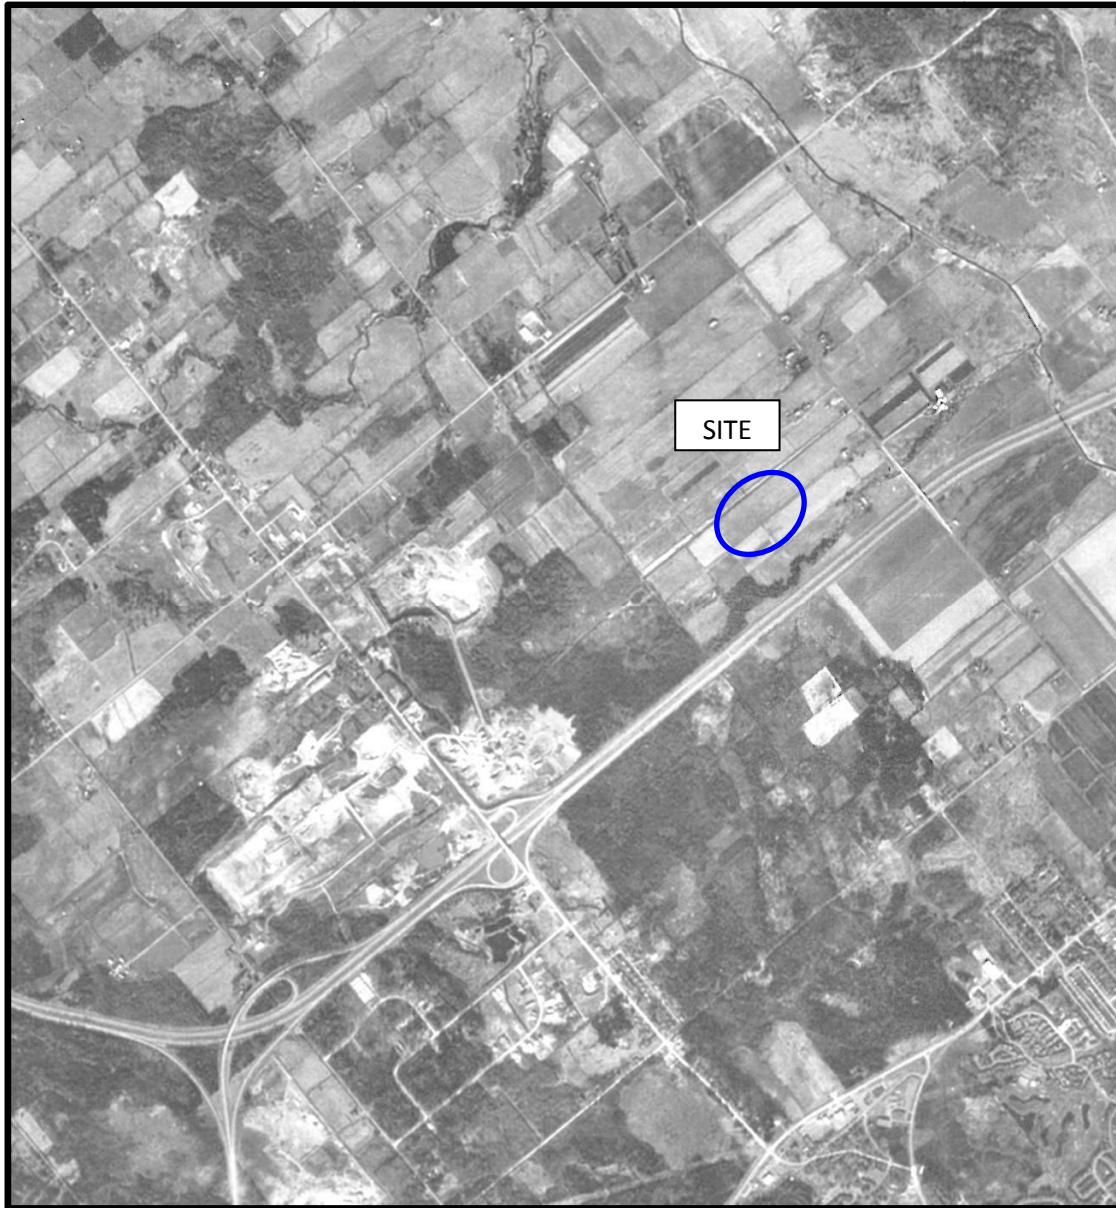
AERIAL PHOTOGRAPH
1988

| 1988 | No changes have been made to the subject site or surrounding properties. |

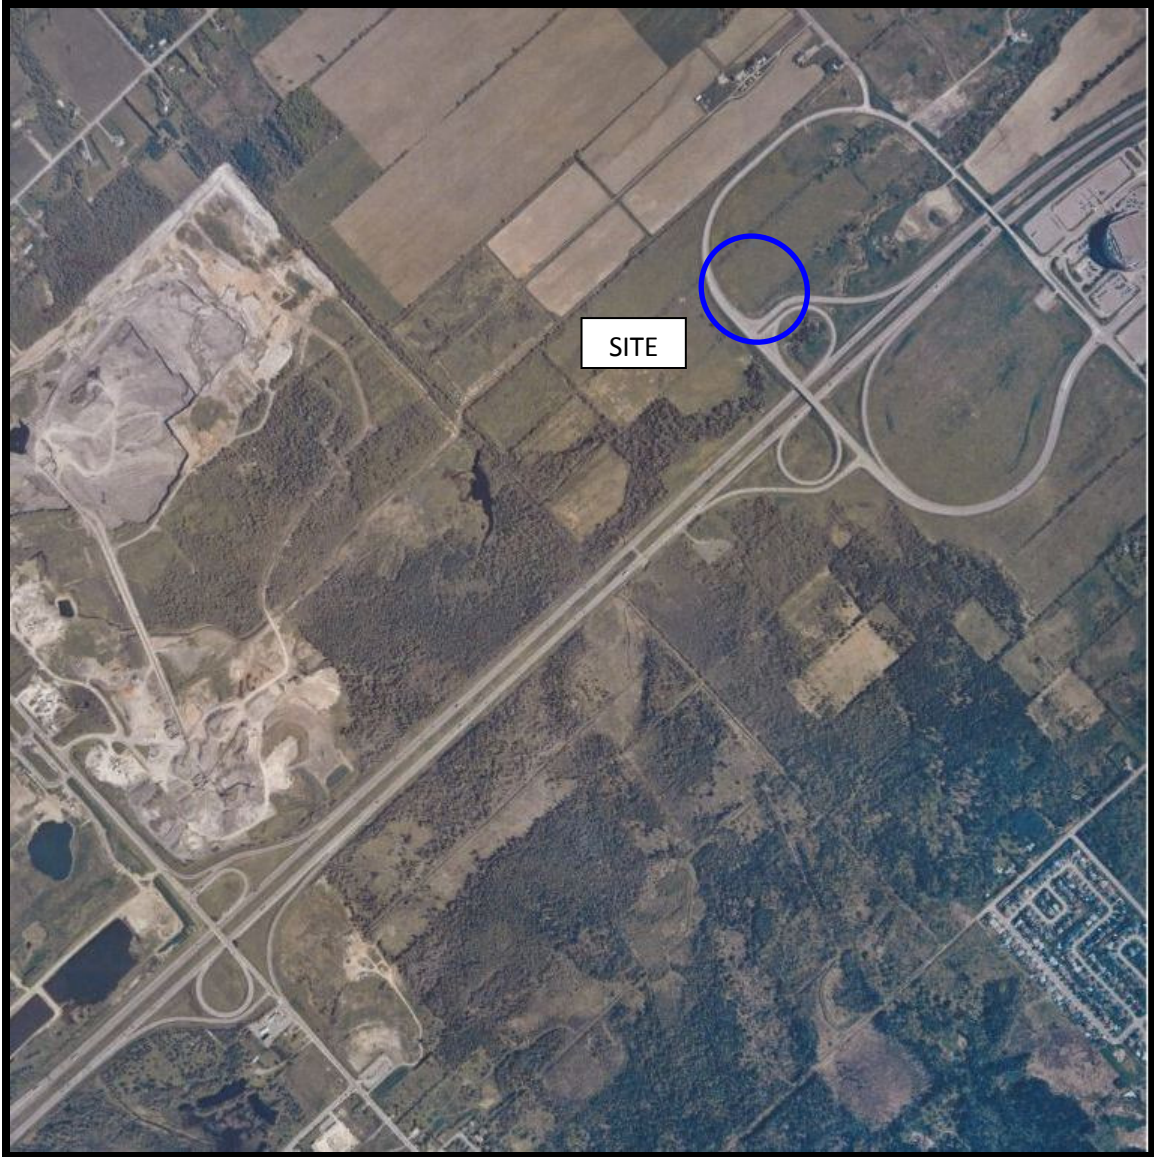
AERIAL PHOTOGRAPH
2002

| 2002 | (City of Ottawa website) No changes have been made to the subject site or surrounding properties. |

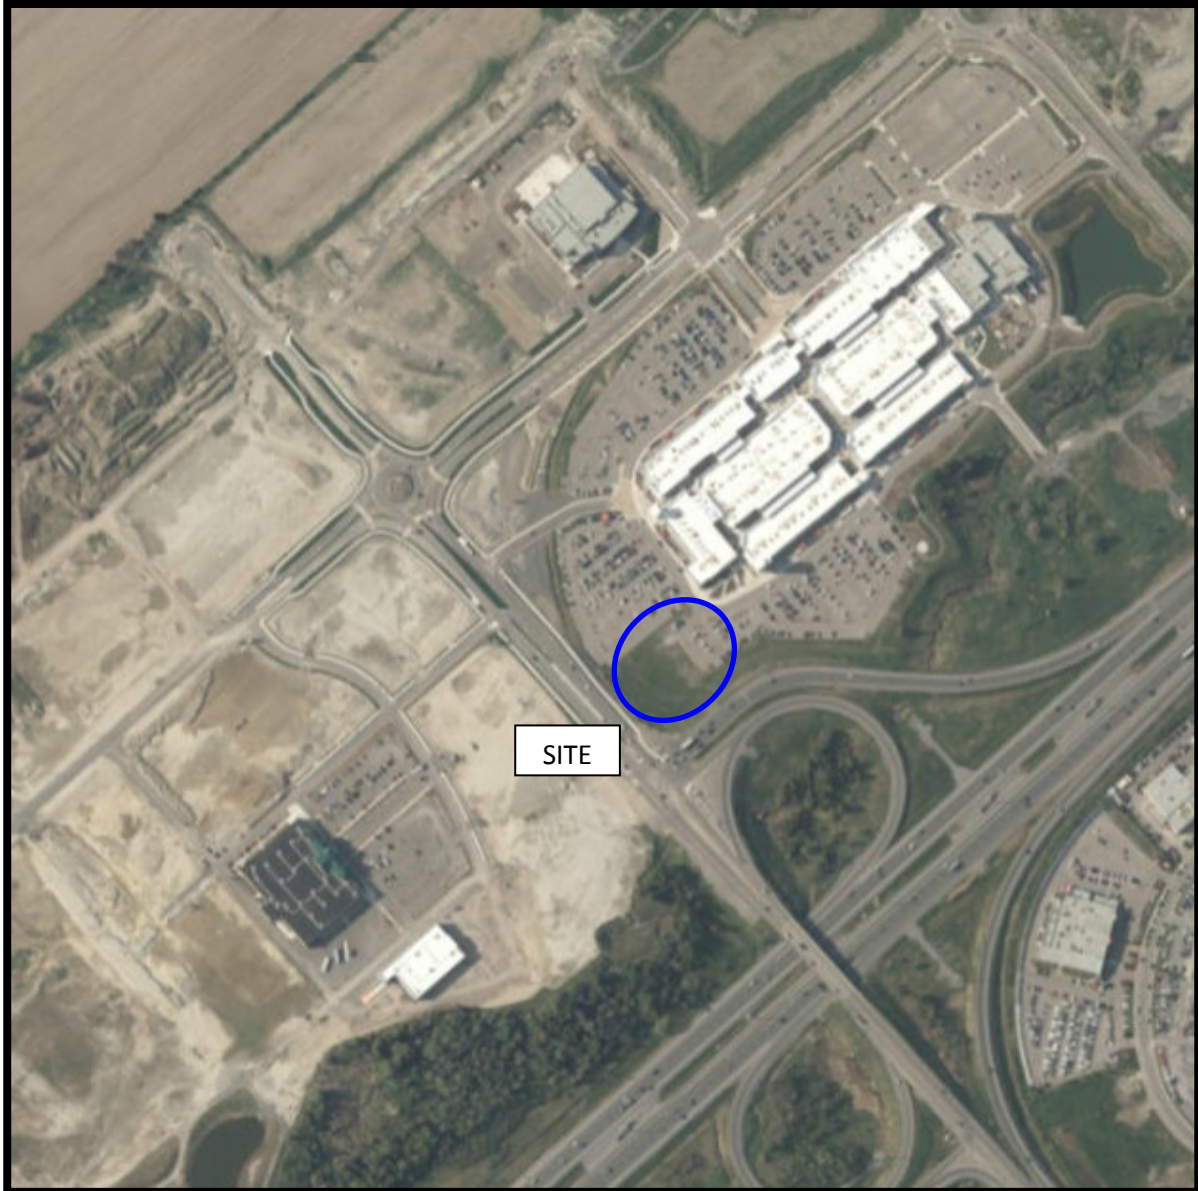
AERIAL PHOTOGRAPH
2017

| 2017 | (City of Ottawa website) The subject site is mostly grass covered. The northeast corner of the site is occupied by part of a parking lot associated with the Tanger Outlet mall. |

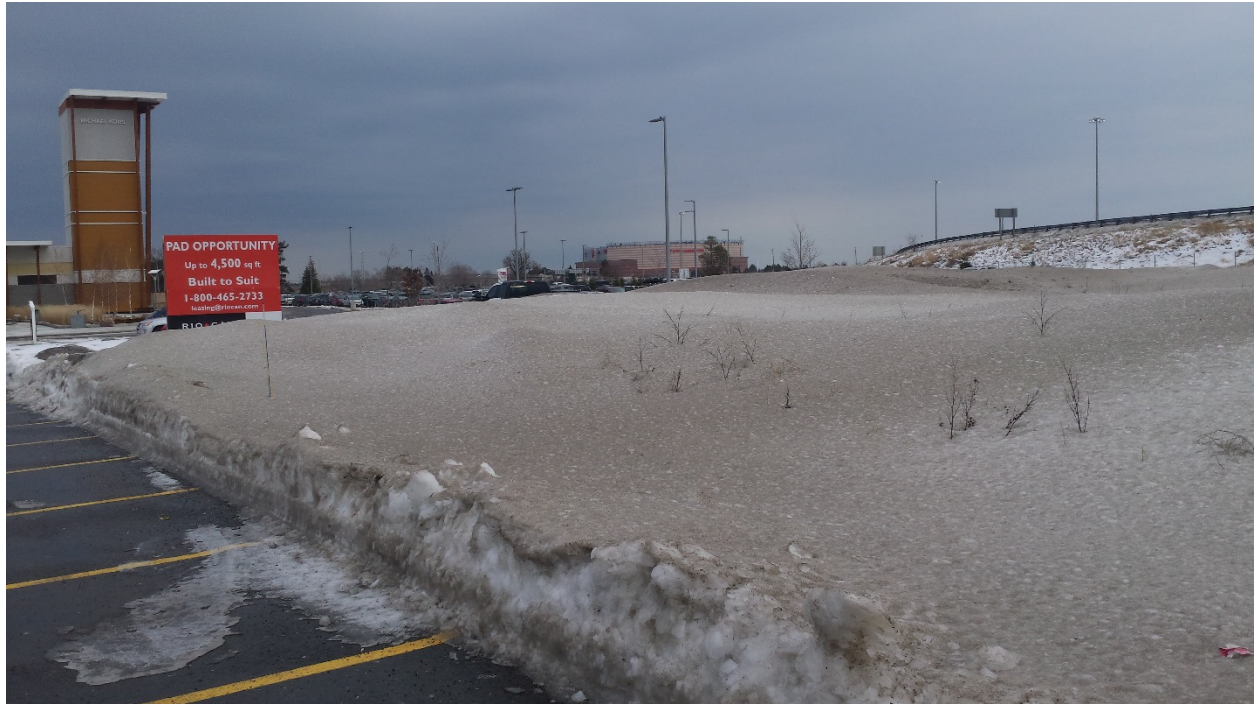
Photograph 1: View of the subject site, looking east.

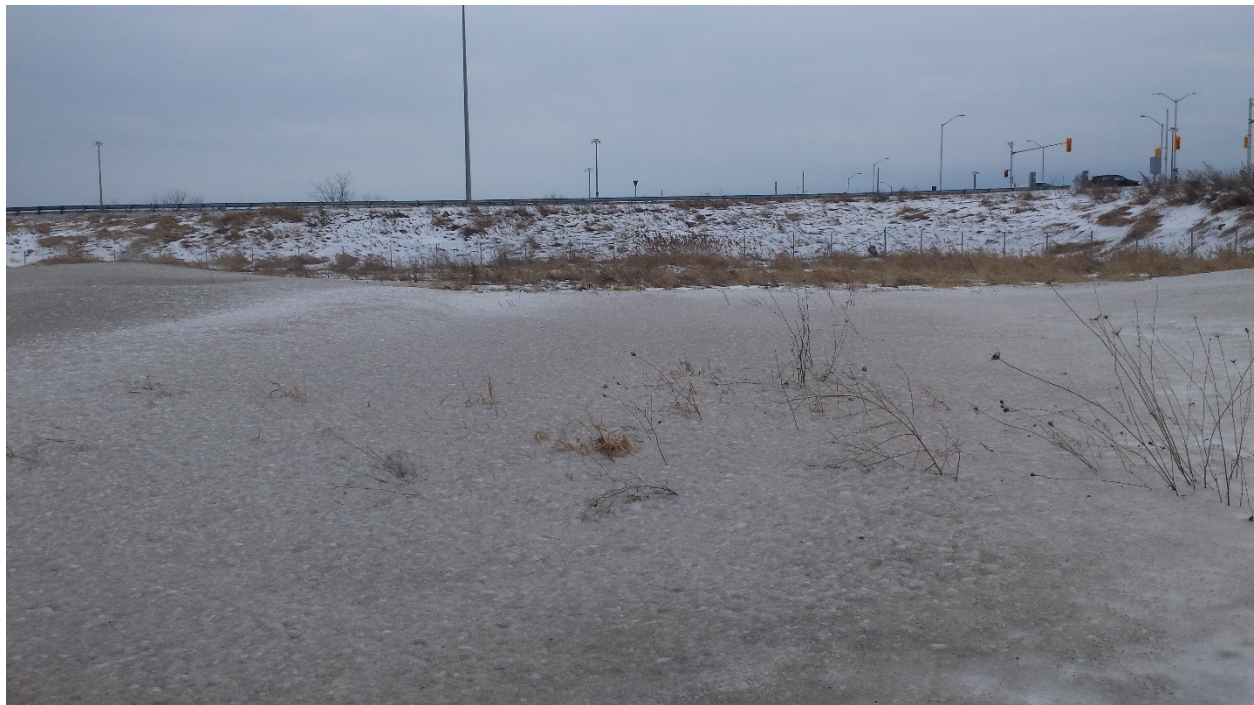
Photograph 2: View of the subject site, looking south. The intersection of the Highway 417 ramp and Palladium Drive is visible at top right.

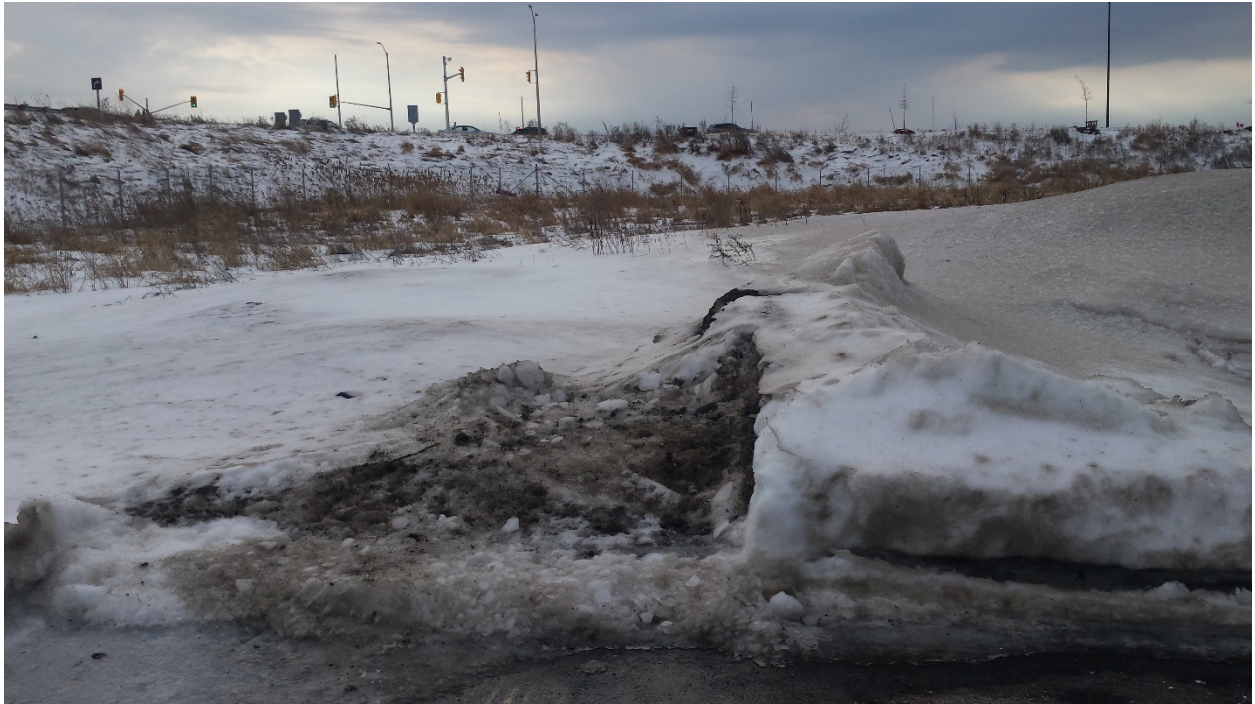
Photograph 3: View of the subject site, looking southwest.

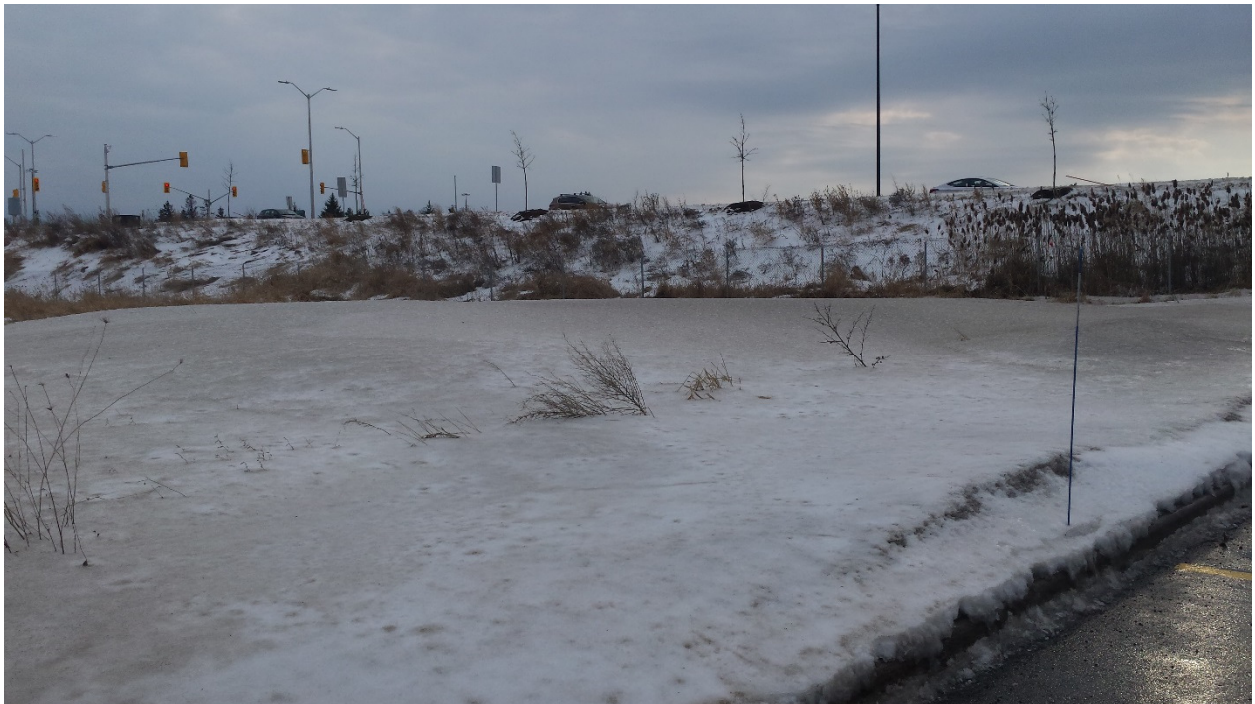
Photograph 4: View of the subject site, looking west.
