Phase I Environmental Site Assessment

Blocks 2 and 3 – McGarry Terrace
Ottawa, Ontario

July 17, 2017

Report: PE4055-1

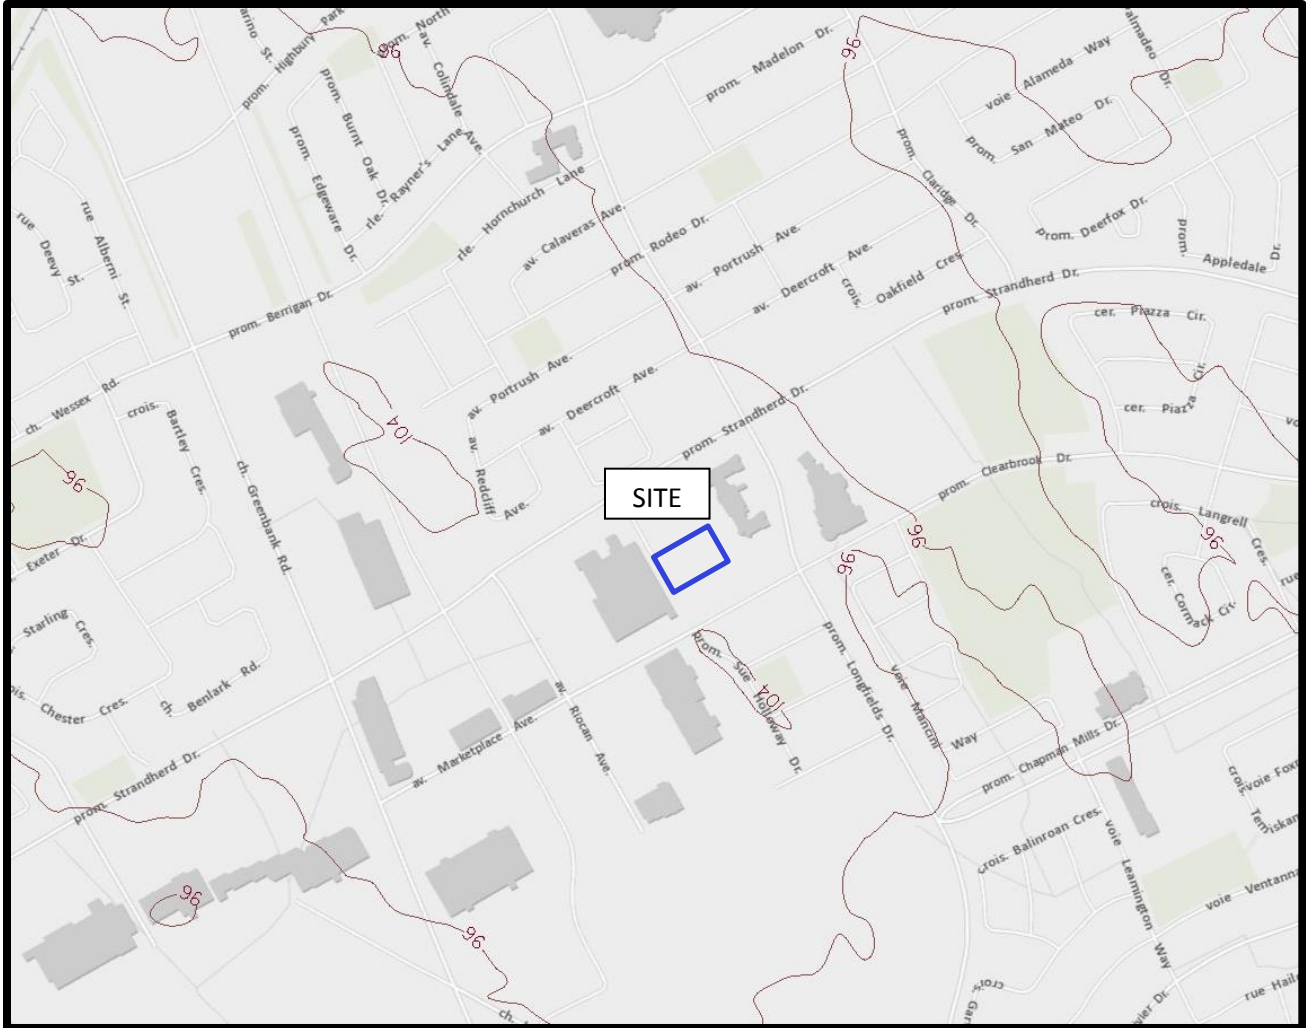
FIGURE 2
TOPOGRAPHIC MAP

Topographic maps were obtained from The City of Ottawa – geoOttawa website. The topographic maps indicate that the regional topography in the area of the subject site slopes slightly to the south towards the Jock River. No environmental concerns were identified on the topographic mapping. An illustration of the referenced topographic map is present on Figure 2 - Topographic Map following the body of this report.

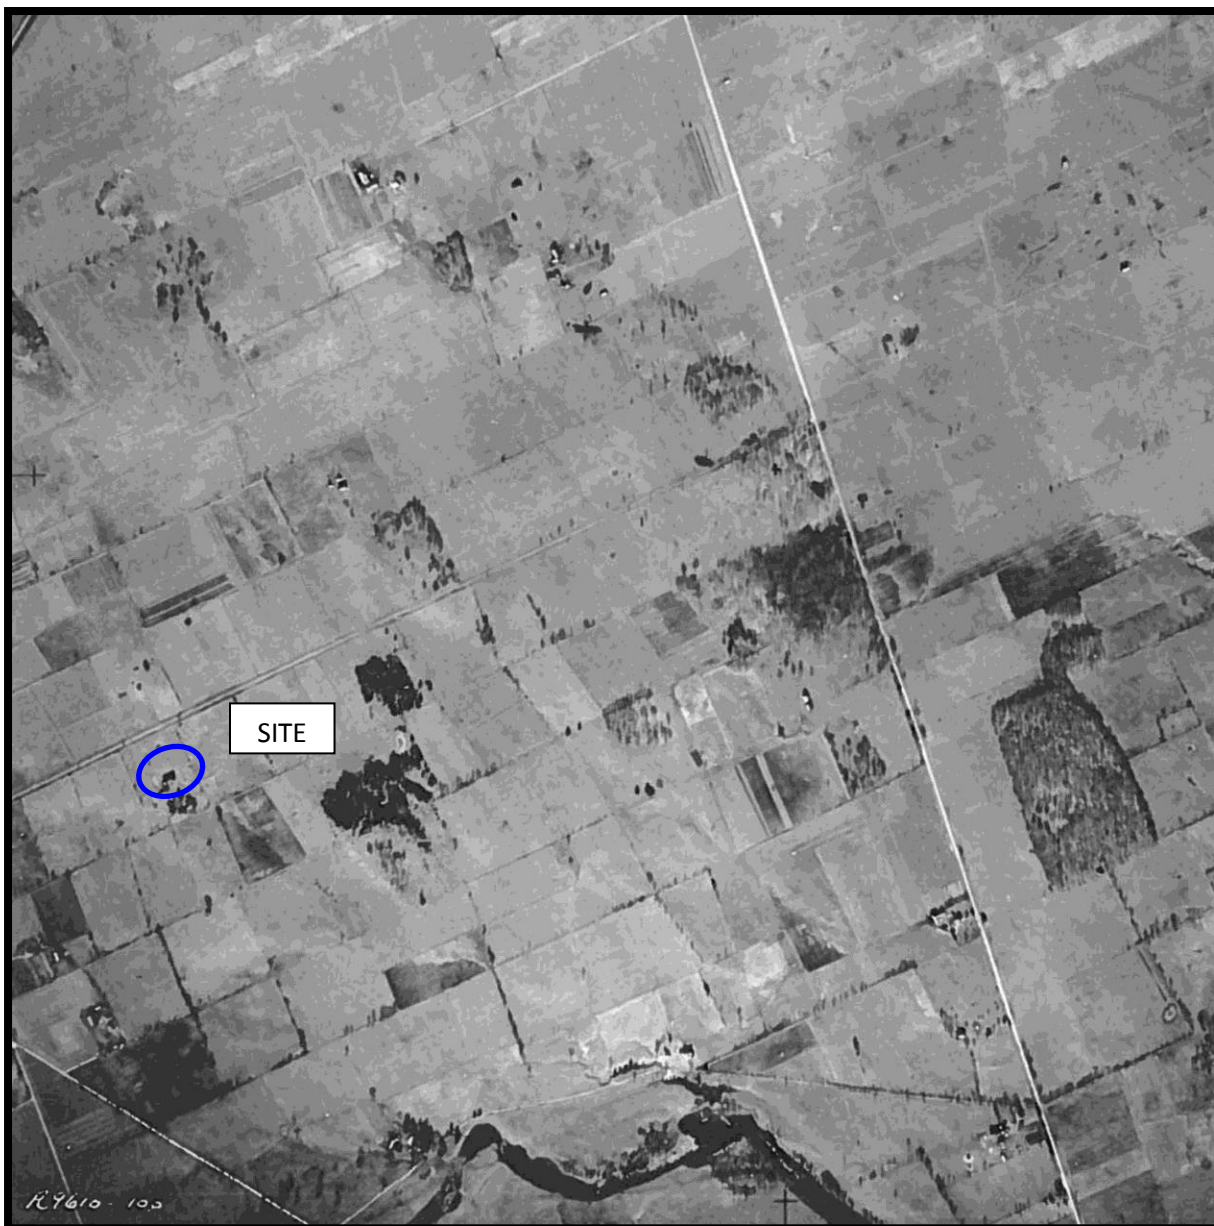
AERIAL PHOTOGRAPH
1945

1945	The subject site appears to be used for agriculture at this time. A structure is visible on the southern part of the subject site, however due to the poor scale of the photograph, it is difficult to distinguish. The majority of the surrounding lands appear to be used for agricultural purposes.
1954	No significant changes have been made to the subject or neighbouring properties. Neighbouring properties appear to be used for agricultural purposes.
1960	No significant changes have been made to the subject site or adjacent properties.
1973	The barn on the southern part of the subject site is no longer present. A laneway is visible extending from Strandherd Drive to the subject site. Two additional buildings, suspected to be the historical garage buildings, are on the property to the south.
1979	No significant changes have been made to the subject site or adjacent properties.
1987	No apparent changes have been made to the subject or neighbouring properties. Increased residential development is apparent further to the northwest.

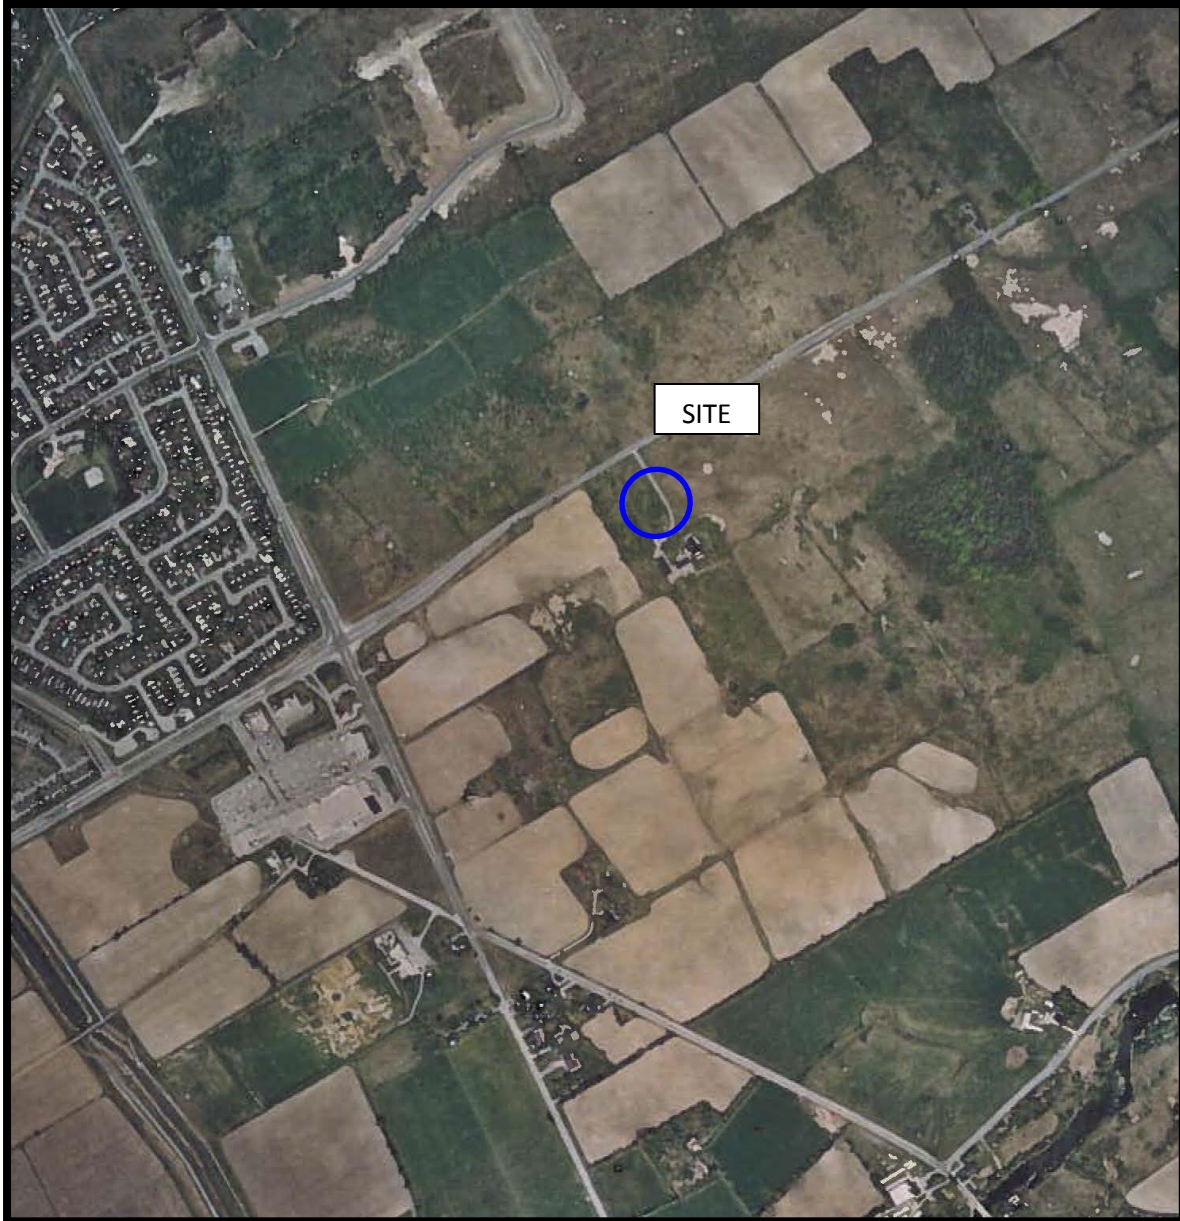
AERIAL PHOTOGRAPH
1999

1999	No significant changes have been made to the subject site or adjacent properties.
2014	(City of Ottawa Website) No significant changes appear to have been made to the subject property. The laneway is still present.

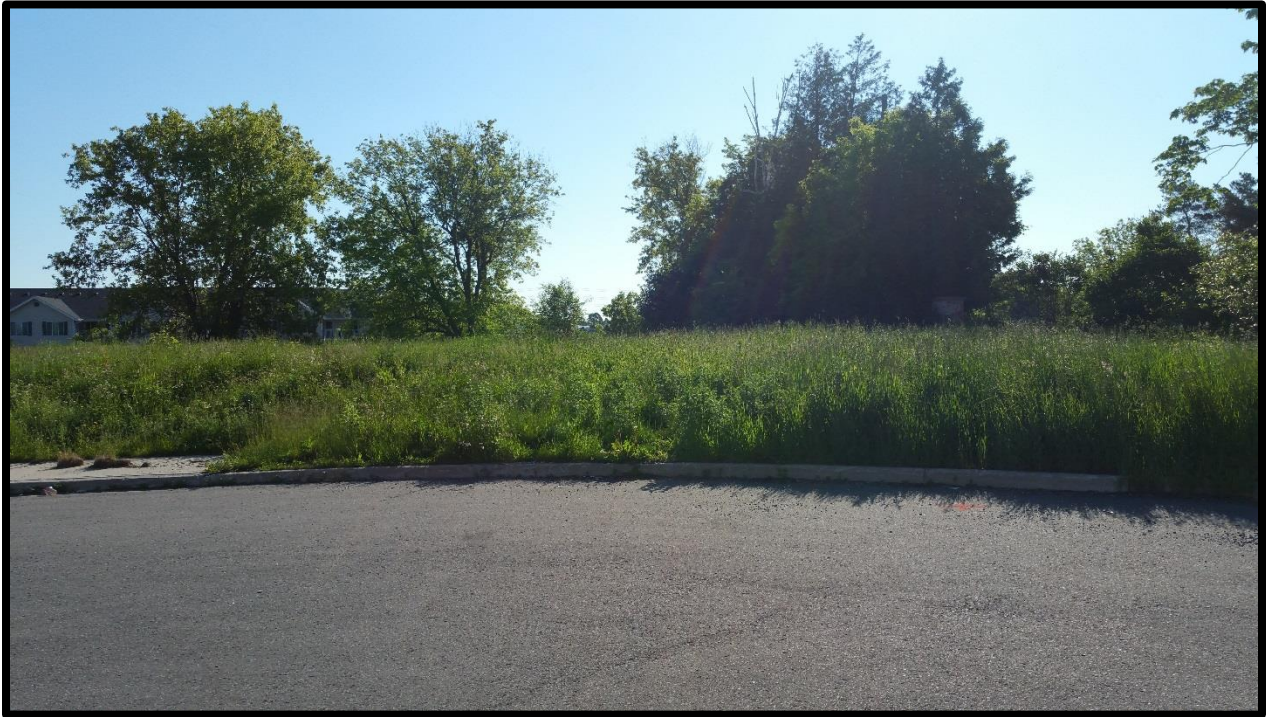
Photograph 1: View of the southwest portion of the subject site, facing east. Photograph illustrates the raised elevation of the site with respect to McGarry Terrace and the main land cover.

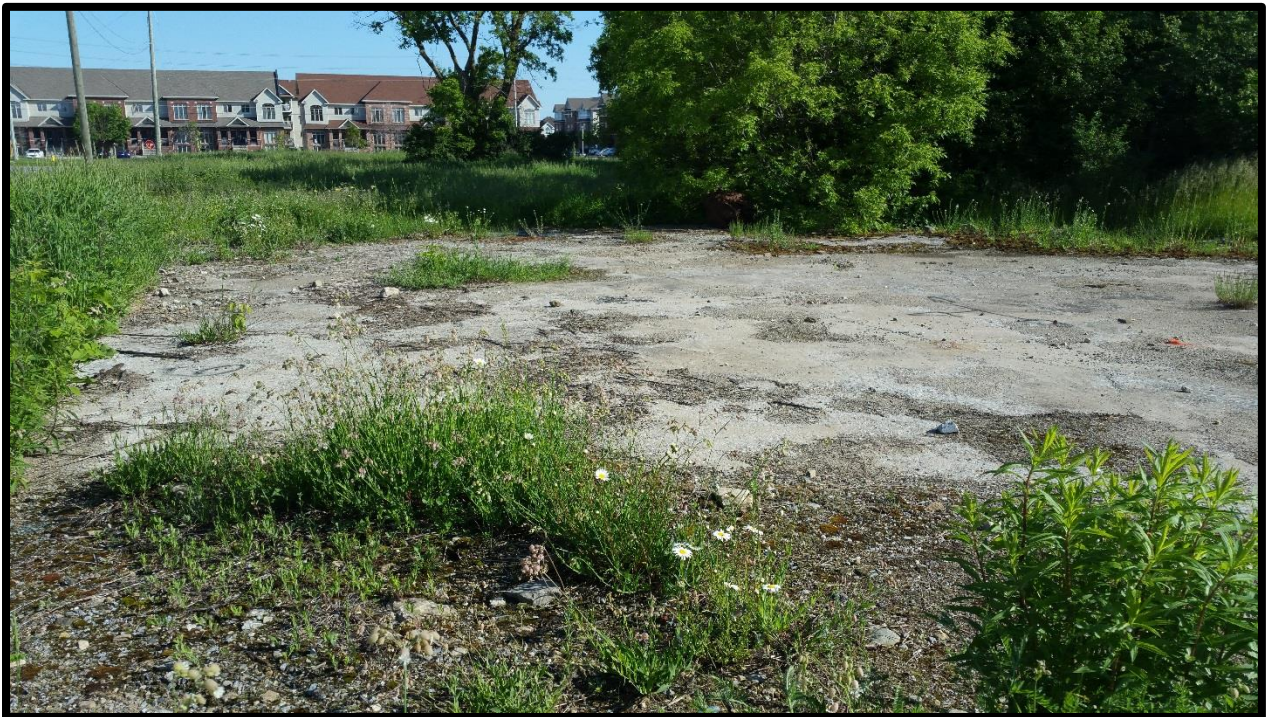
The site was undeveloped at the time of the site visit. One remnant poured concrete slab was observed on the southwest corner of the subject property, adjacent to McGarry Terrace. No other buildings or structures were observed at the time of the site visit.

There are no buildings on the subject site. One remnant concrete slab foundation was identified on the southwest portion of the subject site.

Photograph 2: View of the southwestern portion of the subject site, facing north. Photograph illustrates a remnant foundation on the property. No environmental concerns were identified with the foundation.

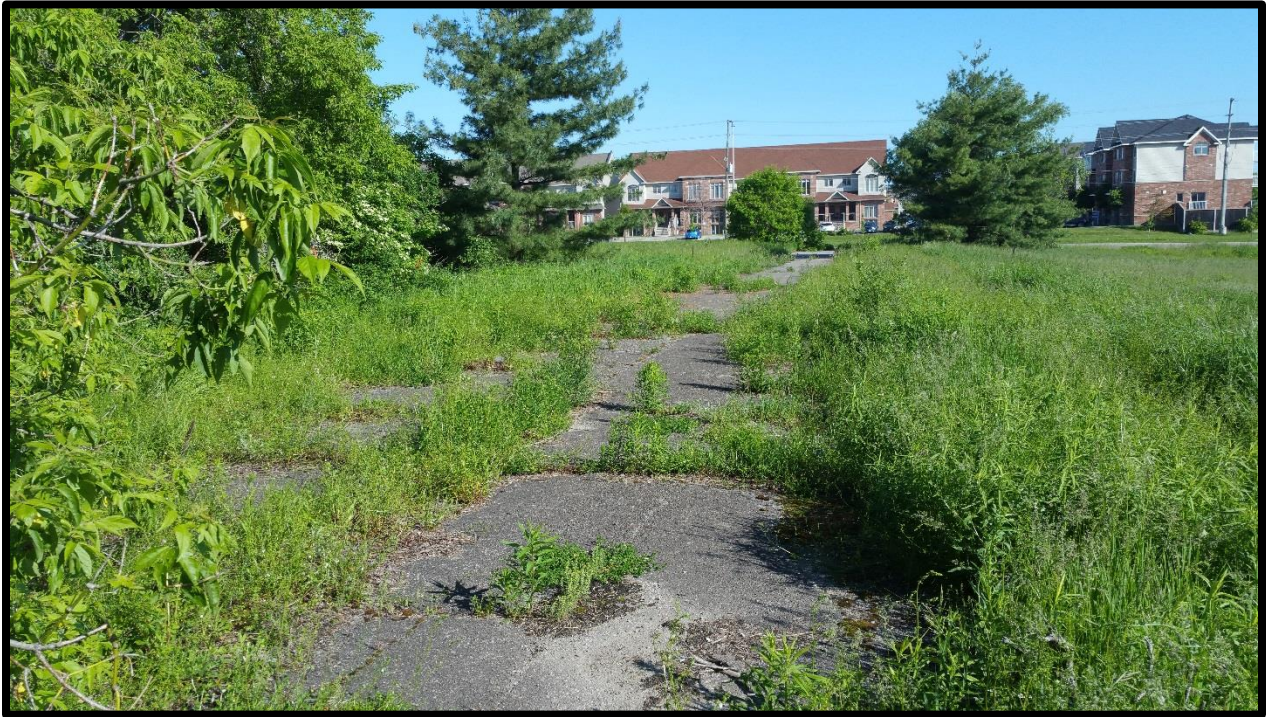
The ground surface across the majority of the property consists of grass covered and treed areas. One asphalt laneway crosses the subject property from north to south. A small remnant poured concrete slab was observed on the southwest portion of the property, adjacent to McGarry Terrace. No areas of stained soil were observed on the property. No visibly stressed vegetation was observed. No standing water was observed on the subject site.

Photograph 3: View of the central portion of the subject site, facing north. Photograph illustrates an asphalt access road leading to the subject site from Strandherd Drive.

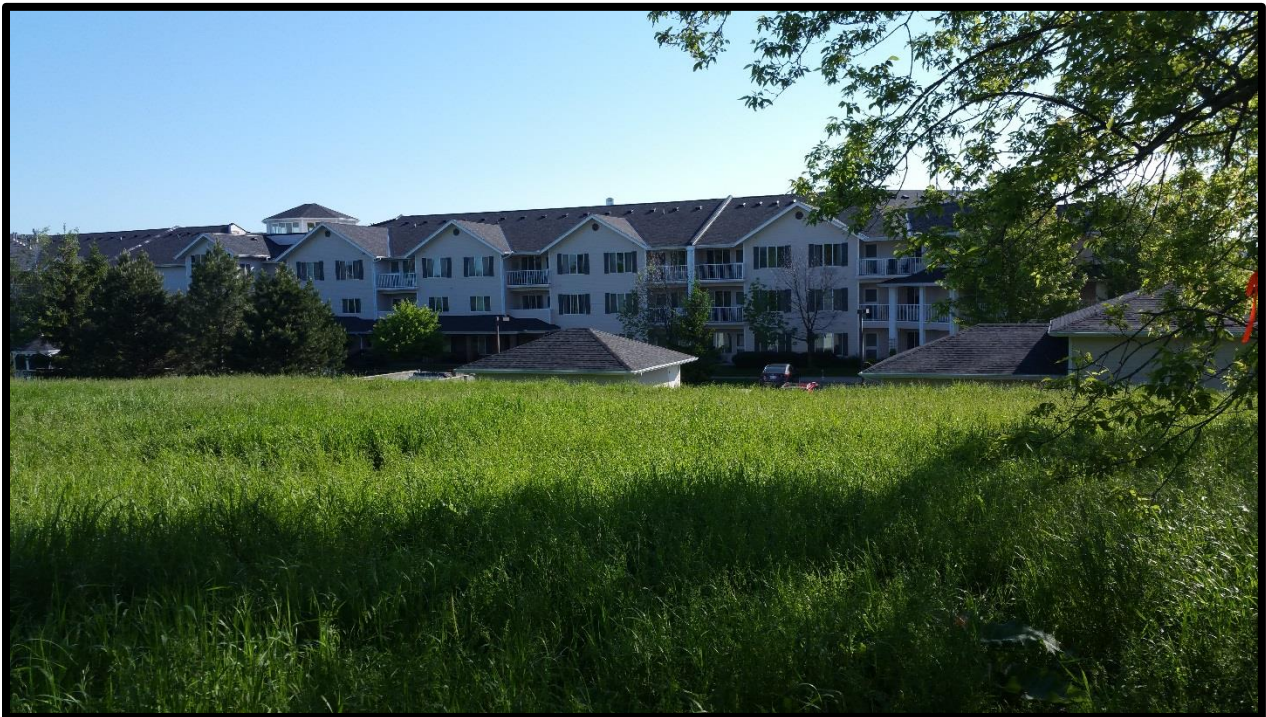
Photograph 4: View of the middle of the subject site, facing east. Photograph illustrates the raised elevation with respect to the adjacent property to the east and the main land cover.
