Phase I Environmental Site Assessment

20 Frank Nighbor Place
Ottawa, Ontario

July 17, 2017

Report: PE4065-1

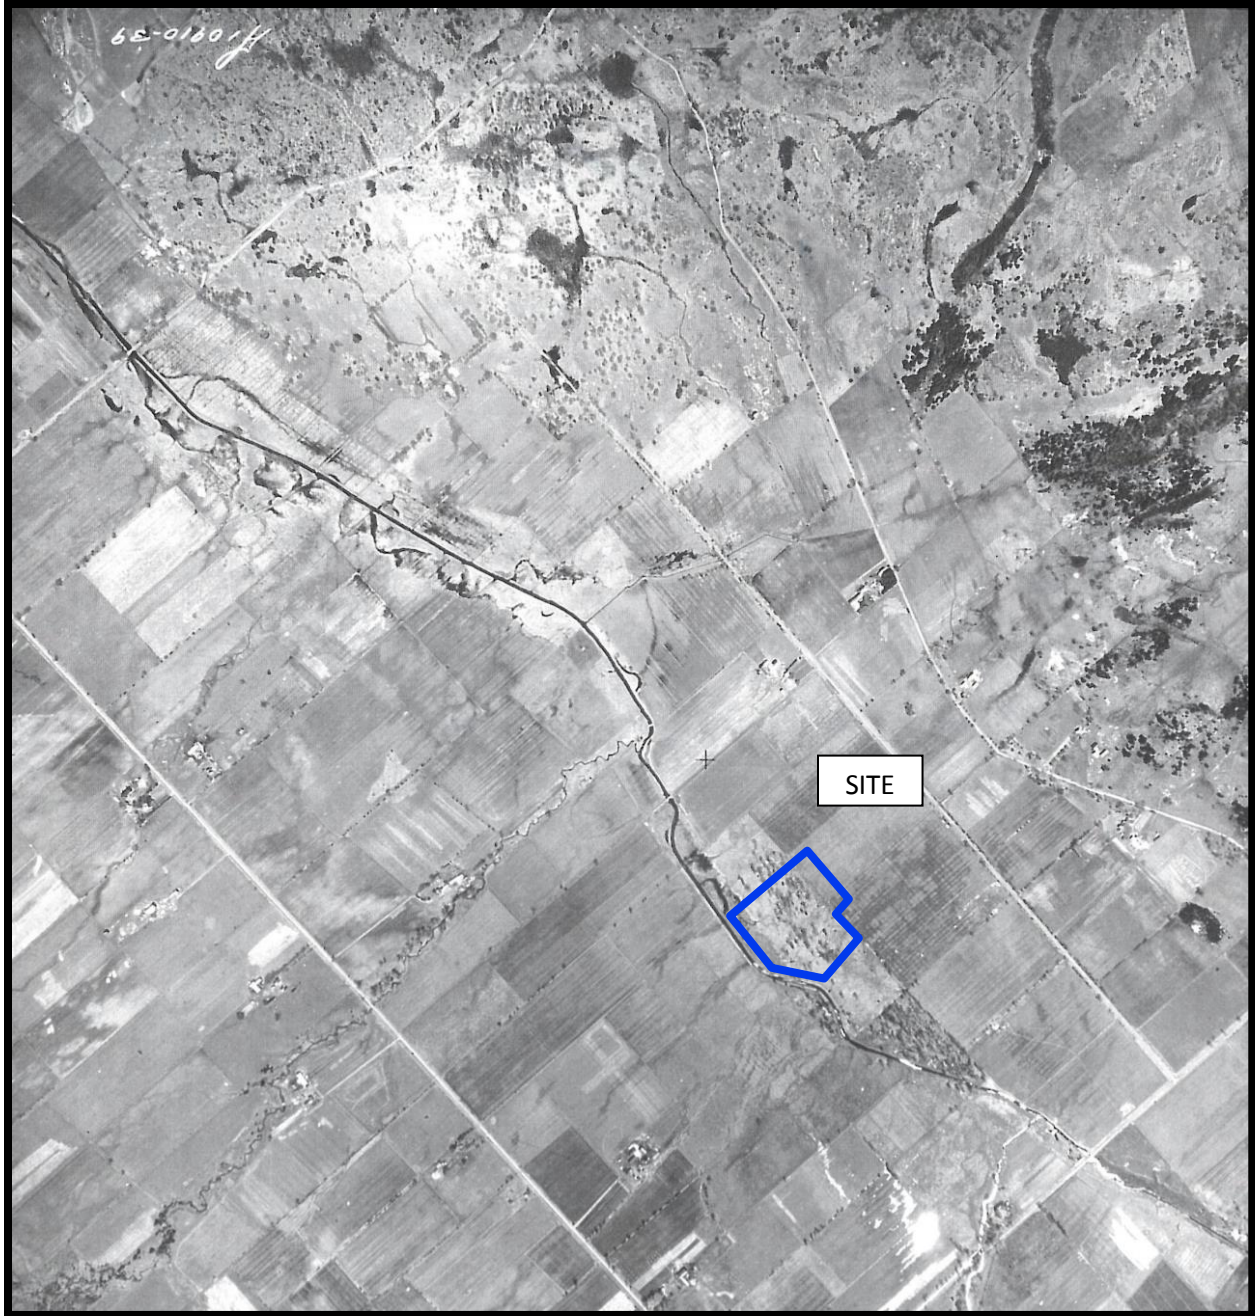
AERIAL PHOTOGRAPH
1947

1947	The subject site is vacant. The west part appears to be vegetated with grass and small brush and the eastern portion used for agricultural purposes. South of the subject site the Carp River is visible. Surrounding lands appear to be used for agricultural purposes with scattered farmsteads present.
------	--

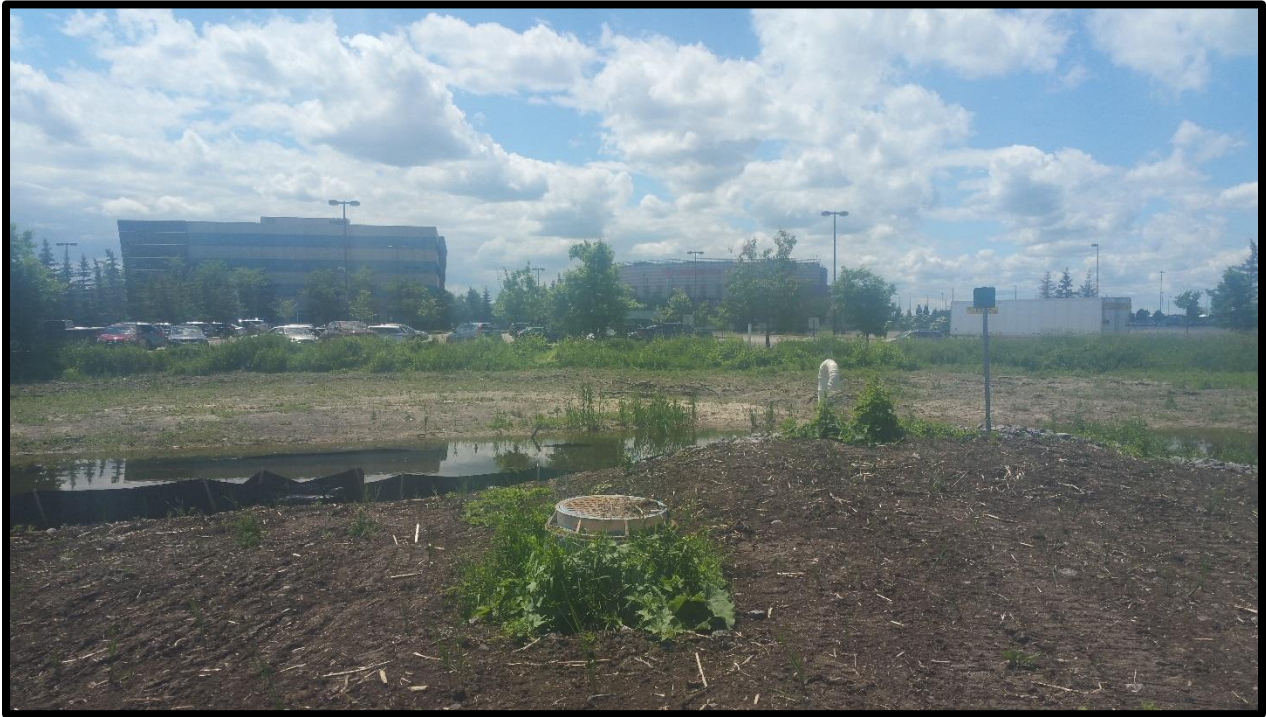
Photograph 1: View of the west side of the site, facing west. Photograph illustrates the Carp River, an on-site sanitary sewer and a non-vegetated cleared area. A commercial business and Canadian Tire Center are visible in the distance. No environmental concerns were identified.

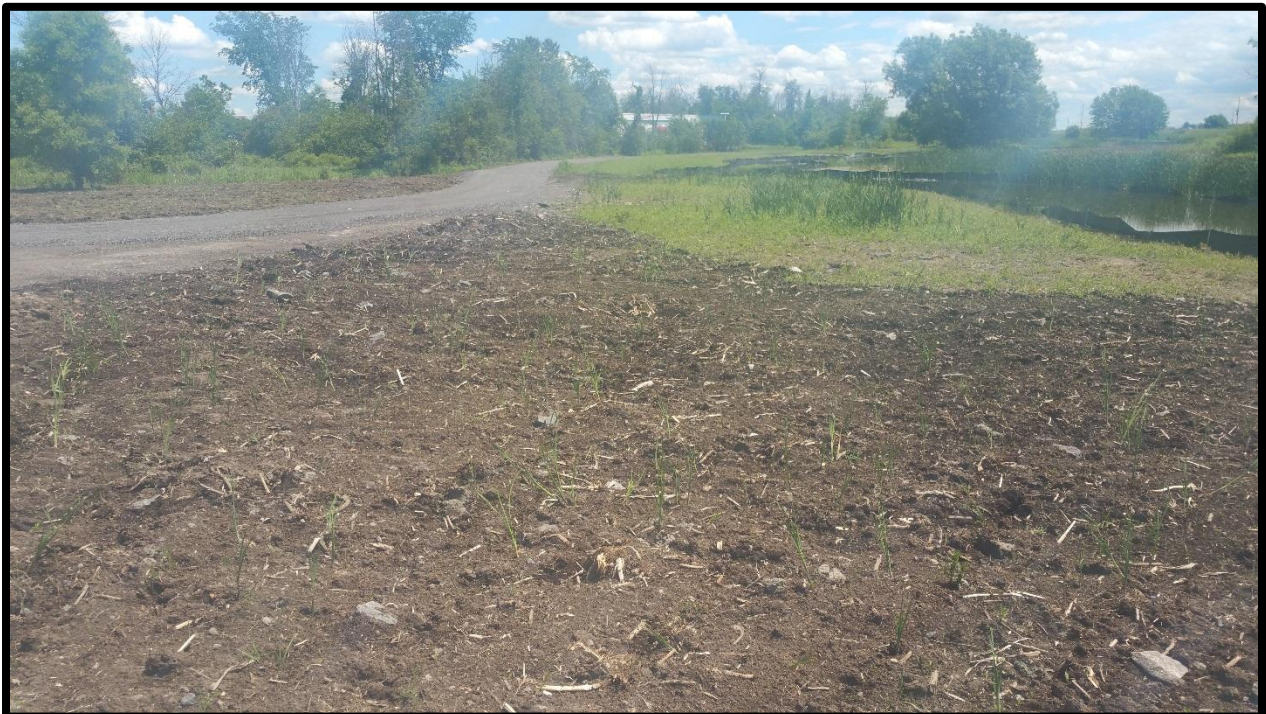
Photograph 2: View from the west side of the subject site, facing south. Photograph illustrates soil, grass, a gravel access road and trees in the distance. No environmental concerns were identified.

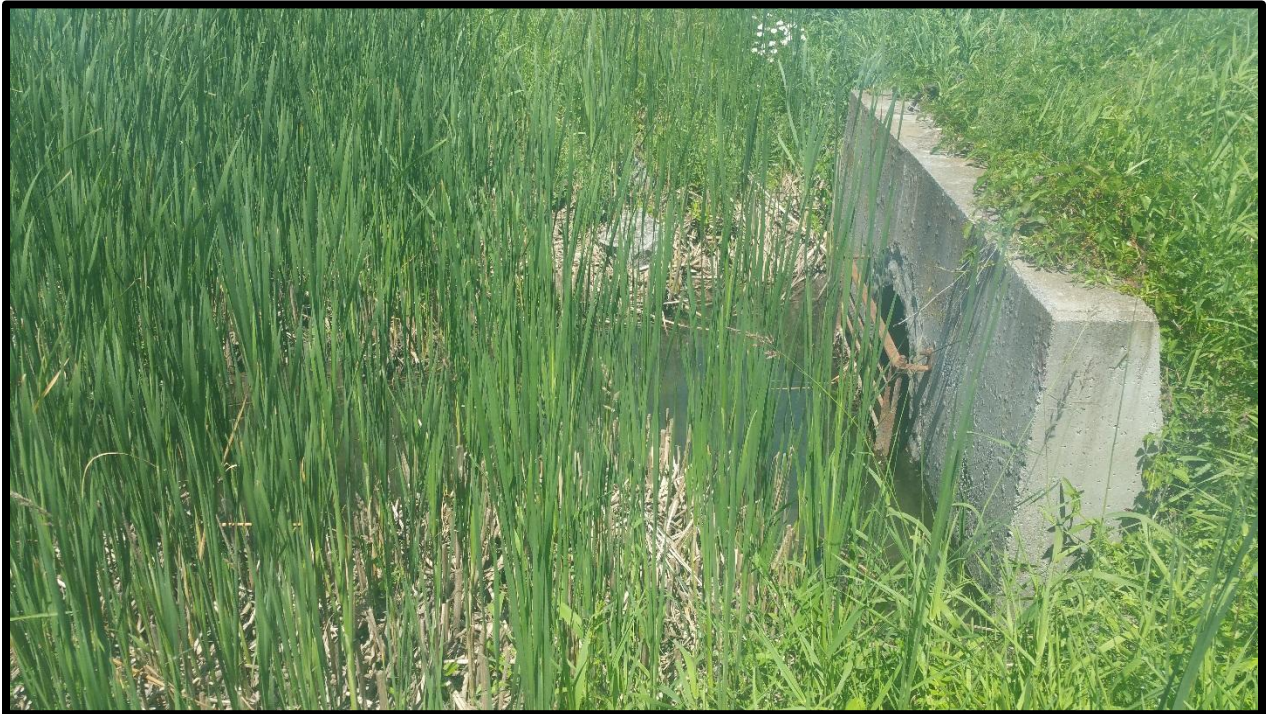
Photograph 3: View of a stormwater ditch and swamp located on the western perimeter of the site. Photograph taken facing north. No environmental concerns were identified.

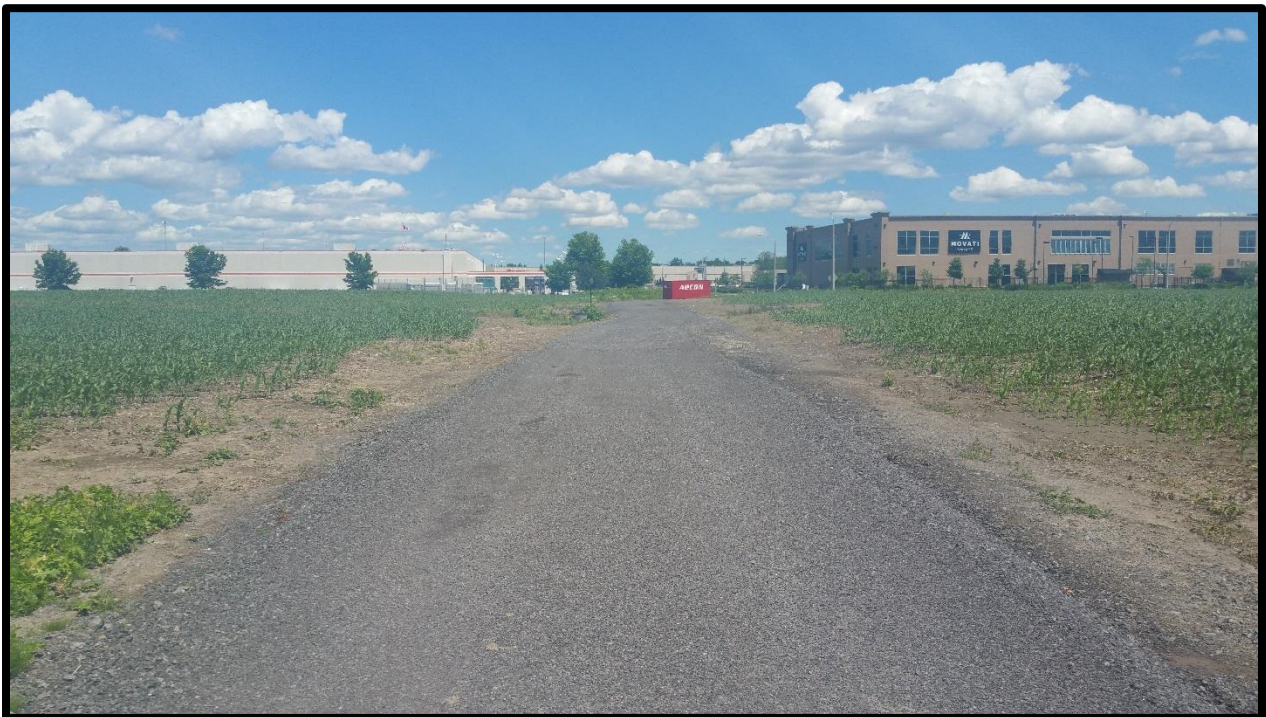
Photograph 4: View of the central and eastern most portion of the subject site. Photograph depicts a gravel access road and corn fields on either side. Photograph taken facing east. No environmental concerns were identified.
