Re: Tree Conservation Report for 16 & 20 Champagne Ave, Ottawa

This report details a pre-construction Tree Conservation Report (TCR) for the above-noted property in Ottawa. The need for this TCR is related to the proposed demolition of the two existing single-family dwellings and construction of a three storey, nineteen-unit apartment building. A full basement is proposed for the building. No parking spaces are proposed.

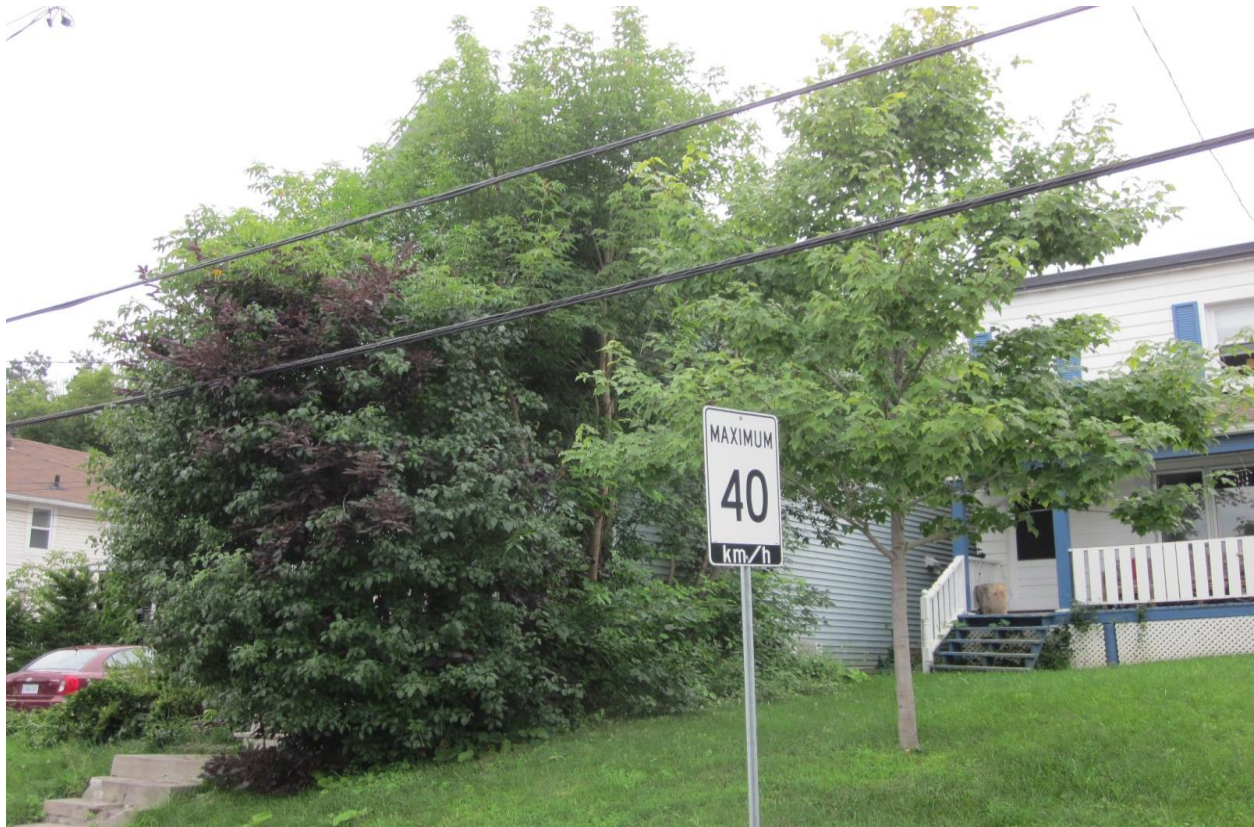
Picture 1. Tree #1 (right) and grouping #2 in front of 14 and 16 Champagne Ave.

| Tree No. | Tree Species | D.B.H. ¹ (cm) | Tree condition, age class and Status (to be removed or preserved and protected) |
|---|--|---|--|
| 1 | Red maple (<i>Acer rubrum</i>) | < 10 | Good; juvenile; recently planted on City of Ottawa property in front of #14; to be preserved and protected |
| 2 | Manitoba maple (<i>Acer negundo</i>); buckthorn (<i>Rhamnus</i> spp.); Chokecherry (<i>Prunus</i> spp.) | < 10 | Poor; maturing; grouping of seeded trees located on city, shared and private property in front of veranda at #16; all introduced naturalized/invasive species; to be removed with permission of adjacent land owners (conflict with construction) |

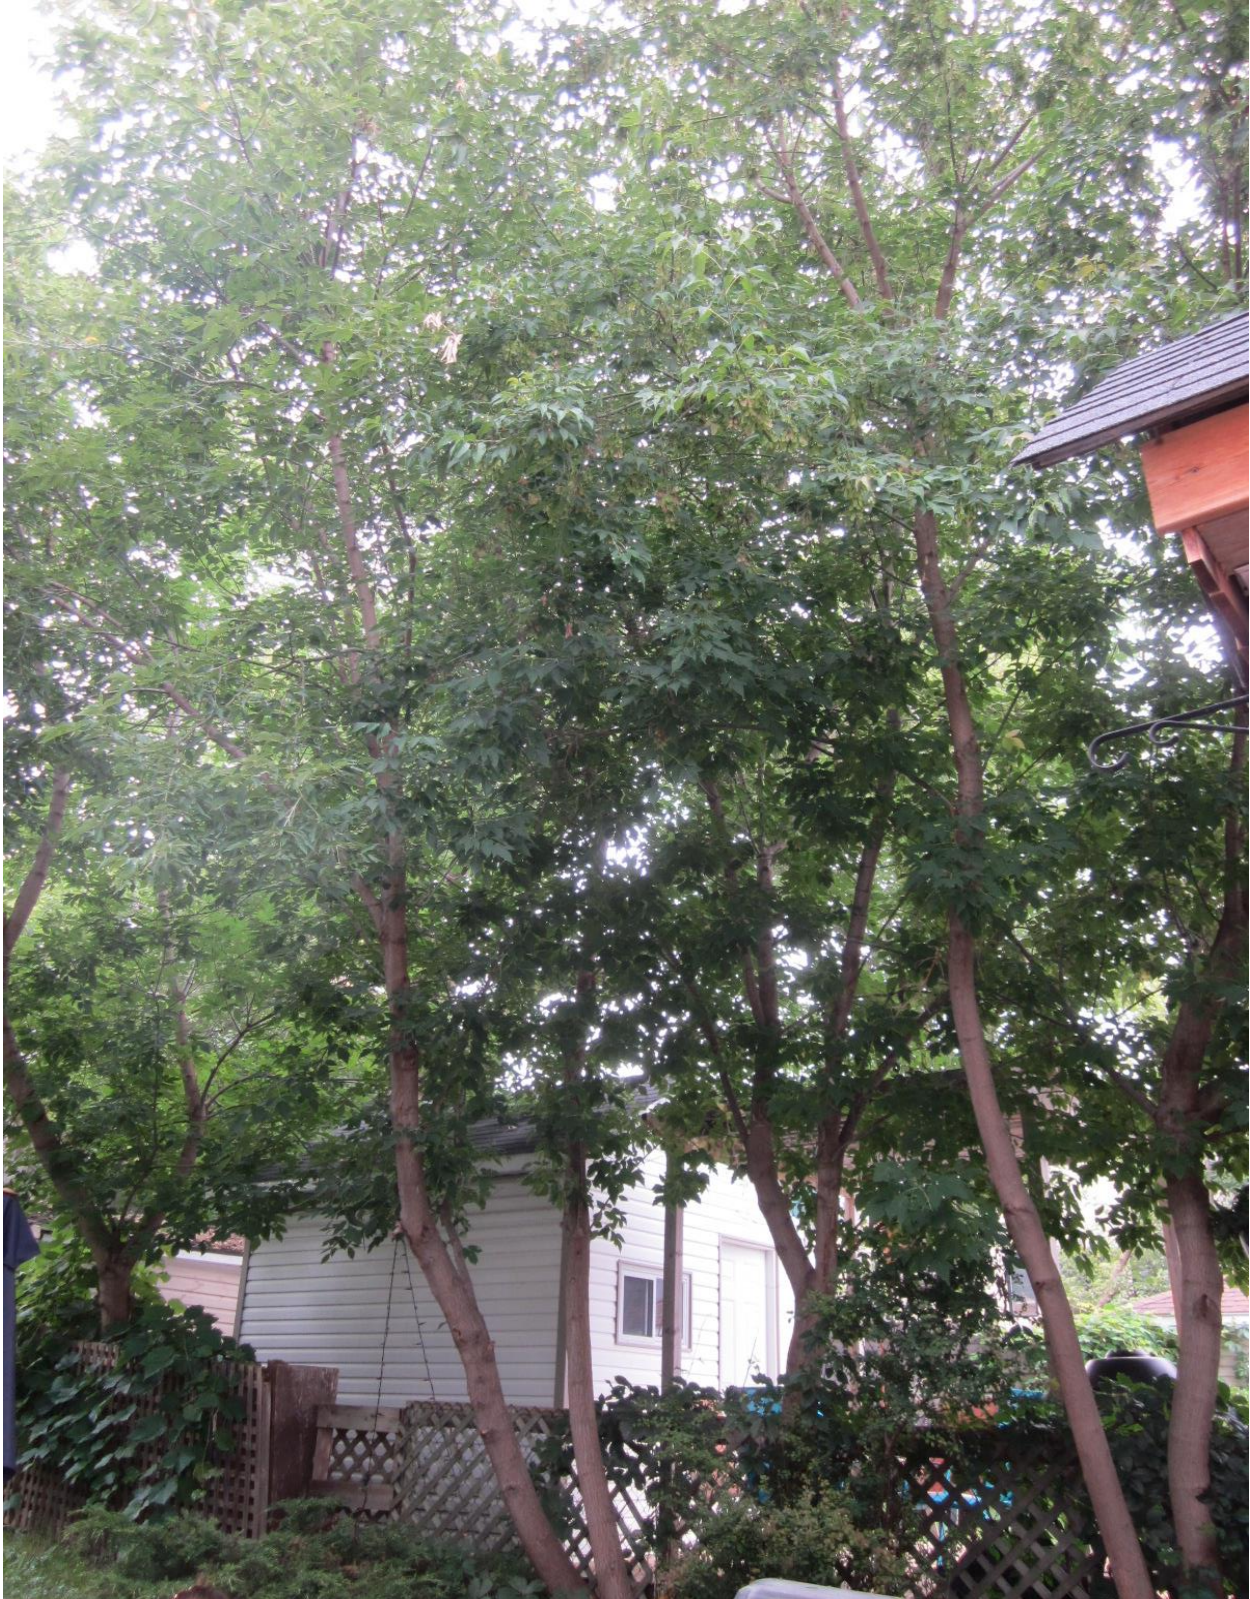
Picture 2. Tree line #3 on or shared with 14 Champagne Ave.

| Tree No. | Tree Species | D.B.H. ¹ (cm) | Tree condition, age class and Status (to be removed or preserved and protected) |
|---|--|---|--|
| 3 | Manitoba maple | 11-19 | Fair; maturing; line of four trees located or shared with neighbouring property (#14); all originating from seed; introduced species; to be preserved and protected |

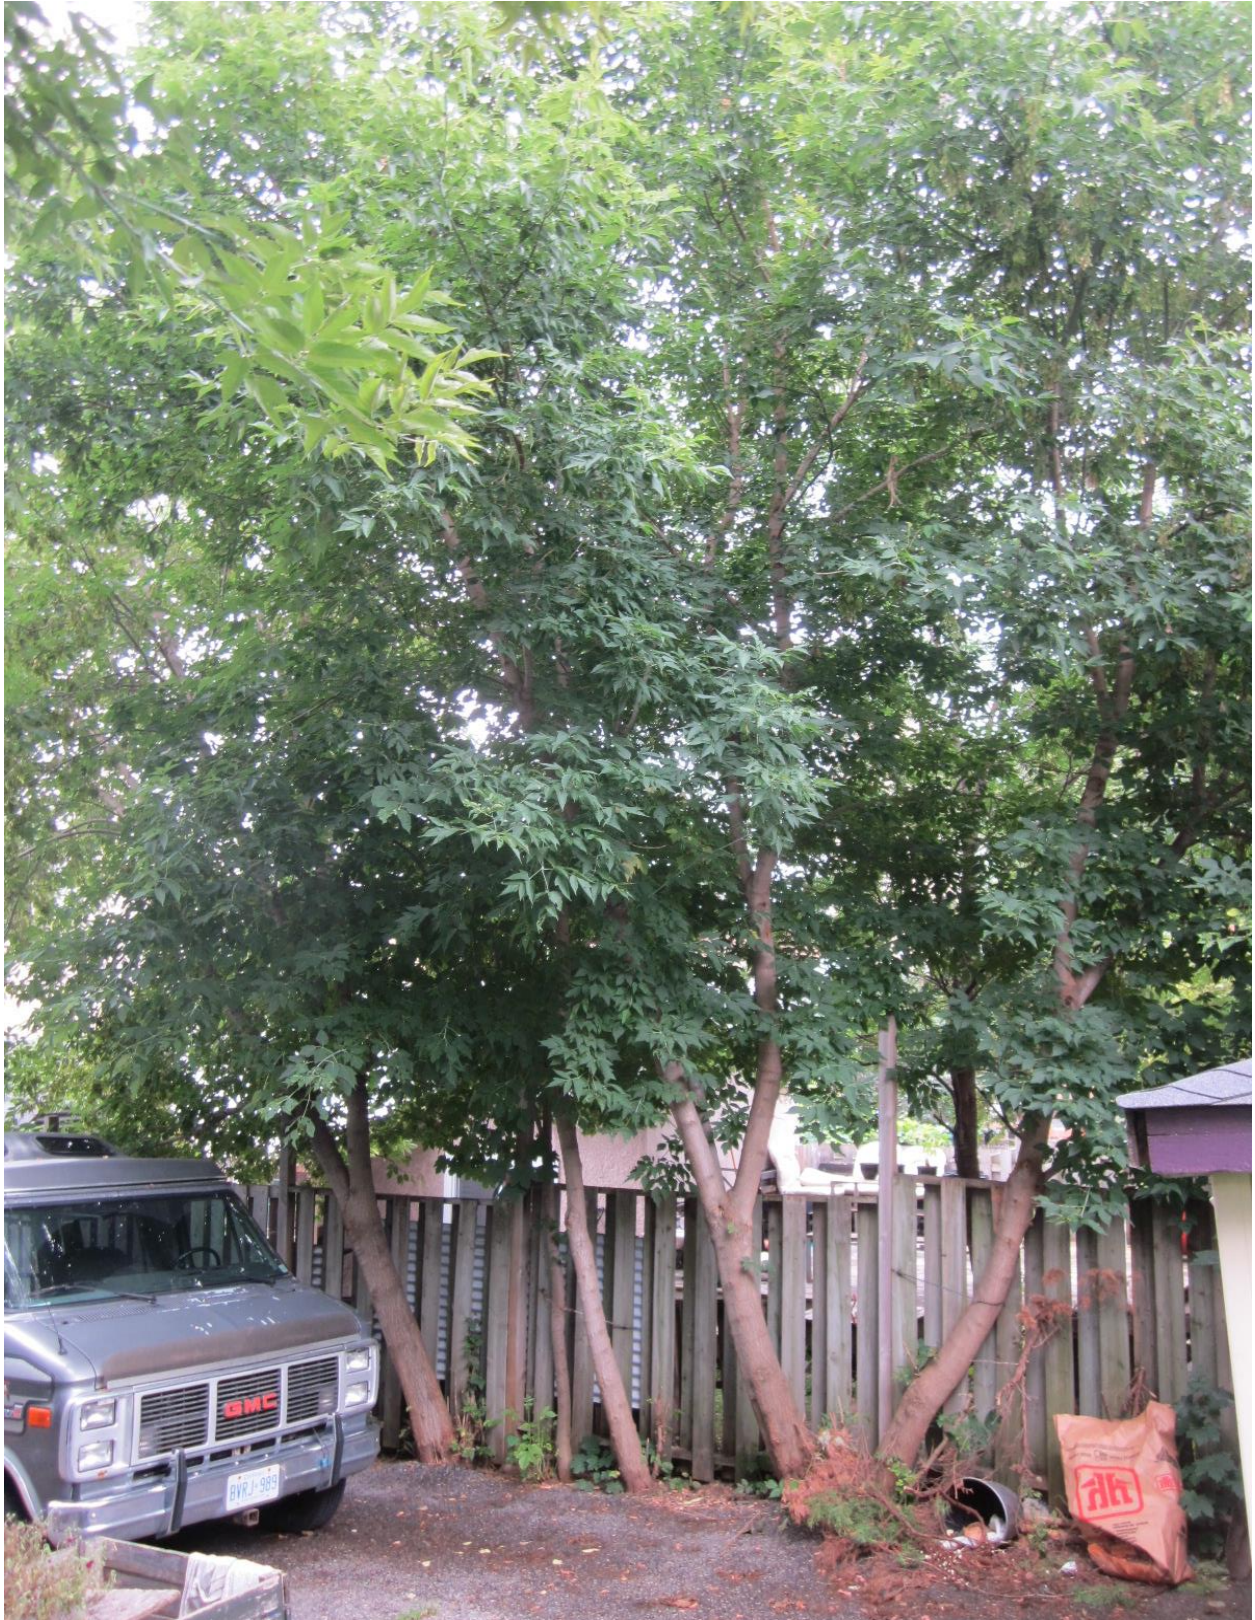
Picture 3. Tree line #4 at 16/20 Champagne Ave.

| Tree No. | Tree Species | D.B.H. ¹ (cm) | Tree condition, age class and Status (to be removed or preserved and protected) |
|---|--|---|--|
| 4 | Manitoba maple | 13-20 | Fair; maturing; line of three trees located along property line between #16 & 20; all originating from seed; introduced species; to be removed (conflict with construction) |

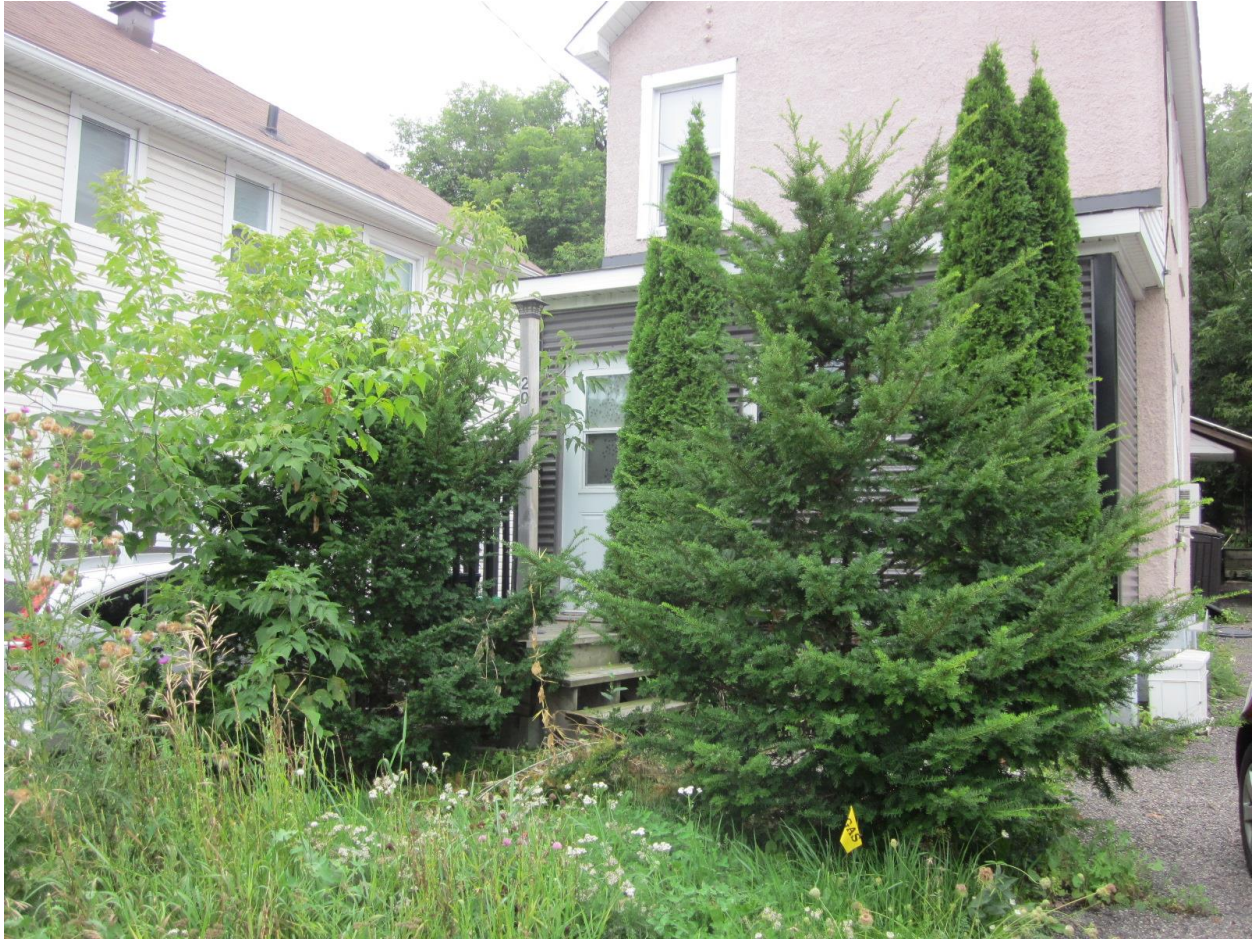
Picture 4. Tree grouping #7 in front of 20 Champagne Ave.

| Tree No. | Tree Species | D.B.H. ¹ (cm) | Tree condition, age class and Status (to be removed or preserved and protected) |
|---|--|---|--|
| 7 | Cedars (<i>Thuja</i> spp.) and yews (<i>Taxus</i> spp.) | < 10 | Good; maturing; grouping of planted trees located on private property in front of porch at #20; all ornamental varieties; to be removed (conflict with construction) |
