Phase I Environmental Site Assessment

2390 and 2410 Stevenage Drive Ottawa, Ontario

Sysco Corporation

Report: PE4373-1

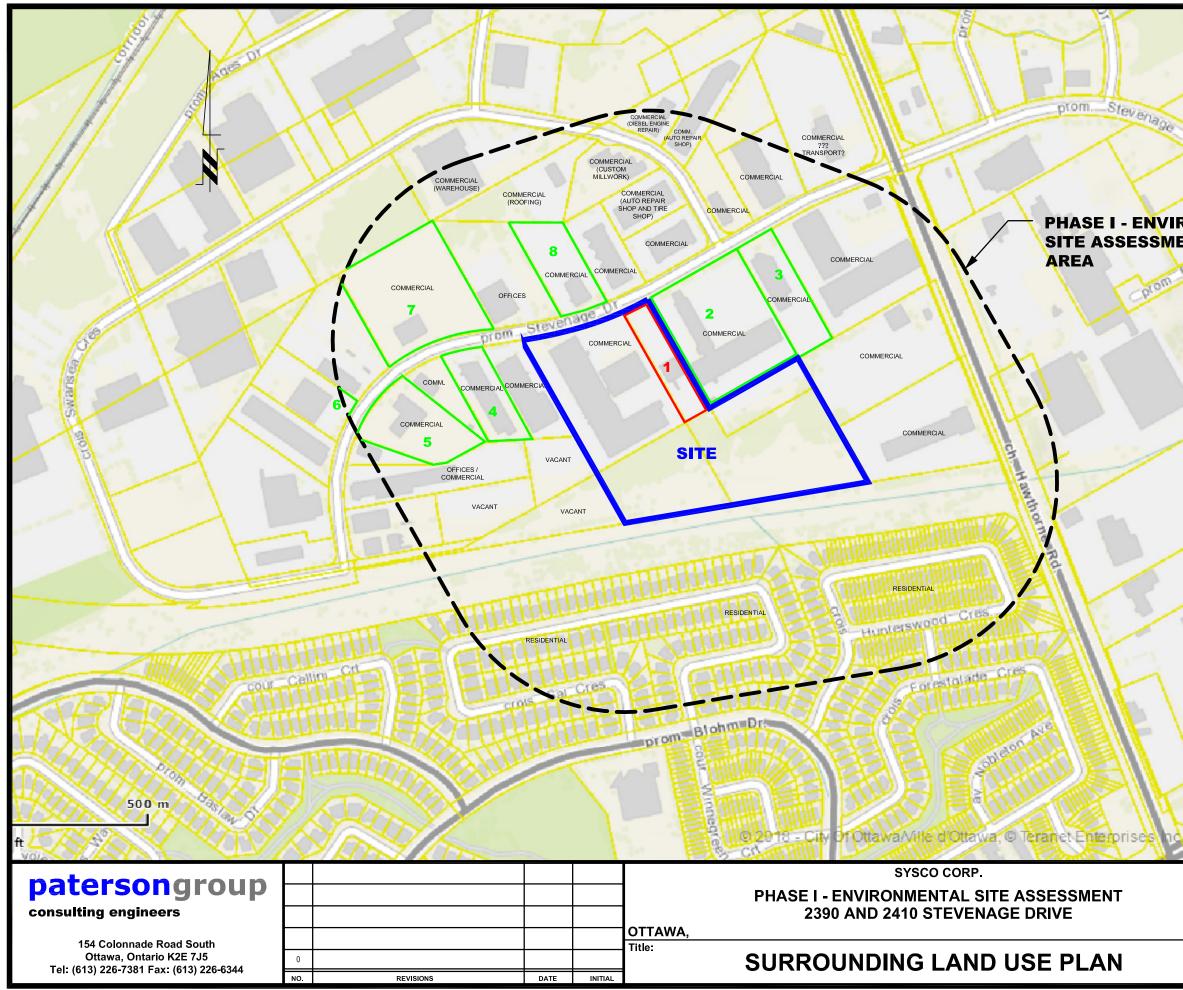
Scale:		Date:
	1:5000	08/2018
Drawn by:		Report No.:
	RCG	PE4373-1
Checked by:		Dwg. No.:
	MW	PE4373-2
Approved by:		FE4373-Z
	MSD	Revision No.: 0
	Drawn by: Checked by:	1:5000 Drawn by: RCG Checked by: MW Approved by:

the remaining off-site PCAs noted above are not considered to represent APECs on the subject land. These PCAs are depicted in green on Drawing PE4373-2 – Surrounding Land use Plan.

RONM	ENTAL TUDY
1	
	POTENTIALLY CONTAMINATING ACTIVITIES:1.2410 STEVENAGE DRIVE - THERMO KING2.2420 STEVENAGE DRIVE - RUSSELL METALS3.2450 STEVENAGE DRIVE - WAJAX POWER SYSTEMS (FORMERLY HARPER DETOIT DIESEL ENGINES)
	 2350 STEVENAGE DRIVE - FORMER AUTOMOTIVE REPAIR SHOP AND CHEMICAL SHOP 2320 STEVENAGE DRIVE - FORMERLY HARPER DETOIT DIESEL ENGINES 2295 STEVENAGE DRIVE - ALLIED PLASTICS 2323 STEVENAGE DRIVE - PENSKE TRUCK RENTAL 2390 STEVENAGE DRIVE - RYDER TRUCK RENTAL

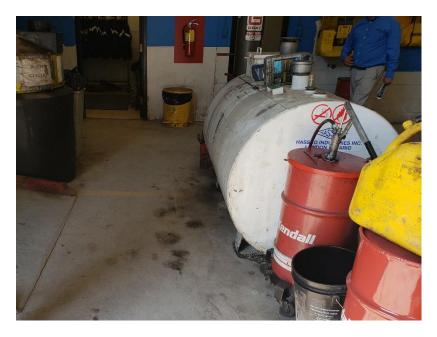
No underground fuel storage tanks (USTs) or vent and fill pipes were observed on the Phase I Property. One aboveground oil storage tank (AST) was identified inside the garage at Thermo King. The AST is used to store of spent engine oil. Some staining was observed below the tank. Both buildings have always been heated using natural gas.

Photograph 1: Above ground used oil storage tank inside the Thermo King service bay.

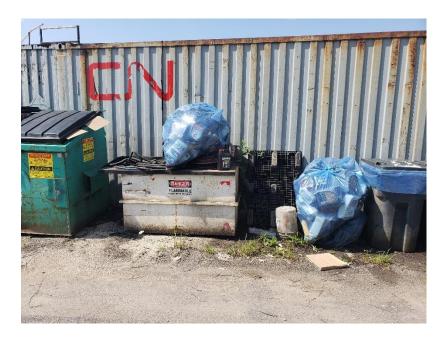
Photograph 2: View of waste collection bins at the south of the Thermo King subject property.

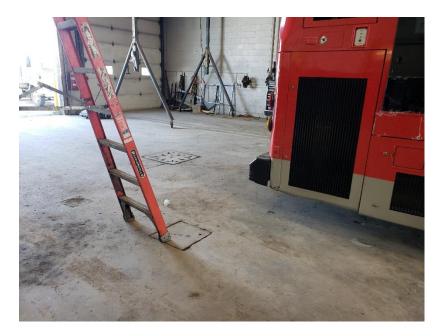
No wastewater drains were observed. Two (2) concrete catchment basins were observed at the garage (Thermo King); one adjacent to the AST and the other 2.5 m away. The catchment basins are emptied yearly by a licensed contractor. No floor drains were observed throughout either subject building.

Photograph 3: View of the interior catch basins of the Thermo King service bay.

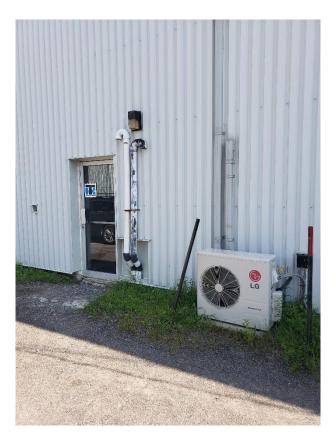
Photograph 4: View of the west facing façade of the Thermo King subject building. Air condition serves the office area and the vent pipes are presumed to serve the service bay catch basins.

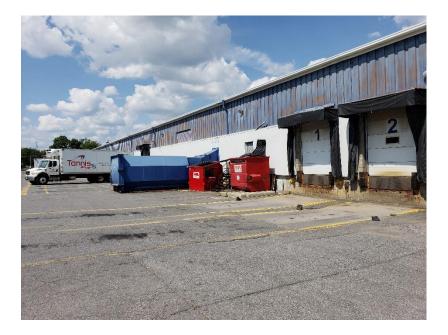
Photograph 6: View of the western loading bay of the Tannis subject building. Also depicted is the garbage compactor and the waste collection bins.

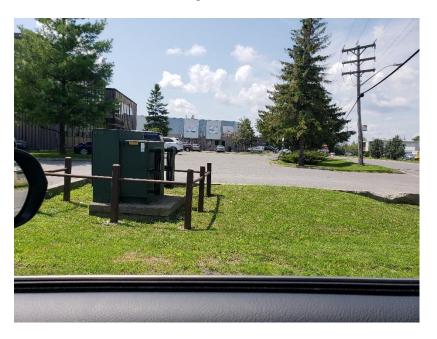
One pad mounted transformer was located off-site on the adjacent property to the west. At the time of assessment, no leaks, staining/discolouration or dead grass beneath the electrical equipment was observed on the concrete pad.

Photograph 6: View of the above ground transformer situated to the north west of the tennis subject building. This transformer was noted to be on the neighboring property.

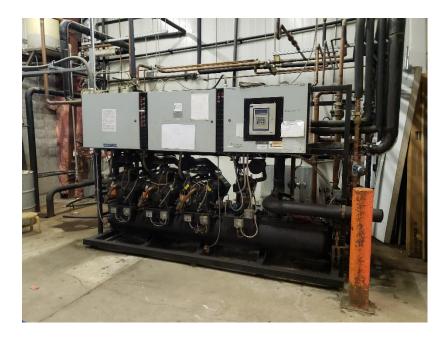
Photograph 8: View of the compressors serving the refrigeration and freezer units of the Tannis subject building.
