**Phase I Environmental Site Assessment**

Vacant Property  
3735 St. Joseph Boulevard  
Ottawa, Ontario

**May 6, 2014**

Report: PE3204-2

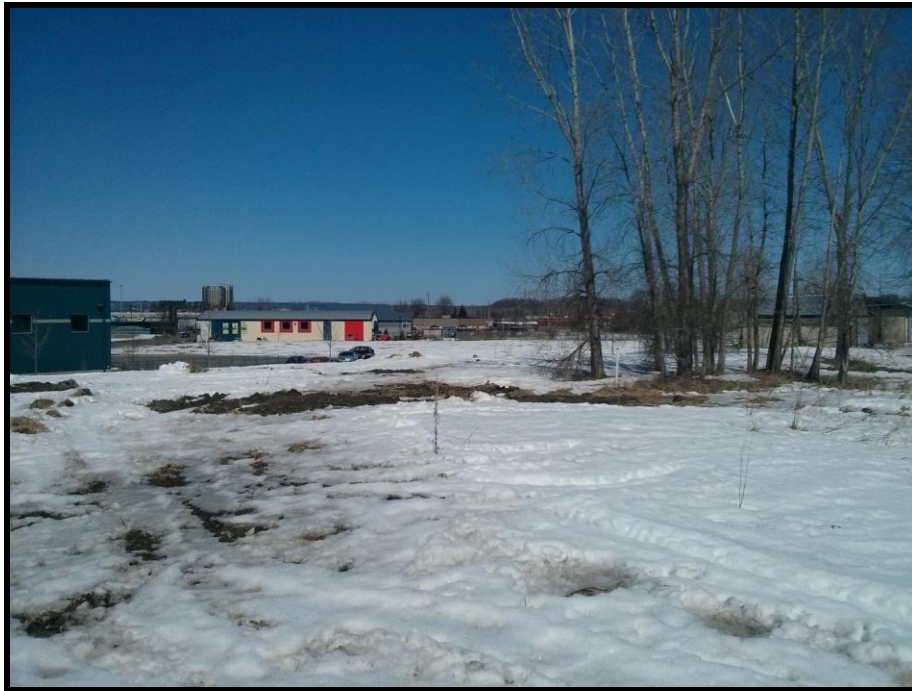
Photograph 1: View of northeast portion of the subject site, facing northeast.

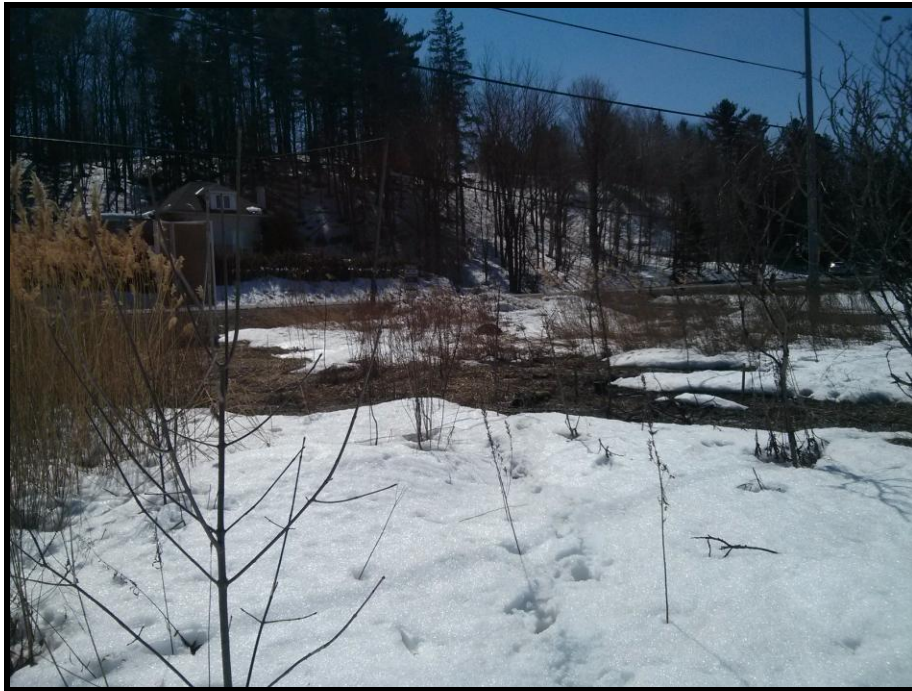
Photograph 5: View of southwest portion of the subject site, facing southwest.
